DETAILED CONTAMINATION SITE INVESTIGATION REPORT

232 Grange Avenue, Marsden Park

ADDRESS: 232 Grange Ave, Marsden Park NSW

REPORT No: NE083

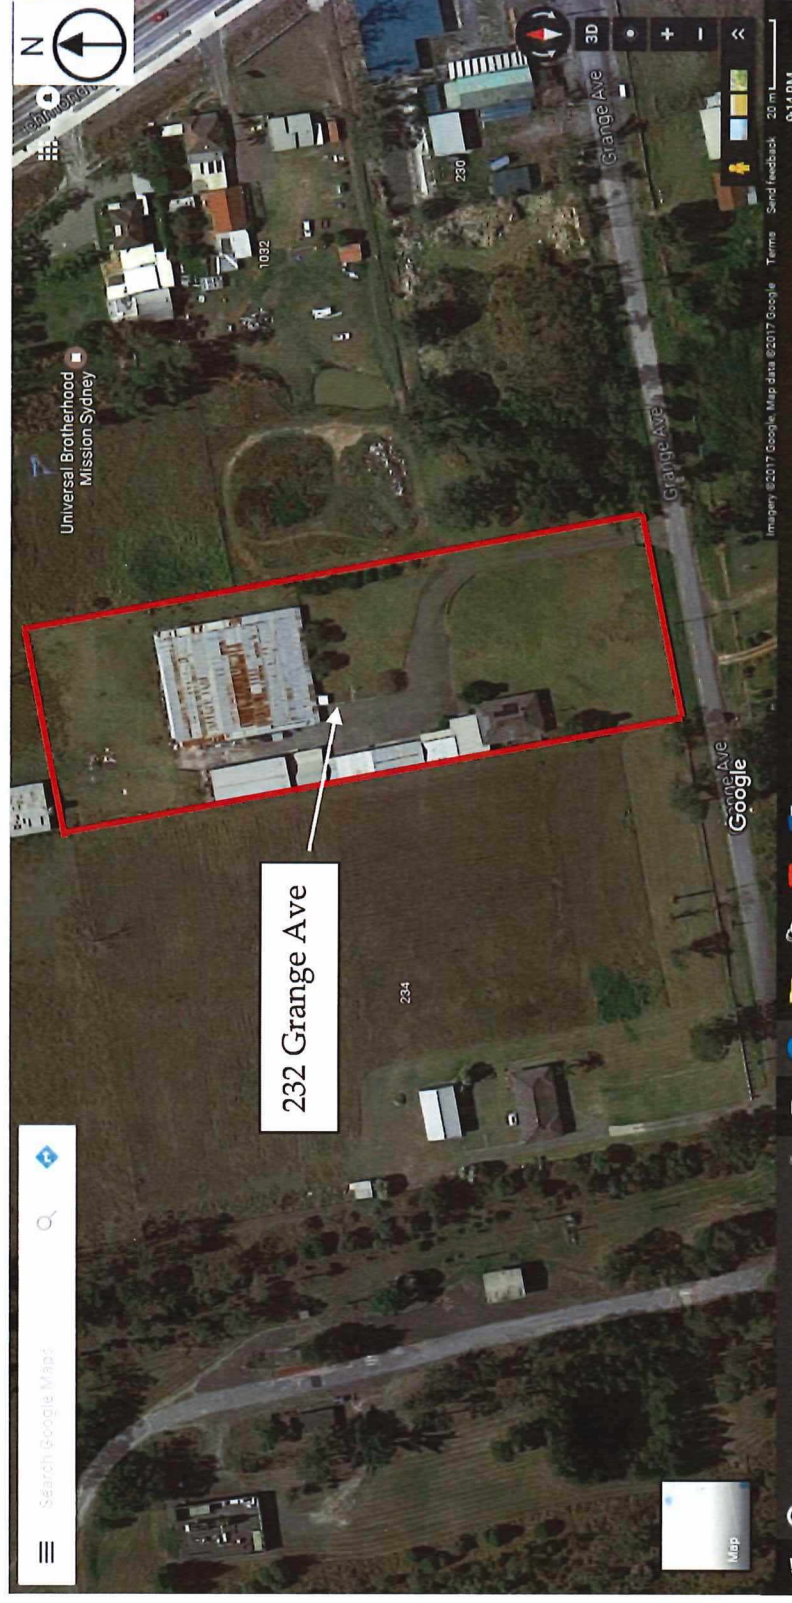
Figure 1: Site Location

Investigation area is situated at 232 Grange Ave, Marsden Park NSW. The site location is shown in Figure 1. The subject site is located on the northern side of the Grange Avenue. The site is rectangular in shape, measuring about 60m along Grange Ave. The area of the site is about 1.1 ha. The site is gently sloping to south. The site is within the Blacktown City Council [1].

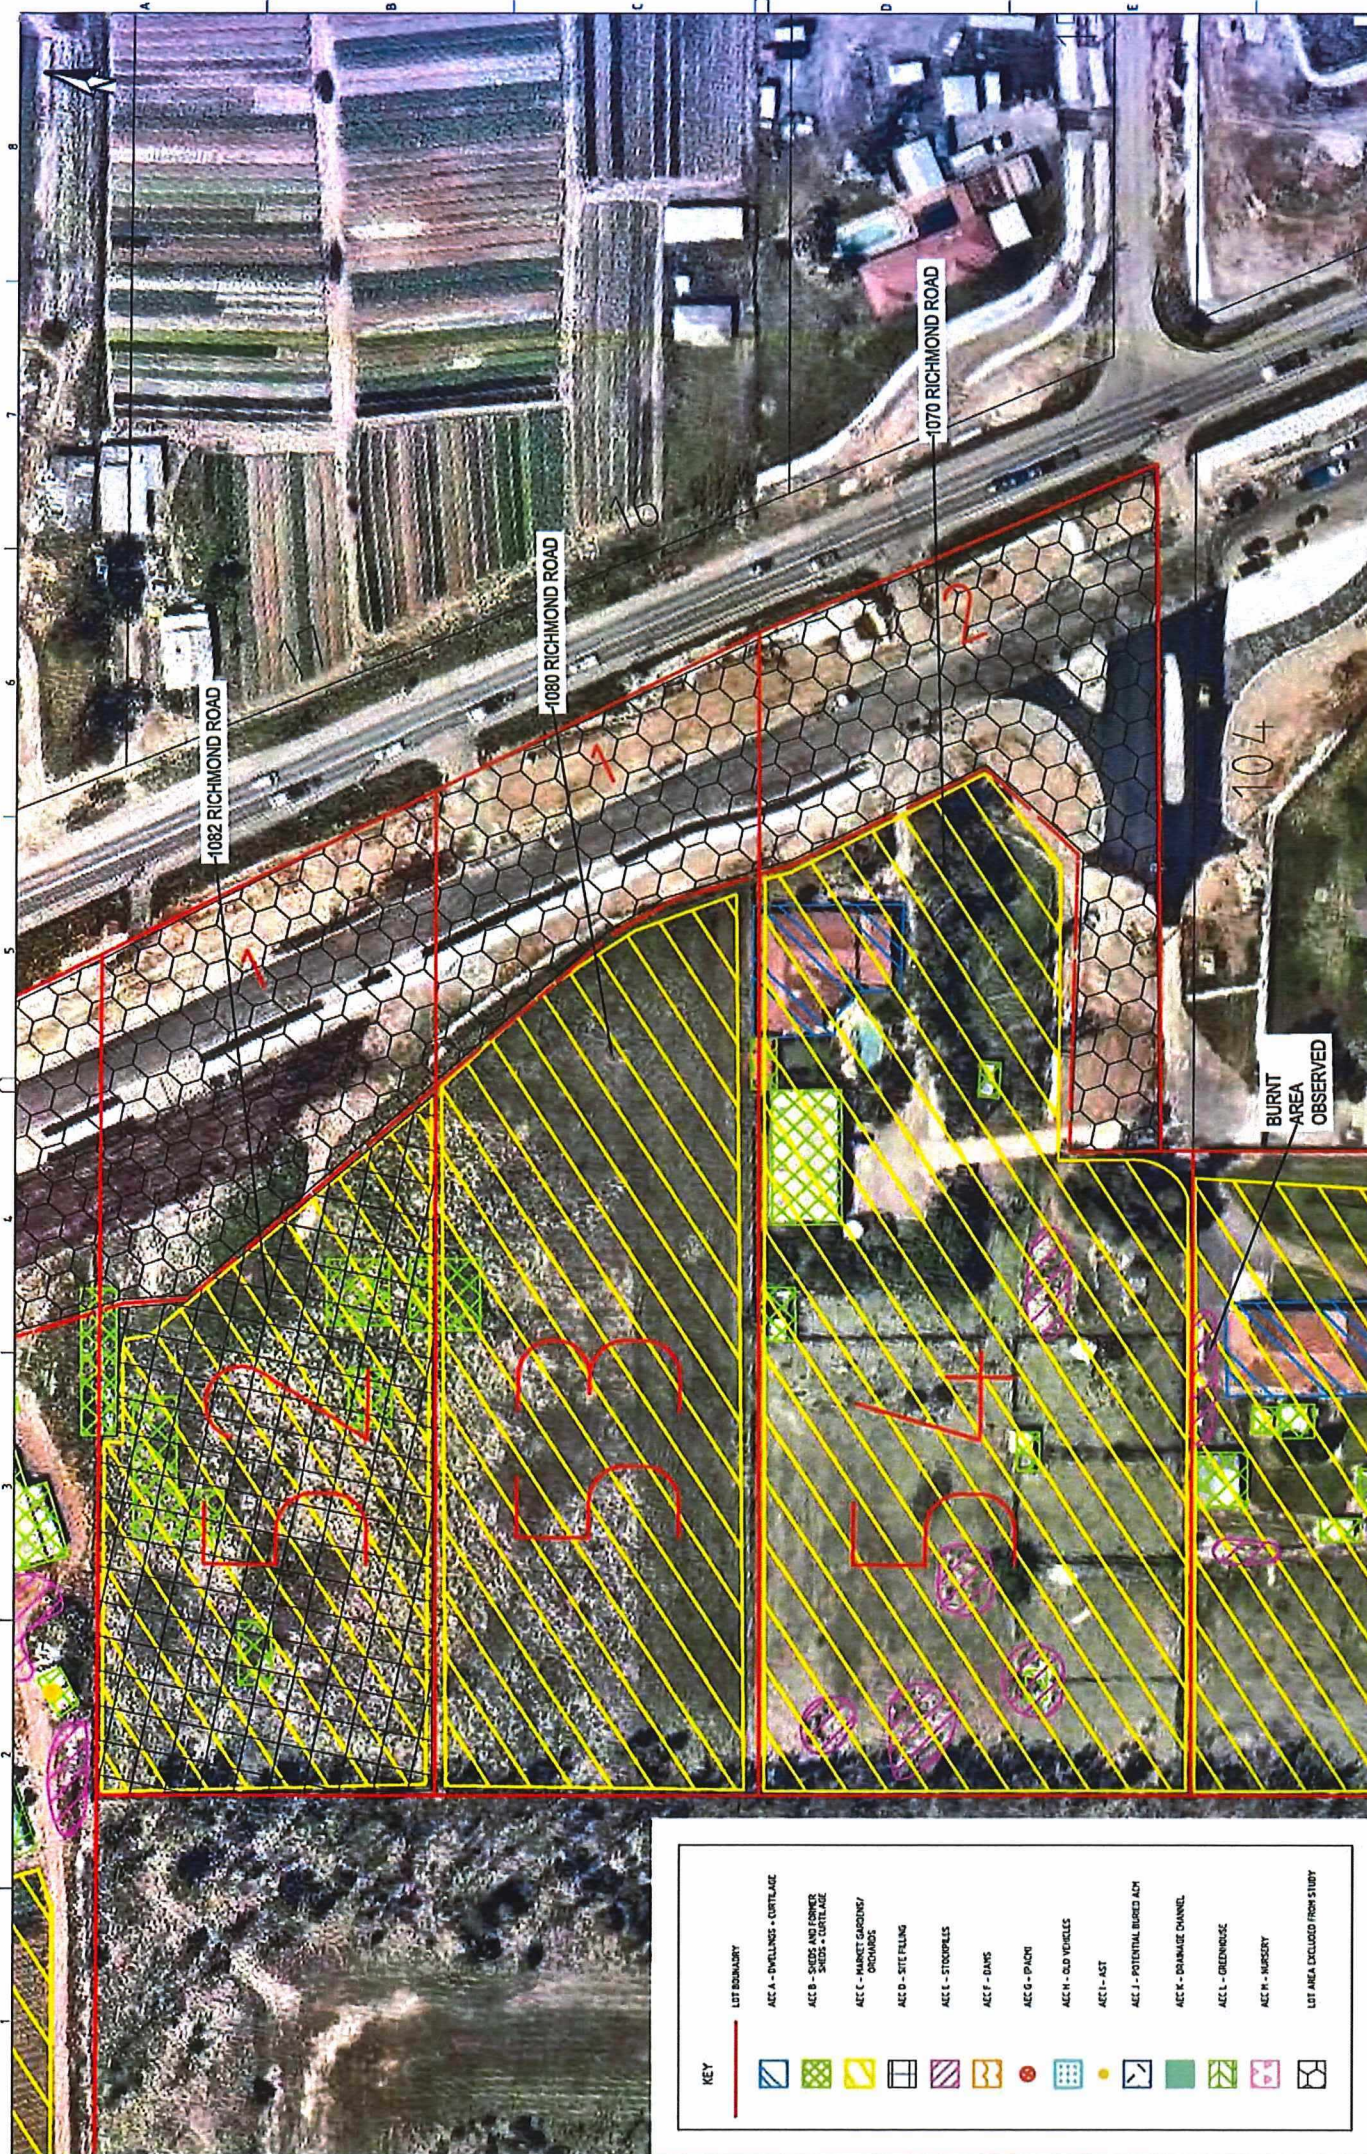
10 Attachment C – AEC Locations

KEY		LOT BOUNDARY	
	ACC A - DWELLINGS - CORTLAGE		ACC E - MARKET GARDENS/ ORCHARDS
	ACC B - SHEEP AND COWS/ SHEEDS - CORTLAGE		ACC D - SITE FILLING
	ACC C - MARKET GARDENS/ ORCHARDS		ACC F - STOCKPILES
	ACC D - SITE FILLING		ACC G - DAMS
	ACC E - MARKET GARDENS/ ORCHARDS		ACC H - OLD VEHICLES
	ACC F - STOCKPILES		ACC I - AST
	ACC G - DAMS		ACC J - POTENTIAL BURIED ALN
	ACC H - OLD VEHICLES		ACC K - DRAINAGE CHANNEL
	ACC I - AST		ACC L - GREENHOUSE
	ACC J - POTENTIAL BURIED ALN		ACC M - MANSERY
	ACC K - DRAINAGE CHANNEL		
	ACC L - GREENHOUSE		
	ACC M - MANSERY		
		<

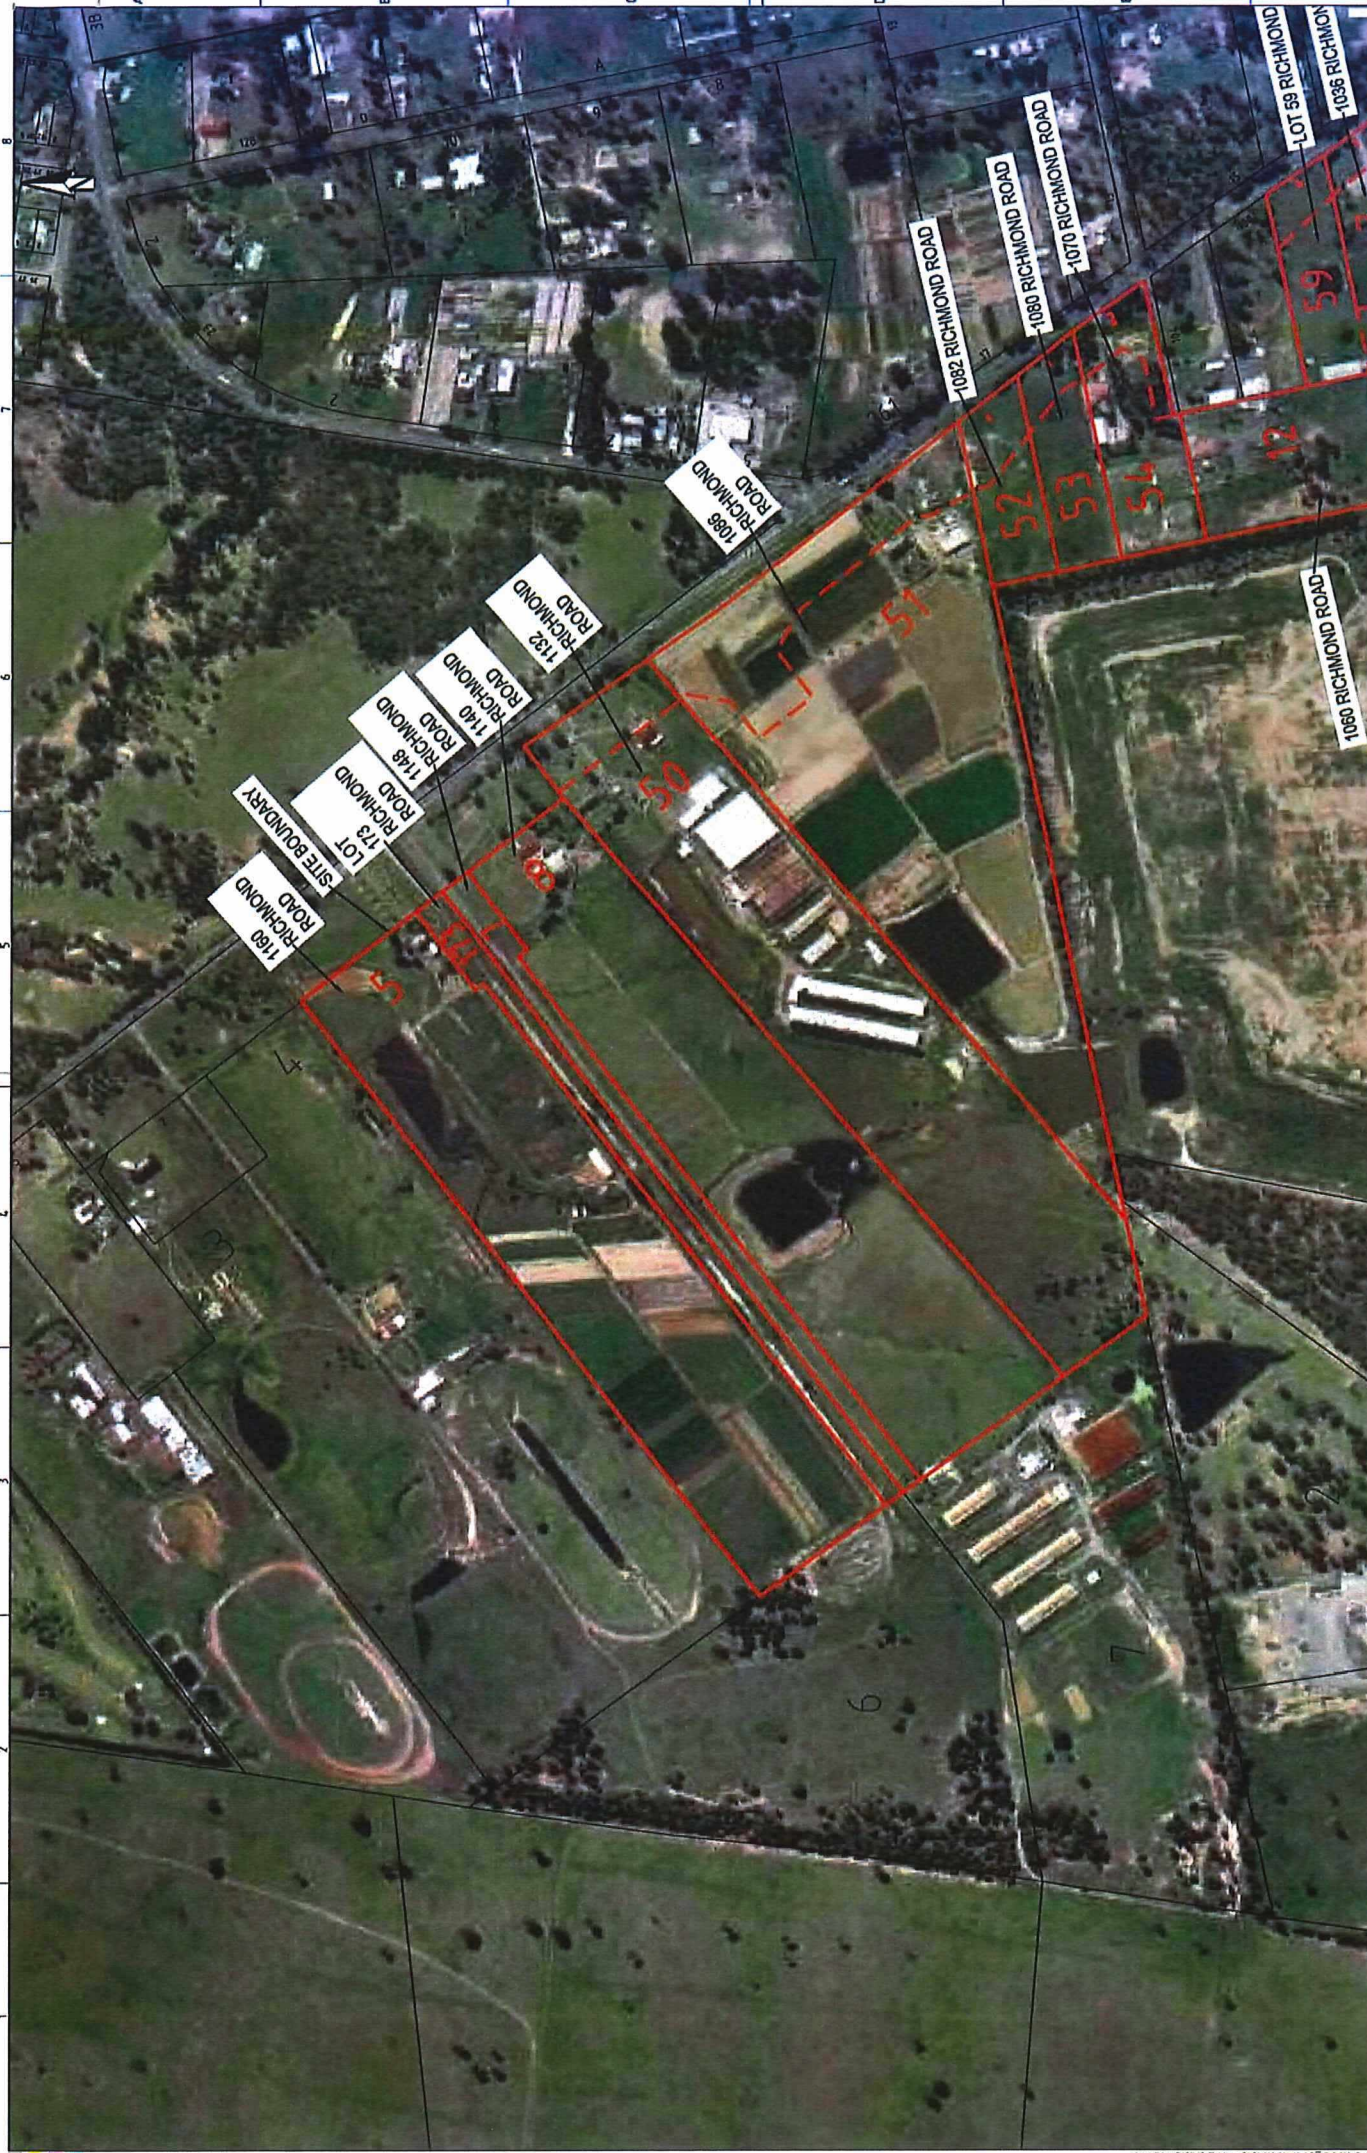
REV		DESCRIPTION	DATE	DRAWN	DESIGNED	CHECKED	APPROVED	SCALE	GRID	DATUM	PROJECT MANAGER	CLIENT	CONSULTING ENGINEERS		DRAWING TITLE		
A			27/07/2015	CS	CS	CS	GT	1:1000 A1 (X3) 12559 115.000	111437 A1 (X3) 12559 115.000	12559 115.000	GT	Universal Property Group Pty Ltd	Martens & Associates Pty Ltd Civil Environment Infrastructure Geotechnical		AERIAL PHOTOGRAPHY 2007 LAYOUT 1 (SOURCE: GOOGLE EARTH)		
													PROJECT NO	PROJECT NO	ISSUE NO	DRAWING NO	REVISION
													P1504888	P1504888	02	PS01-A014	A
													PROJECT NO	PROJECT NO	ISSUE NO	DRAWING NO	REVISION
													PS01	PS01	02	PS01-A014	A
													ISSUE NO	ISSUE NO	ISSUE NO	ISSUE NO	ISSUE NO
													02	02	02	02	02
