DETAILED CONTAMINATION SITE INVESTIGATION REPORT

230 Grange Avenue, Marsden Park

ADDRESS: 230 Grange Ave, Marsden Park NSW

REPORT No: NE083

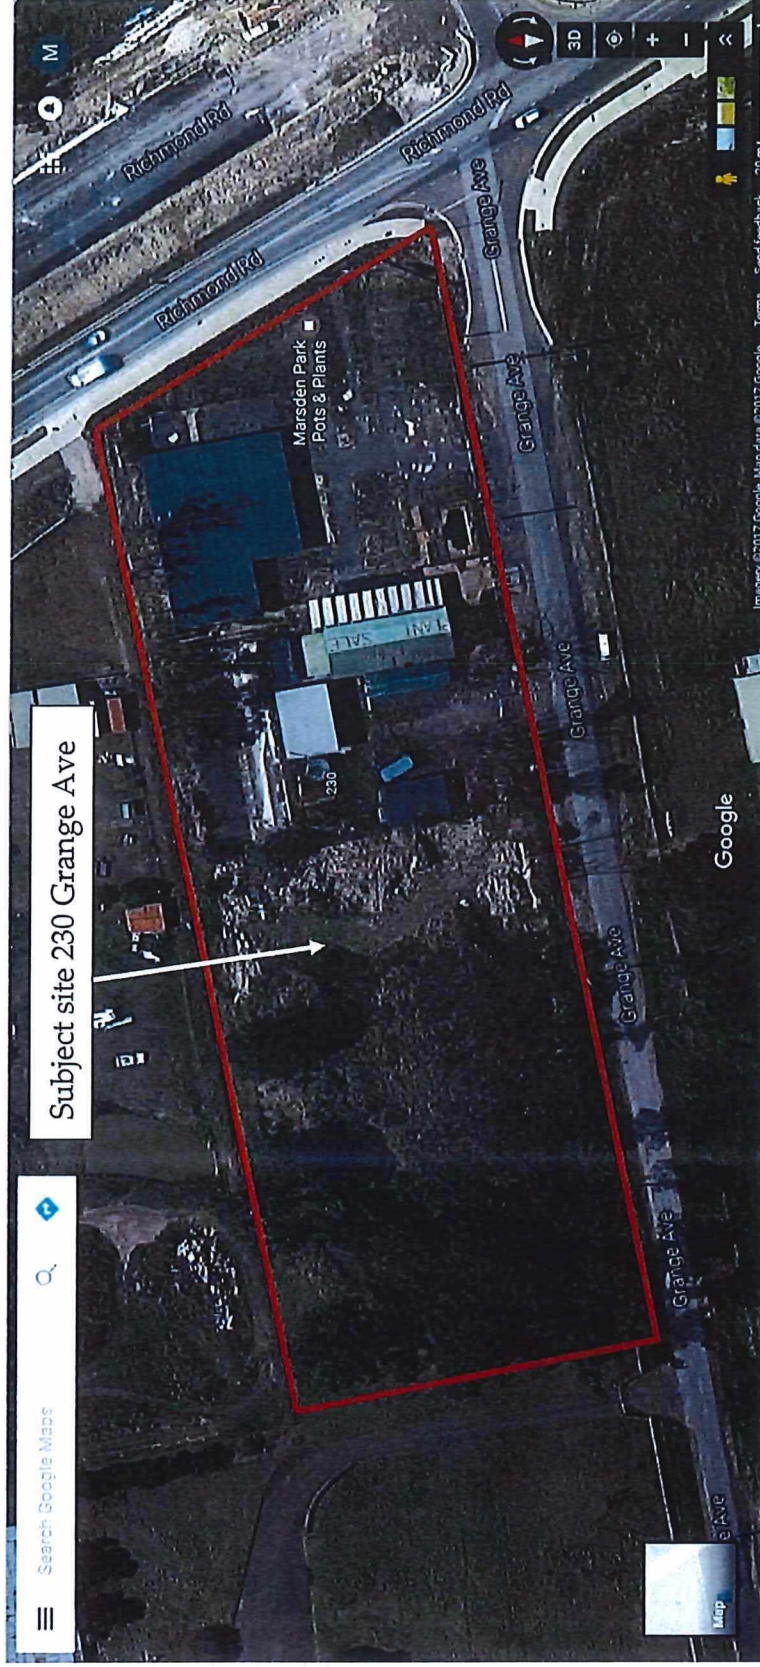
Figure 2: Site Location

Investigation area is situated at 230 Grange Ave Marsden Park, NSW. The site location is shown in Figure 2. The subject site is located on the western side of Richmond Road and northern side of Grange Ave. The site is trapezoidal in shape and its area is approximately 1.1ha. The site lengths along the Richmond Rd and Grange Ave are 65m and 200m, respectively. The site is gently sloping to the west. The site is within the Blacktown City Council [1].

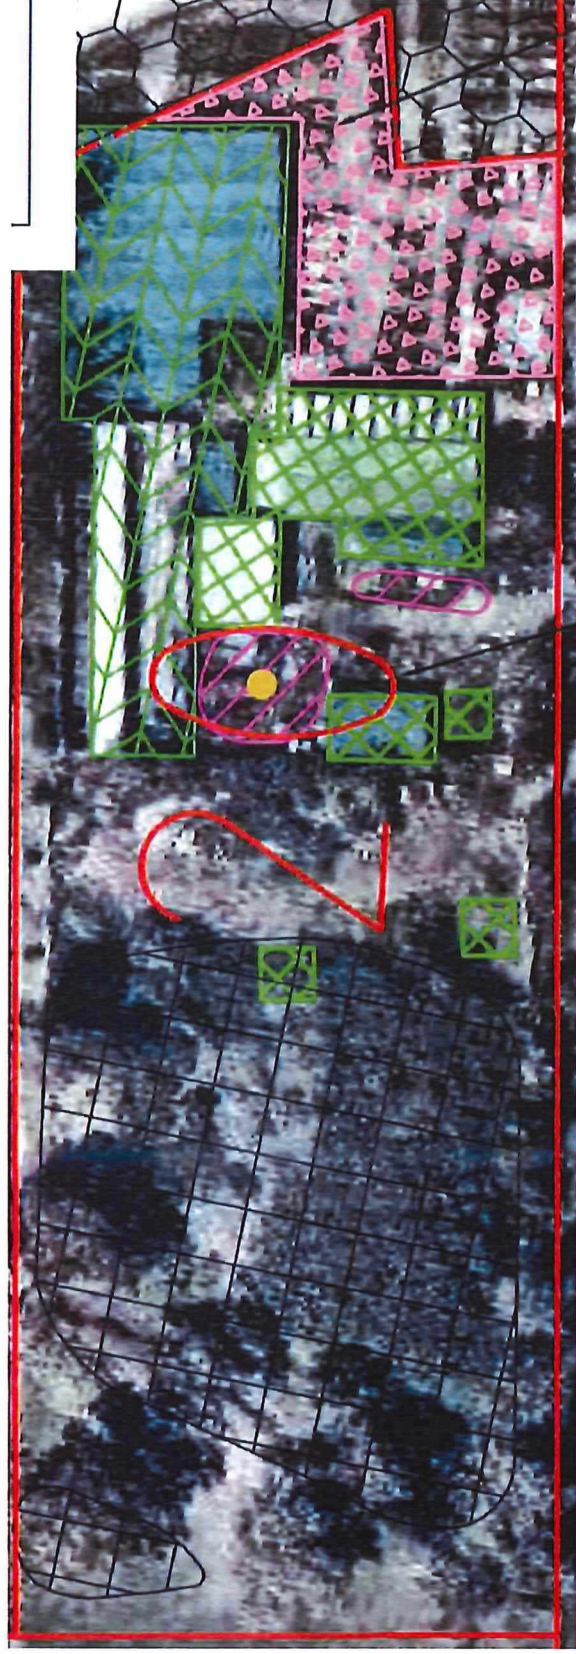
Figure 3: Areas of Contamination Concerns [1]

Dwelling + curtilage	 	Sheds and former sheds	 	Stockpiles	 	Green house	 	Nursery

Site Fillings
---	-------------------------	---	------------------------------	---	------------	---	-------------	---	---------	---	---------------

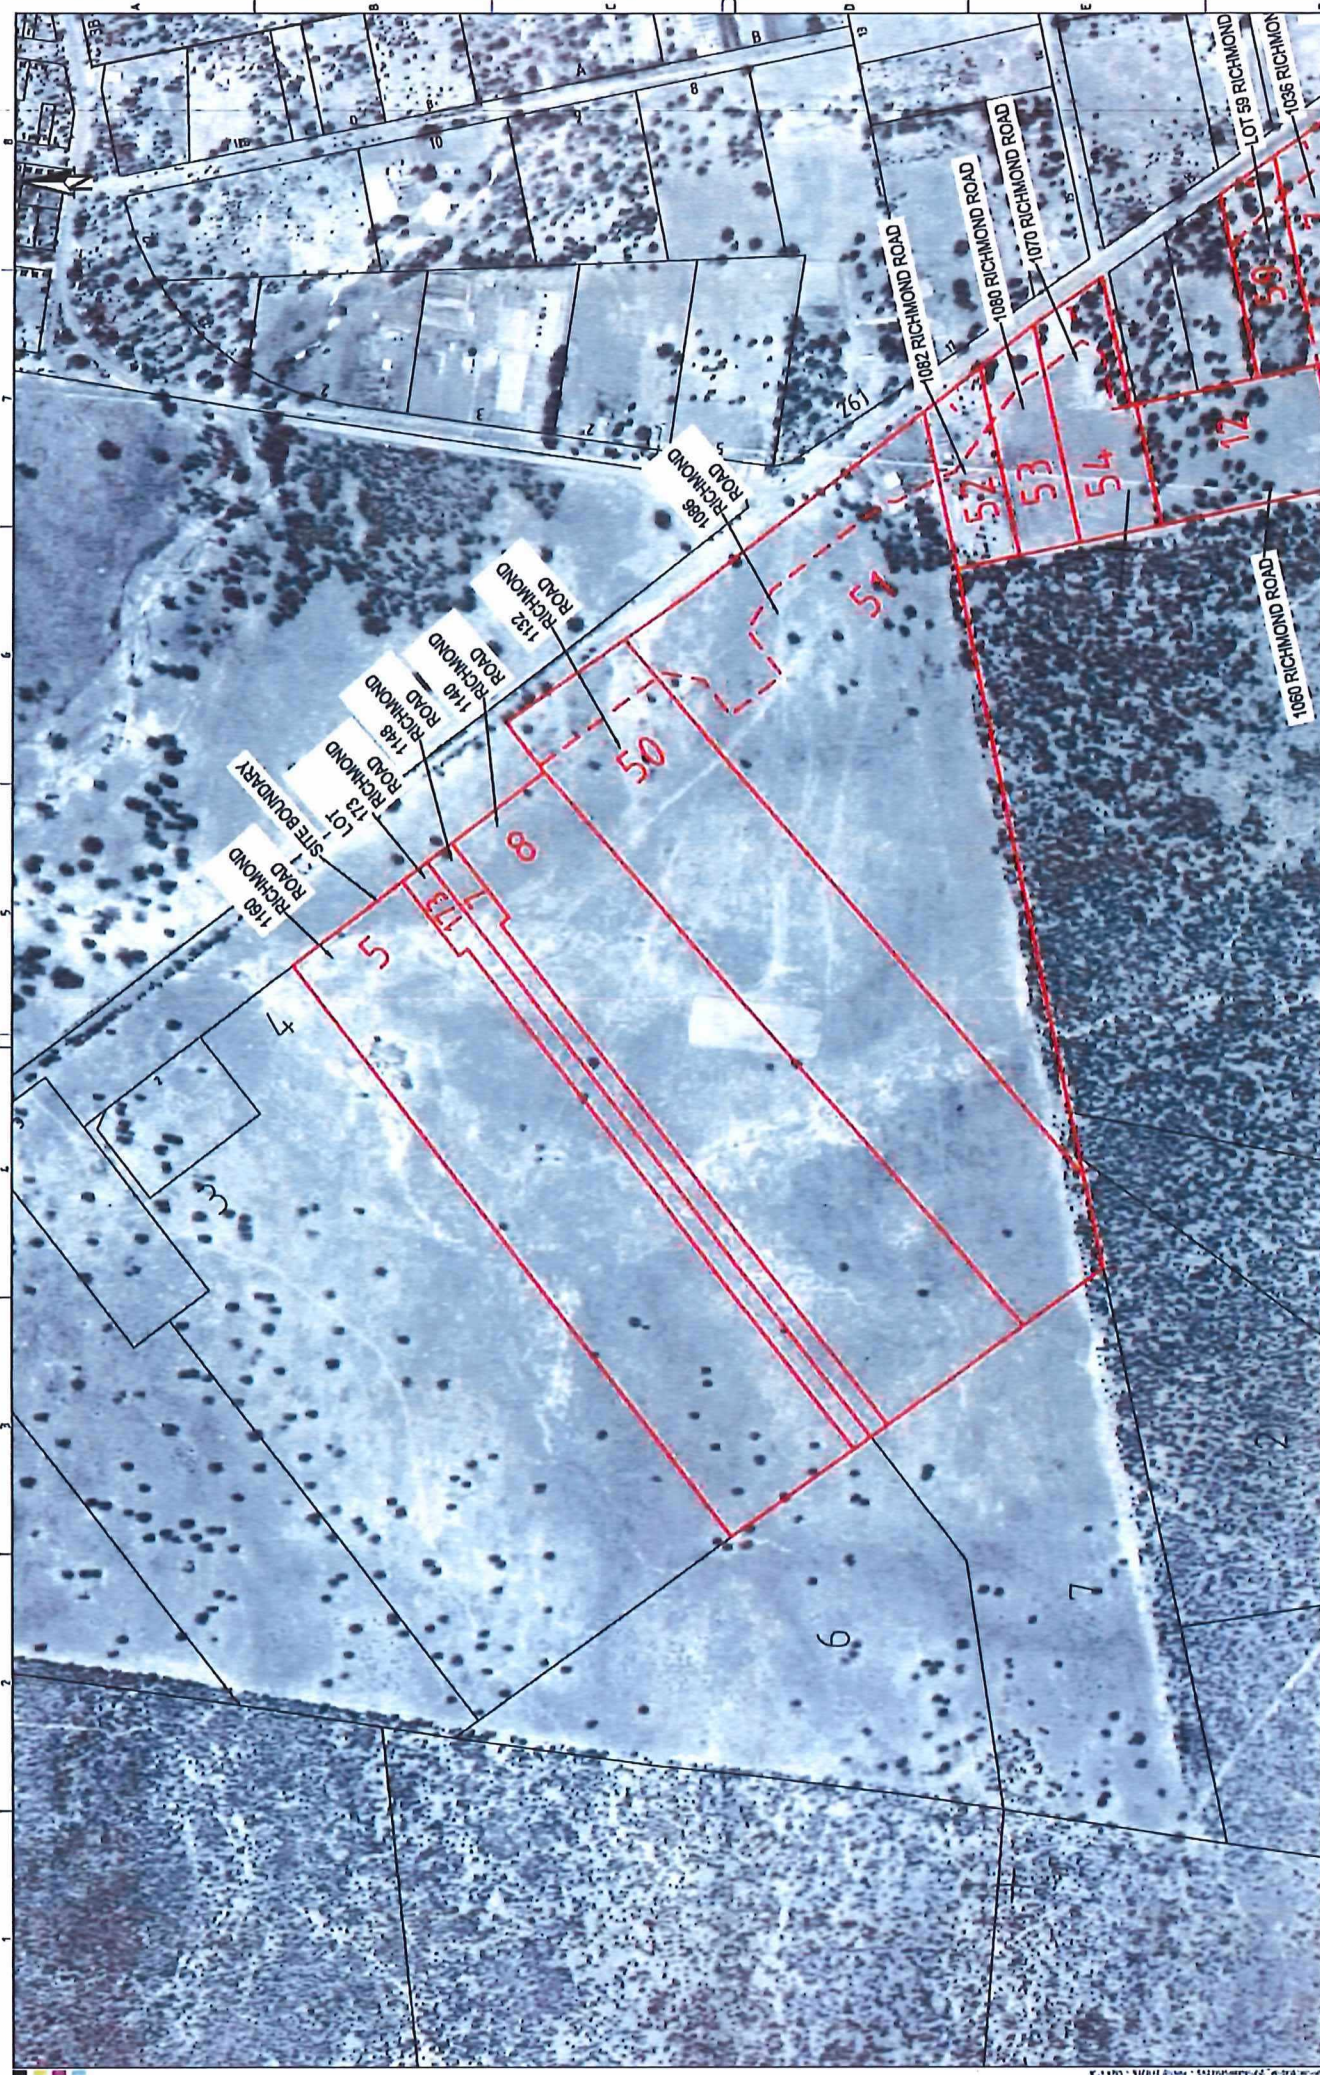
11 Attachment D – Historical Aerial Photographs
