GEOTECHNICAL INVESTIGATION REPORT

339 FOREST ROAD, BEXLEY NSW

PREPARED FOR
LOGOS GROUP PTY LTD
REPORT ID: G19077BEX-R01F

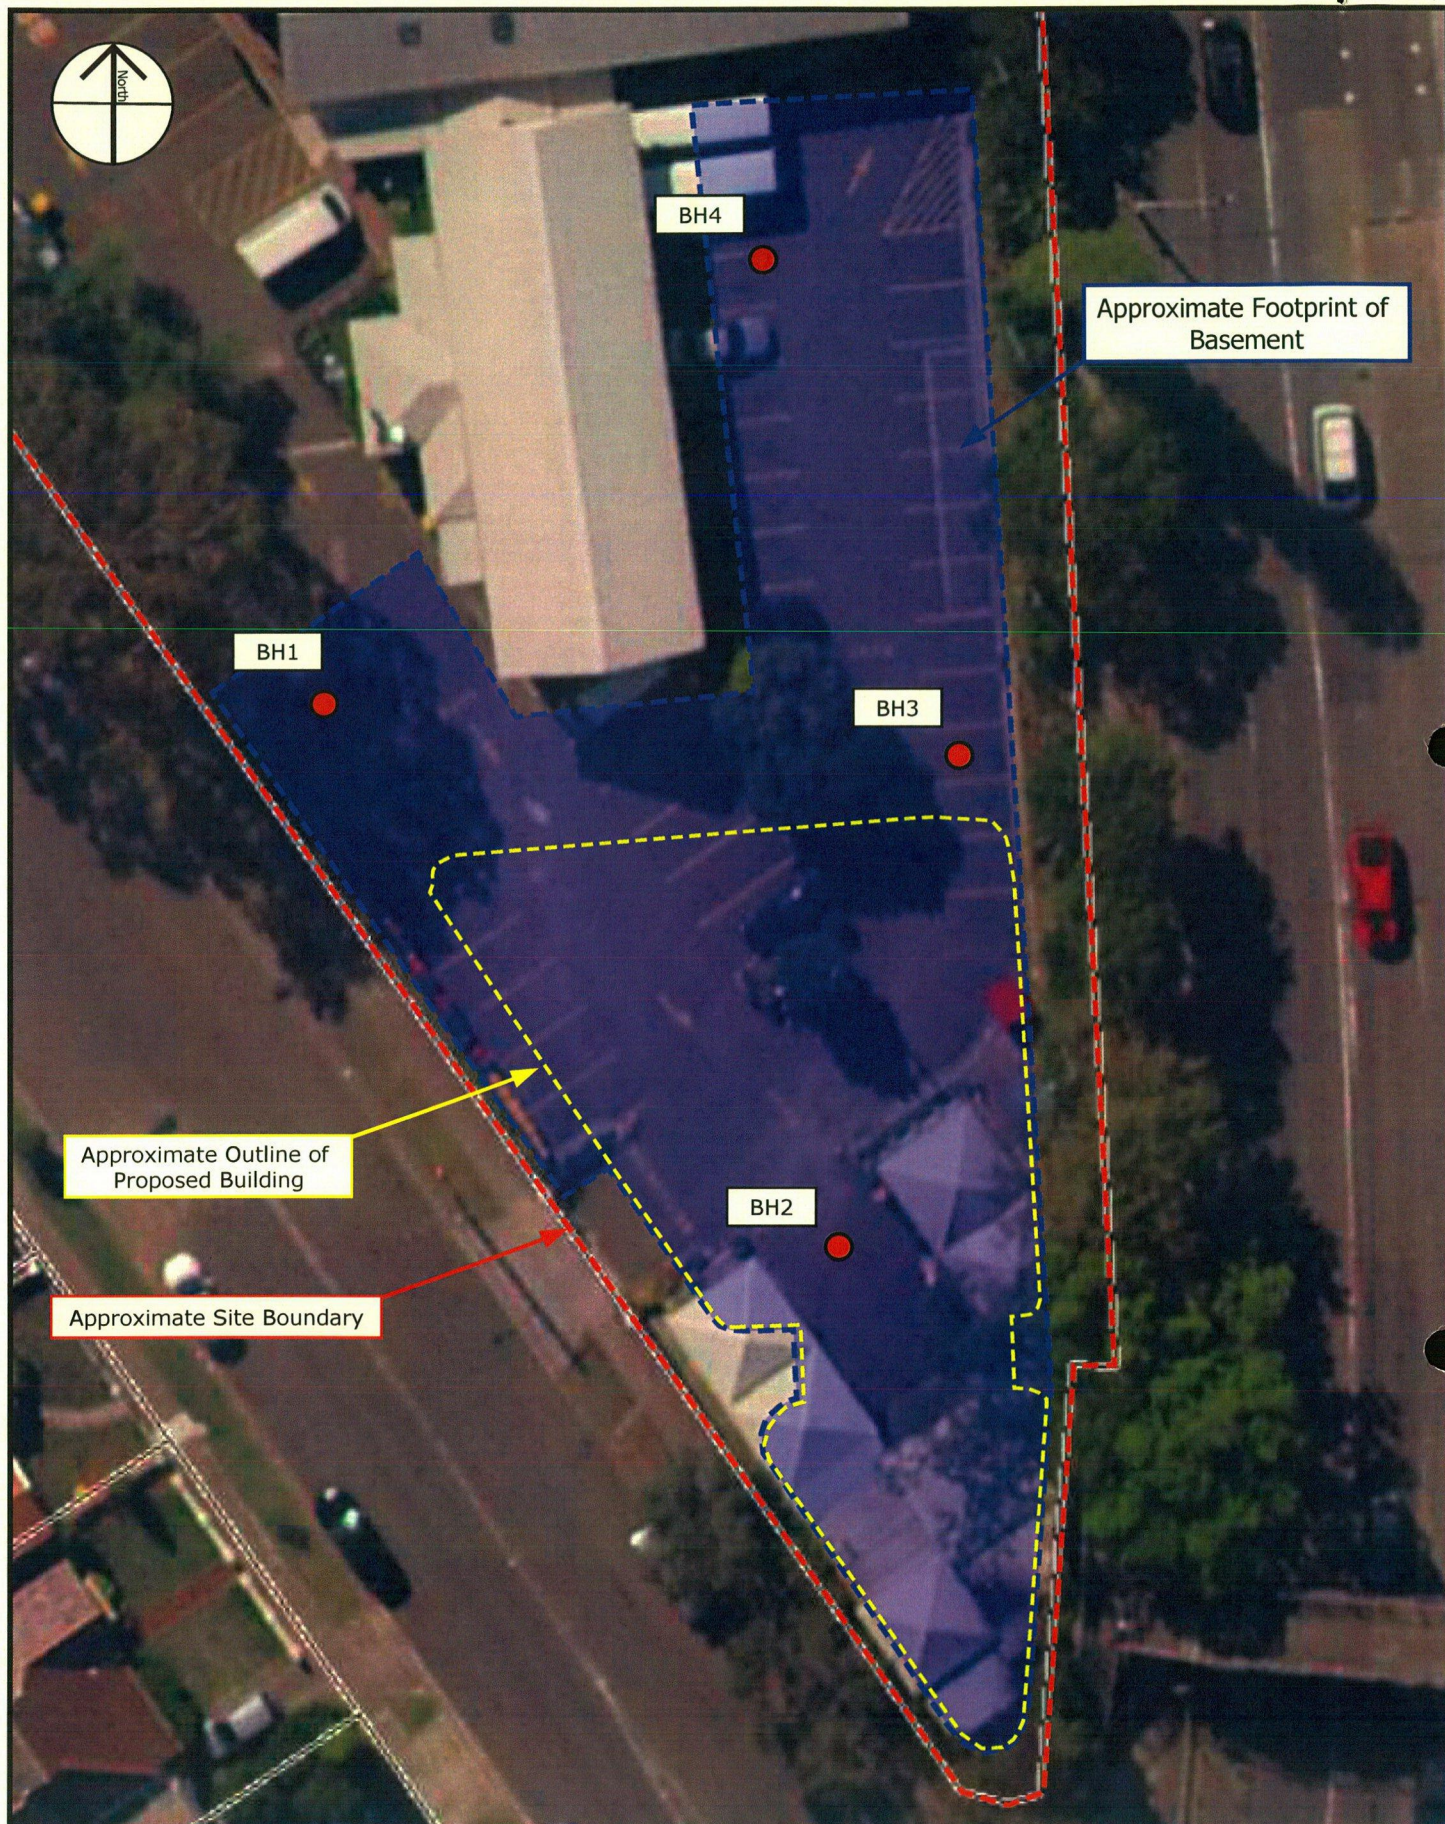
1 – Site Plan

A site plan showing the existing site features and the footprint of the proposed basement is provided as **Figure 1**. Photographs of the site, which were taken during our field investigations are provided for reference in **Plates 1 to 6** below.
