# FINAL REPORT

## Detailed Site Investigation

3 Wiston Gardens, Double Bay NSW

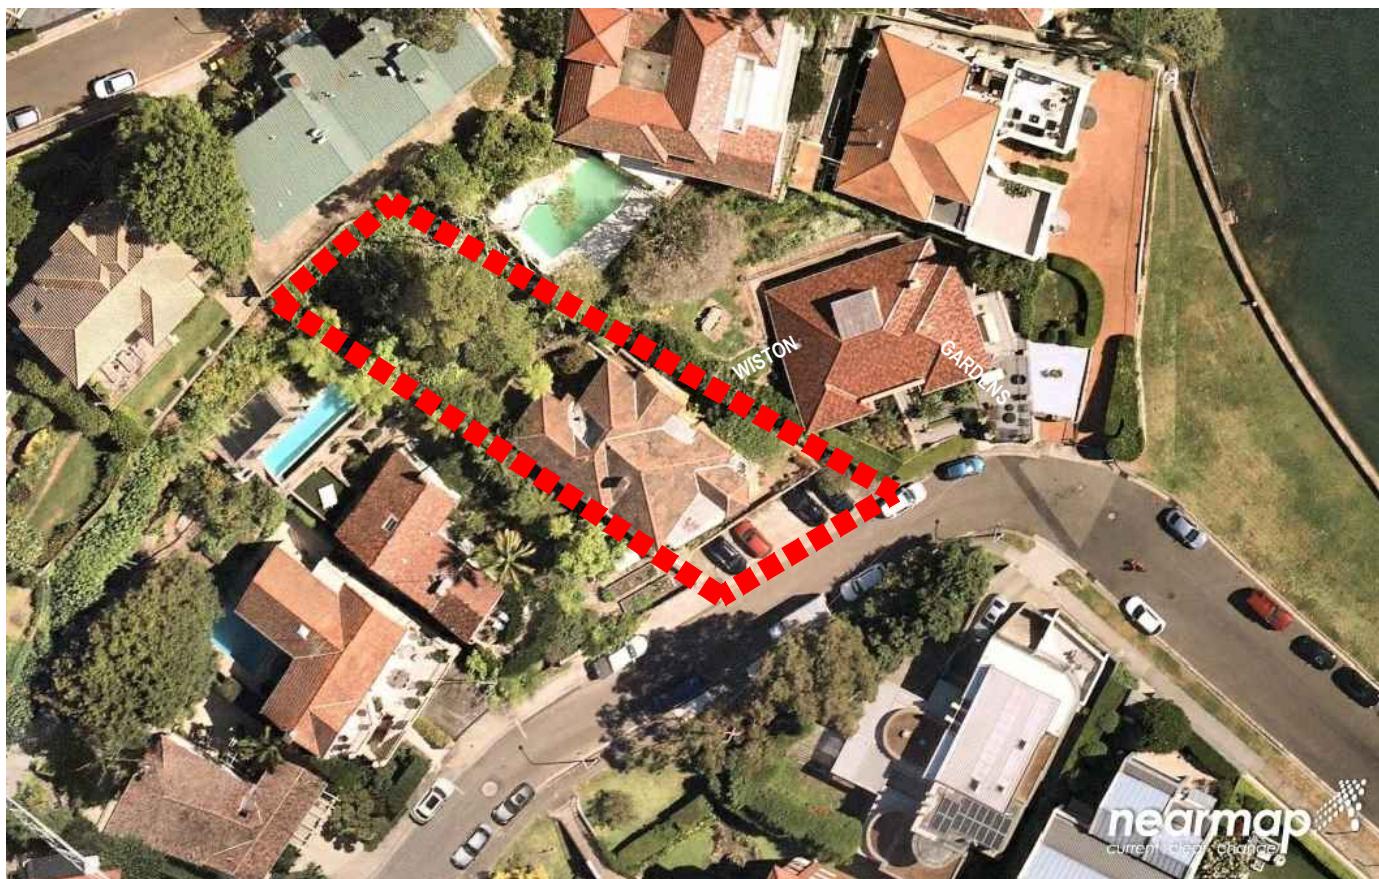
| Figure 2: Site Layout..... | 20 |

A steeply terraced sandstone ridge is present across the north-western area of the Site and the ground floor of the building sits at the base of this cliff face which then slopes down to the road. Garages are present at the road level with the frontage of the building located on top of the garages. The building footprint together with the sandstone cliff occupies the majority of the area of the Site. Some minimal garden beds and landscaping areas are present at the northern side and frontage of the current building above the garages and some of the higher sandstone terraces contain some vegetation. The current layout of the Site is shown on Figure 2.

CONSARA Pty Ltd (CONSARA) has been commissioned by Merman Investments Pty Ltd (Merman Investments) to undertake a detailed site investigation (DIS) for a property located at 3 Wiston Gardens, Double Bay NSW (the Site). The location of the Site is presented in Figure 1 and the layout of the Site is presented on Figure 2.

A steeply terraced sandstone ridge is present across the north-western area of the Site and the ground floor of the building sits at the base of this cliff face which then slopes down to the road. Garages are present at the road level with the frontage of the building located on top of the garages. The building footprint together with the sandstone cliff occupies the majority of the area of the Site. Some minimal garden beds and landscaping areas are present at the northern side and frontage of the current building above the garages and some of the higher sandstone terraces contain some vegetation. The current layout of the Site is shown on Figure 2.
