Flood Study Report
on
65 Beresford Road, Bellevue Hill
for
Mr A. Thorpe

Ref. 1169/rep1
October 2020

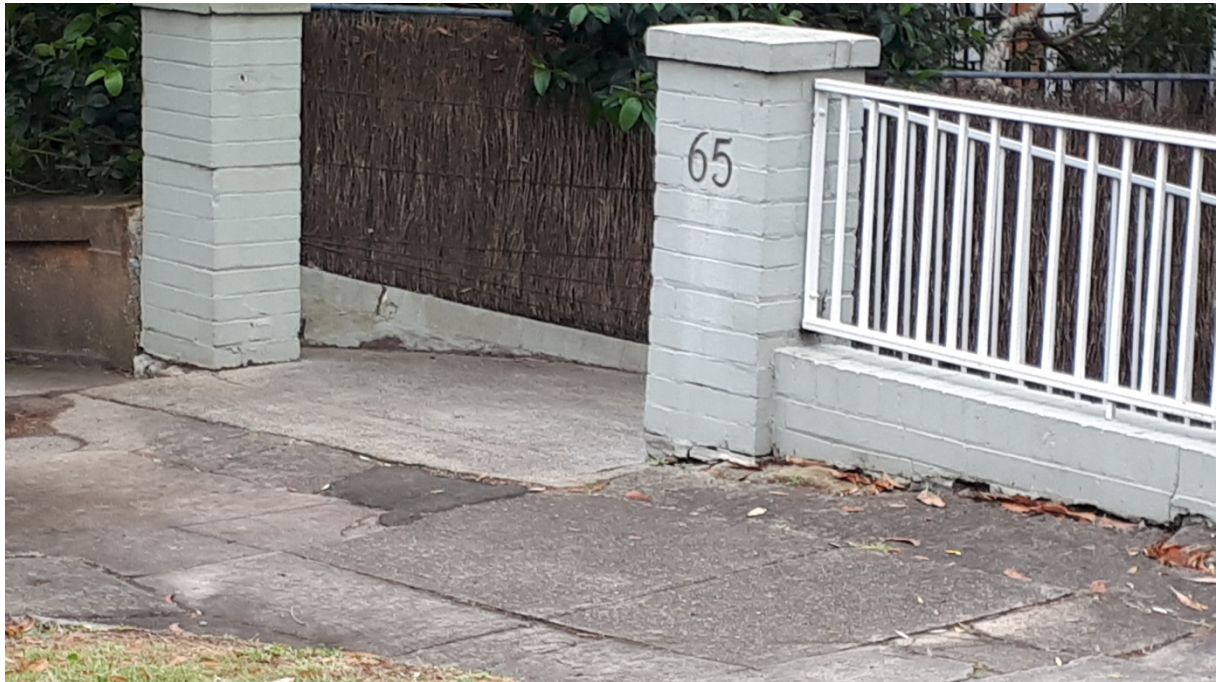
PHOTO 1 – CRACKED DRIVEWAY

The current driveway has settled and is cracked (Photo 1). We have redesigned the driveway as detailed on Sections 1 and 2 to ensure no floodwater enters the site.

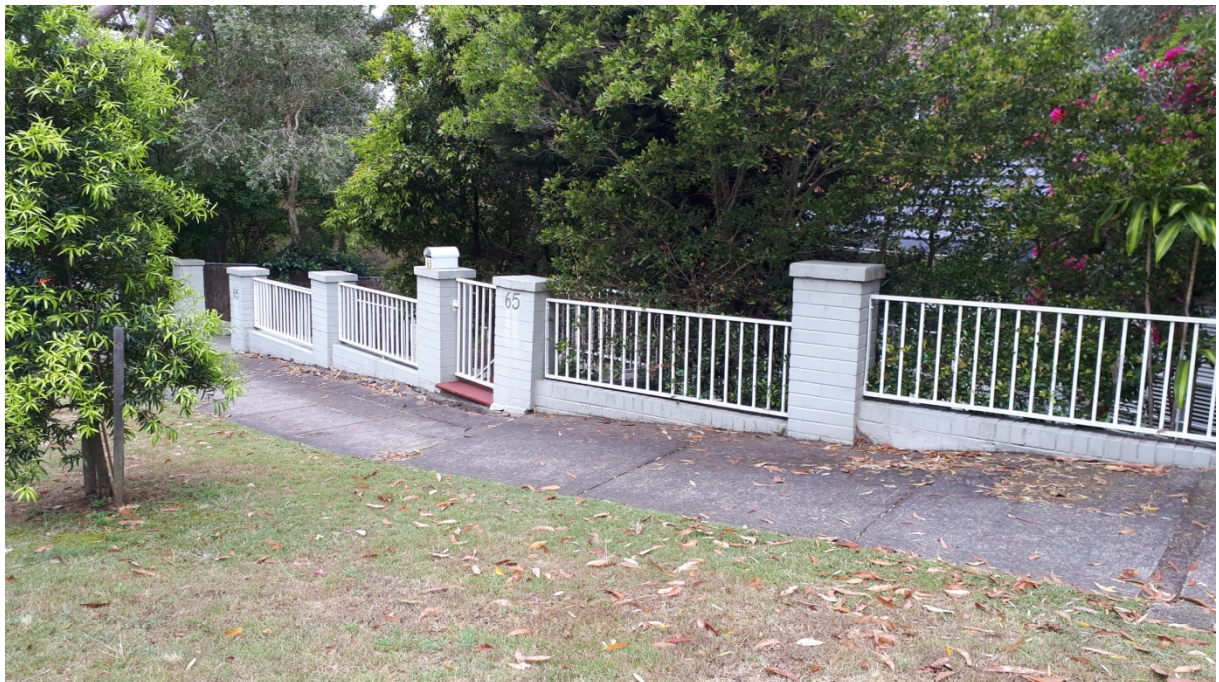
PHOTO 2 – BRICK FENCING

As the depth of flow is less than 200mm under the PMF, these sections demonstrate that the site will not be affected by flooding and is protected by brick fencing (Photo 2).

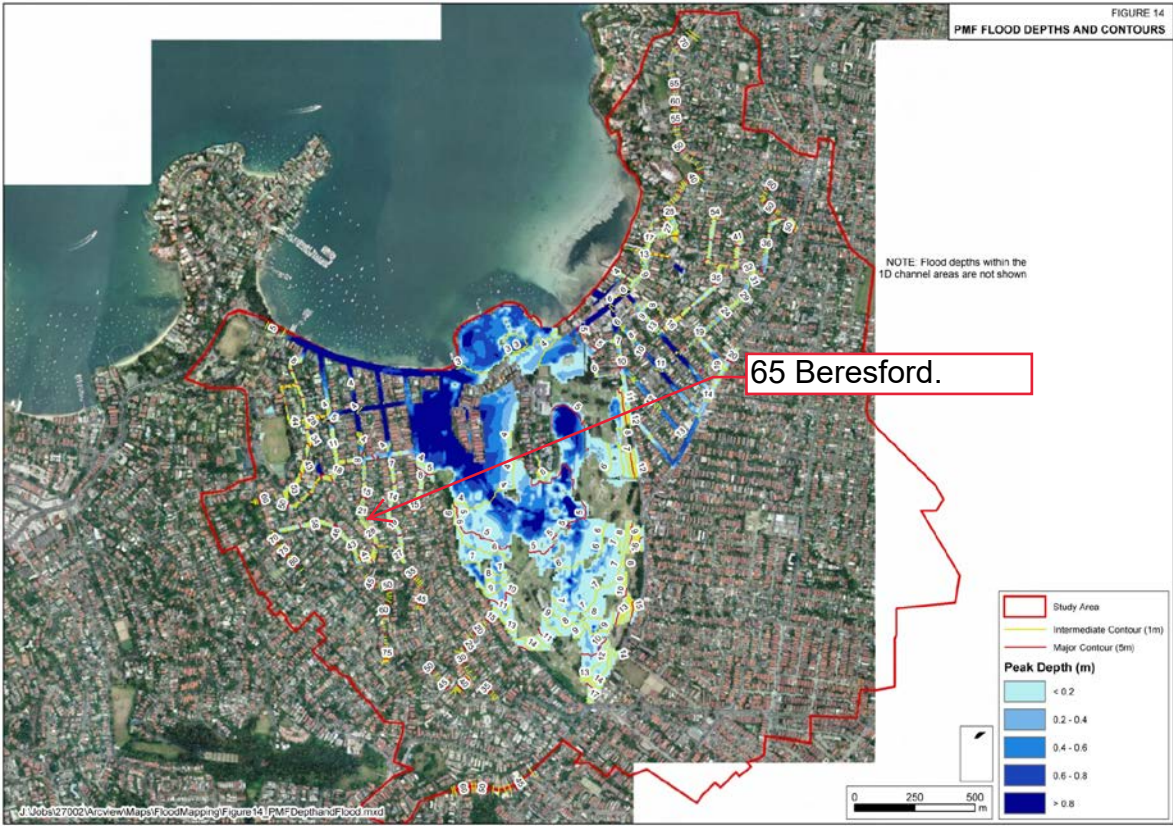
FIGURE 5 – PMF FLOOD DEPTHS AND CONTOURS

The peak overland flow outside the site for 100-year ARI is 0.5 to 1.0 m³/sec as the majority of flow is on the other side of the road (Figure 2). Similar flows are nominated for PMF in Figure 3. The maximum depth of flow identified in Figure 4 and Figure 5 is less than 200mm for both 100 ARI and PMF floods. Beresford Road is identified as a high hazard floodway.
