Report on  
Preliminary Geotechnical Investigation

Proposed Mixed-Use Development

87-91 Union Rd, 634-638 High St, Penrith

Project 85867.00  
October 2021

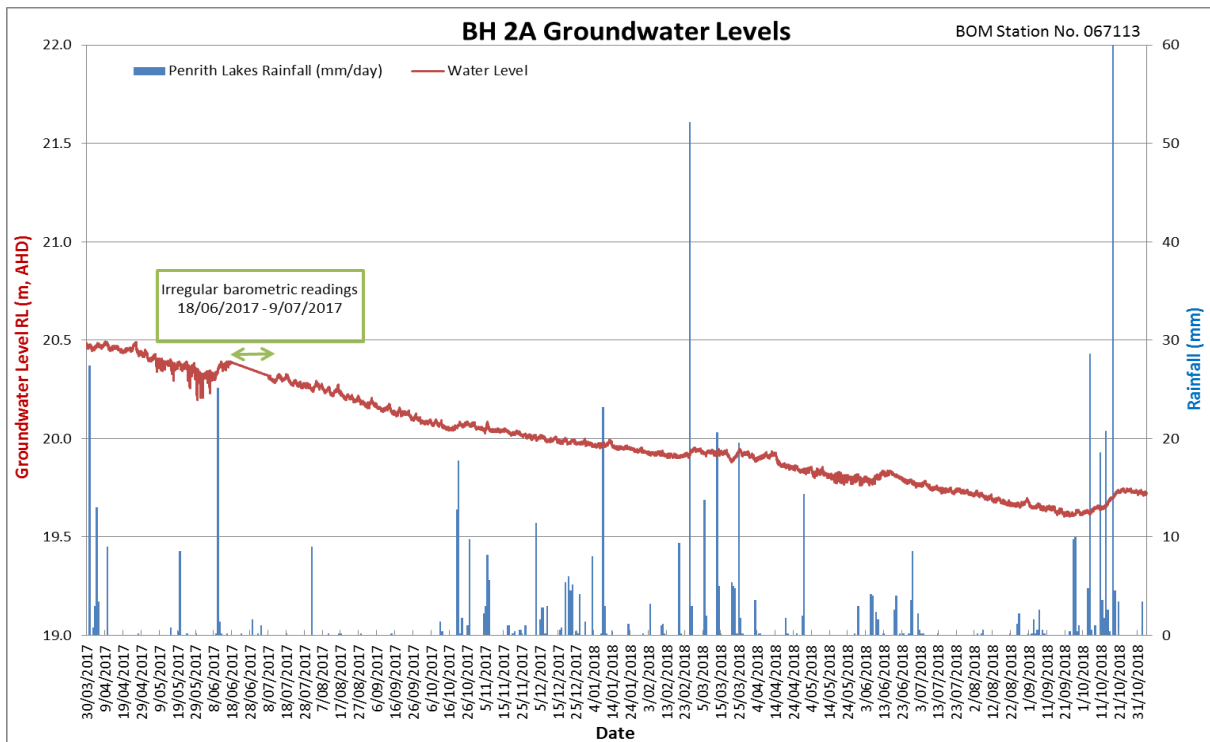
**Figure 1 – Data-logger and rainfall data for BH2A**

The groundwater levels obtained from the data loggers between 30 March 2017 to 5 November 2018 are presented in Figure 1 and 2 below. The results show the groundwater levels together with rainfall measurements recorded at Penrith Lakes AWS (BOM Station Number 067113, [www.bom.gov.au](http://www.bom.gov.au)).

The groundwater table was encountered during the field work (drilling, well development and groundwater monitoring programme) at approximately 6.5 m to 9 m depth (between RL 20.5 to RL 18.3 m AHD). Design should allow for a rise in the water table, especially in times of flooding. Records held by DP for Penrith Plaza show groundwater level fluctuations of up to 3 m. A preliminary design groundwater level of RL 23.5 m AHD is therefore recommended, however, higher short term levels may occur during flooding.

Based on the groundwater levels at RL20.5 to RL18.3 measured during the investigation and groundwater monitoring programme, the bulk excavation for Basement 3 (assumed RL18.1 m) will be 2.4 m below the highest measured water level. There is potential for groundwater levels to rise by at least 3 m during and following prolonged heavy rainfall and possibly higher during floods and this should be considered. Longer term groundwater monitoring is recommended to assess current groundwater levels and to further assess fluctuations and response to rainfall.

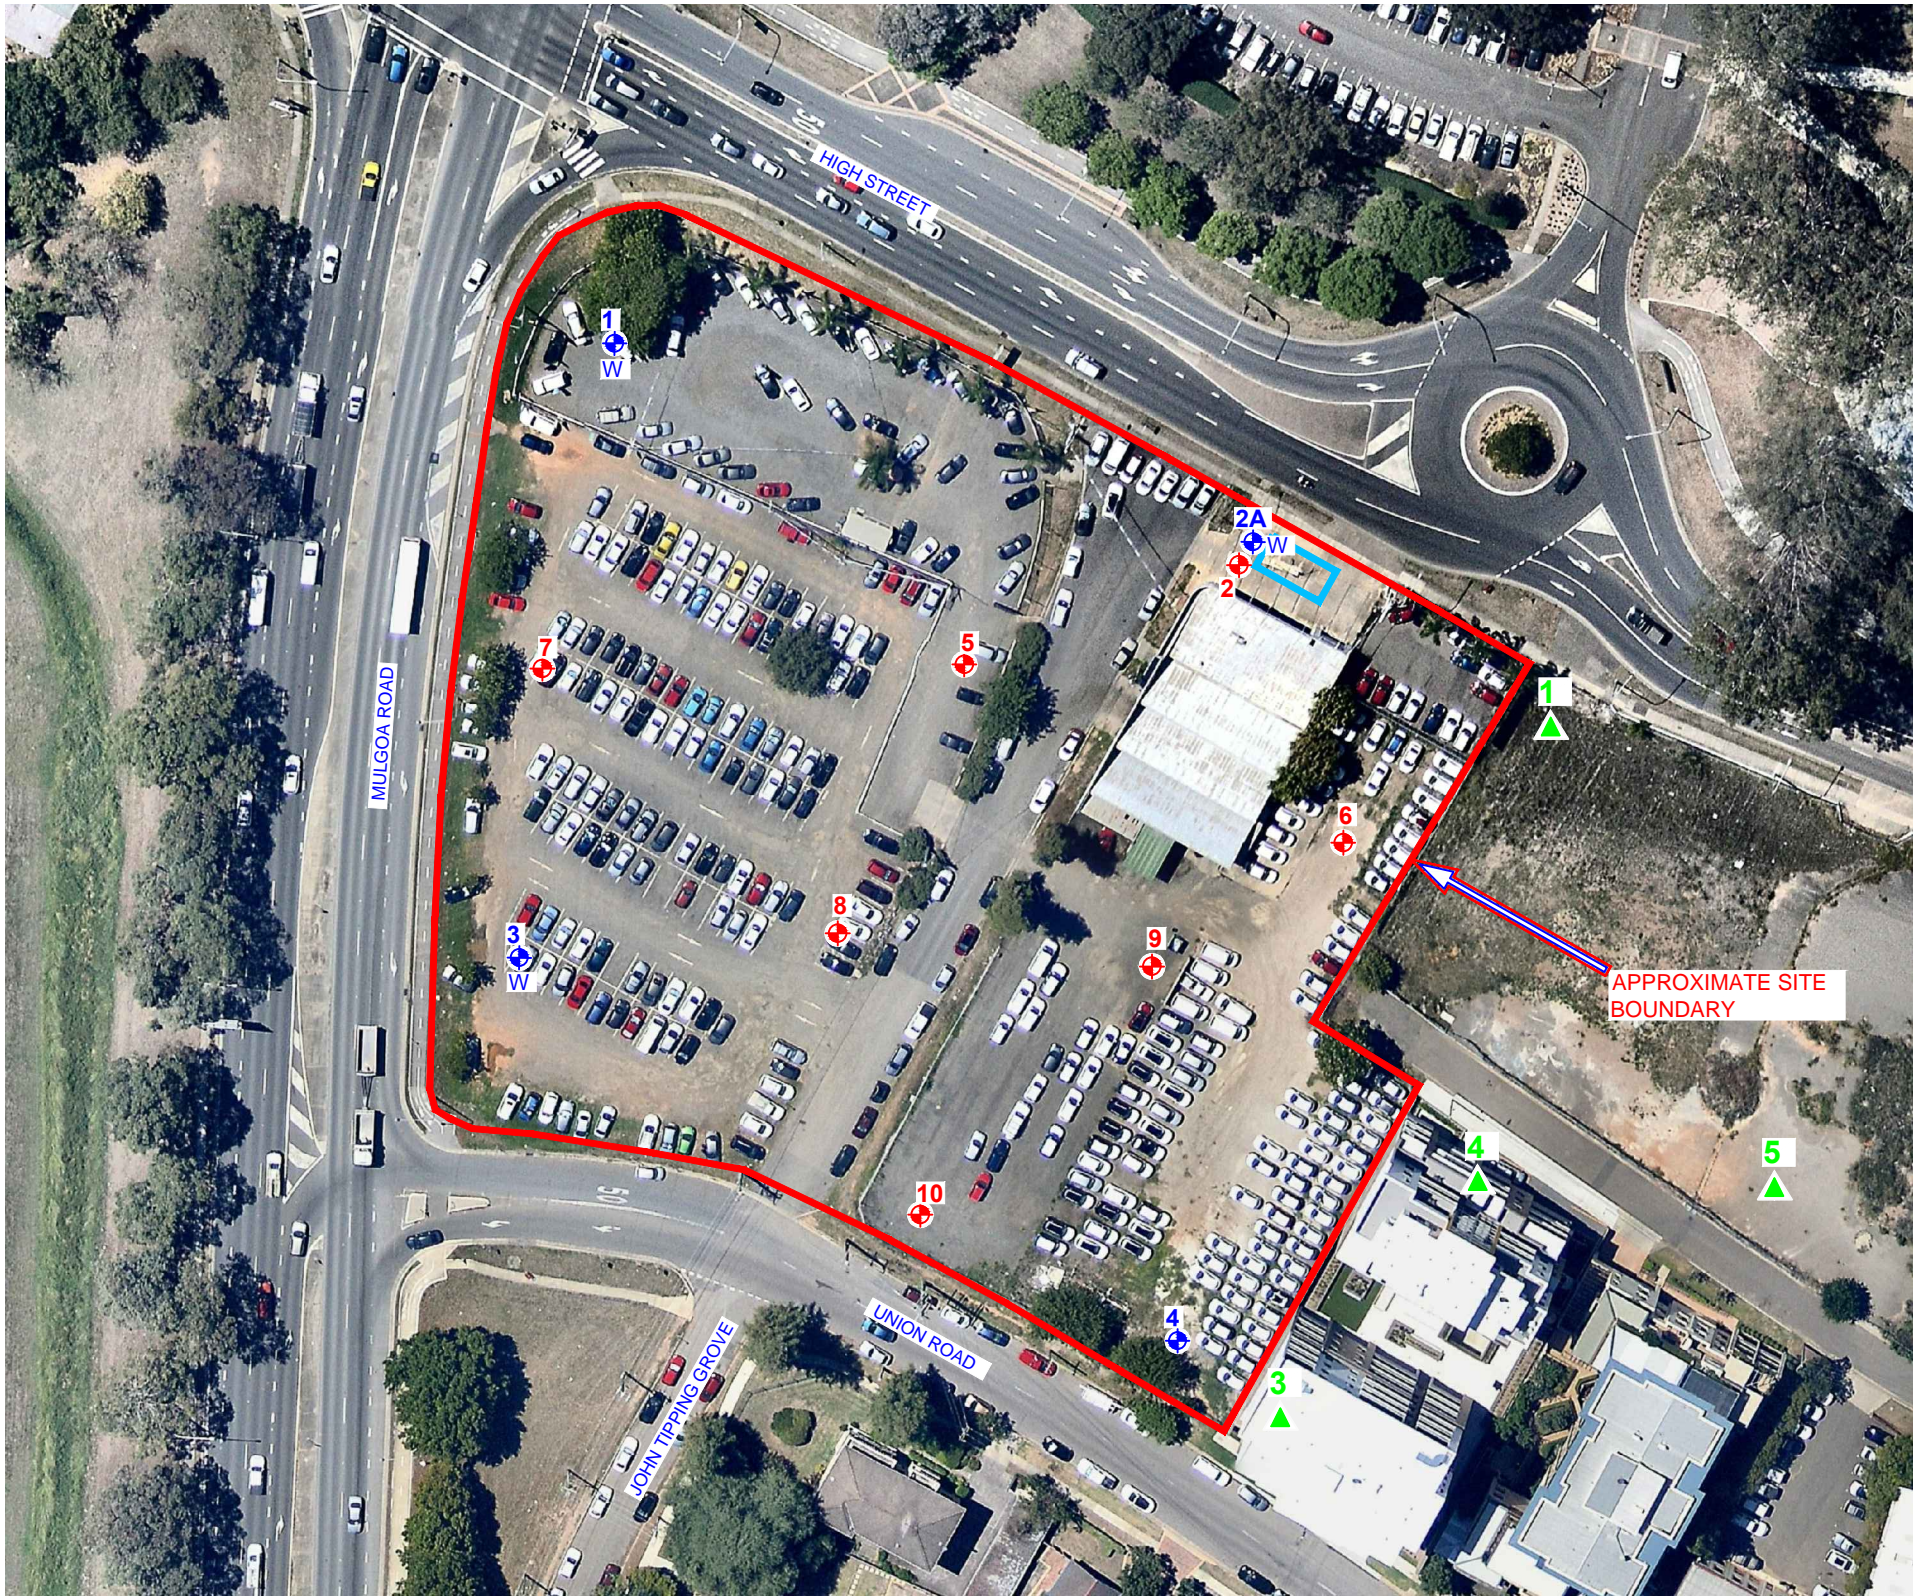
Drawing 1

NOTE:  
1: Base image from Nearmap.com  
(Dated Feb. 2017)  
2: Test locations are approximate only and were  
located using hand-held GPS.

This report presents the results of a geotechnical investigation undertaken by Douglas Partners Pty Ltd (DP) for the site at 87-91 Union Rd, 634-638 High St, and 640-652 High St, Penrith as shown on the attached Drawing 1. The work was commissioned by Mr Bernardo Reiter Landa on behalf of Toga Penrith Developments Pty Ltd (Toga) and was carried out in general accordance with DP's proposal SYD170044 dated 23<sup>rd</sup> January 2017 and subsequent emails and DP's general conditions of engagement.
