Solar Reflectivity Assessment for:
High Street Penrith
Sydney, Australia

Prepared for:
Toga Group
Level 5, 45 Jones Street,
Ultimo NSW 2007
October 2021

CPP Project: 11310

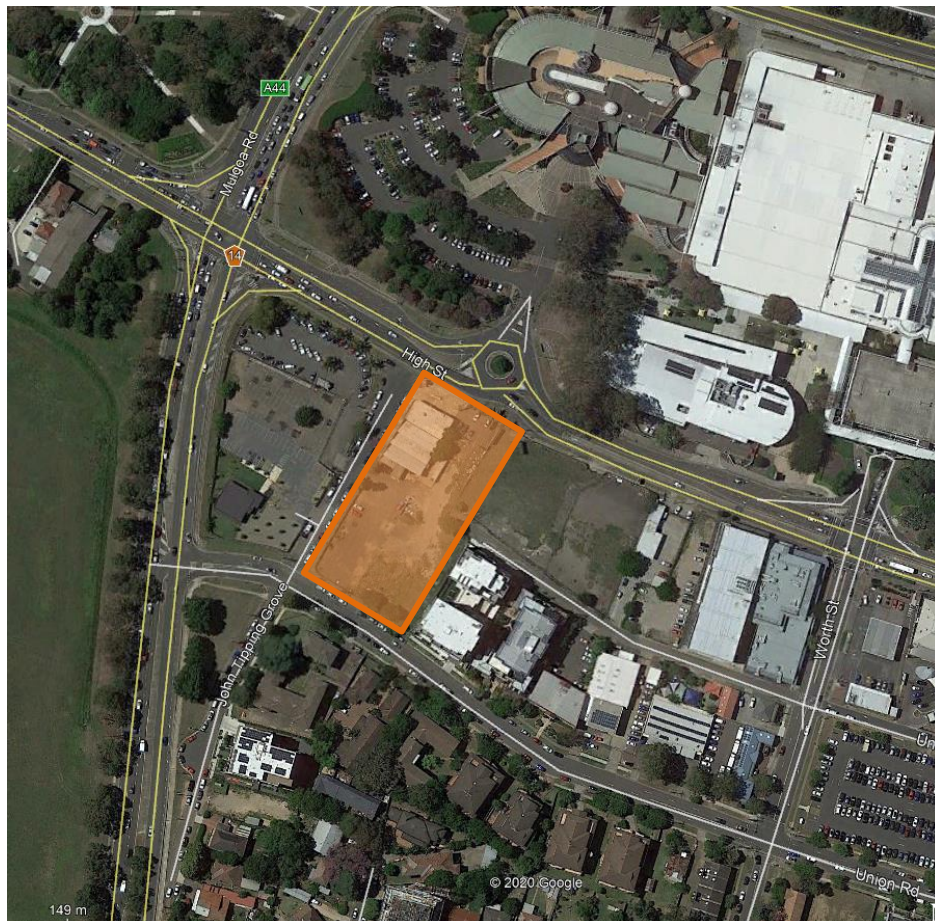
Figure 1: Aerial view of the proposed development site (Google Earth, 2020).

Cermak Peterka Petersen Pty. Ltd. has been engaged by Toga Group to provide an assessment on the potential of the proposed development at Penrith in Sydney, Australia, to produce solar reflectivity impacts on surrounding public roadway locations, Figure 1. The proposed development is bordered by High Street to the north, Union Rd to the south and John Tipping Grove to the west. A temporary new road will also be constructed to the east of the proposed site.

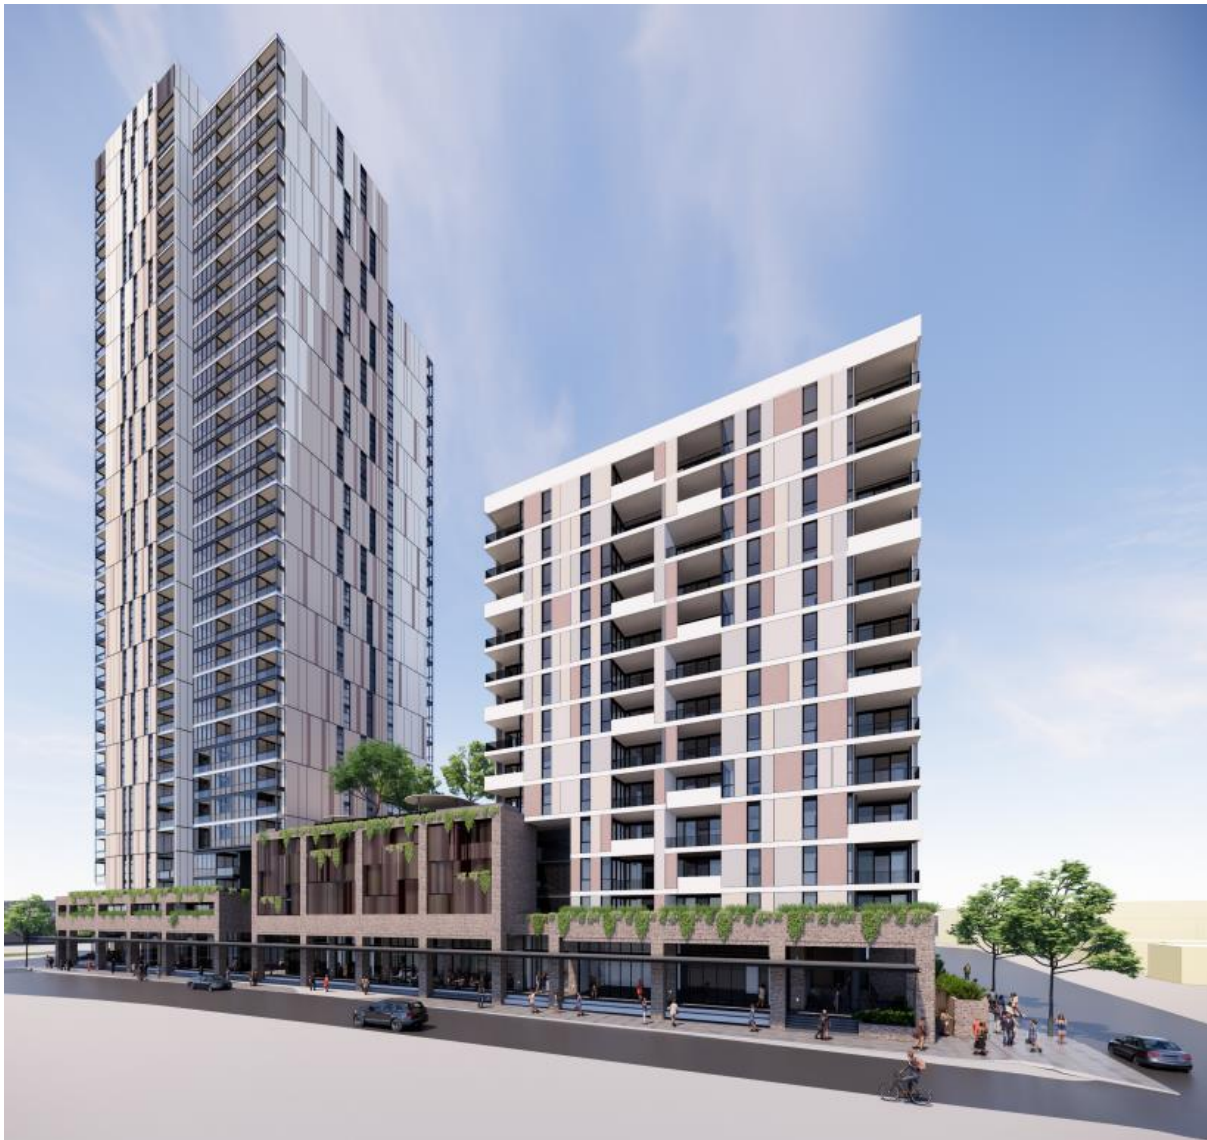
Figure 2: Structures and massing within the proposed development (perspective view from southwest).

The proposed development consists of two separate towers with height of approximately 49m and 123m above High Street, Figure 2, and is surrounded by mixture of low to medium-rise buildings to the east quadrant.

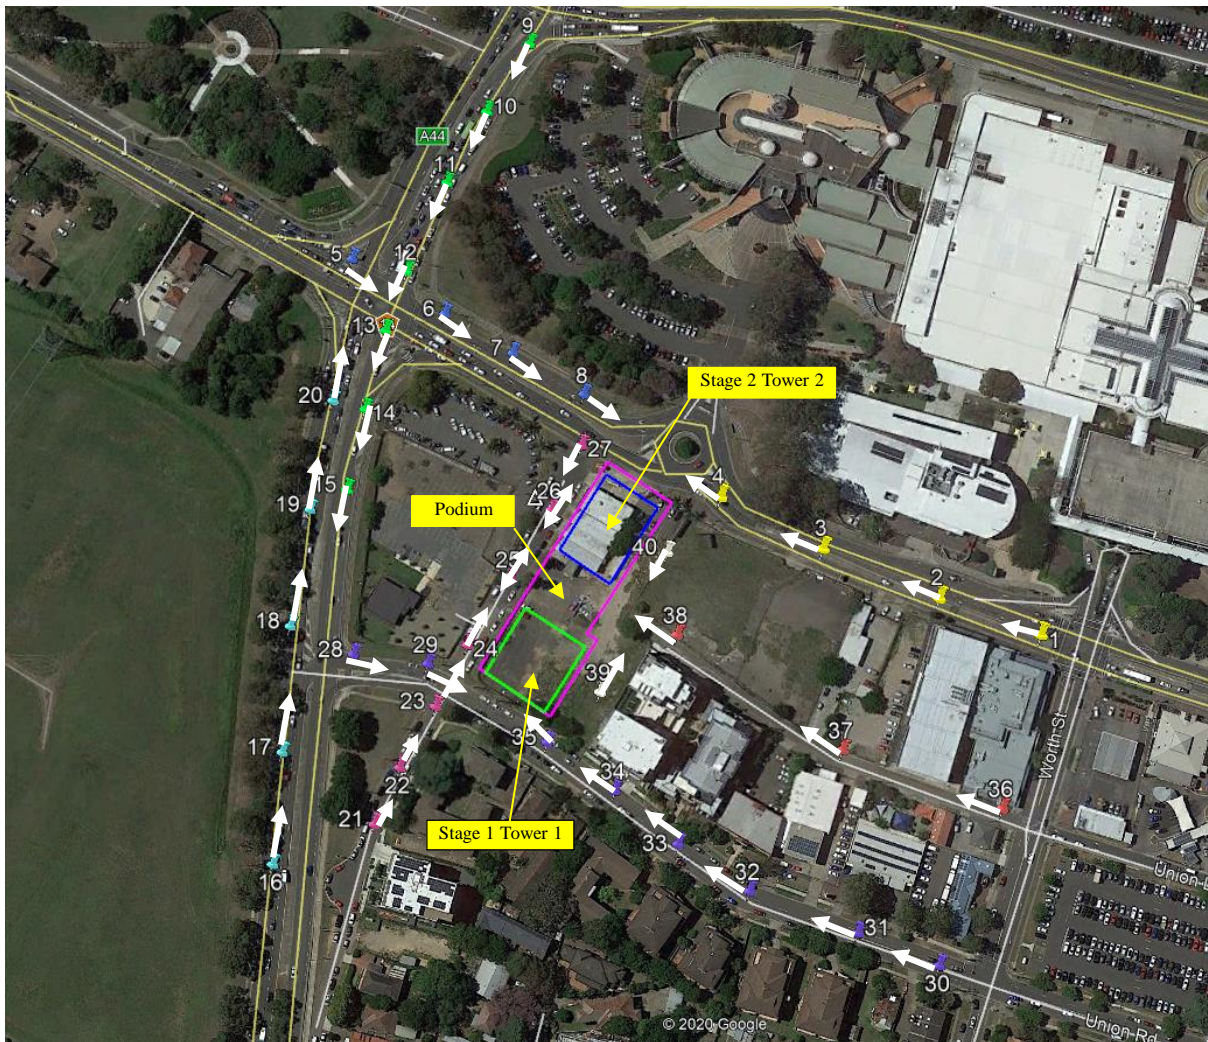
Figure 3: Investigated impact locations of vehicles travelling in indicated directions.

CPP use, in part, methodology developed by Hassall (1991), and the concept of veiling glare and contrast when quantifying the potential for hazard rogue specular solar reflections from the proposed development onto selected surrounding receiver locations, Figure 3.

Proprietary software was used to calculate TI values at expected maximum impact locations of vehicles travelling in the directions as marked in Figure 3 where potential future changes in traffic conditions have been considered. CPP also utilises the commercially available software suite SGHAT where identified glare impacts approach TI criterion limits and an additional reference is sought. Whilst

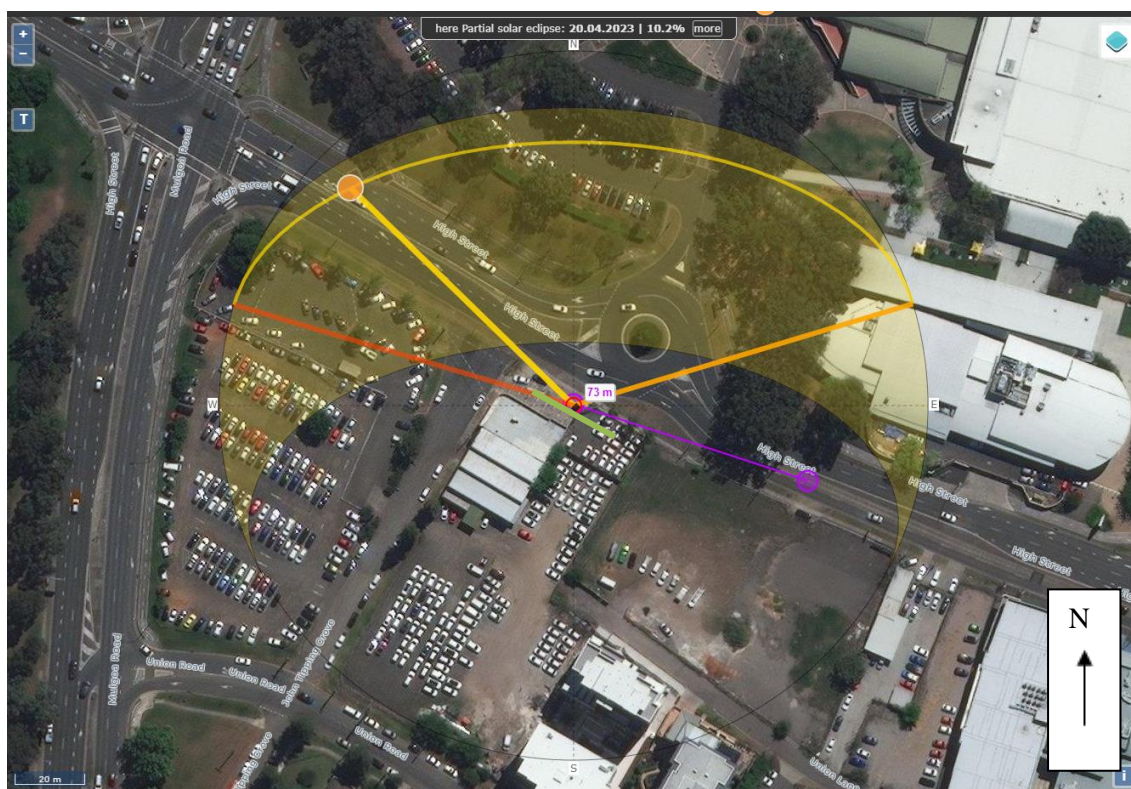
Similar levels of moderate exceedance were found at other locations analysed along High Street travelling northwest toward the development site were found for shorter periods of time from the Podium's South-West façade. It is noted this analysis conservatively assumes a fully glazed podium façade at this location. The reflections generating the high levels of glare will occur when the sun's altitude is low, and its solar rays are emanating near parallel to the façade. As currently planned, the North- East façade at podium level is predominantly made of masonry and the presence of vertical opaque façade elements shown in current architectural drawings will largely block glancing reflections.

Hence it is expected solar reflections from the Podium's North-East façade will not negatively impact the vision of drivers' who are travelling northwest along High Street.

Figure 6: Representation of incident and reflection of solar rays from the Podium's North-East façade onto High Street.

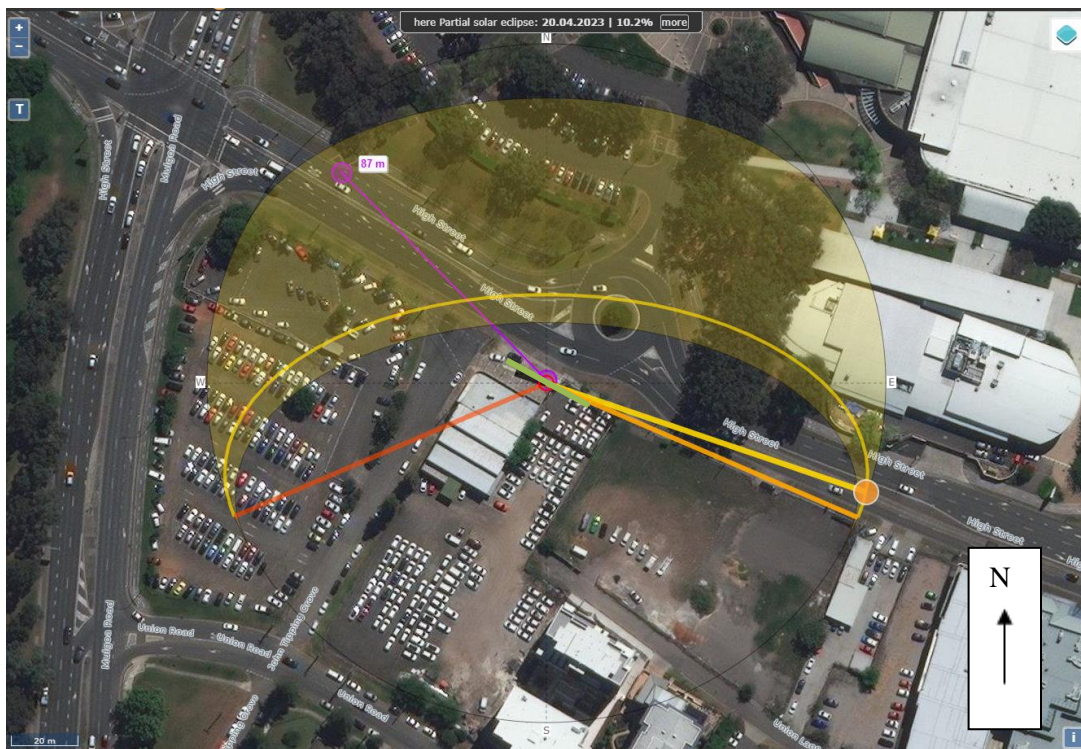
Drivers at other locations analysed along High Street travelling toward the development site were found to experience lower levels of TI values for shorter periods of time from the Podium's North-East façade. Thus, it is expected solar reflections from the Podium's North-East façade will not negatively impact the vision of drivers' who are travelling southeast along High Street.

Figure 7: Representation of incident and reflection of solar rays from the Podium's North-East façade onto High Street.

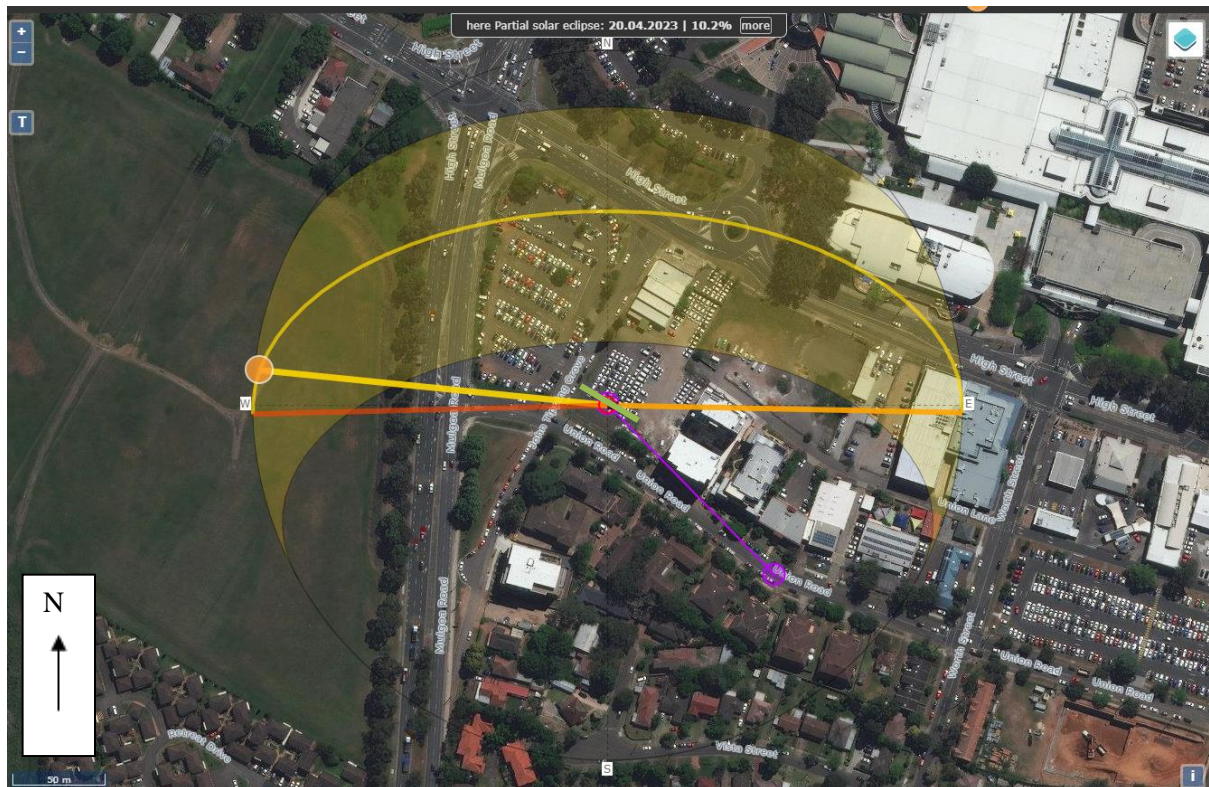
Similar levels of moderate exceedance were found at other locations analysed along Union Road travelling northwest toward the development site were found for shorter periods of time from the Podium's South-West façade. It is noted this analysis conservatively assumes a fully glazed podium façade at this location. As currently planned, the South- West façade at podium level is predominantly made of masonry and the presence of vertical opaque façade elements shown in current architectural drawings will largely block glancing reflections.

Hence it is expected solar reflections from the Podium's South-West façade will not negatively impact the vision of drivers' who are travelling northwest along Union Road.

Figure 10: Representation of incident and reflection of solar rays from the Podium's South-West façade onto Union Road.

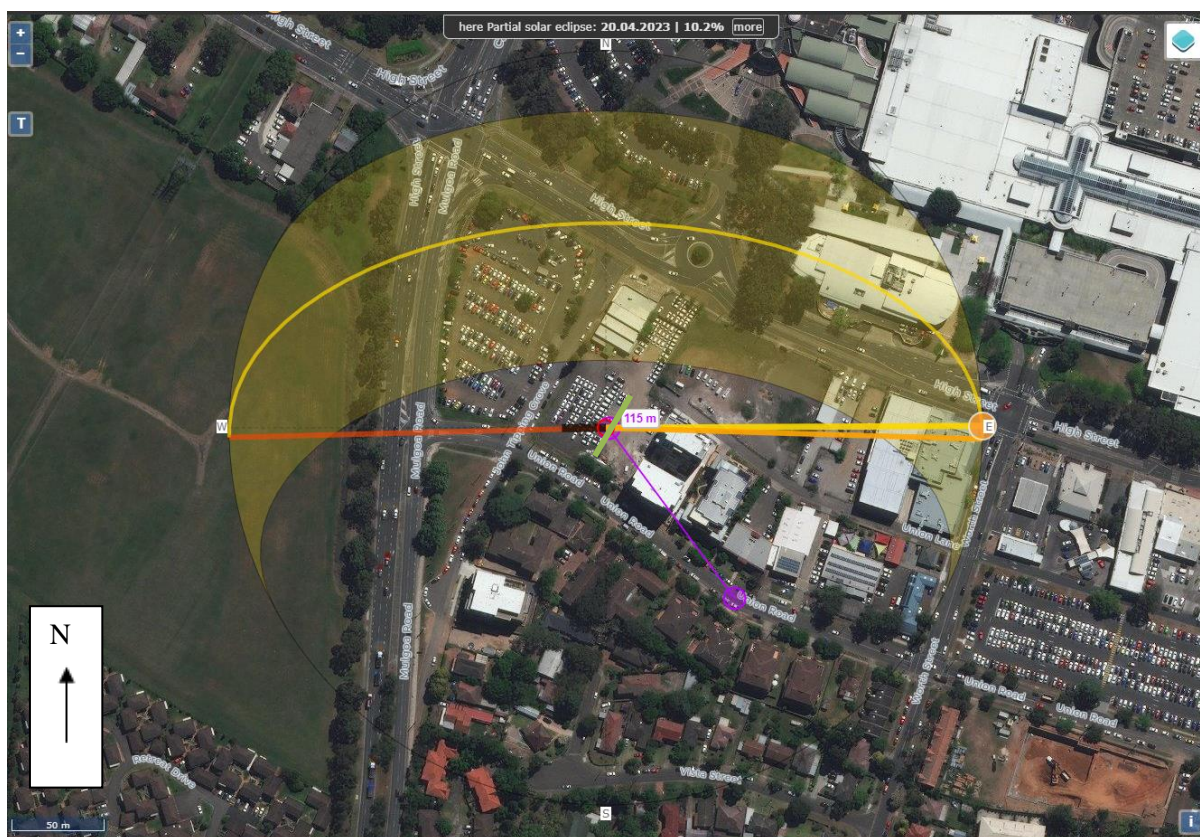
Drivers at other locations analysed along Union Road travelling northwest toward the development site were found to experience lower levels of TI values for shorter periods of time from the Podium's South-East façade 1. Thus, it is expected solar reflections from the Podium's South-East façade 1 will not negatively impact the vision of drivers' who are travelling northwest along Union Road.

Figure 11: Representation of incident and reflection of solar rays from the Podium's South-East façade 1 onto Union Road.

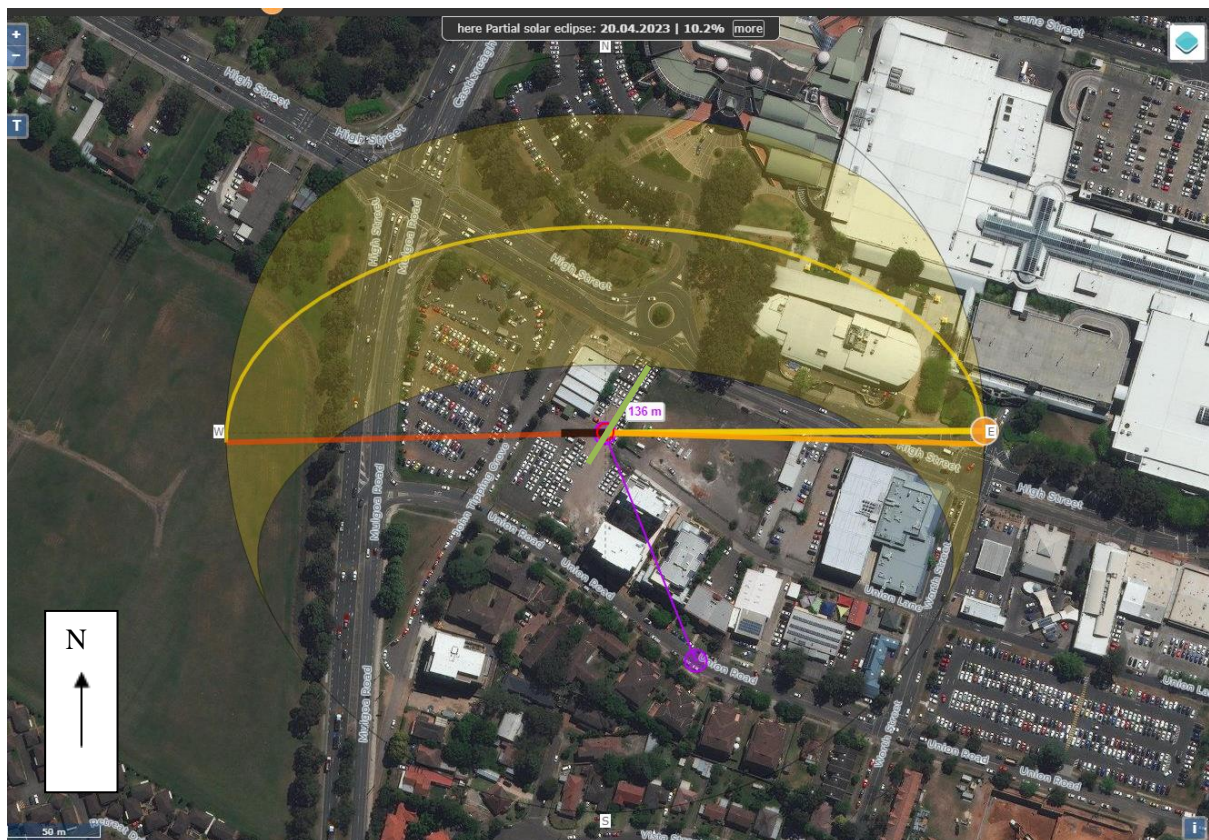
Drivers at other locations analysed along Union Road travelling northwest toward the development site were found to experience lower levels of TI values for shorter periods of time from the Podium's South-East façade 2. Thus, it is expected solar reflections from the Podium's South-East façade 2 will not negatively impact the vision of drivers' who are travelling northwest along Union Road.

Figure 13: Representation of incident and reflection of solar rays from the Podium's South-East façade 2 onto Union Road.

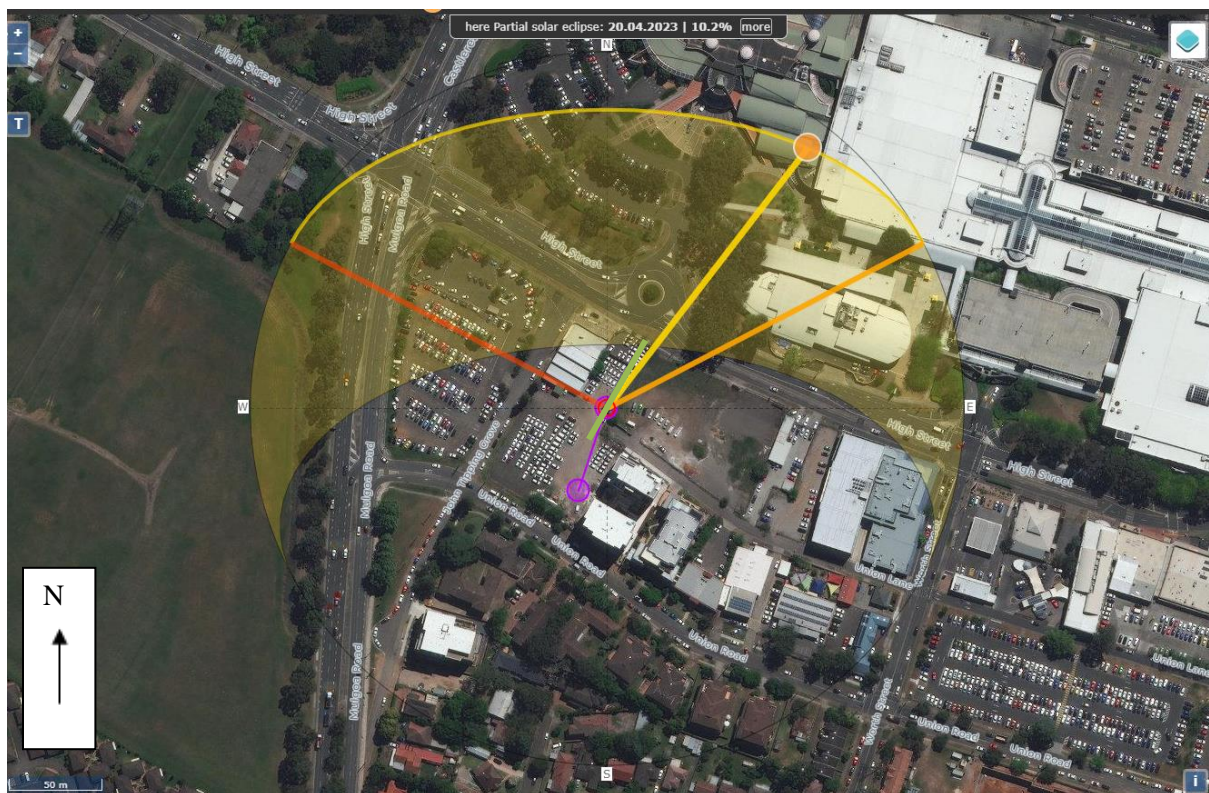
Drivers at other locations analysed along Temporary New Road travelling northeast toward the development site were found to experience higher levels of TI values for shorter periods of time from the Podium's South-East façade 2. Thus, it is expected solar reflections from the Podium's South-East façade 2 will not negatively impact the vision of drivers' who are travelling northeast along Temporary New Road.

Figure 15: Representation of incident and reflection of solar rays from the Podium's South-East façade 2 onto Temporary New Road.

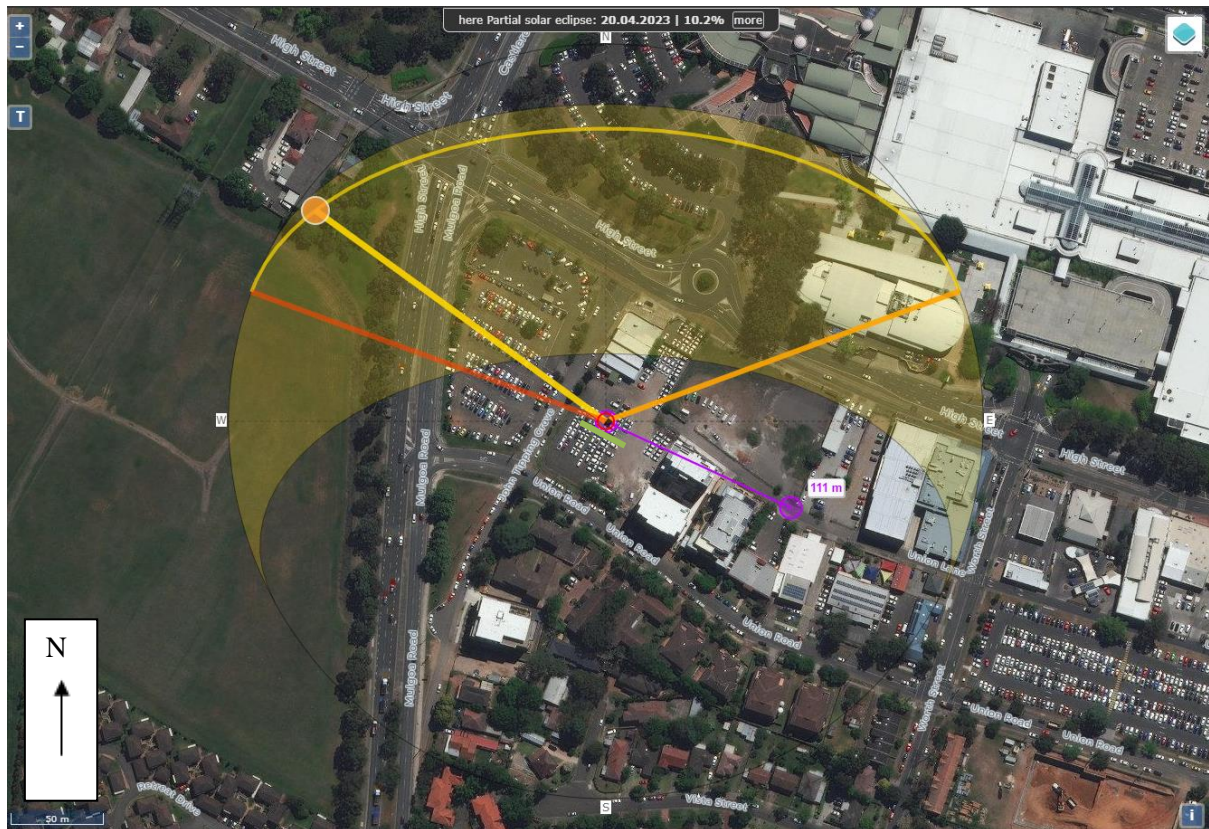
Similar levels of moderate exceedance were found at other locations analysed along Union Lane travelling northwest toward the development site were found for shorter periods of time from the S1T1's North-East façade. It is noted this analysis conservatively assumes a fully glazed tower façade at this location. The reflections generating the high levels of glare will occur when the sun's altitude is low, and its solar rays are emanating near parallel to the horizon. Thus, solar rays are likely blocked by podium which is predominantly made of masonry and vertical opaque façade elements.

To improve glare result, it is recommended each glazing unit be vertically recessed behind adjacent non-glazed and non-reflective façade elements in a ration of 1:10, e.g. 100mm deep vertical mullion for every 1000mm width of glass.

With this measure in place, it is expected solar reflections from the S1T1's North-East façade will not negatively impact the vision of drivers' who are travelling northwest along Union Lane.

Figure 16: Representation of incident and reflection of solar rays from the S1T1's North-East façade onto Union Lane.

Stage 1 Tower 1	NE	37	Union Lane	<20%	2.30pm to 3.30pm	Mid autumn to early spring	Low altitude, incident solar rays likely blocked by upstream buildings during this time period. Façade treatment (ratio 1:10, e.g. 100m deep vertical mullion for every 1000mm width of glass) recommended to reduce the impact of glare onto investigated locations.
		40	Temporary New Road	<20%	10am to 11am	Mid autumn to early spring	
	NW	21	John Tipping Grove	<20%	10am	Late autumn and late winter	
		28	Union Road	<20%	12.30pm to 2pm	Mid autumn to early spring	
	SW	32	Union Road	~30%	3pm to 5pm	Autumn, mid winter to early spring	Low altitude, incident solar rays likely blocked by upstream buildings during this time period. Façade predominantly made of masonry and presence of vertical opaque façade element is expected to reduce the impact of glare onto investigated locations.
	SE	32	Union Road	~20%	5am to 7.30am	Late spring to late summer	Low altitude, incident solar rays likely blocked by upstream buildings during this time period. Façade predominantly made of masonry and presence of vertical opaque façade element is expected to reduce the impact of glare onto investigated locations.

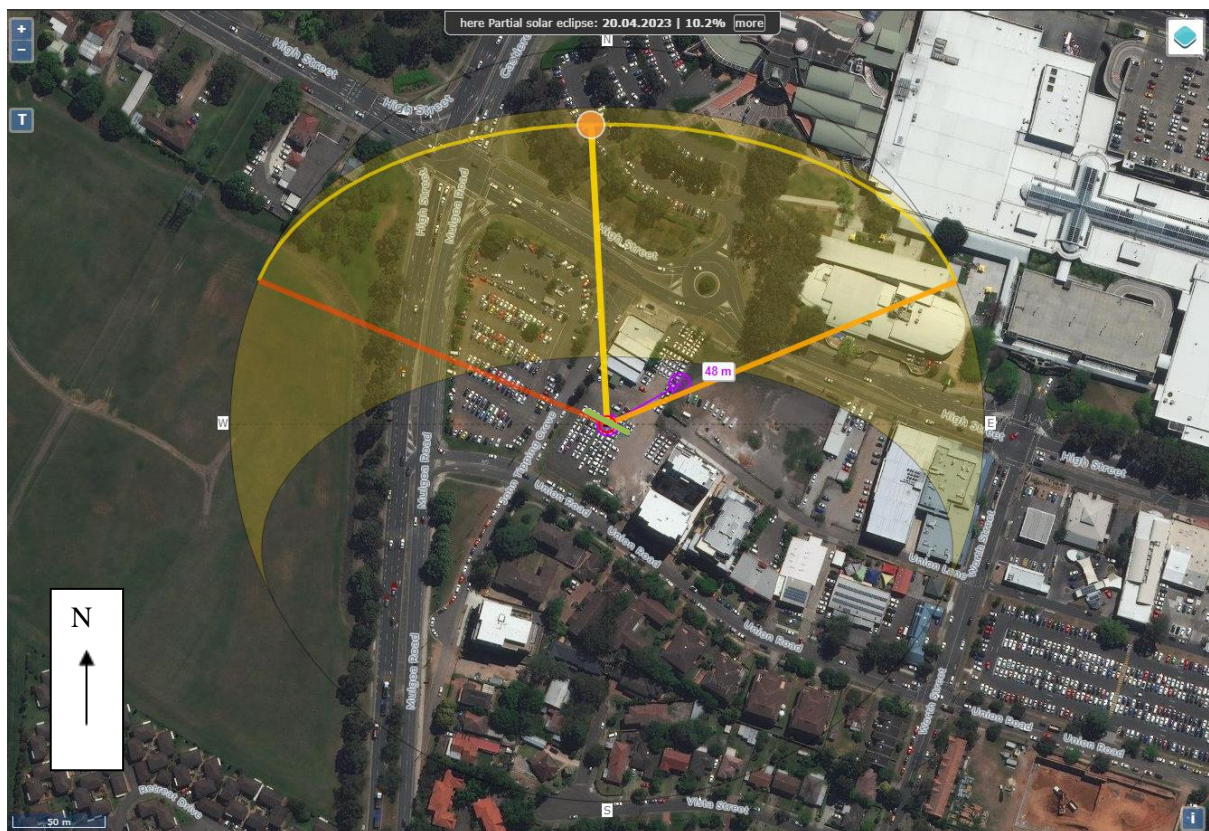
Drivers at other locations analysed along Temporary New Road travelling southwest toward the development site were found to experience lower levels of TI values for shorter periods of time from the S1T1's North-East façade. Thus, it is expected solar reflections from the S1T1's North-East façade will not negatively impact the vision of drivers' who are travelling southwest along Temporary New Road.

Figure 17: Representation of incident and reflection of solar rays from the S1T1's North-East façade onto Temporary New Road.

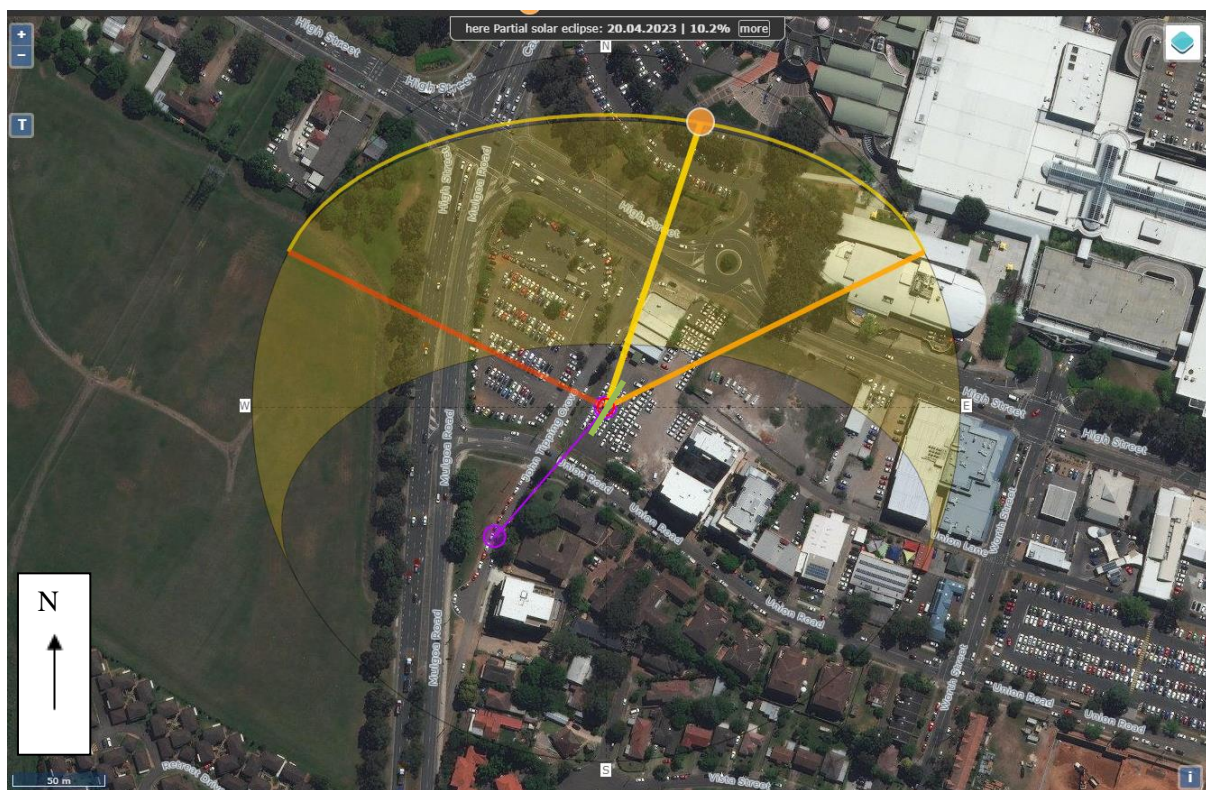
Drivers at other locations analysed along John Tipping Grove travelling northwest toward the development site were found to experience lower levels of TI values for shorter periods of time from the S1T1's North-West façade. Thus, it is expected solar reflections from the S1T1's North-West façade will not negatively impact the vision of drivers' who are travelling northwest along John Tipping Grove.

Figure 18: Representation of incident and reflection of solar rays from the S1T1's North-West façade onto John Tipping Grove.

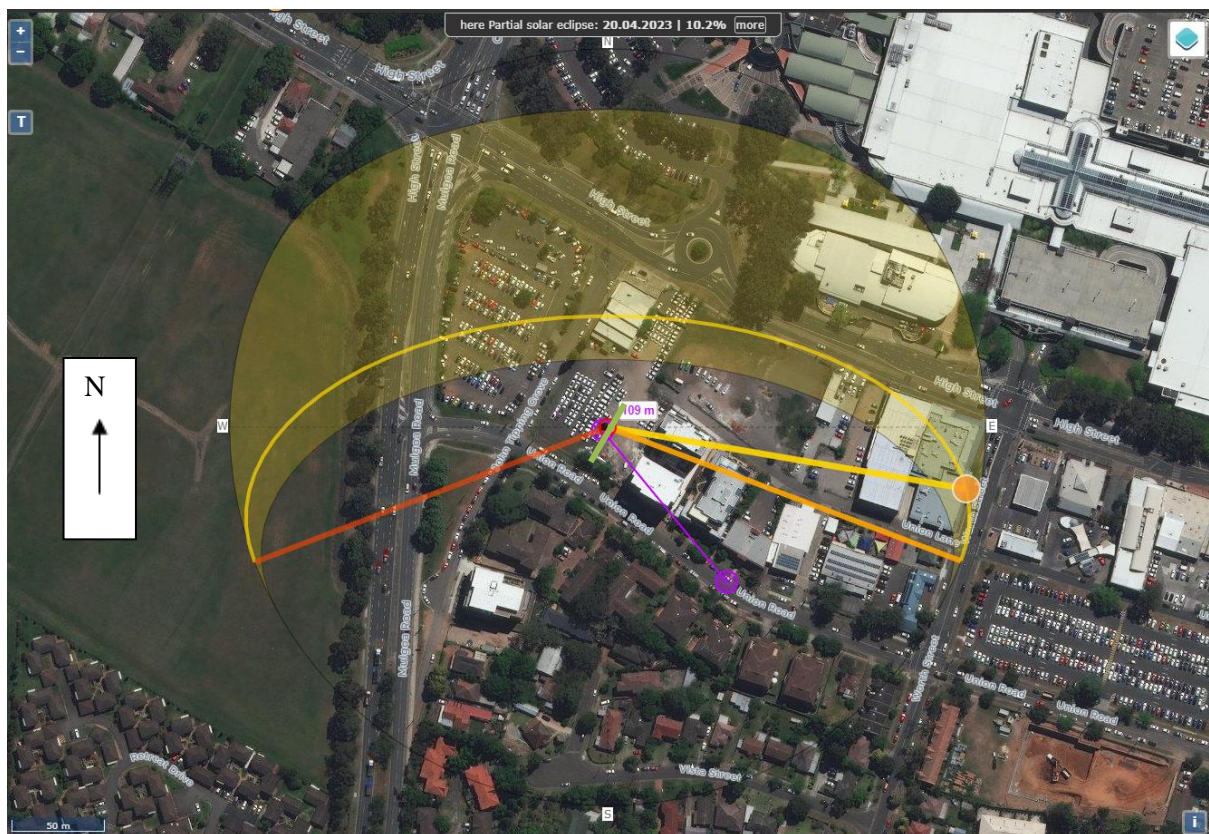
Similar levels of moderate exceedance were found at other locations analysed along Union Road travelling northwest toward the development site were found for shorter periods of time from the S1T1's South-East façade. It is noted this analysis conservatively assumes a fully glazed tower façade at this location. As currently planned, the S1T1's South-East façade is predominantly made of masonry and the presence of vertical opaque façade elements shown in current architectural drawings will largely block glancing reflections.

Hence it is expected solar reflections from the S1T1's South-East façade will not negatively impact the vision of drivers' who are travelling northwest along Union Road.

Figure 21: Representation of incident and reflection of solar rays from the S1T1's South-East façade onto Union Road.

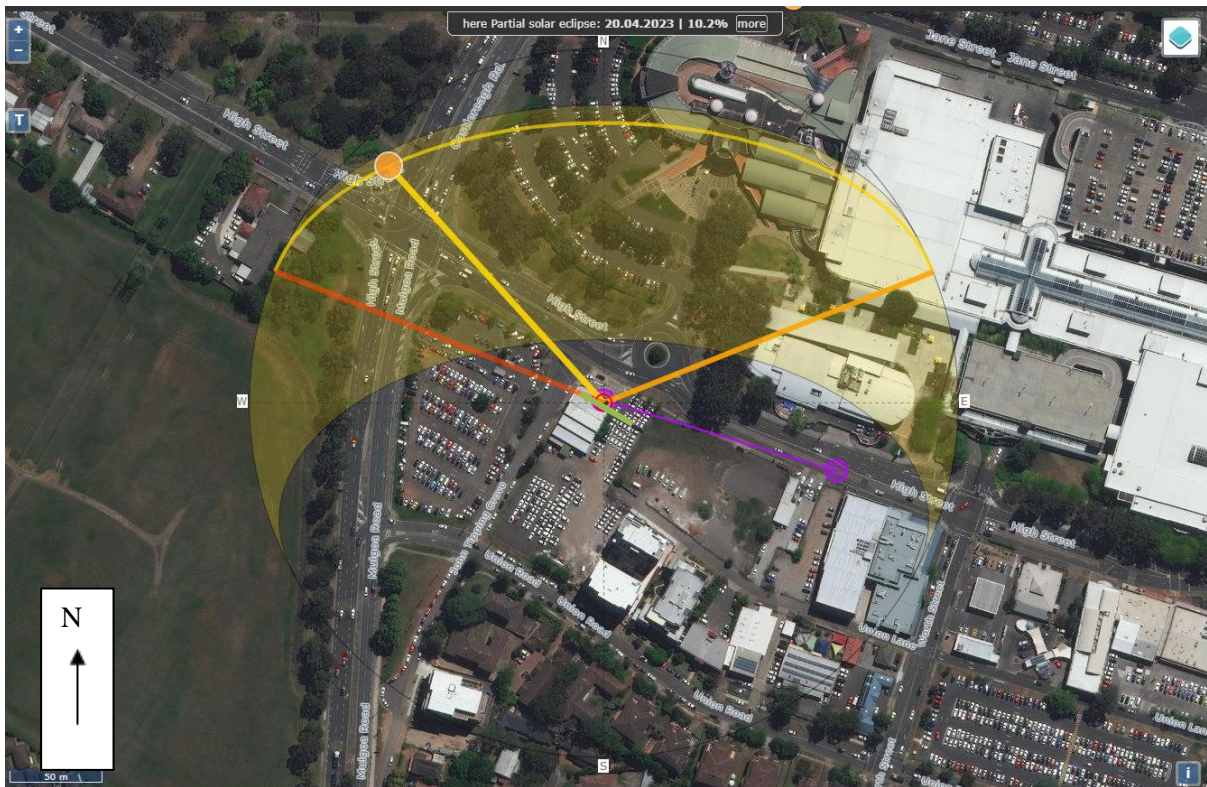
Hence, it is recommended that each glazing unit on the North-East façade be vertically recessed behind adjacent non-glazed and non-reflective façade elements in a ration of 1:10, e.g. 100mm deep vertical mullion for every 1000mm width of glass to minimize impact of glare produced by S2T2's North-East façade on the vision of driver's who are travelling northwest along High Street.

Figure 22: Representation of incident and reflection of solar rays from the S2T2's North-East façade onto High Street.

Stage 2 Tower 2	NE	2	High Street	<20%	2pm to 3pm	Early autumn to mid spring	Low altitude, incident solar rays likely blocked by upstream buildings during this time period. Façade treatment (ratio 1:10, e.g. 100m deep vertical mullion for every 1000mm width of glass) recommended to reduce the impact of glare onto investigated locations.
		7	High Street	<20%	5am to 6am	Early summer to mid summer	
	NW	5	High Street	<20%	3pm to 5pm	Late summer to mid autumn, spring	
		21	John Tipping Grove	<20%	10am to 10.30am	Mid autumn to late autumn, late winter to early spring	
	SW	30	Union Road	<20%	4pm to 4.30pm	Mid autumn and early spring	
		38	Union Lane	~50%	2pm to 5pm	Early autumn to mid spring	Low altitude, incident solar rays likely blocked by upstream buildings during this time period. Façade treatment (ratio 1:10, e.g. 100m deep vertical mullion for every 1000mm width of glass) recommended to reduce the impact of glare onto investigated locations.

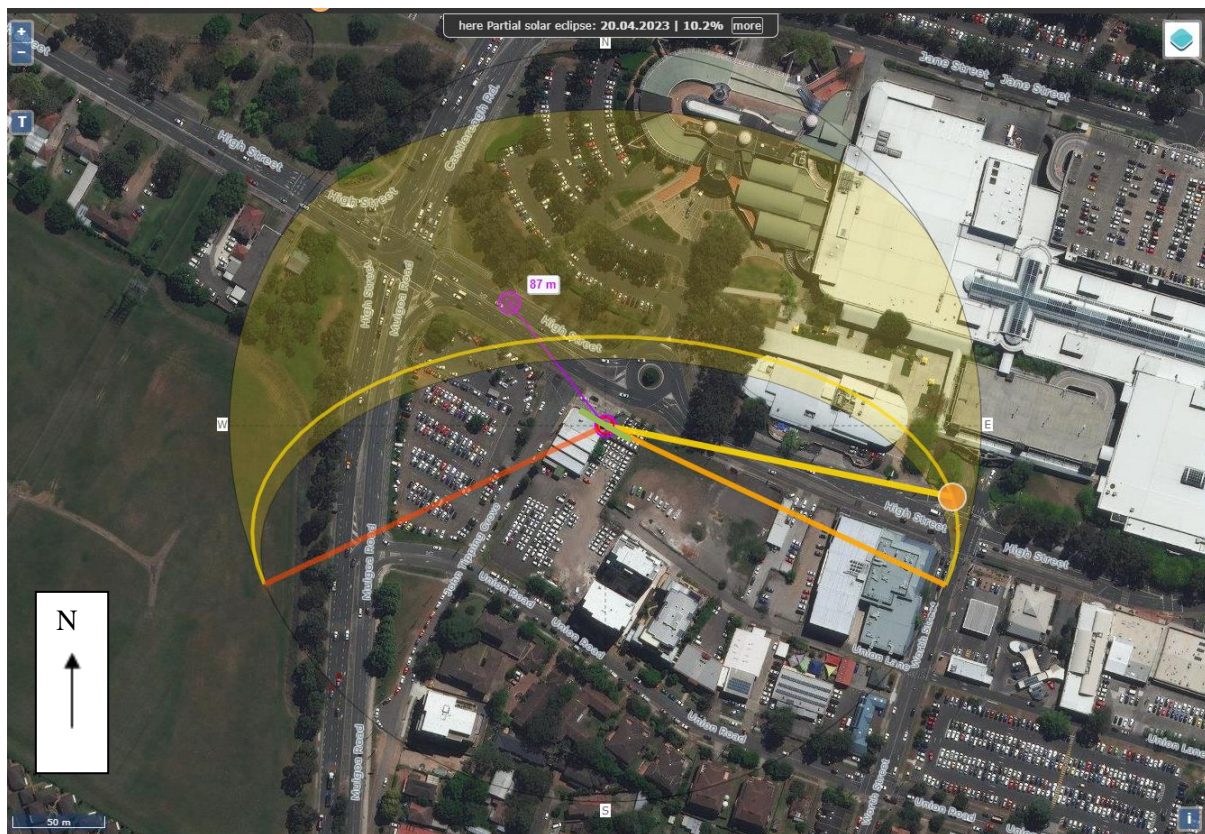
Drivers at other locations analysed along High Street travelling southeast toward the development site were found to experience lower levels of TI values for shorter periods of time from the S2T2's North-East façade. Thus, it is expected solar reflections from the S2T2's North-East façade will not negatively impact the vision of drivers' who are travelling southeast along High Street.

Figure 23: Representation of incident and reflection of solar rays from the S2T2's North-East façade onto High Street.

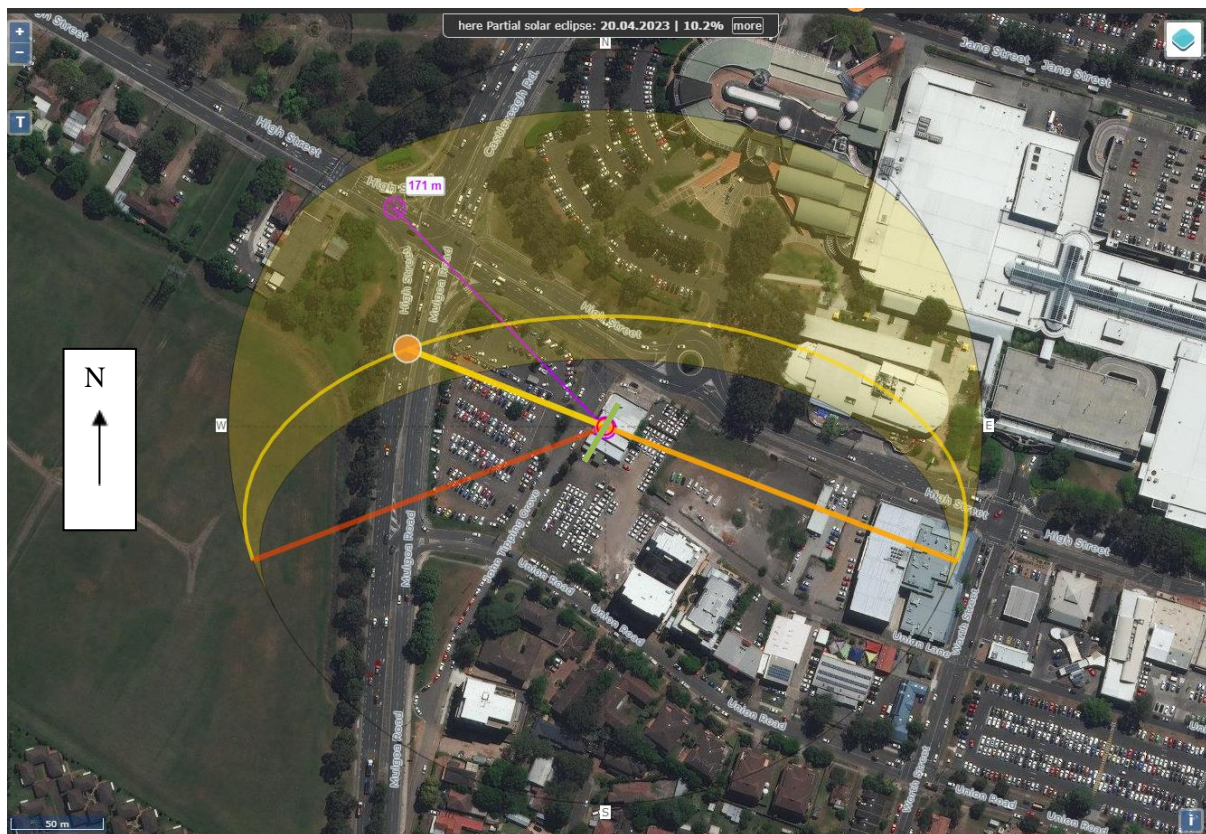
Drivers at other locations analysed along High Street travelling southeast toward the development site were found to experience lower levels of TI values for shorter periods of time from the S2T2's North-West façade. Thus, it is expected solar reflections from the S2T2's North-West façade will not negatively impact the vision of drivers' who are travelling southeast along High Street.

Figure 24: Representation of incident and reflection of solar rays from the S2T2's North-West façade onto High Street.

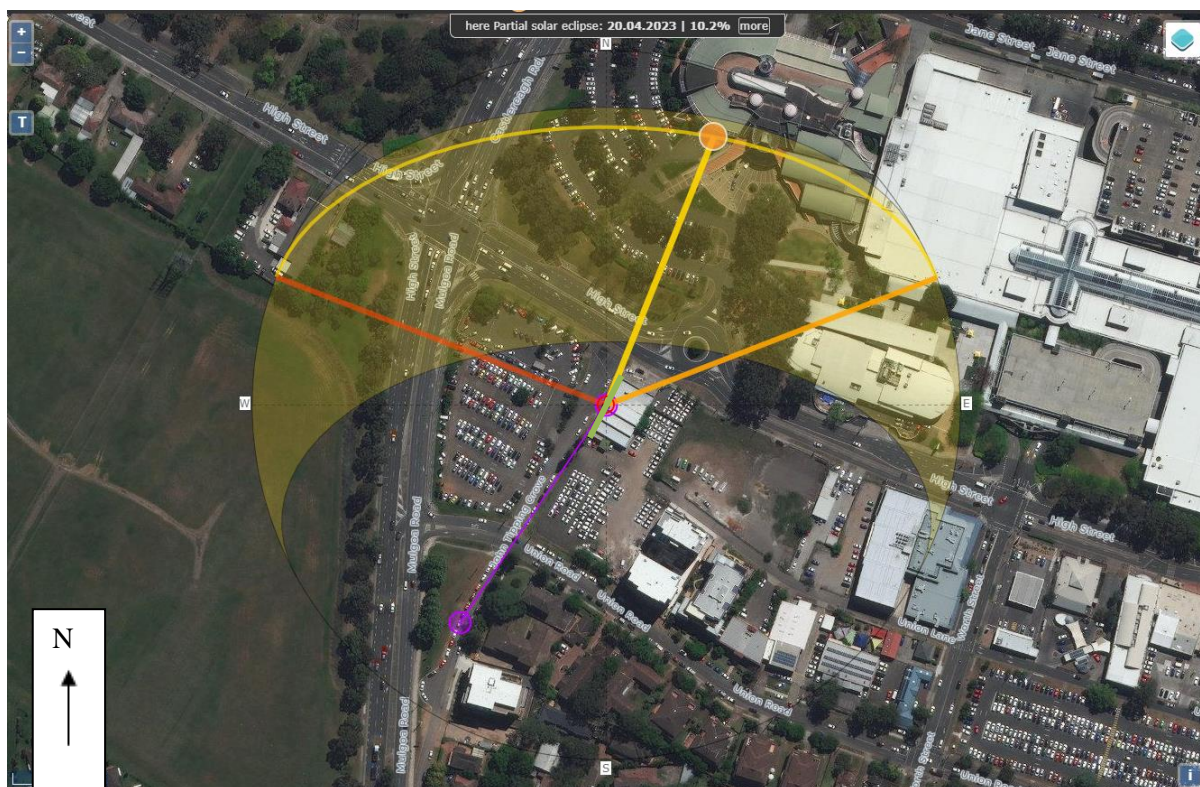
Drivers at other locations analysed along John Tipping Grove travelling northeast toward the development site were found to experience lower levels of TI values for shorter periods of time from the S2T2's North-West façade. Thus, it is expected solar reflections from the S2T2's North-West façade will not negatively impact the vision of drivers' who are travelling northeast along John Tipping Grove.

Figure 25: Representation of incident and reflection of solar rays from the S2T2's North-West façade onto John Tipping Grove.

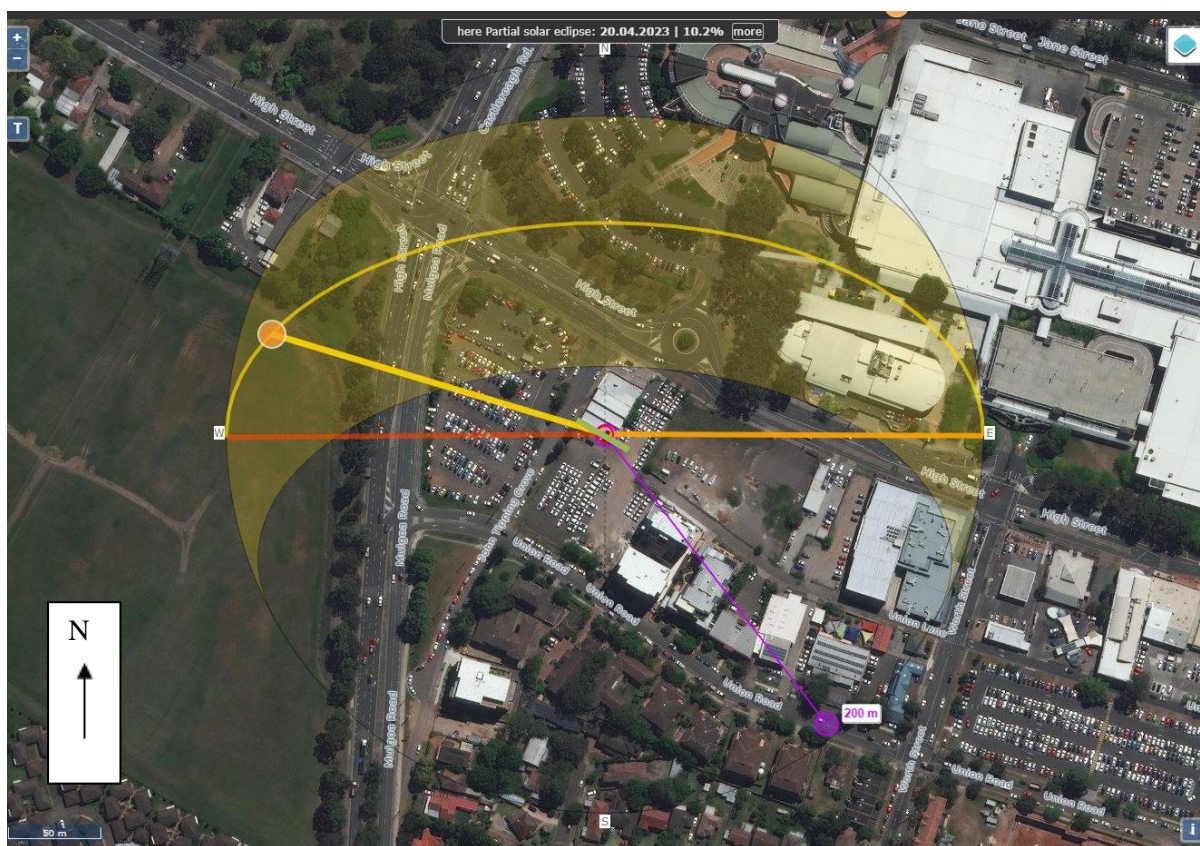
Drivers at other locations analysed along Union Road travelling northwest toward the development site were found to experience lower levels of TI values for shorter periods of time from the S2T2's South-West façade. Thus, it is expected solar reflections from the S2T2's South-West façade will not negatively impact the vision of drivers' who are travelling northwest along Union Road.

Figure 26: Representation of incident and reflection of solar rays from the S2T2's South-West façade onto Union Road.
