Solar Reflectivity Assessment for:
High Street Penrith
Sydney, Australia

Prepared for:
Toga Group
Level 5, 45 Jones Street,
Ultimo NSW 2007
October 2021

CPP Project: 11310

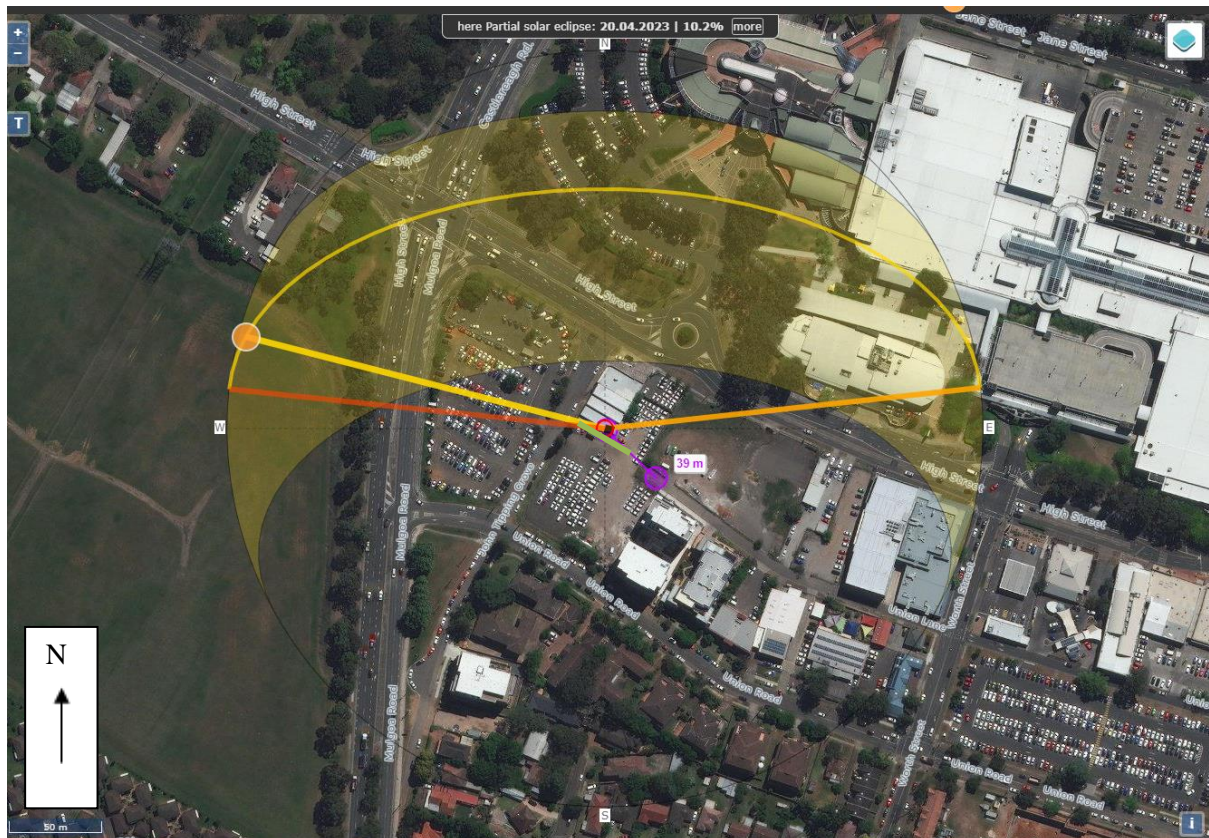
Similar levels of moderate exceedance were found at other locations analysed along Union Lane travelling northwest toward the development site were found for shorter periods of time from the S2T2's South-West façade. It is noted this analysis conservatively assumes a fully glazed tower façade at this location. The reflections generating the high levels of glare will occur when the sun's altitude is low, and its solar rays are emanating near parallel to the horizon. As currently planned, the S2T2's South-West façade at lower level consists of a podium which is predominantly made of masonry and the presence of vertical opaque façade elements shown in current architectural drawings will largely block glancing reflections.

To improve glare result, it is recommended that each glazing unit on the South-West façade be vertically recessed behind adjacent non-glazed and non-reflective façade elements in a ration of 1:10, e.g. 100mm deep vertical mullion for every 1000mm width of glass to minimize impact of glare produced by S2T2's South-West façade on the vision of driver's who are travelling northwest along Union Lane.

Hence it is expected solar reflections from the S2T2's South-West façade will not negatively impact the vision of drivers' who are travelling northwest along Union Lane.

Figure 27: Representation of incident and reflection of solar rays from the S2T2's South-West façade onto Union Lane.

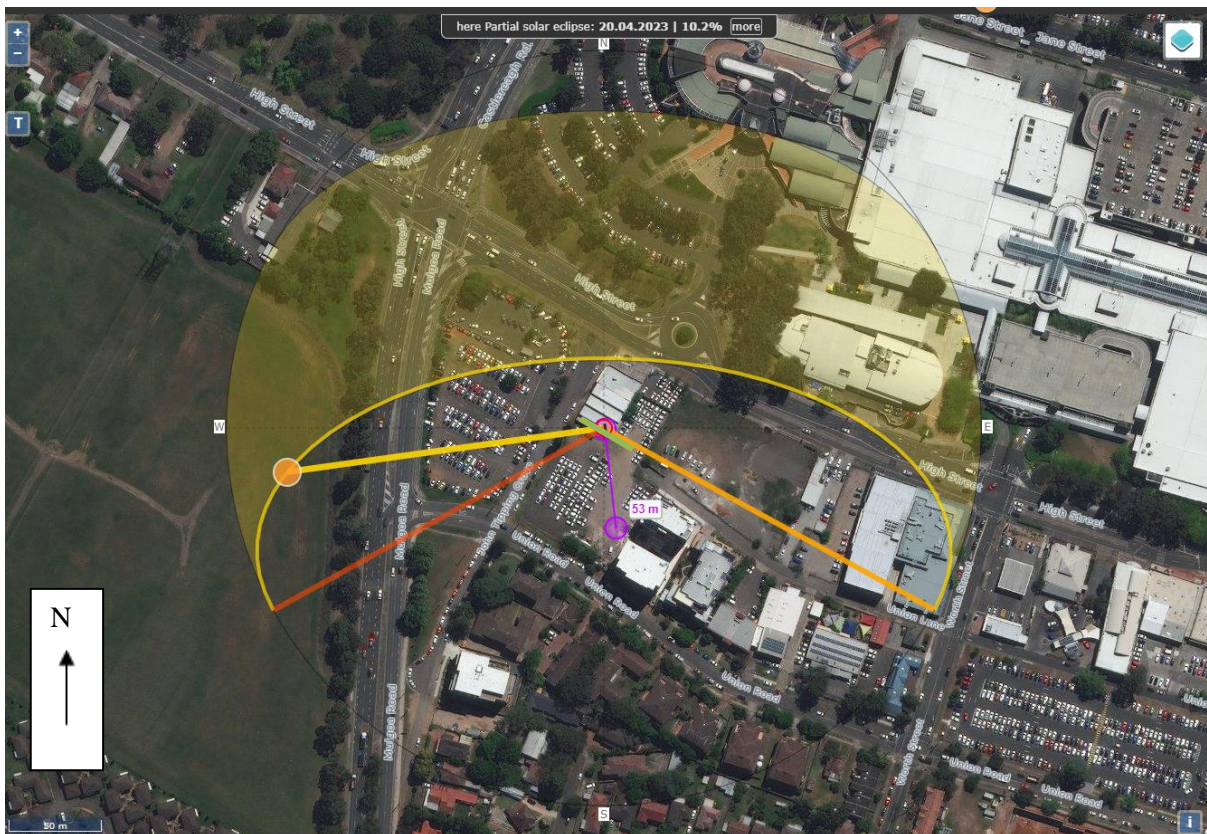
Drivers at other locations analysed along Temporary New Road travelling northeast toward the development site were found to experience lower levels of TI values for shorter periods of time from the S2T2's South-West façade. Thus, it is expected solar reflections from the S2T2's South-West façade will not negatively impact the vision of drivers' who are travelling northeast along Temporary New Road.

Figure 28: Representation of incident and reflection of solar rays from the S2T2's South-West façade onto Temporary New Road.

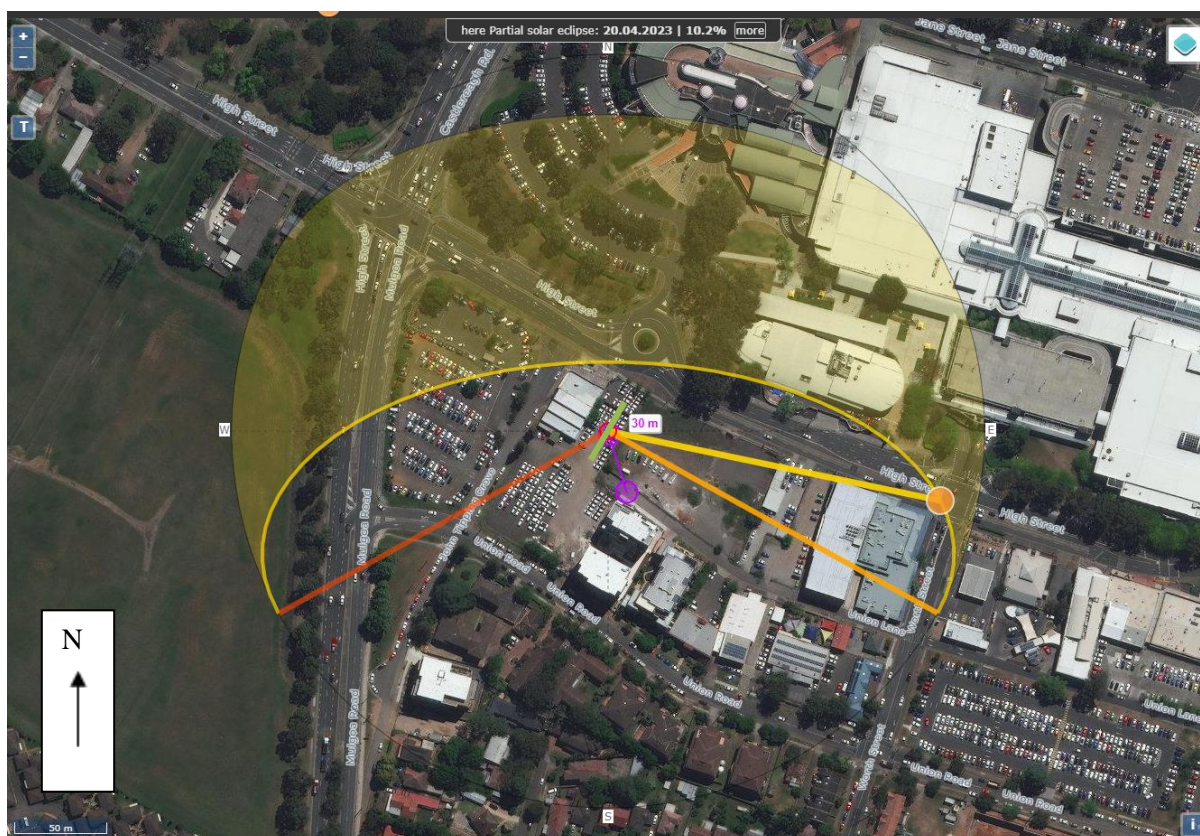
Analysis showed that between approximately 5am till 7.30am, drivers travelling northwest at Location 38, Figure 29, experienced solar glare with TI values of approximately 25%, which is slightly higher than the prescribed public roadway limit of 20% (AS/NZS 1158.1.1:2005). Given the marginal exceedance and the lower volume of traffic at this location, it is expected solar reflections from the S2T2's South-East façade will not negatively impact the vision of drivers' who are travelling northwest along Union Lane.

Figure 29: Representation of incident and reflection of solar rays from the S2T2's South-East façade onto Union Lane.

39	Temporary New Road	<20%	5pm to 7pm	Early summer to mid summer	
	SE	38	Union Lane	~25%	5.00am to 7.30am	Late spring to late summer	Low altitude, incident solar rays likely blocked by upstream buildings during this time period. Façade treatment (ratio 1:10, e.g. 100m deep vertical mullion for every 1000mm width of glass) recommended to reduce the impact of glare onto investigated locations.
		39	Temporary New Road	<20%	7am to 9.30am	Early autumn to mid spring

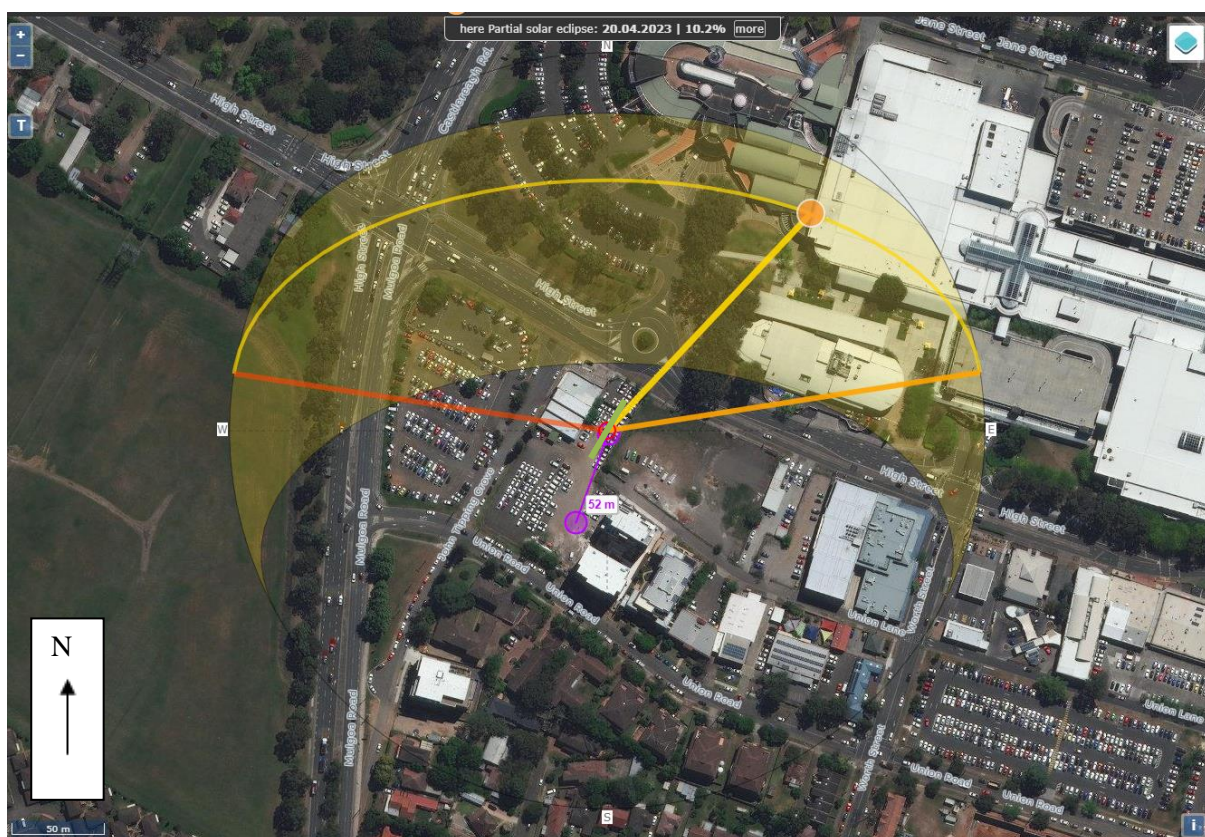
Drivers at other locations analysed along Temporary New Road travelling northeast toward the development site were found to experience lower levels of TI values for shorter periods of time from the S2T2's South-East façade. Thus, it is expected solar reflections from the S2T2's South-East façade will not negatively impact the vision of drivers' who are travelling northeast along Temporary New Road.

Figure 30: Representation of incident and reflection of solar rays from the S2T2's South-East façade onto Temporary New Road.
