# **Geotechnical Investigation Report**

Proposed Development at:  
225 & 227 Bungaribee Road  
Blacktown NSW 2148

G21674-1

28<sup>th</sup> October 2021

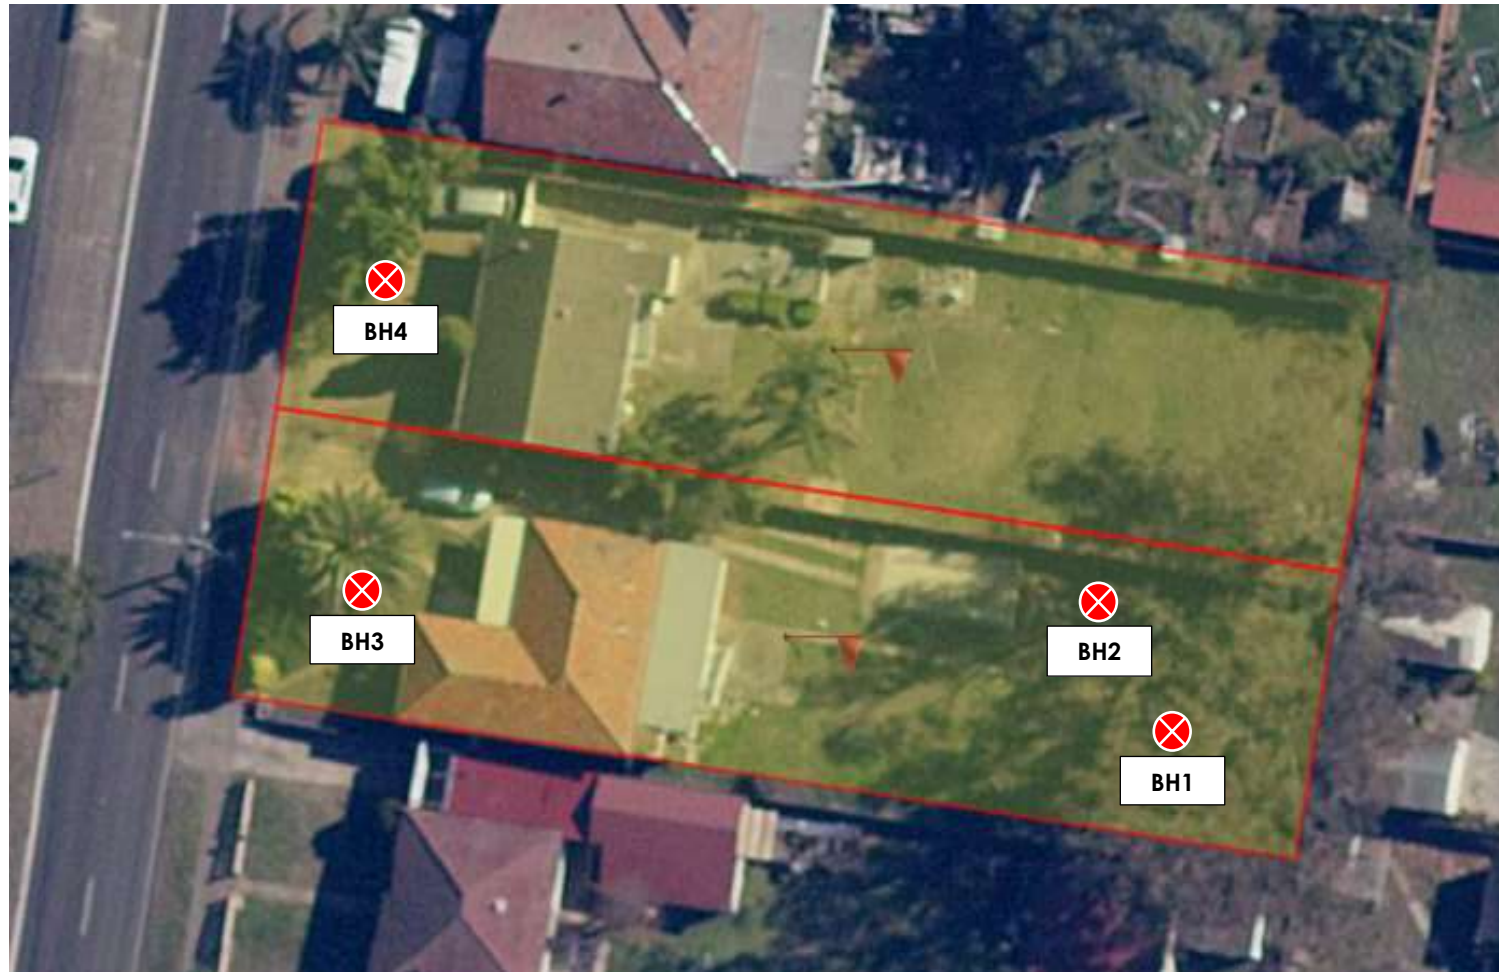
Figure 1 Site Plan	<b>Geotechnical Investigation</b>	Drawn: GN/GA

Approximate Borehole Location

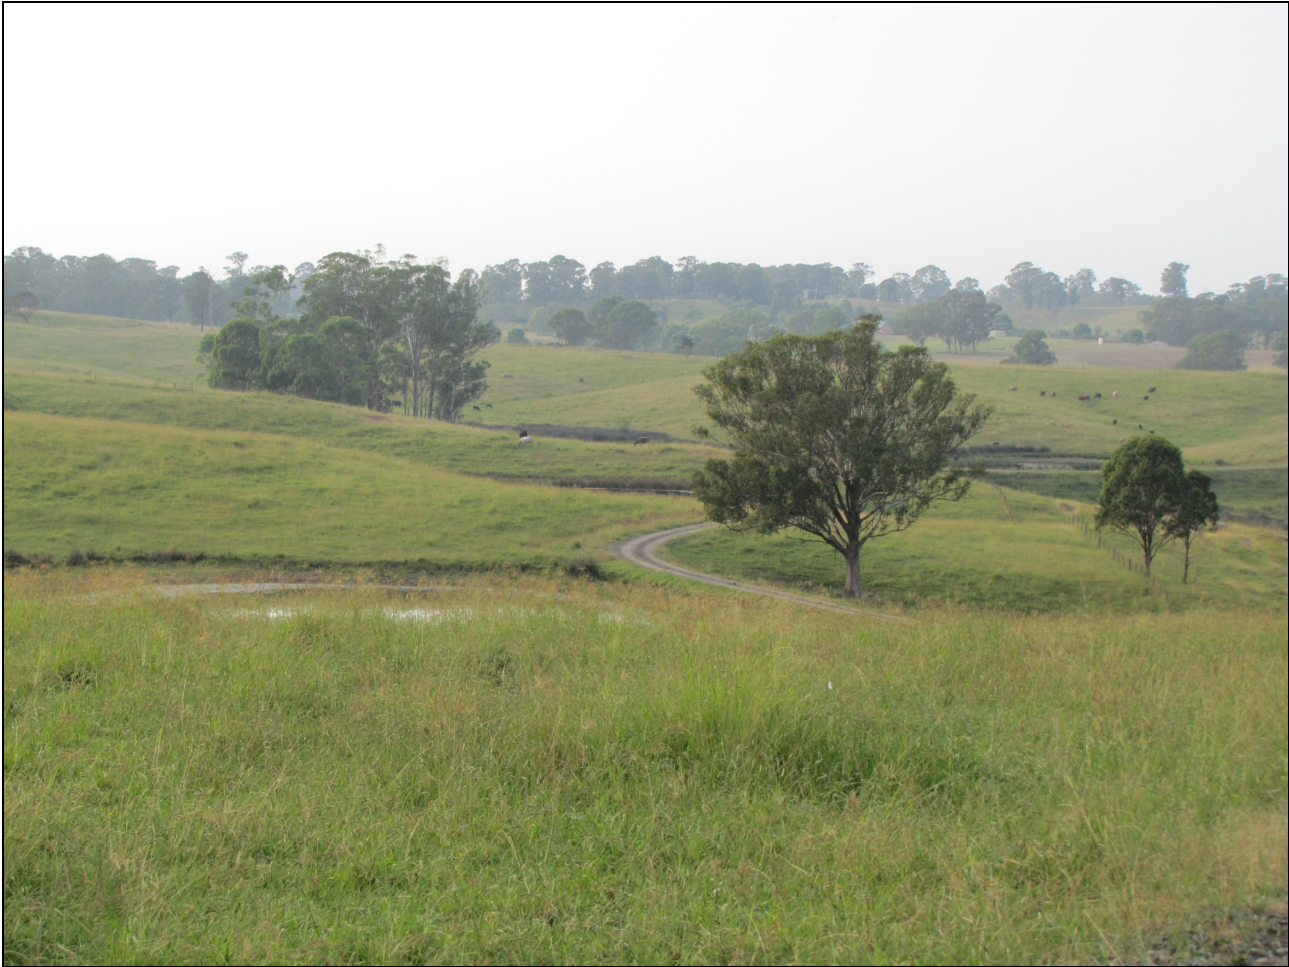
bt	BLACKTOWN	Residual
----	-----------	----------

**Landscape**—gently undulating rises on Wianamatta Group shales. Local relief to 30 m, slopes usually >5%. Broad rounded crests and ridges with gently inclined slopes. Cleared Eucalypt woodland and tall open-forest (dry sclerophyll forest).

**Soils**—shallow to moderately deep (>100 cm) hardsetting mottled texture contrast soils, Red and Brown Podzolic Soils (Dr3.21, Dr3.31, Db2.11, Db2.21) on crests grading to Yellow Podzolic Soils (Dy2.11, Dy3.11) on lower slopes and in drainage lines.
