Detailed Site Investigation

227 Bungaribee Road

E21211-1

28th October 2021

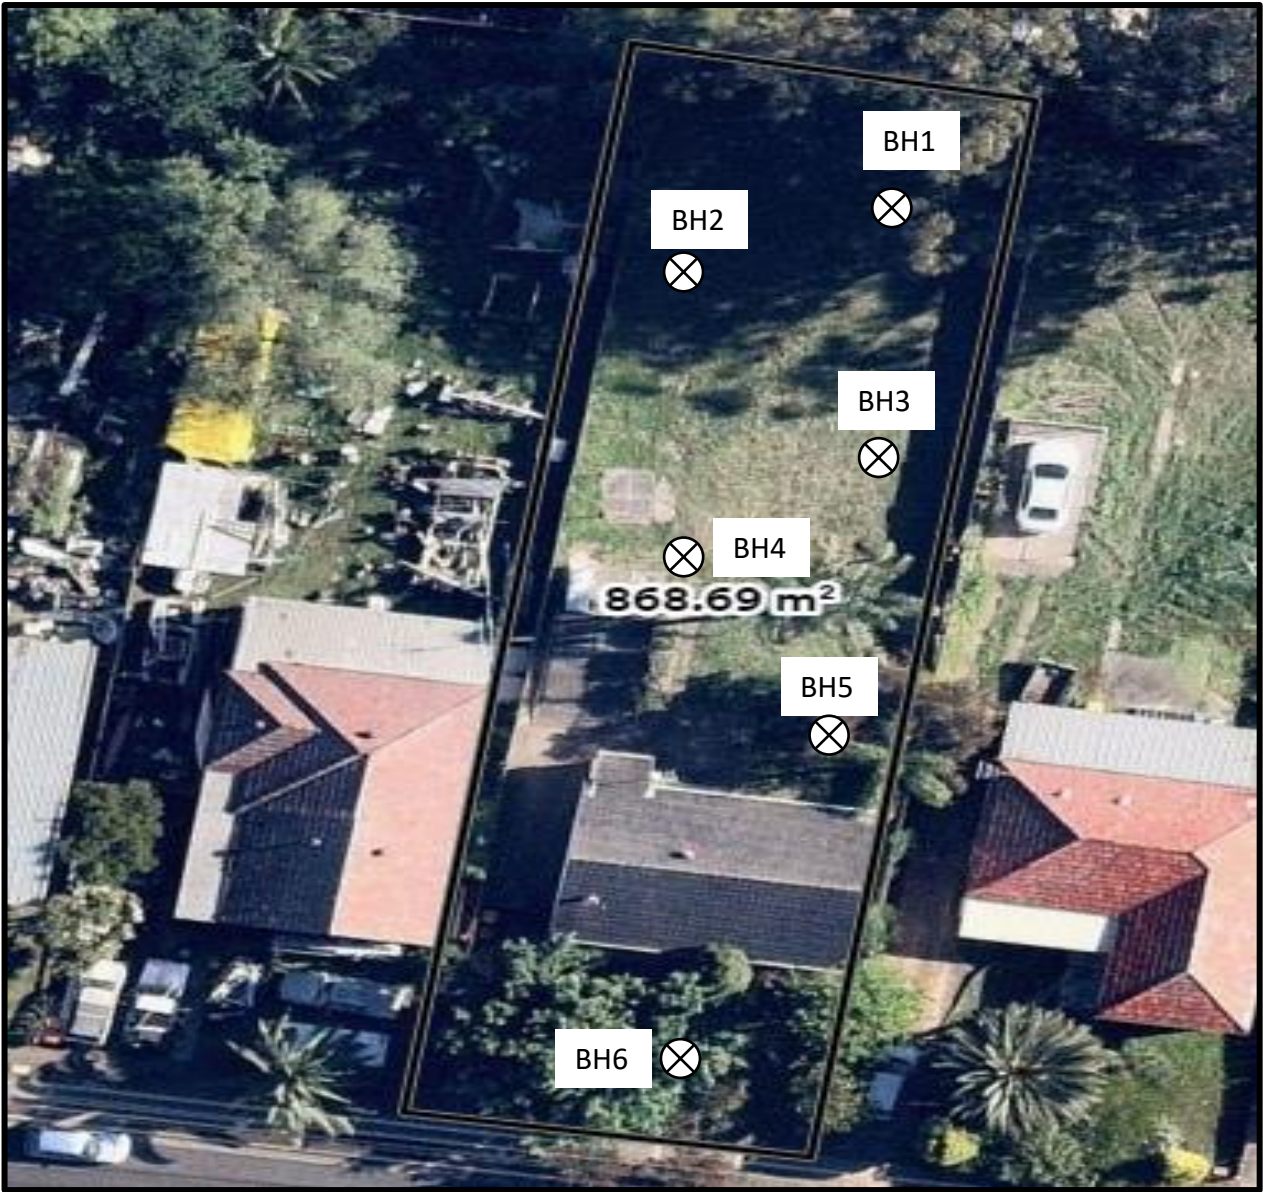
Borehole Locations

Figure 2	Site Area
Project	227 Bungaribee Road, Blacktown, NSW, 2148

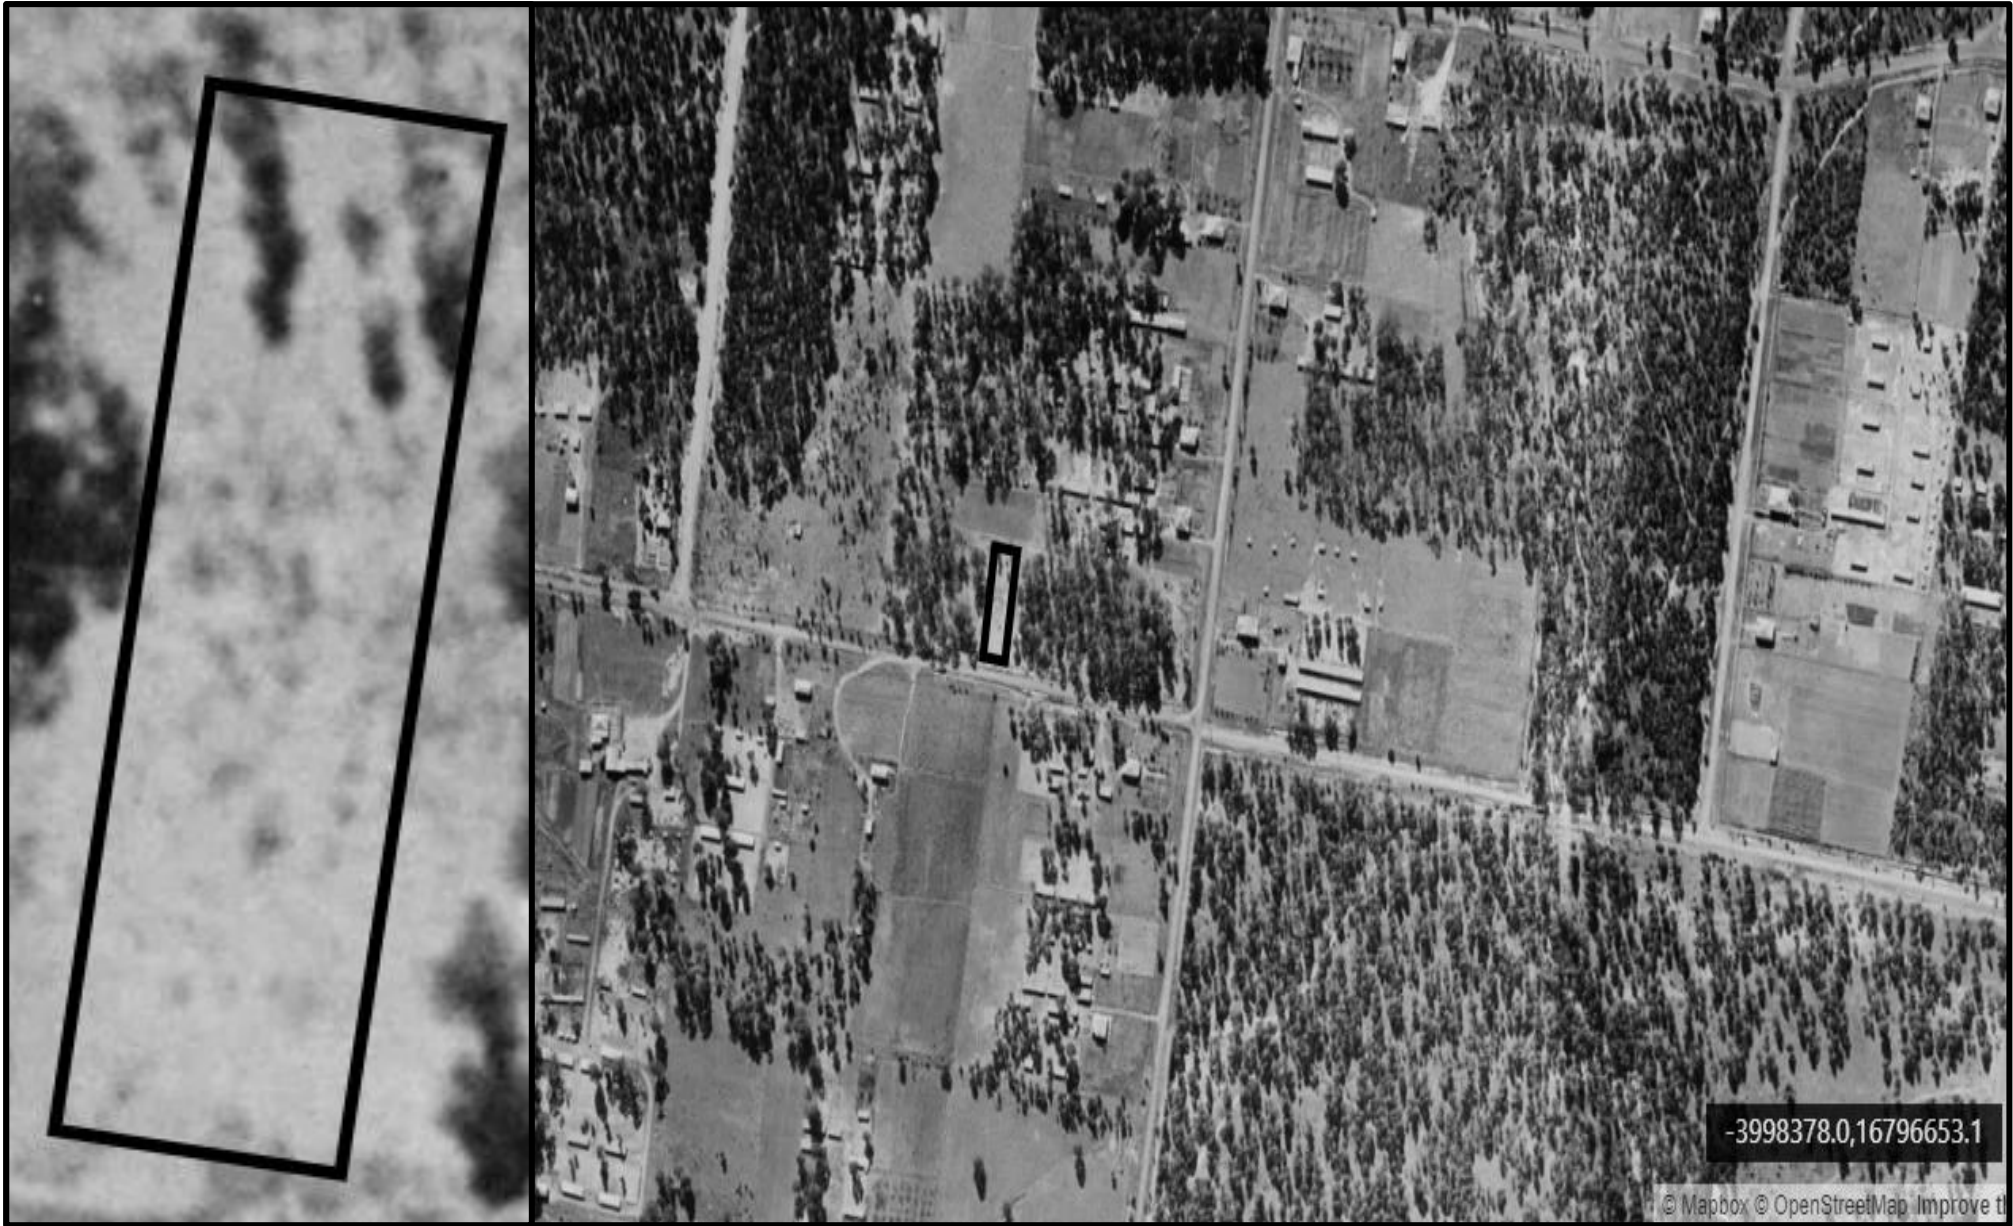
Figure 3	Aerial Image 1943
Project	227 Bungaribee Road, Blacktown, NSW, 2148

Figure 3. Aerial image of the site and surrounding area in 1943. The site is a vacant lot during this period. The surrounding area is composed of residential properties within farm/rural lands.

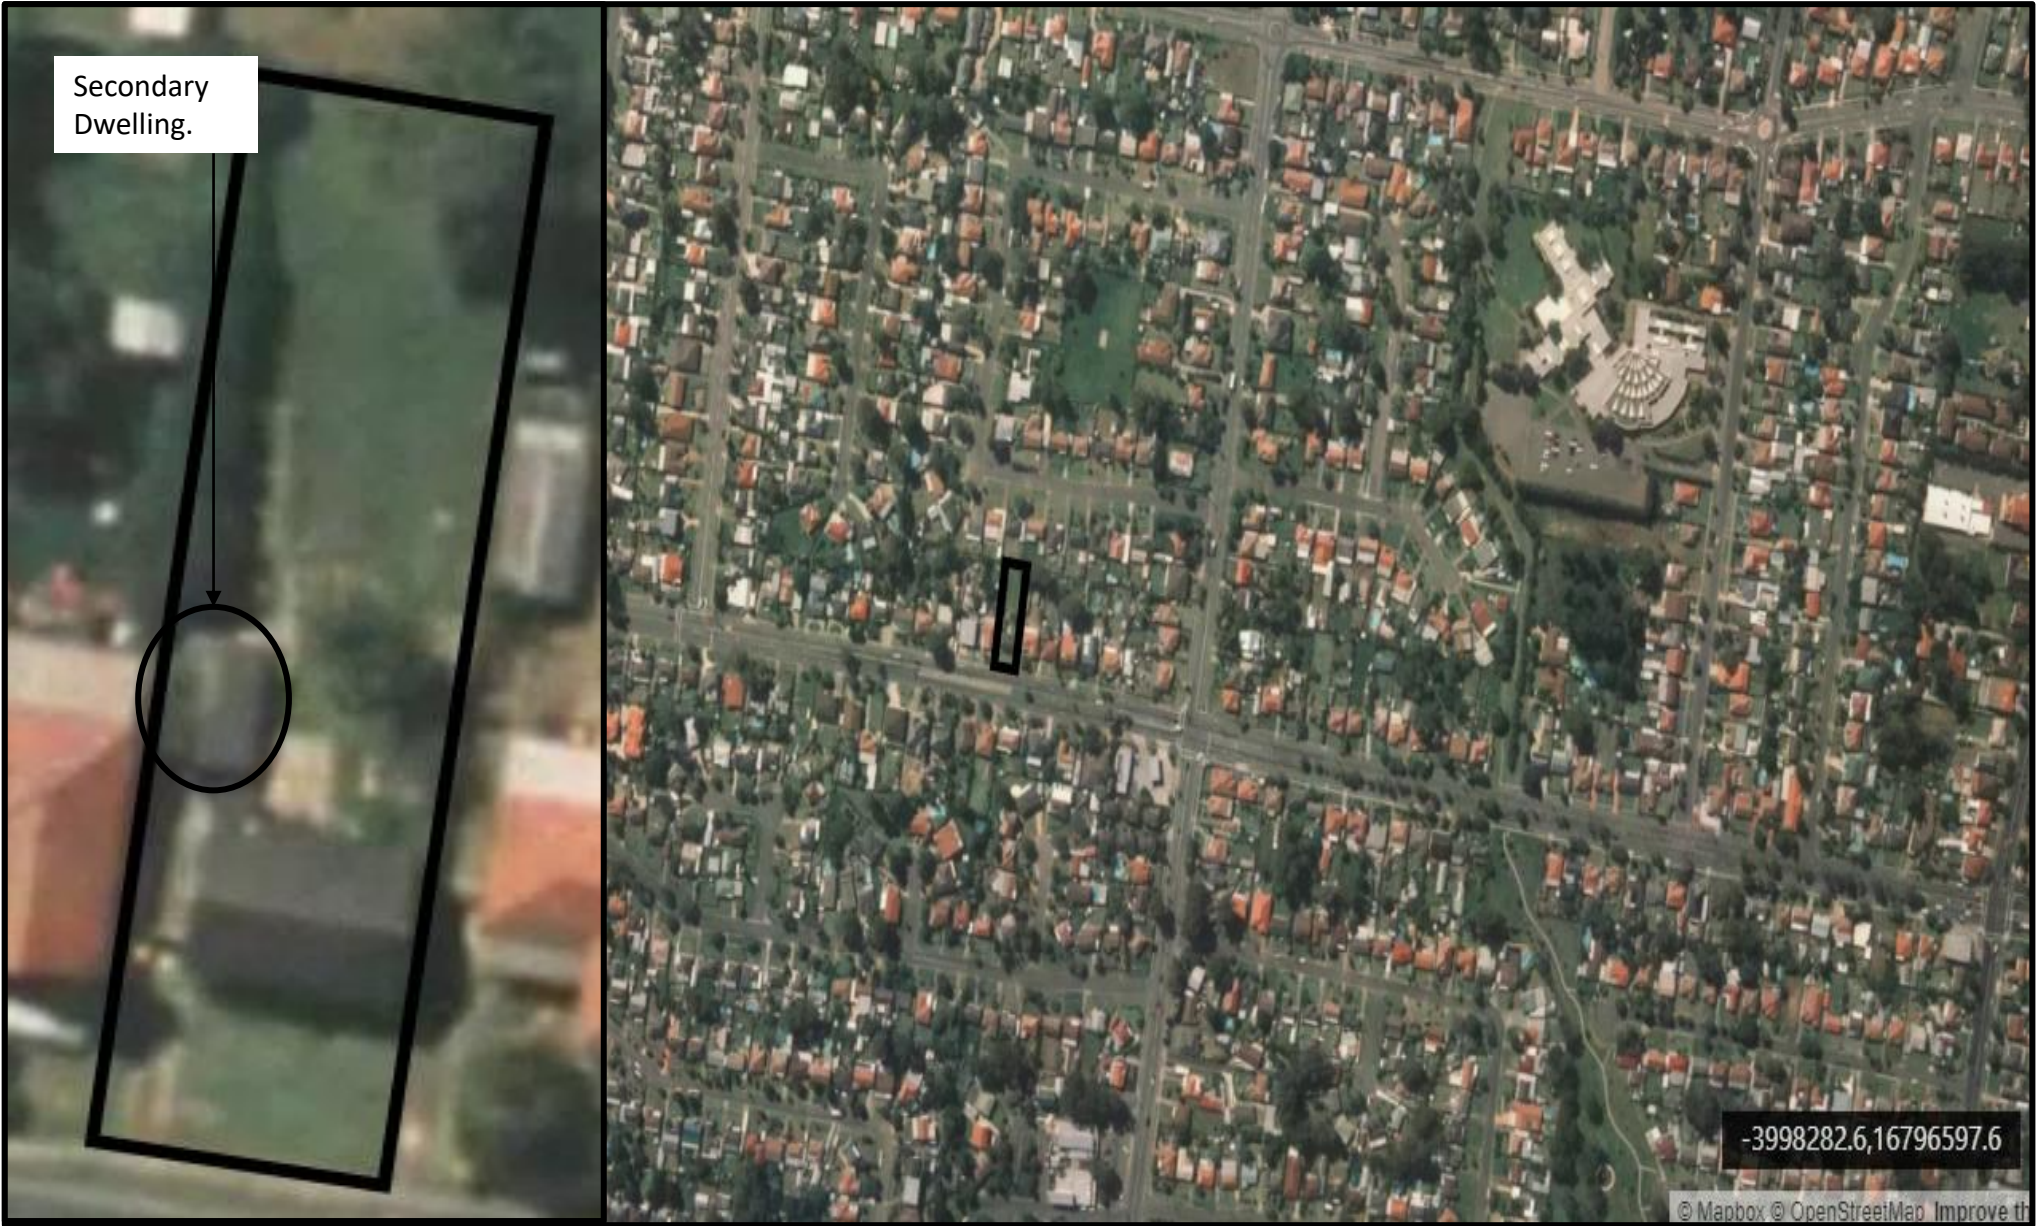
Figure 4	Aerial Image 2000
Project	227 Bungaribee Road, Blacktown, NSW, 2148

Figure 4. Aerial image of the site and surrounding area in 2000. The site is composed of a rectangular lot that contains a single storey residential property. The dwelling is located within the front portion of the lot, while the rear end is vacant. There is a secondary dwelling (or shed) located within the site. The surrounding area is zoned as R2 – Low Density Residential.

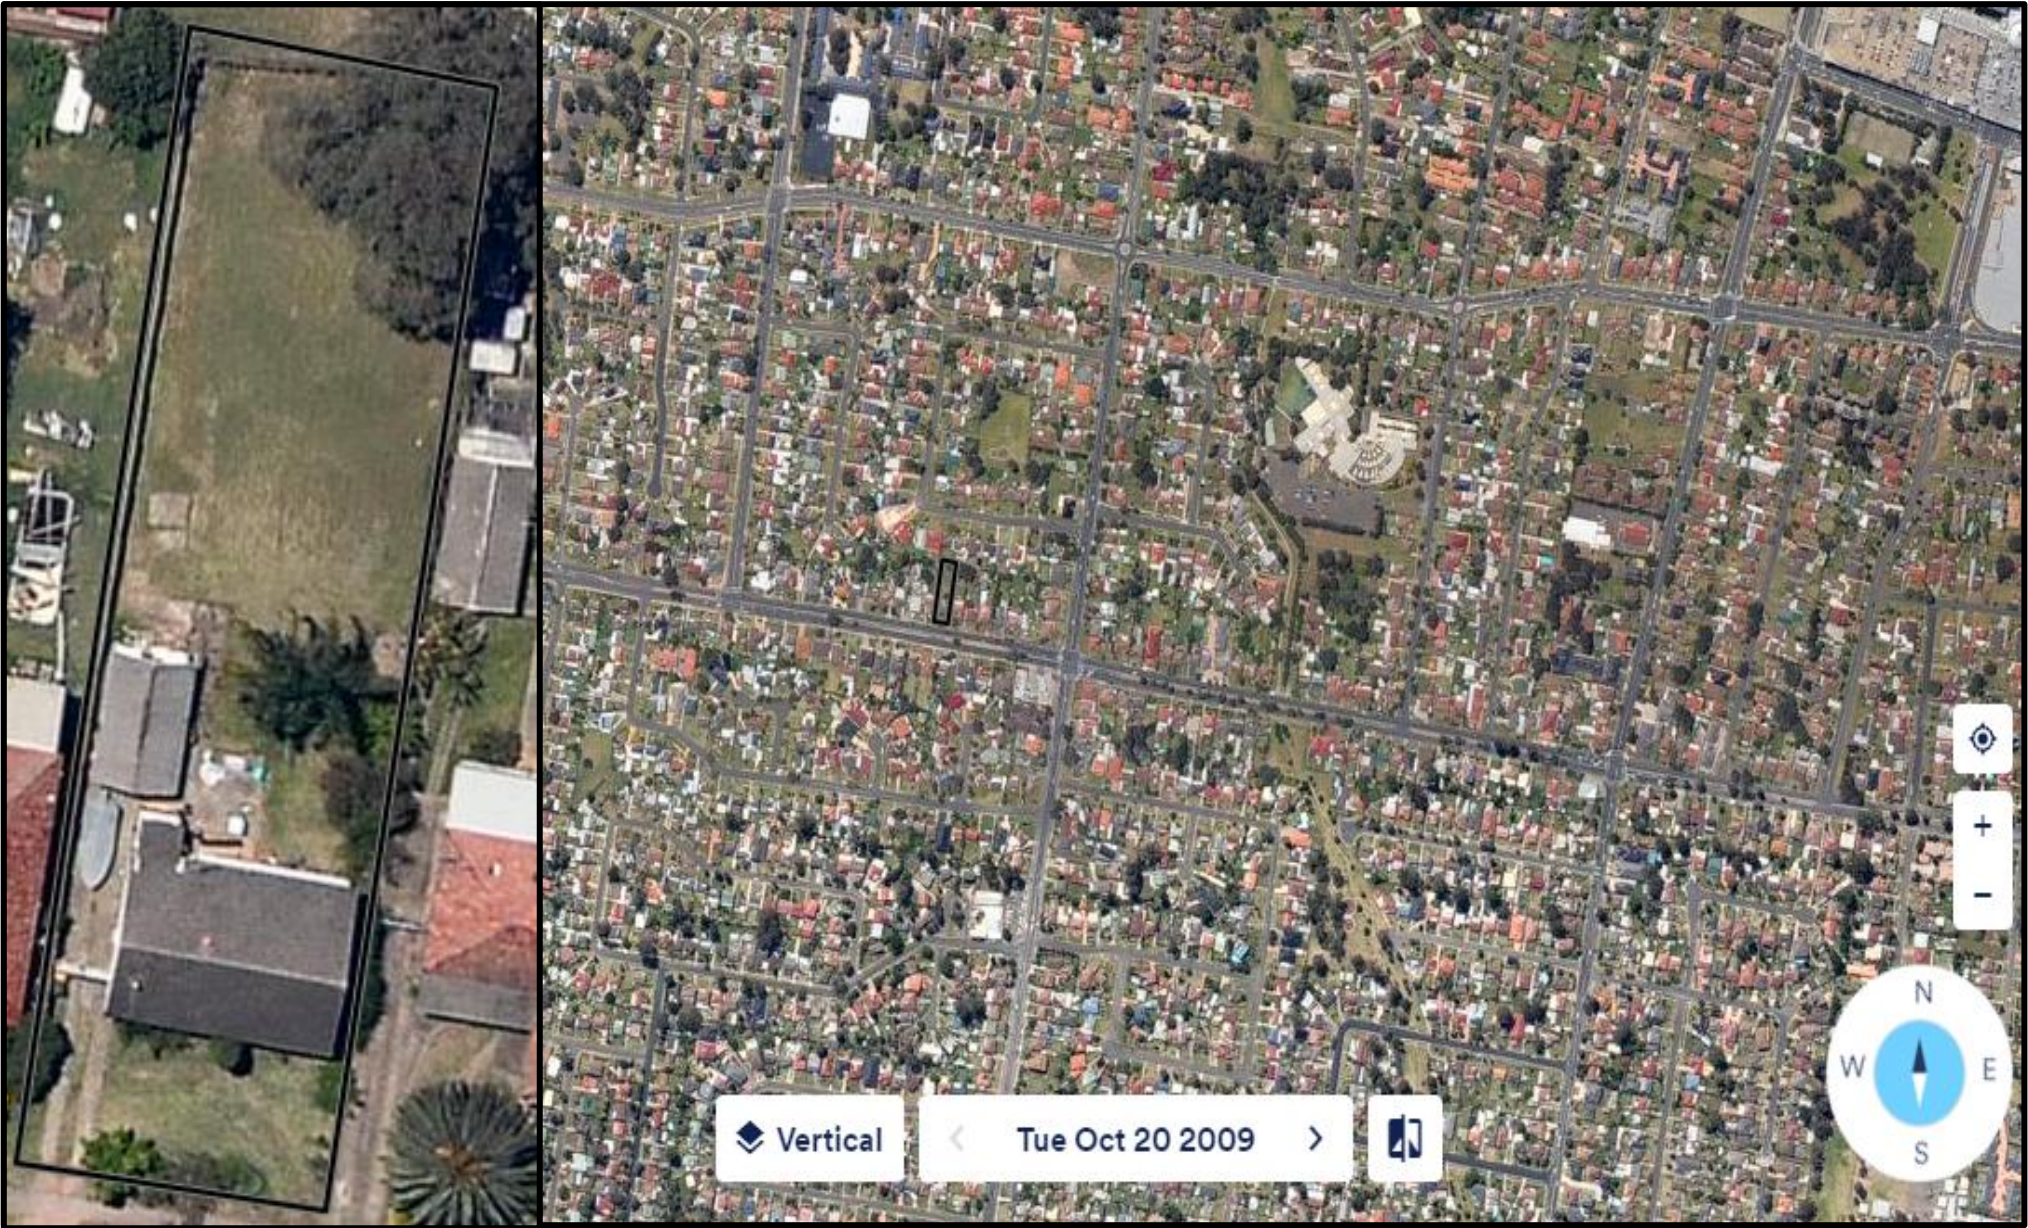
Figure 5	Aerial Image 2009
Project	227 Bungaribee Road, Blacktown, NSW, 2148

Figure 5. Aerial image of the site and surrounding area in 2009. The site and surrounding area is similar to the previous image taken in the year 2000.

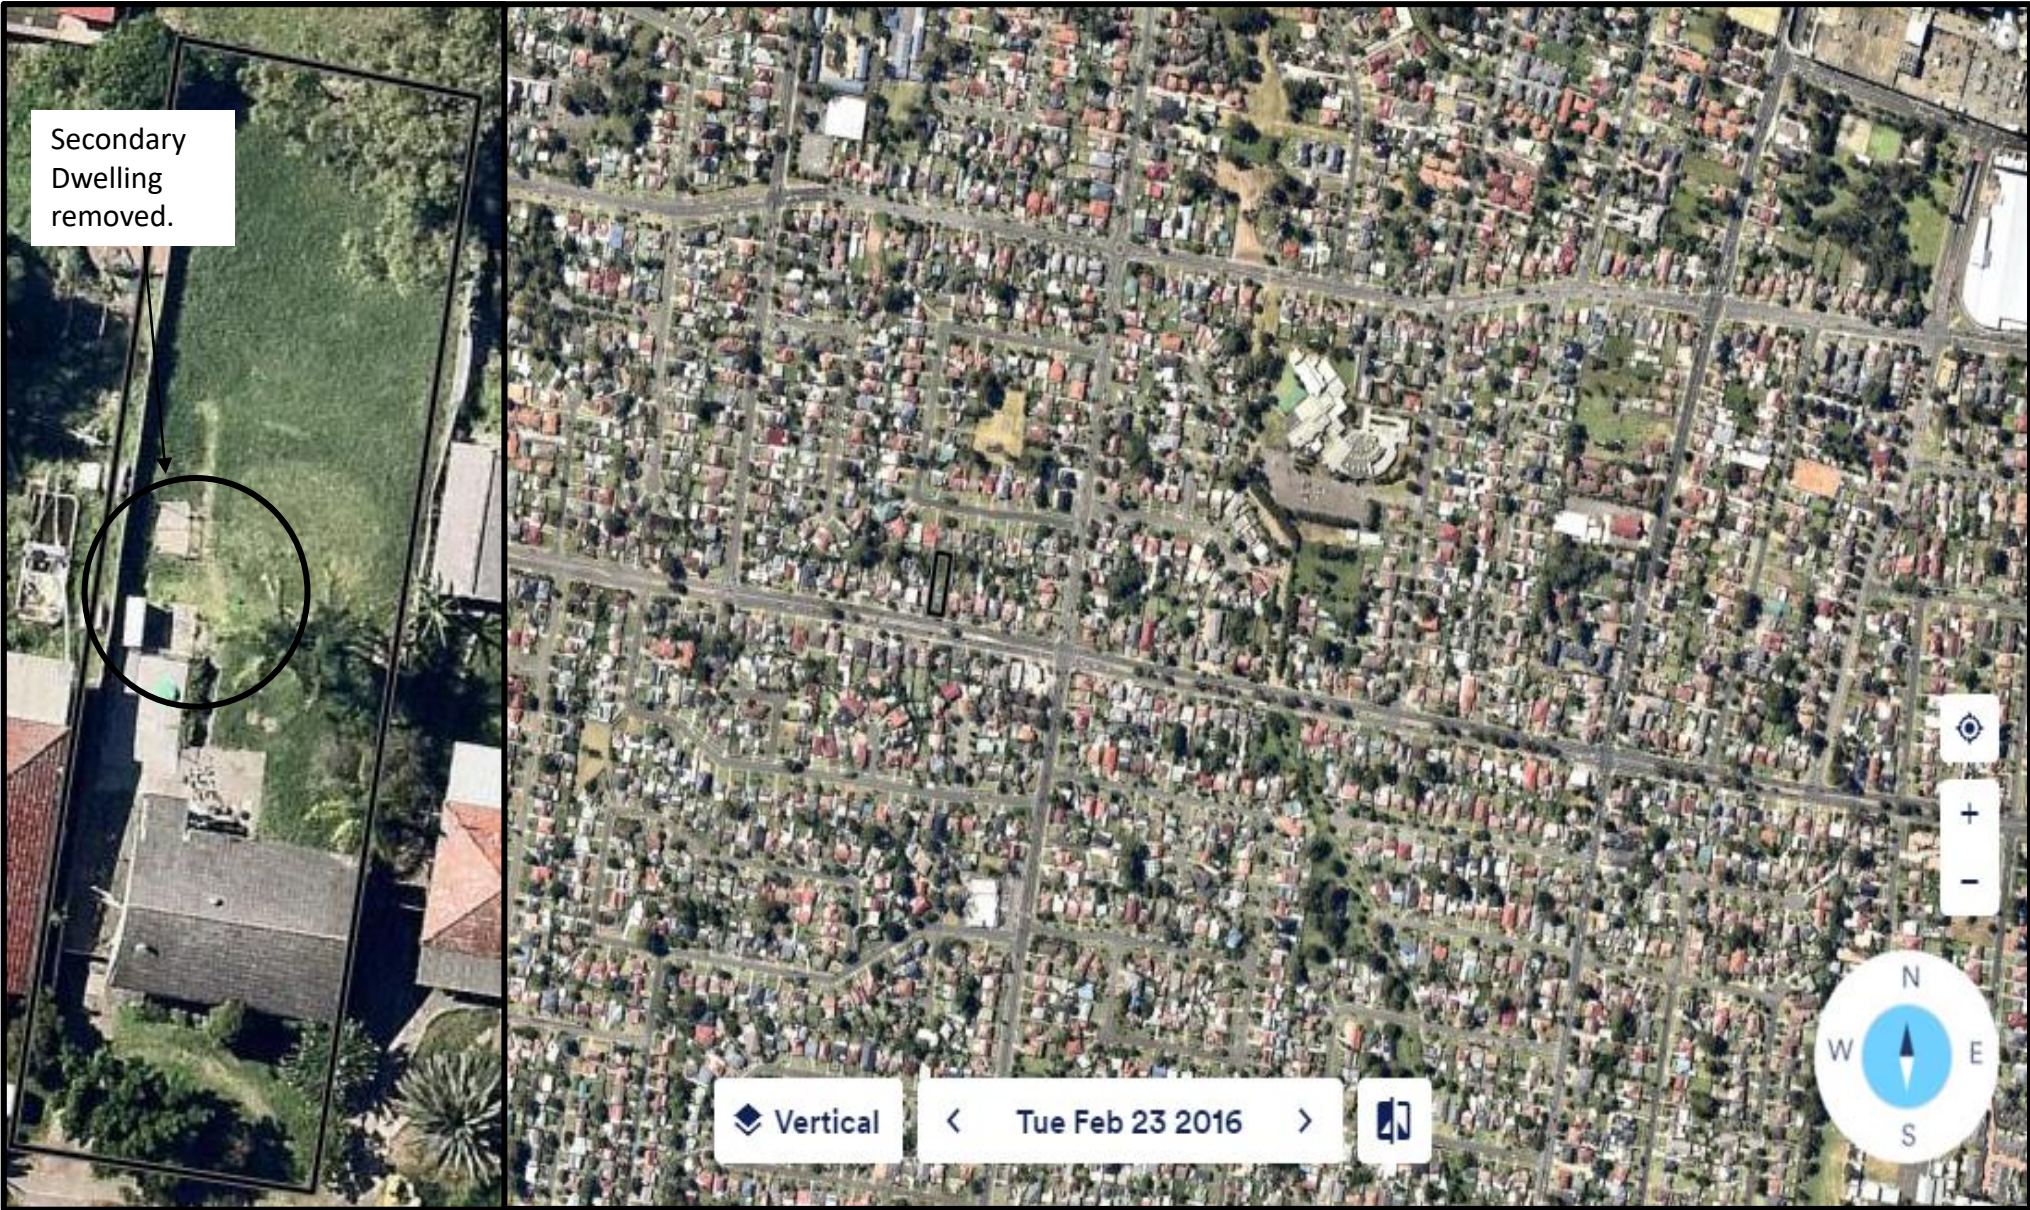
Figure 6	Aerial Image 2016
Project	227 Bungaribee Road, Blacktown, NSW, 2148

Figure 6: Aerial image of the site and surrounding area in 2016. The site does not contain the secondary dwelling. The surrounding area is similar to the previous image taken in 2000 and 2009.

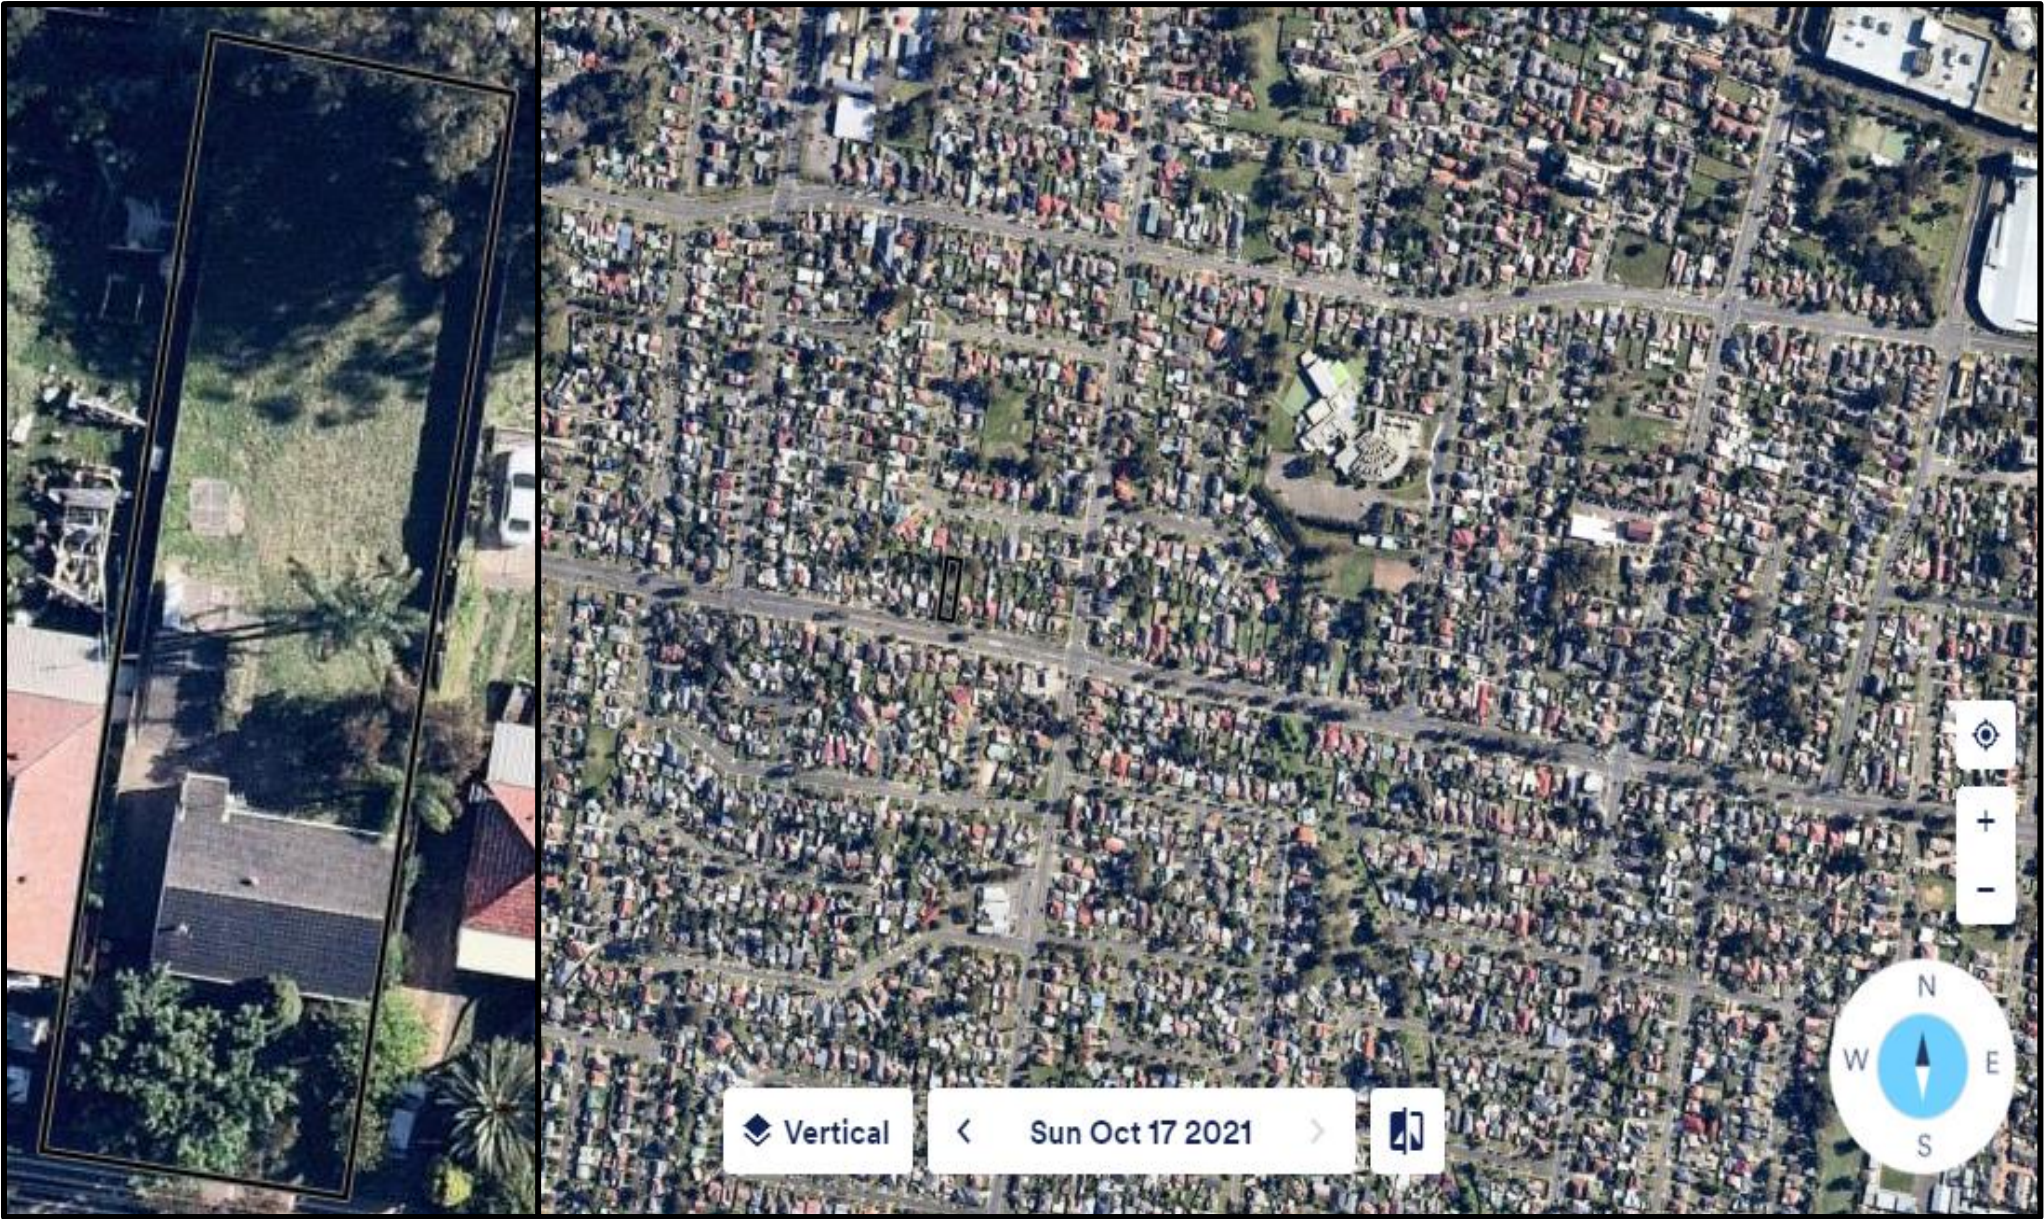
Figure 7	Aerial Images: 2021
Project	227 Bungaribee Road, Blacktown, NSW, 2148

Figure 7: Aerial image of the site and surrounding area in 2021. The site and surrounding area is similar to the previous image taken in 2000, 2009 and 2016.

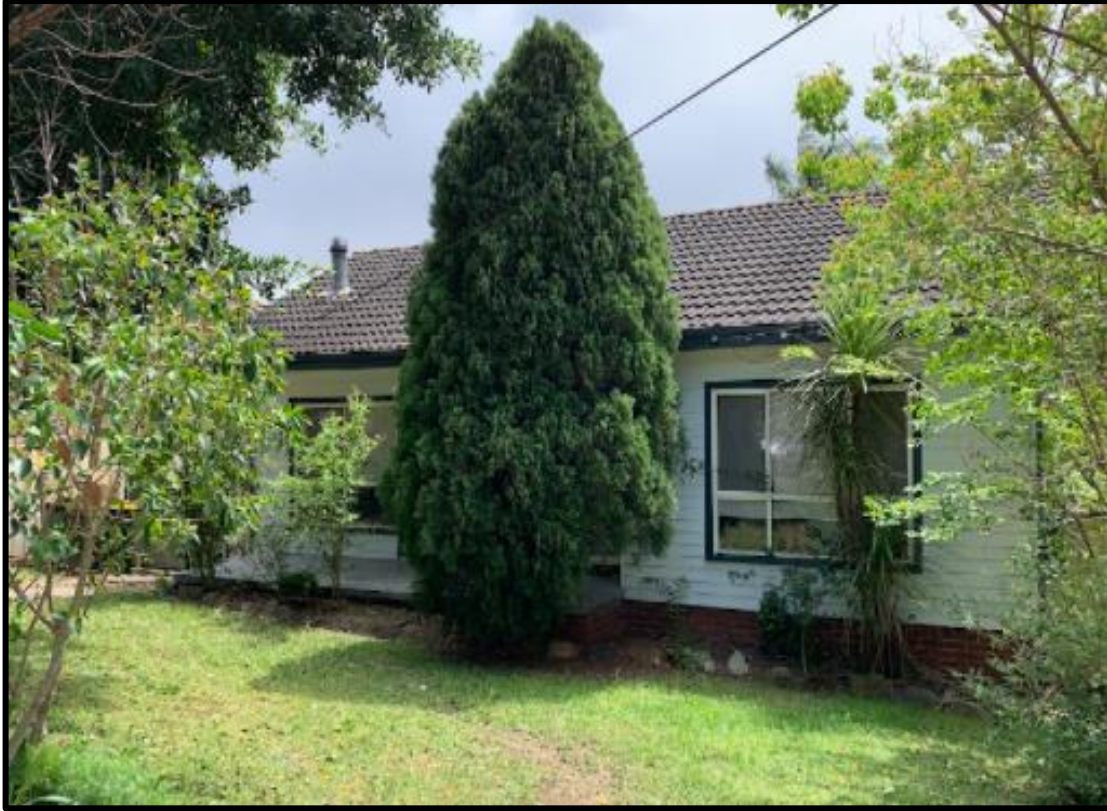
Figure 8. Depicts the front of the site. The site contains a white single storey cladded residential dwelling. In front of the site is a grassed area, trees and shrubbery.

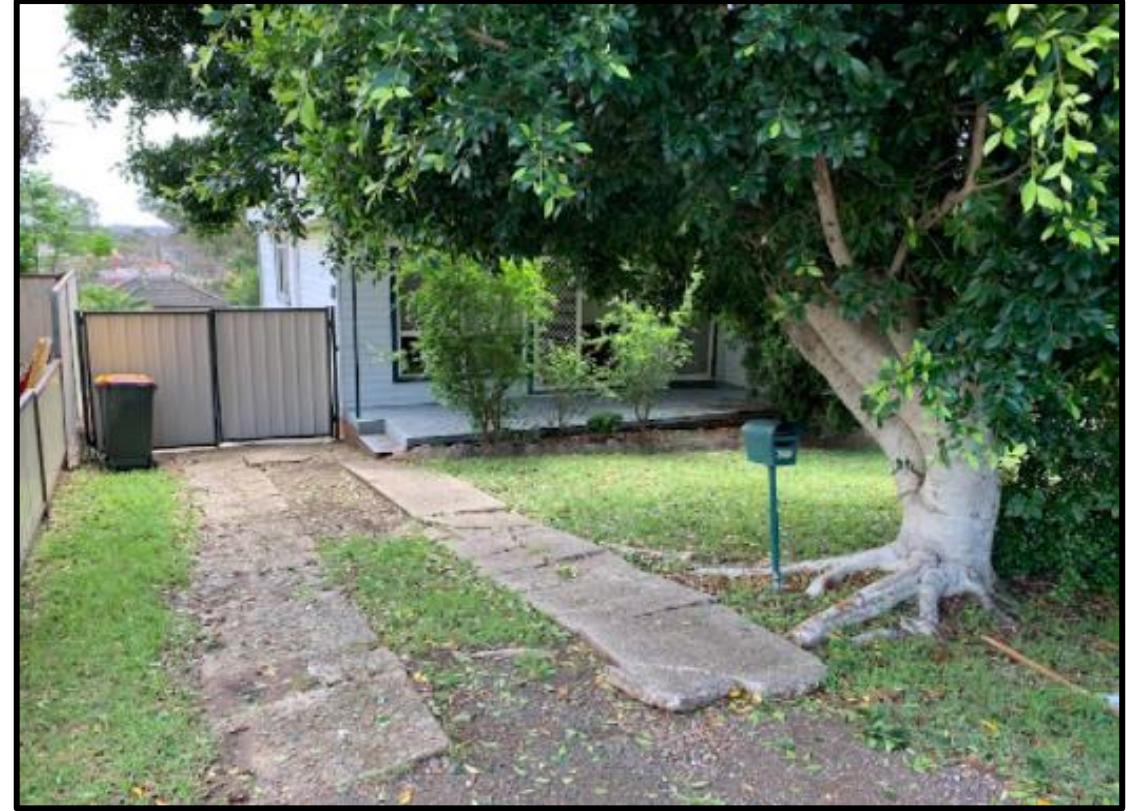
- The driveway is composed of broken concrete with a grass patch located at the centre;
- There is a grass area located at the front of the structural dwelling. The front area also contains healthy shrubbery and trees;

Figure 9. A broken paved driveway is located west of the site. There is a dirt grassed area located within the centre of the driveway. There is a decrease in elevation from the front of the site to the rear end of the lot.

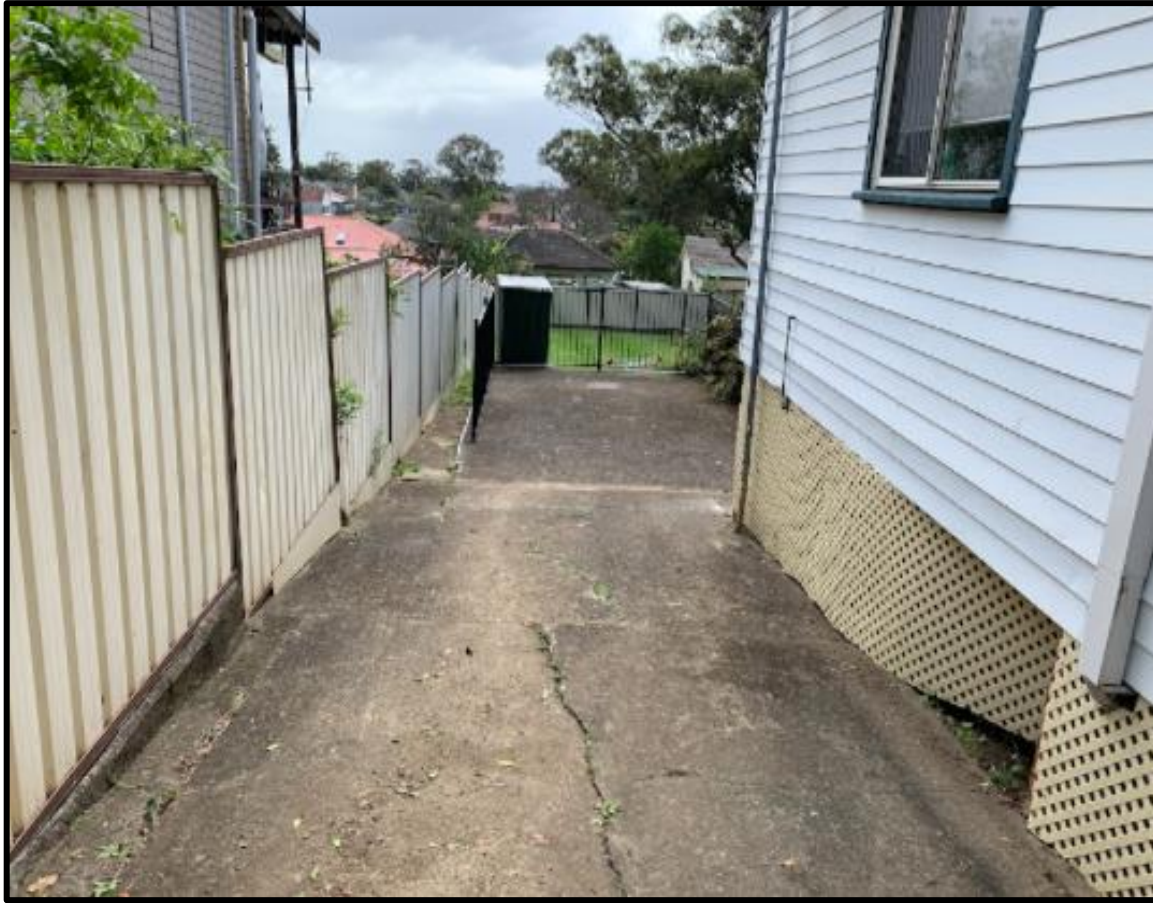
Figure 10. The driveway leads to the rear end of the site. There is a black metal fence to avoid any vehicles from continuing further down the site. The groundcover is concrete.

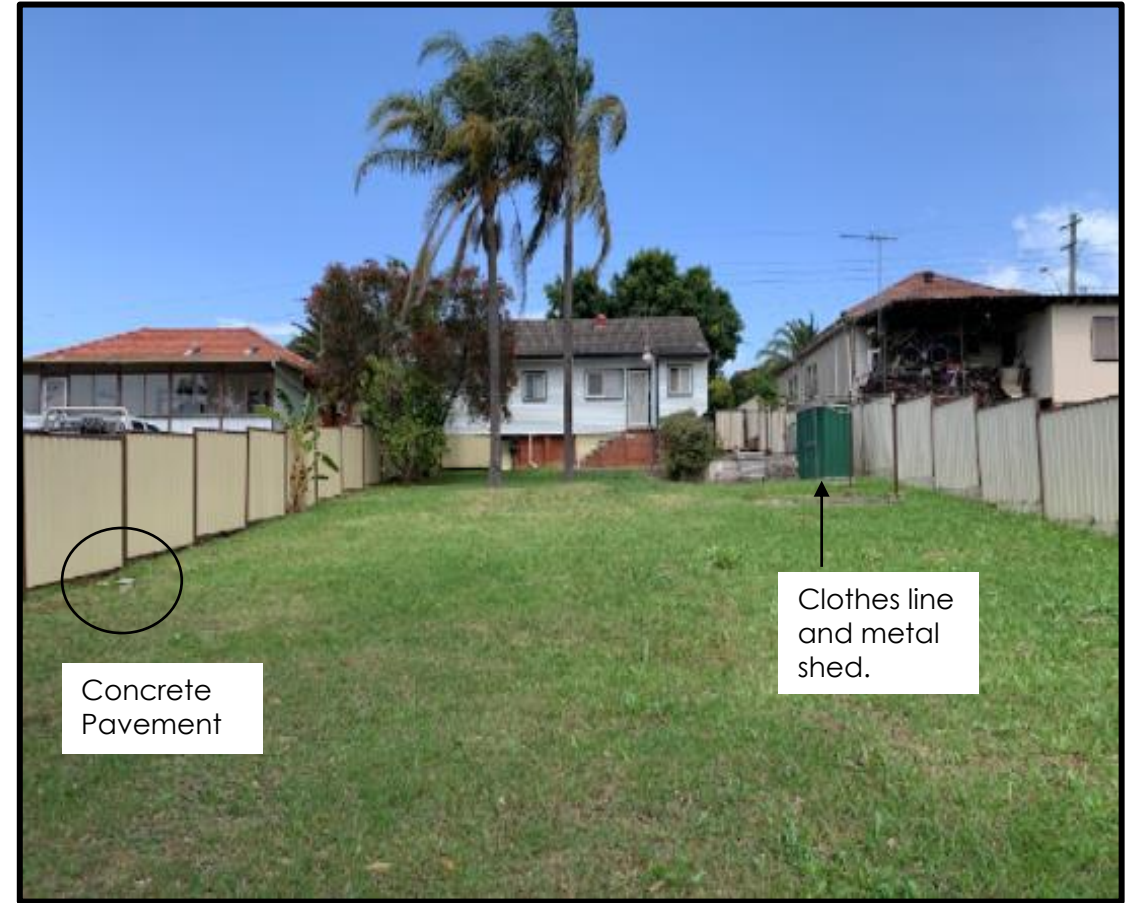
- The rear end of the property is a vacant grassed area with only one large tree located in the north – east corner of the site;
- West of the site is a single broken driveway which leads to the rear end of the structural dwelling;

Figure 11. Depicts the rear end of the site. The groundcover is mostly healthy manicured grass. The image also depicts the location of the clothes line, concrete pavement and metal shed.

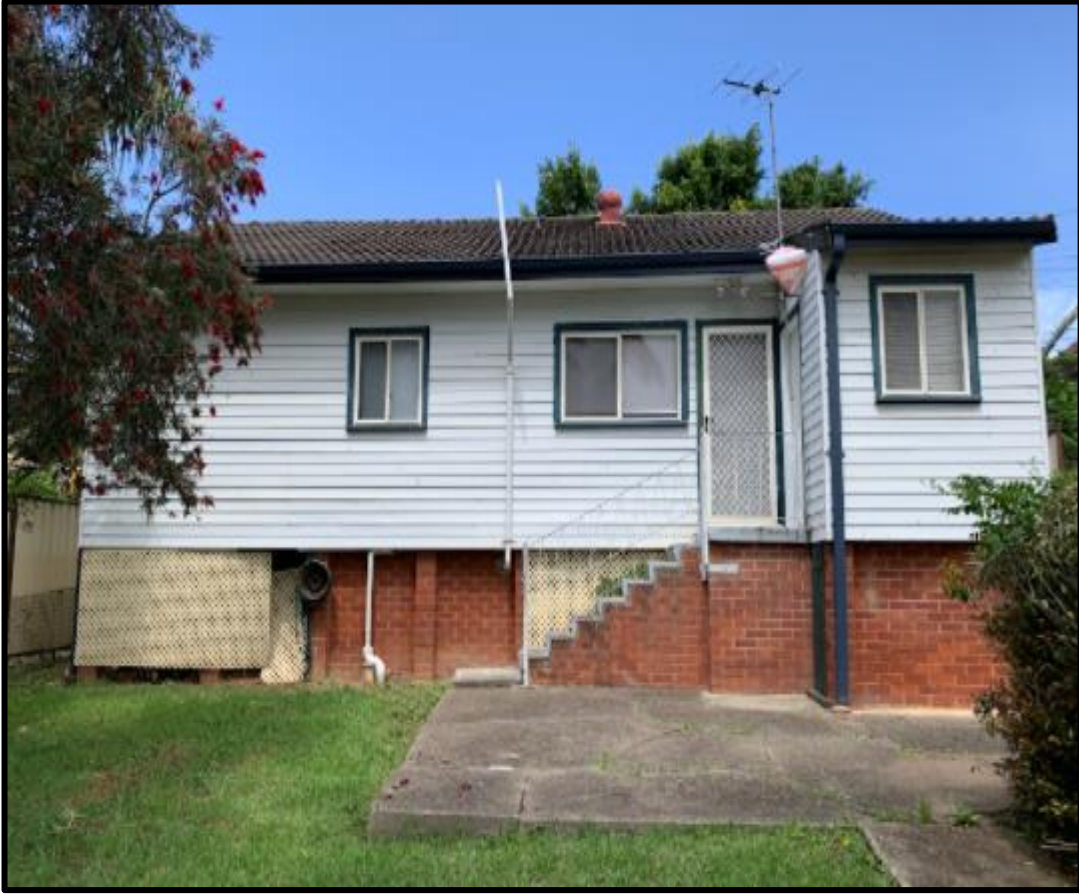
Figure 12. A close up image of the rear end of the structural dwelling. There is a bricked staircase which leads to the back door of the dwelling.

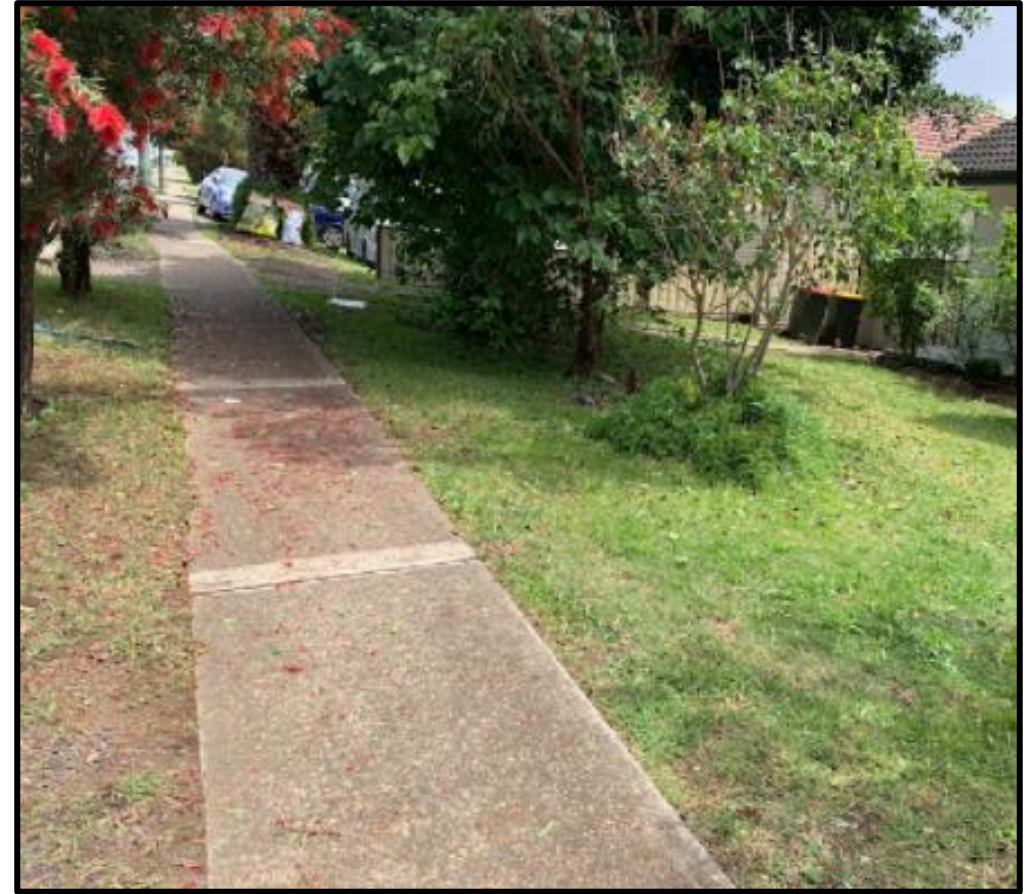
Figure 13. Depicts a concrete footpath in front of the site to allow individuals to walk around the neighbourhood.

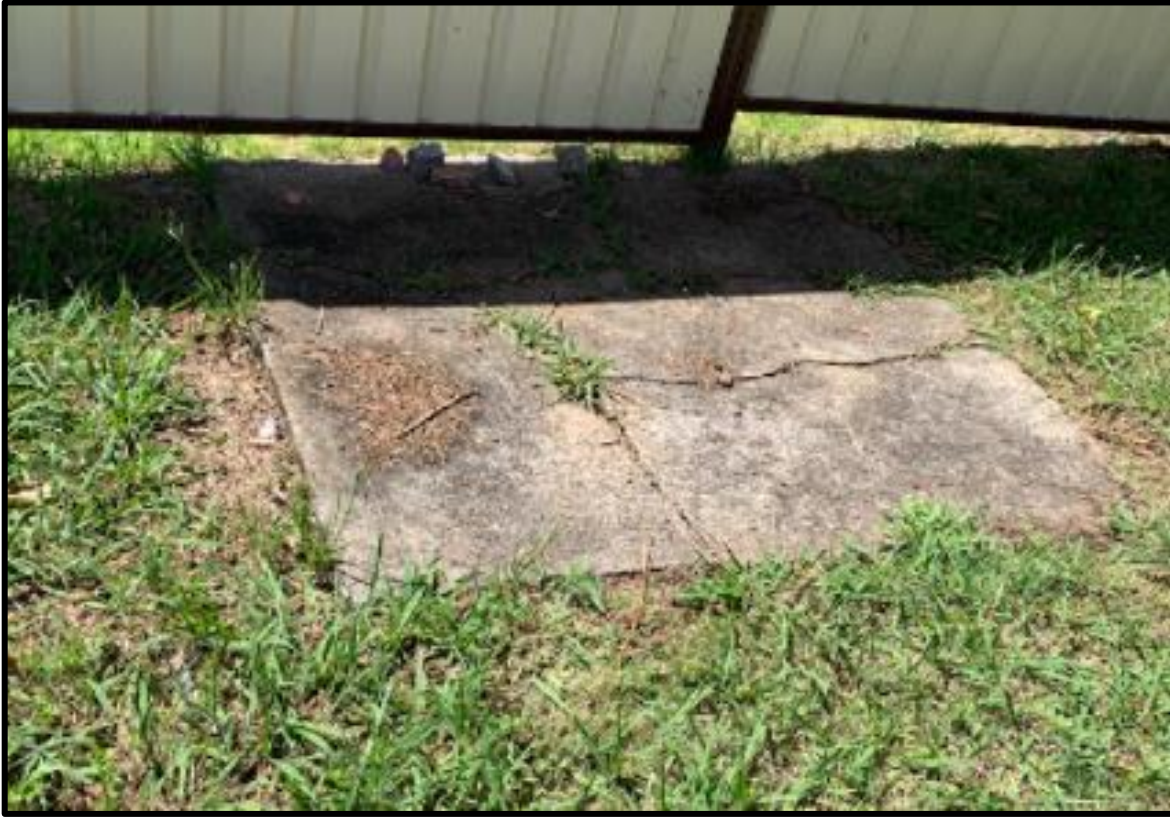
Figure 14. A concrete slab is located within the rear end of the property. The slab is located between the rear end of the structural dwelling to the rear end of the site.

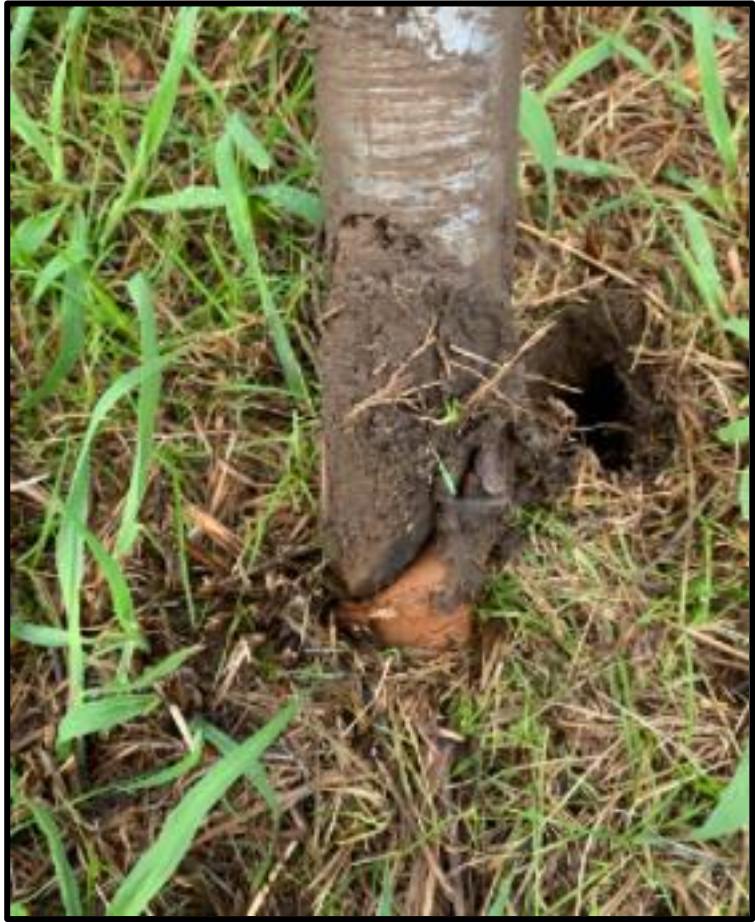
Figure 15. Depicts the soil profile of BH2. The soil is natural clay.

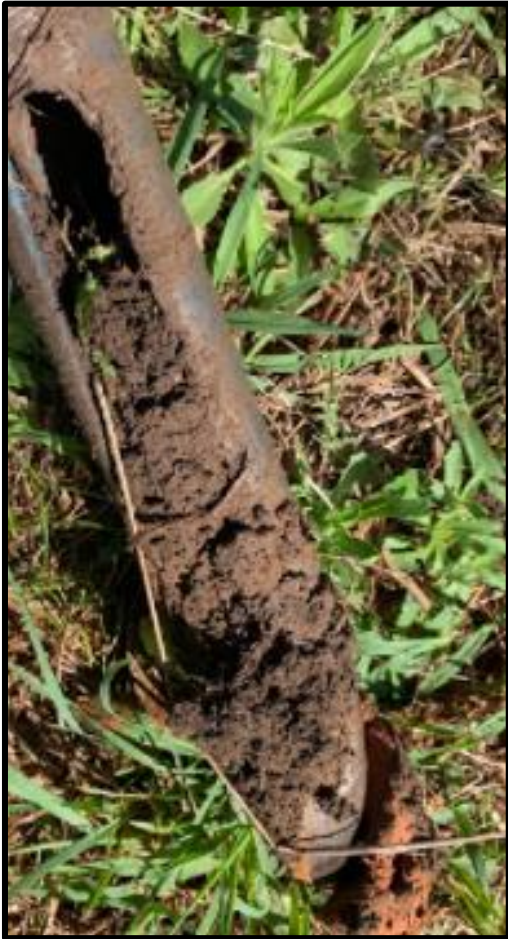
Figure 16. Depicts the soil profile of BH4. The dominant soil type is a natural clay.
