Detailed Site Investigation

227 Bungaribee Road

E21211-1

28th October 2021

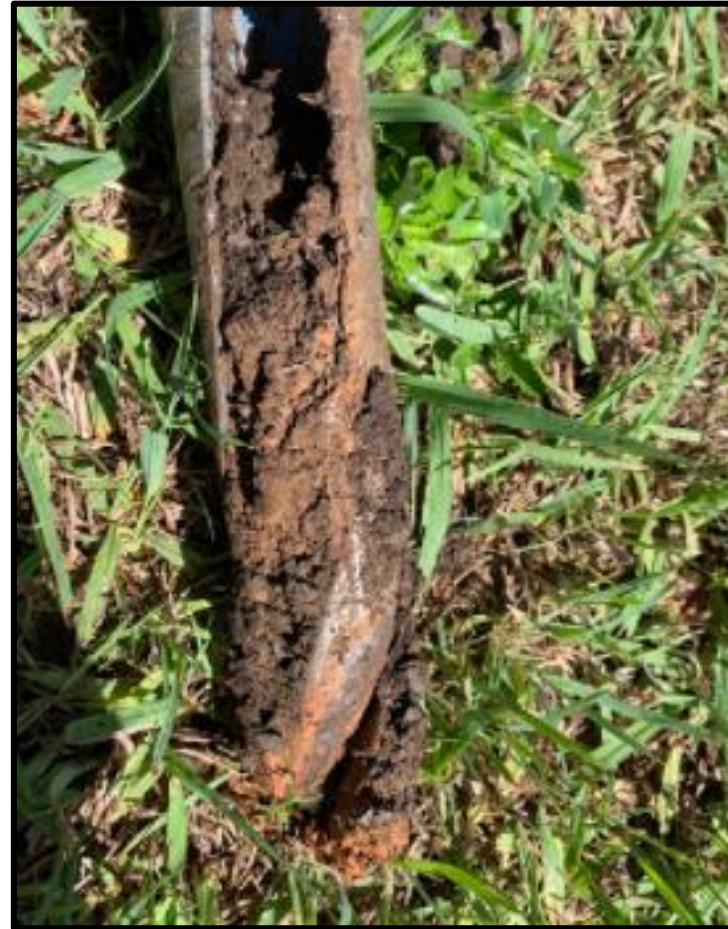
Figure 17. Depicts the soil profile of BH5. The soil is natural clay.

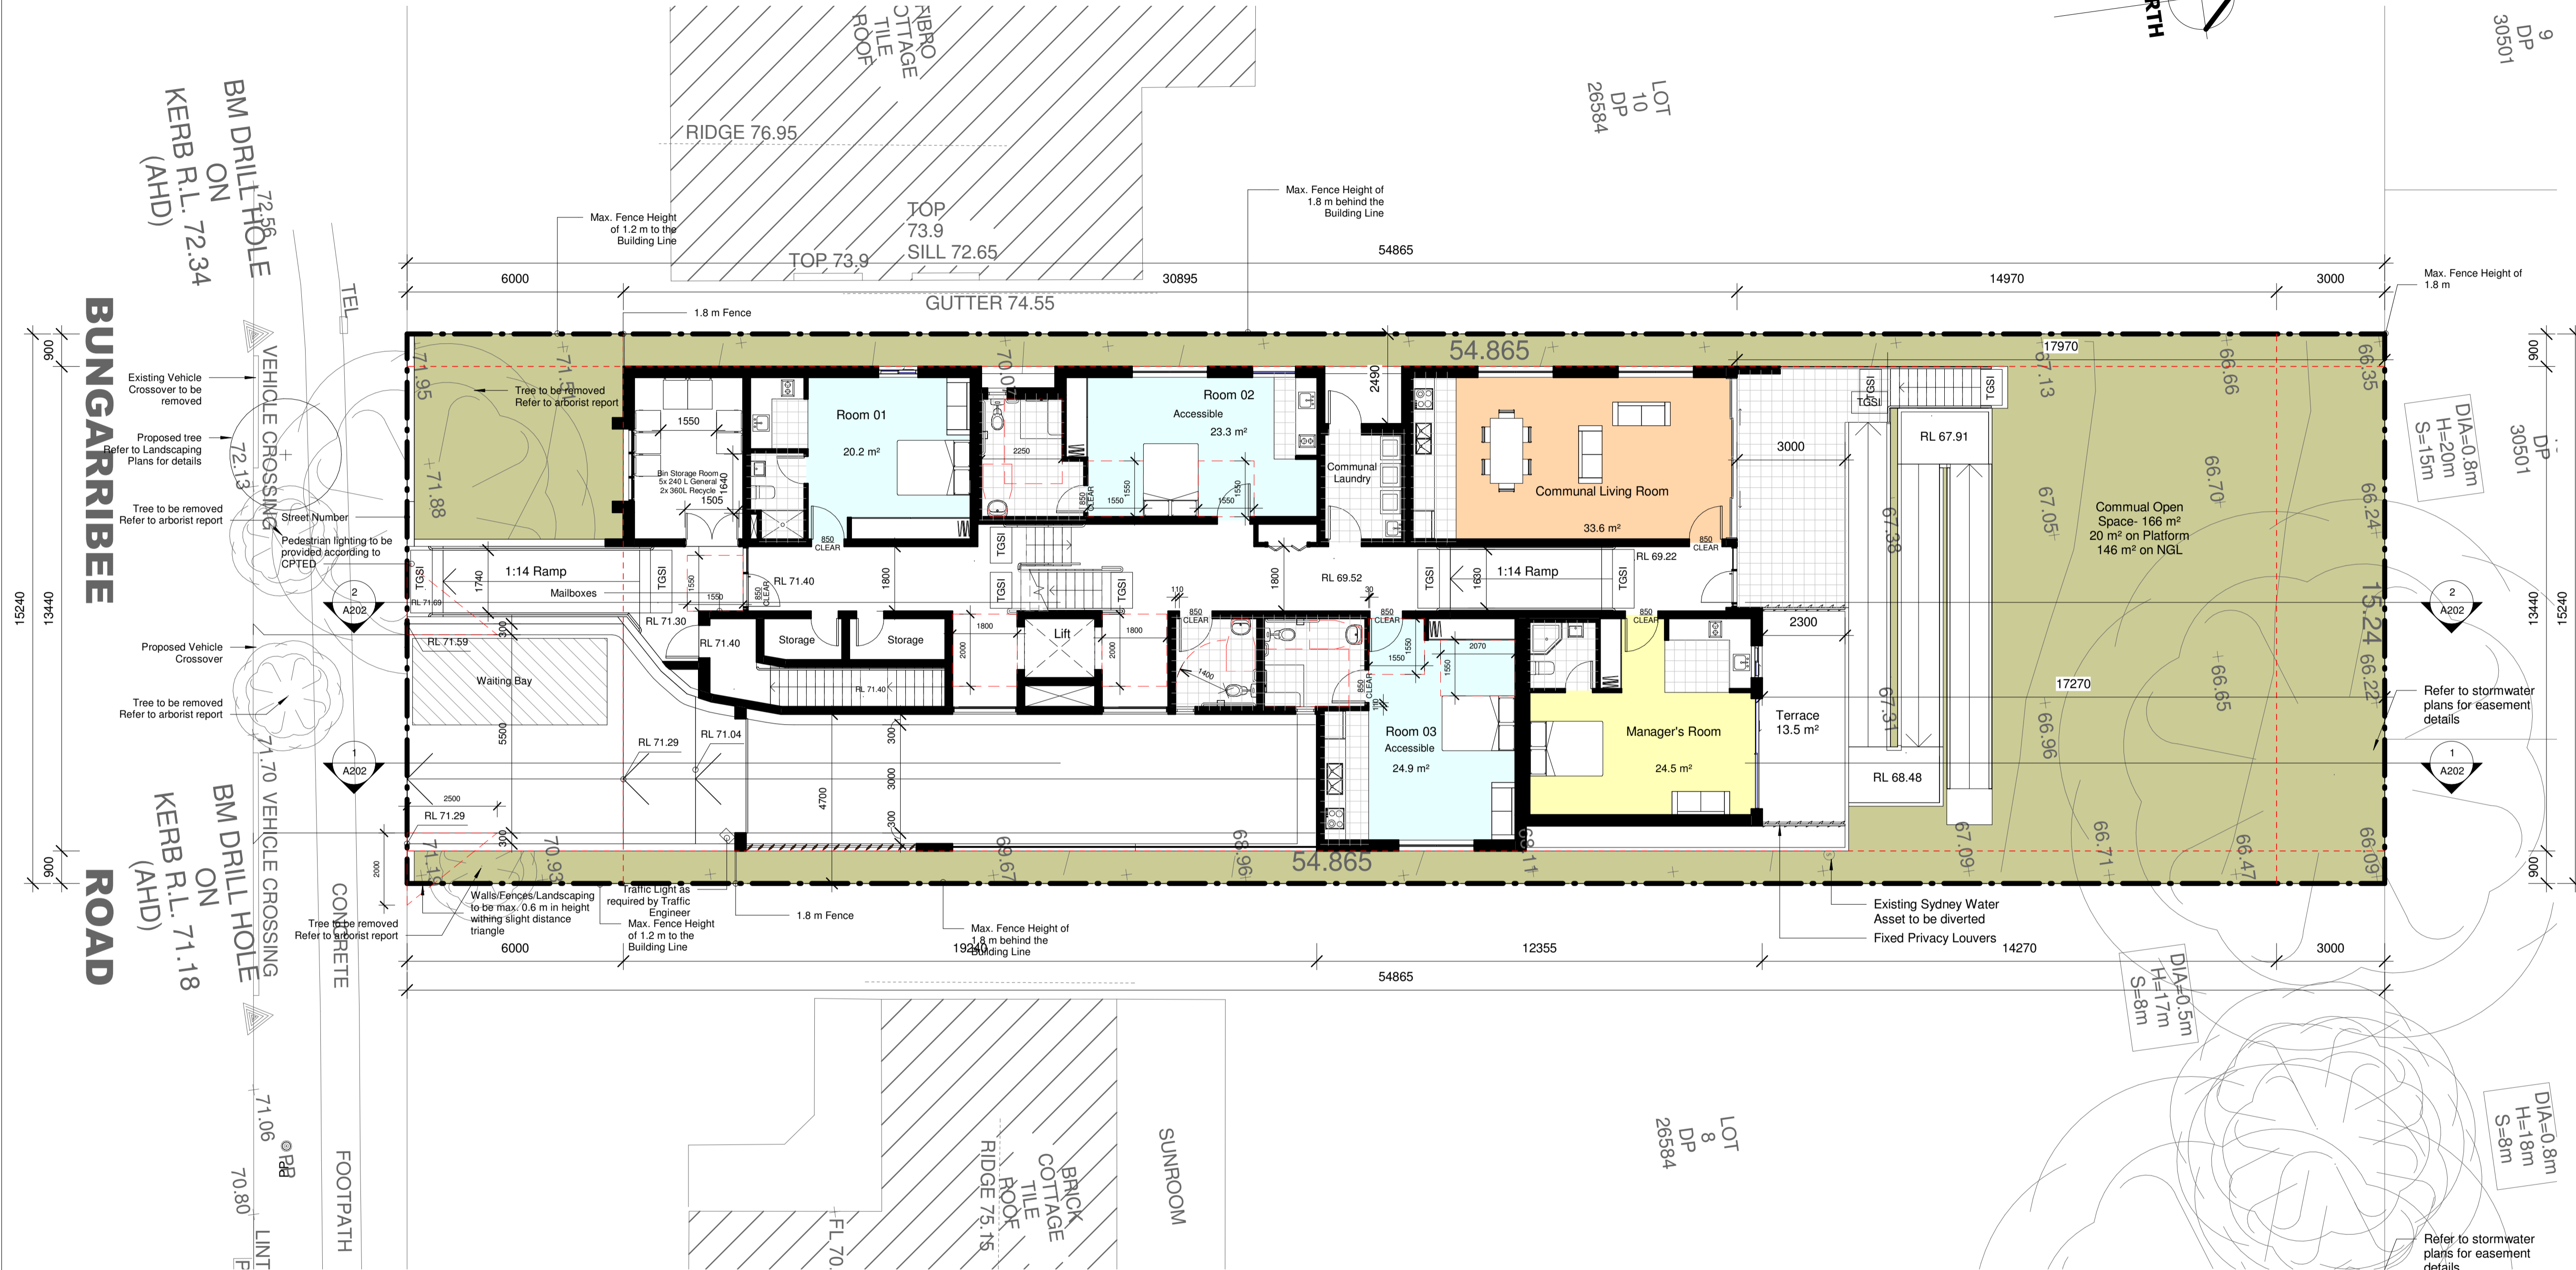
1 Ground Floor Plan
1 : 100

Ground Level Plan

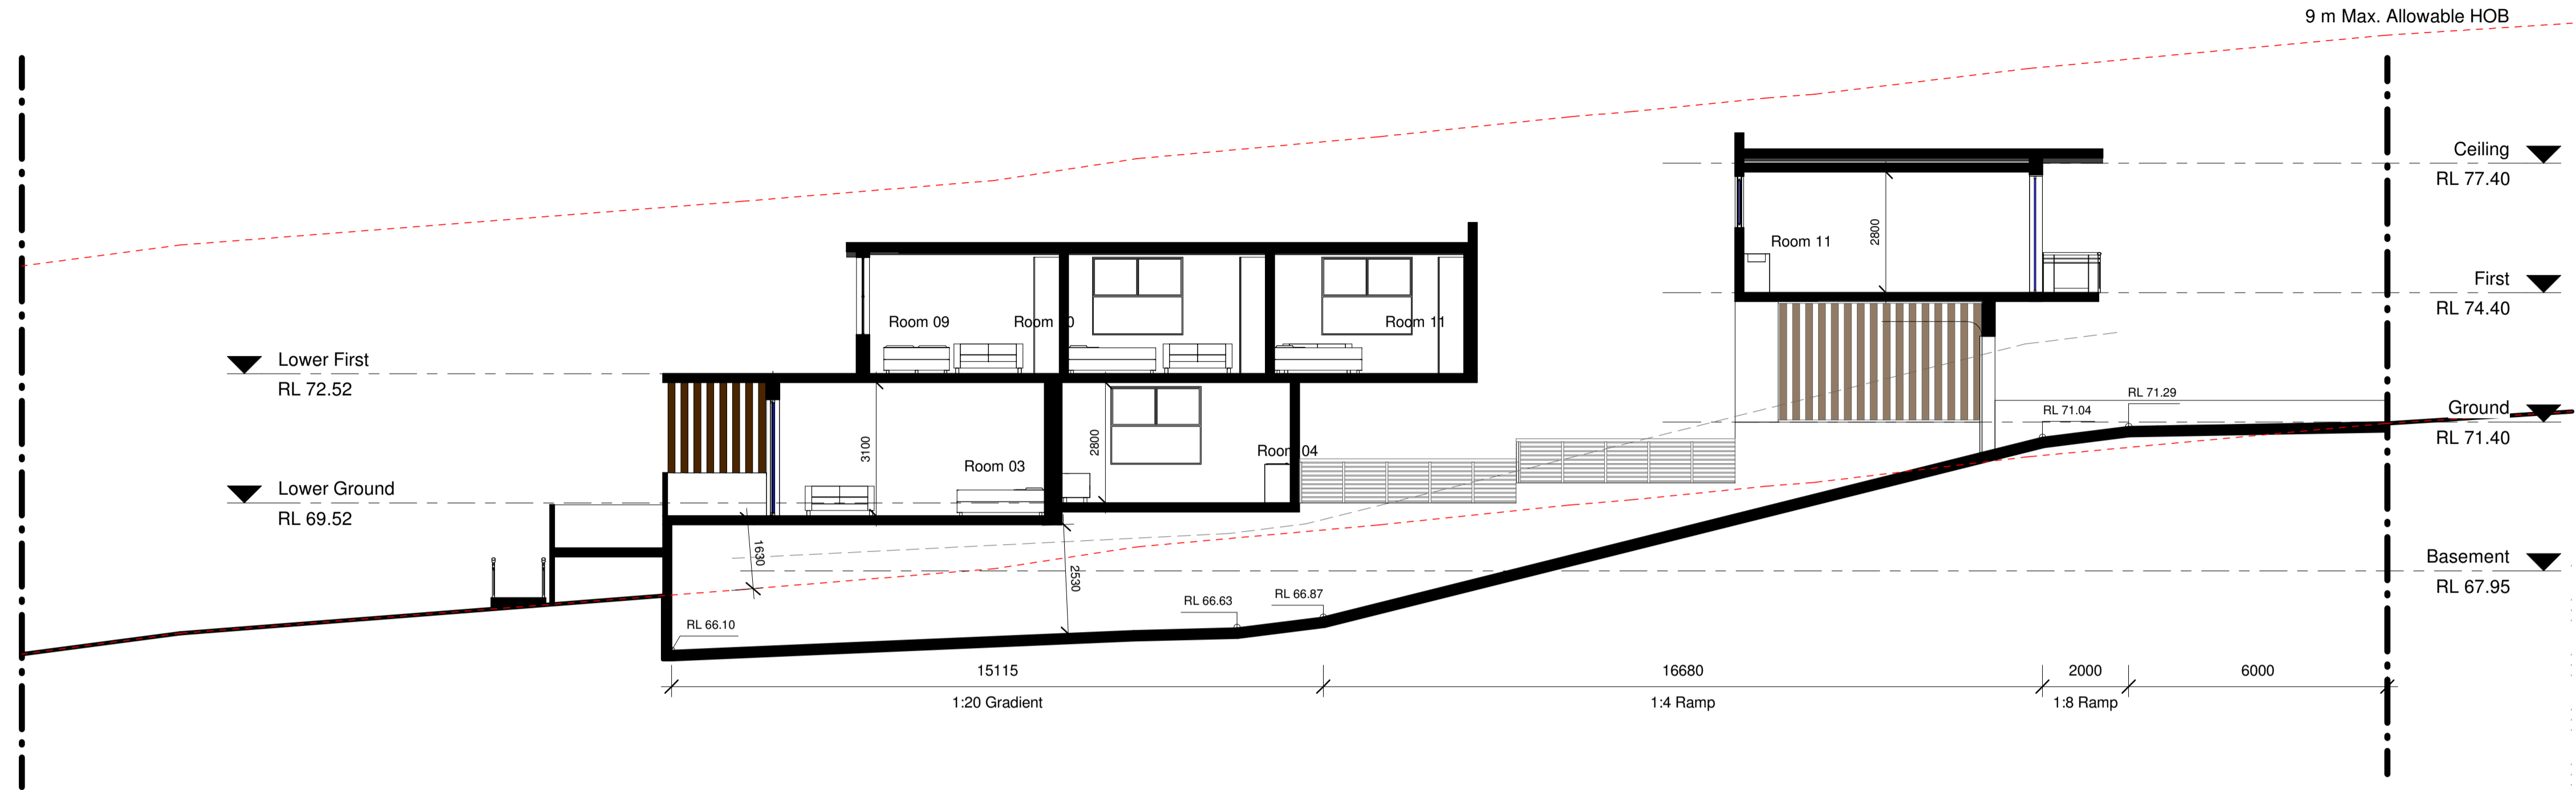
1 Long Section AA
1 : 100

Sections		
FOR	DA	ONLY
Project number		2020-19
Date		Feb-2021
Drawn by	SL/GF	Printed 9/09/2021 5:01:30 PM
Checked by		GF
A202		
Scale	Drawing : DA	Issue D
1 : 100
