No. 60 Macleay Street, Narrawallee NSW
Report on Acid Sulfate Soil Investigation

Our Ref: TERRA21-502.Rep1.Rev0

19 November 2021

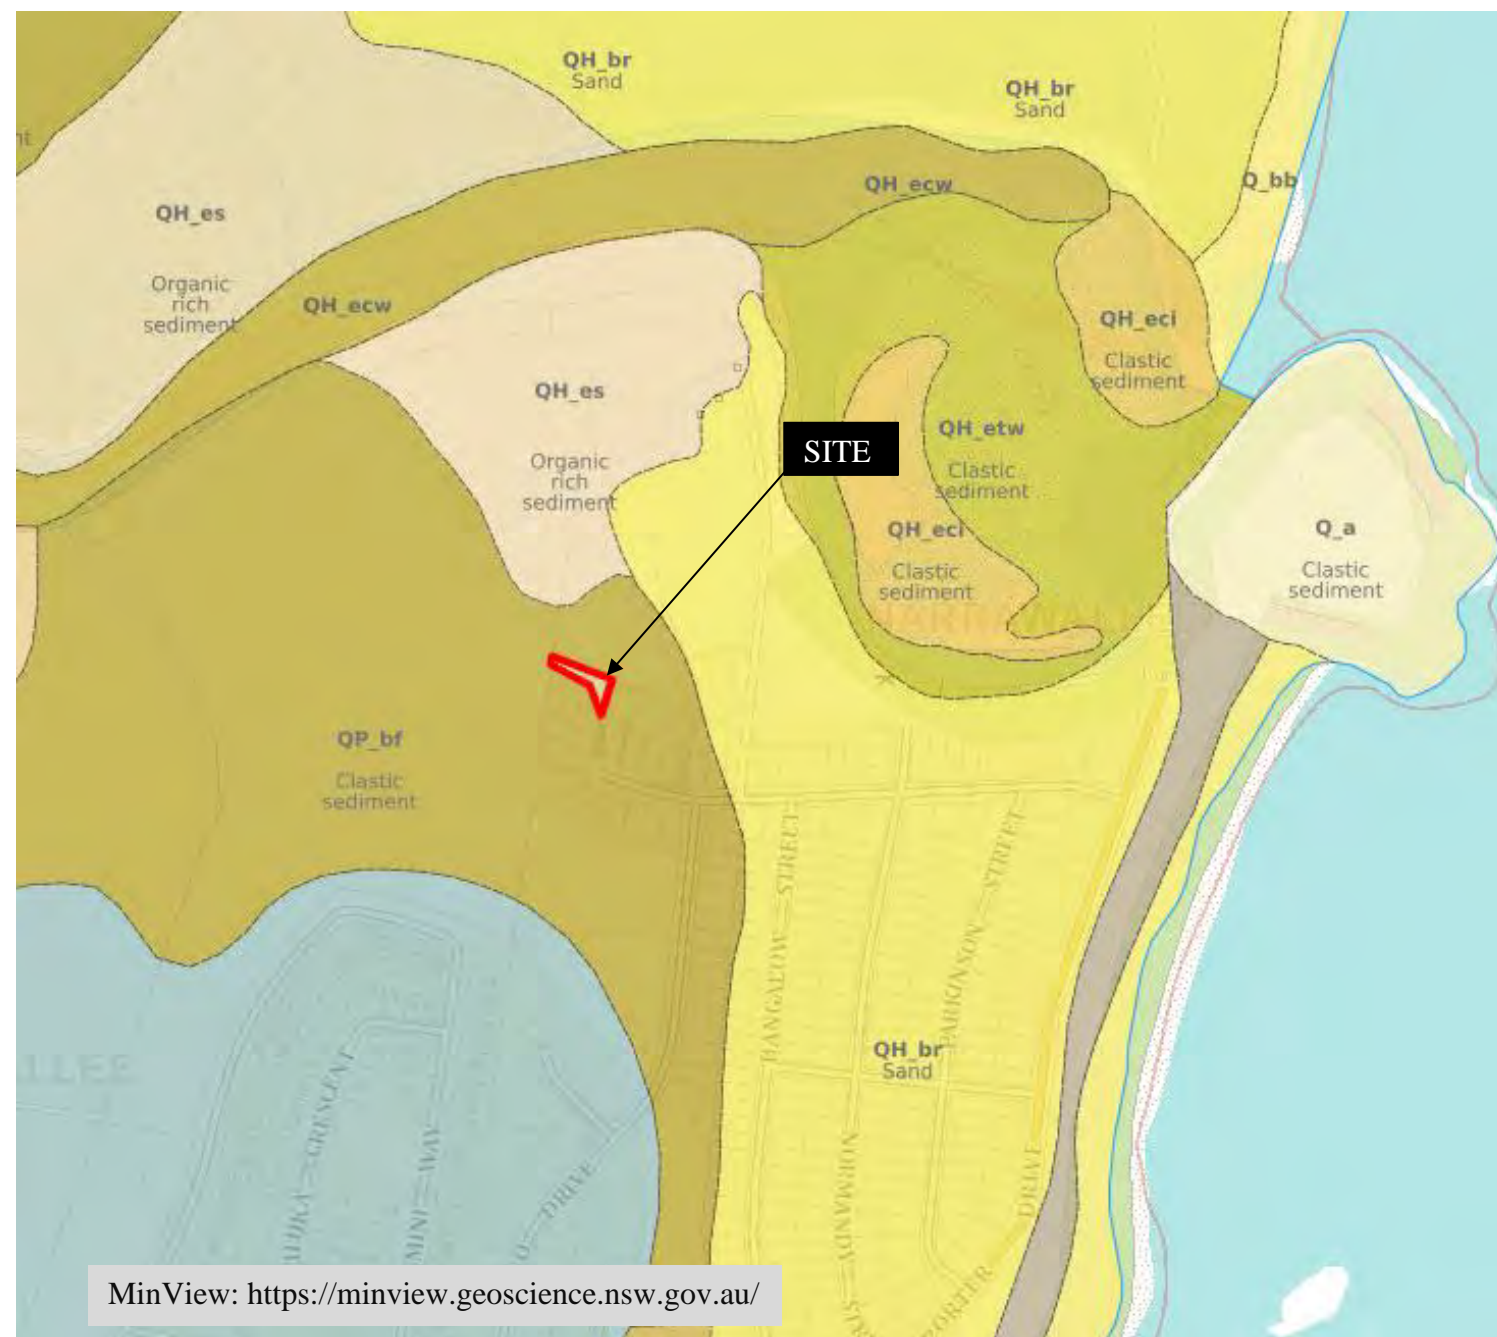
revision	description	drawn	approved	date				client:	Planning Lawyer Solutions	
	Site location	XJ	KEG	19/11/2021				project:	Acid Sulfate Soil Investigation No. 60 Macleay Street Narrawallee	
						scale	NTS	title:	Site Location	
						original size	A3	project no:	TERRA21-502	figure no: FIGURE 1

Site Geology

Symbol	Group	Unit	Lithology
QH_es	-	Estuarine swamp	Organic-rich mud, peat, clay, silt, very fine- to fine-grained sand (marine-deposited), fine- to medium-grained sand (fluvially deposited)
QP_bf	-	Coastal deposits - backbarrier flat facies	Fine- to medium-grained quartz-lithic sand with carbonate and humic components (marine-deposited), indurated sand, silt, clay, gravel, organic mud, peat
Pshs	Shoalhaven Group	Snapper Point Formation	Fine- to medium-grained sandstone, pebbly sandstone and polymictic pebble conglomerate (down sequence), medium- to coarse-grained sandstone with lithic pebbles and fragments, minor siltstone (up sequence); brachiopod, bivalve and bryozoan fossils

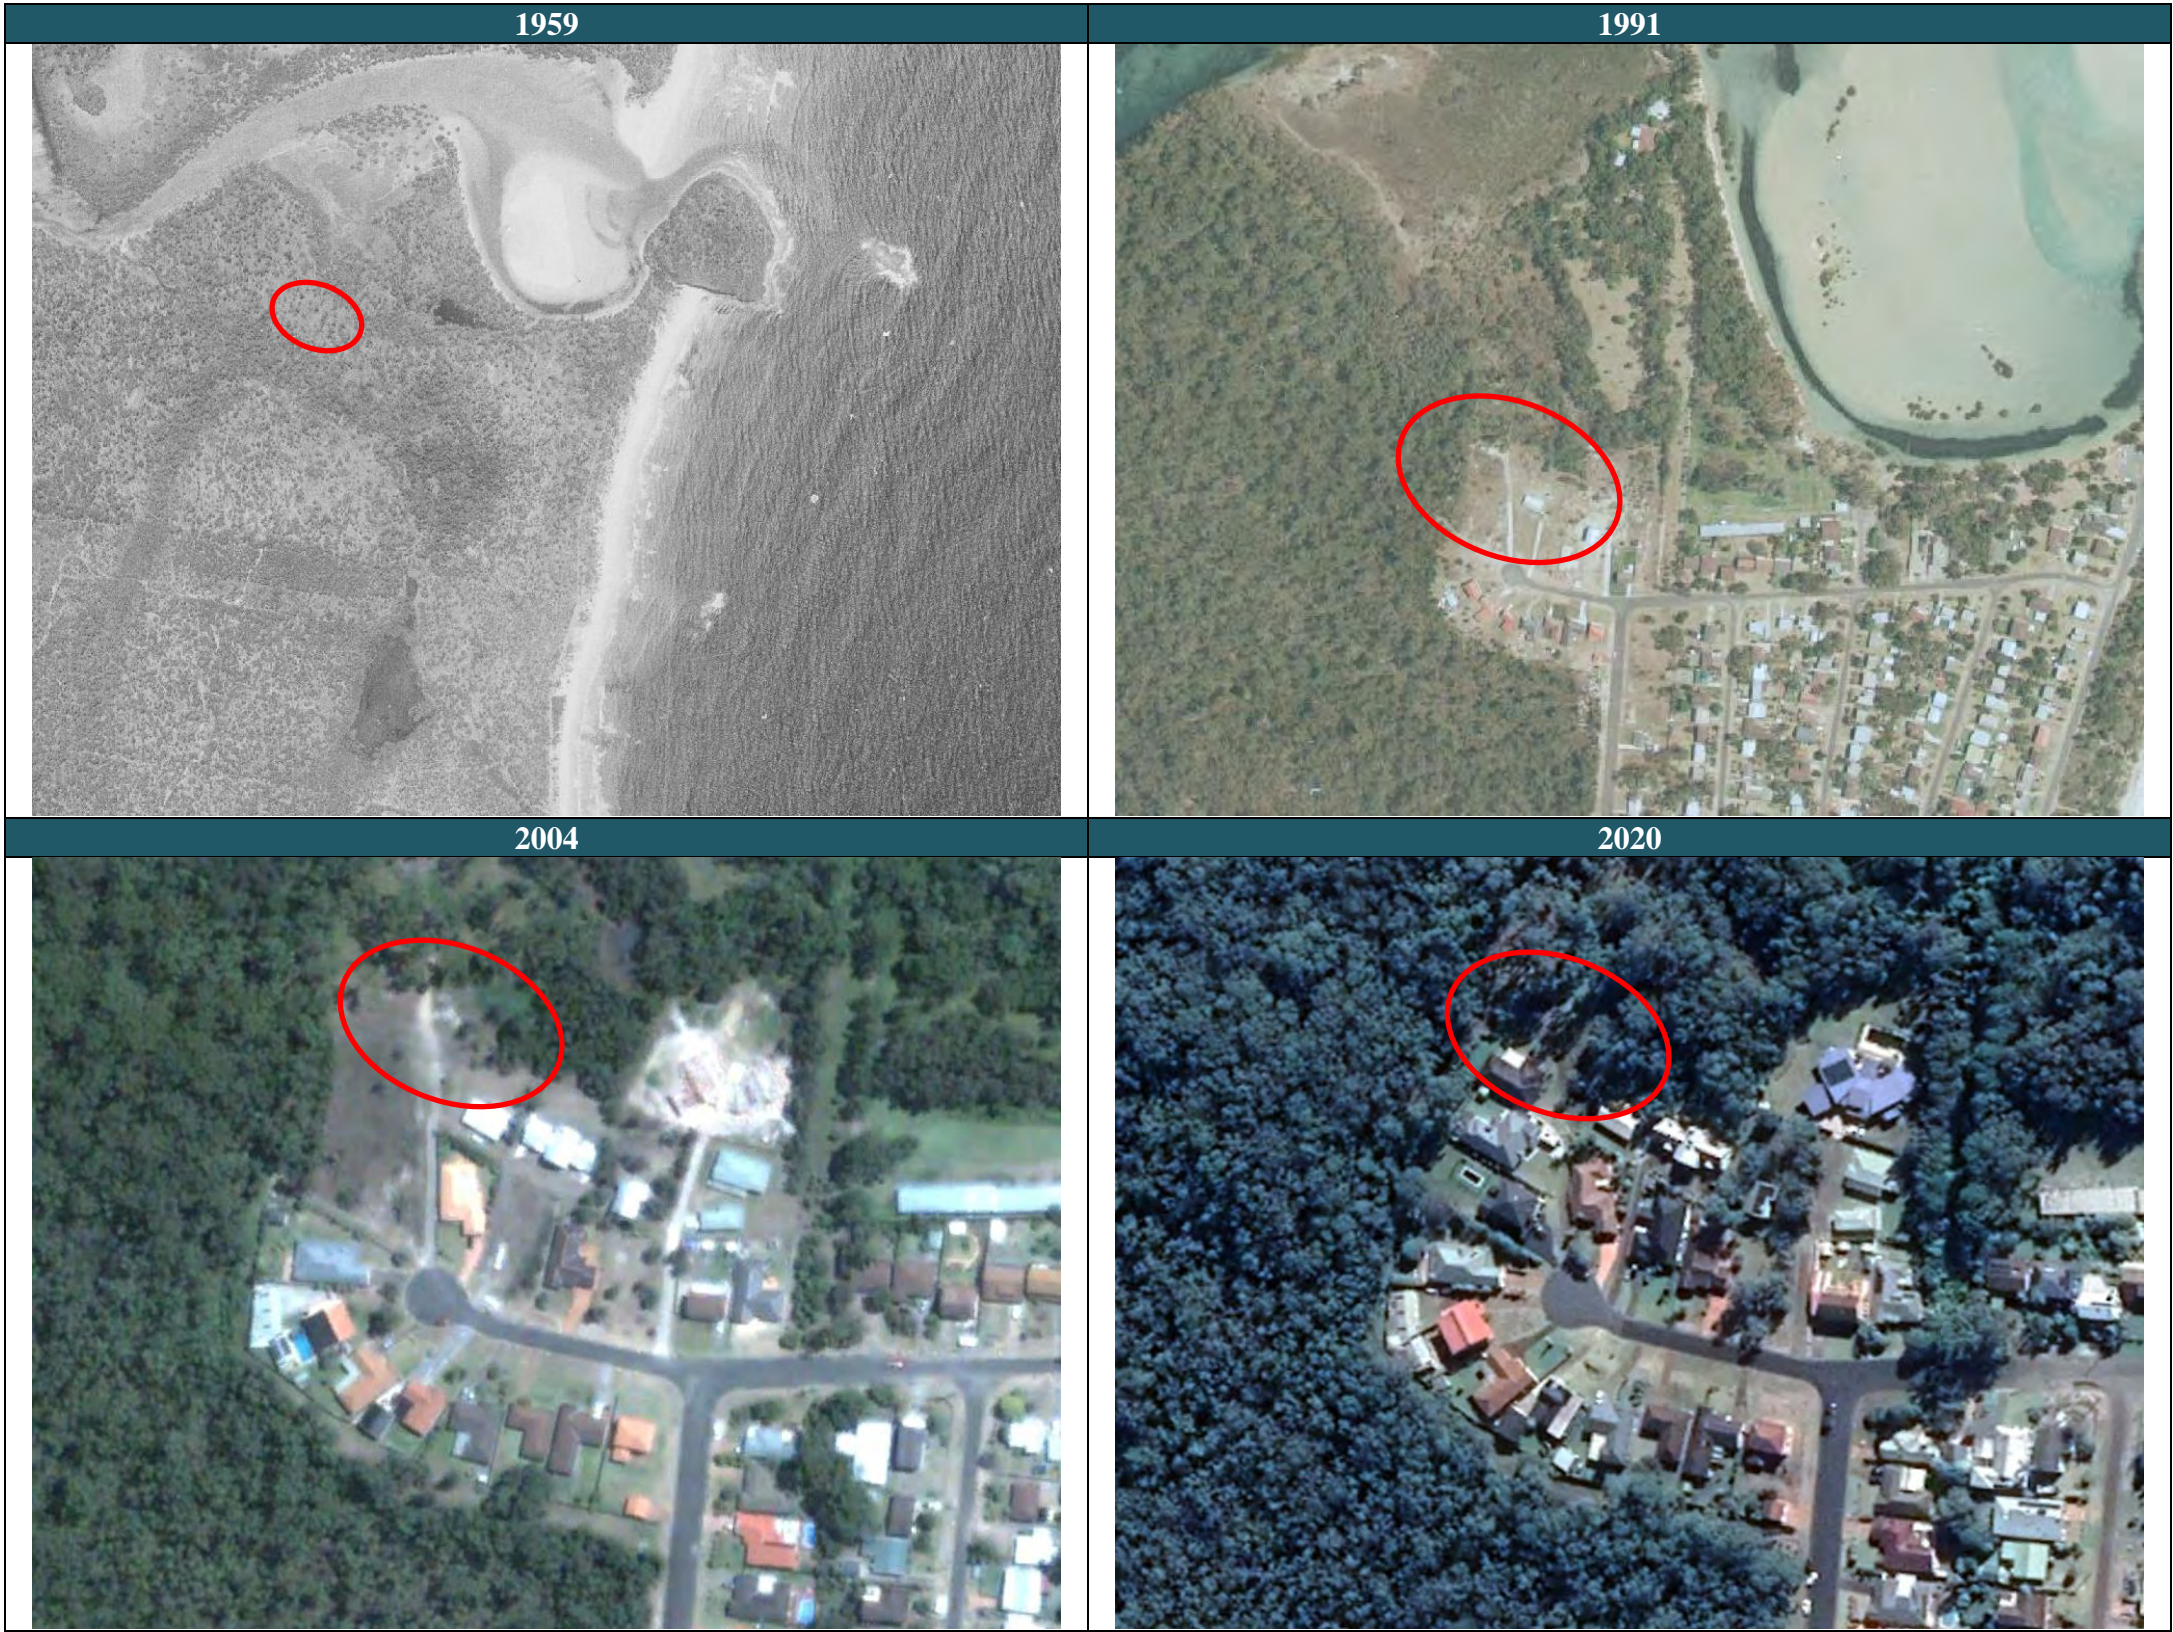
client: Planning Lawyer Solutions	
	Historical Aerial Imagery	XJ	KEG	19/11/2021				project: Acid Sulfate Soil Investigation No. 60 Macleay Street Narrawallee	
						scale	NTS	title: Historical Imagery	
						original size	A3	project no: TERRA21-502	figure no: FIGURE 2

Historical Imagery

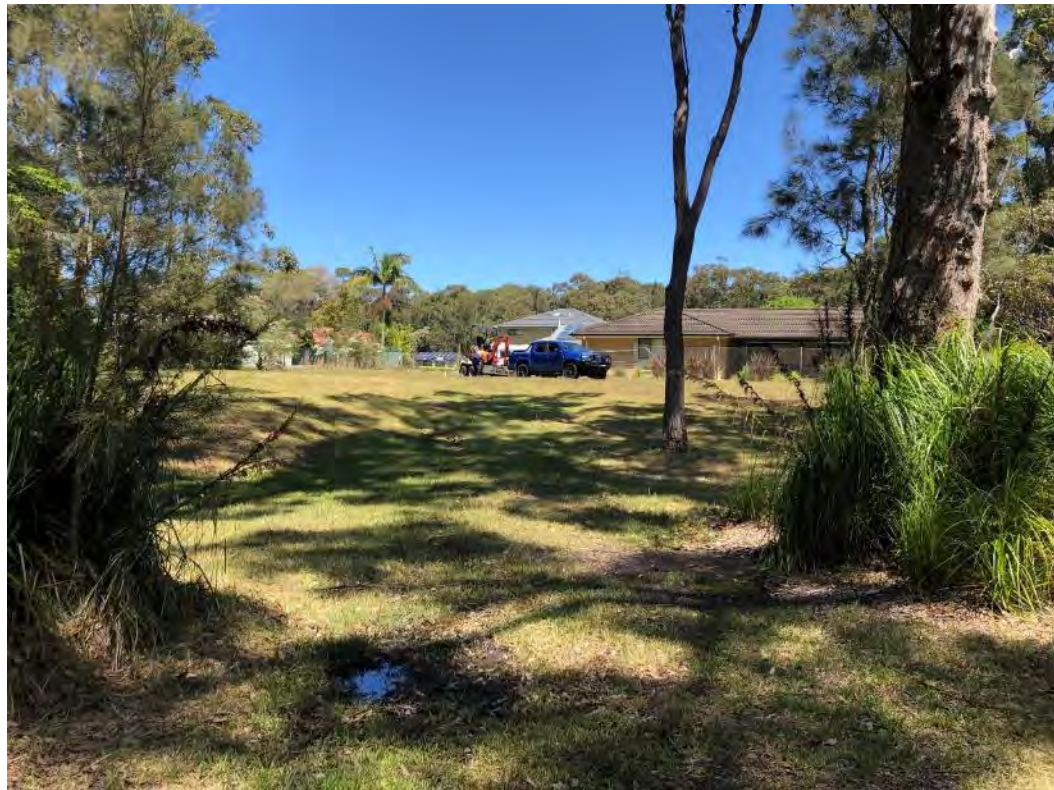
Photograph 3: View looking south-west from lower portion of property towards the site with water ponding.

- The site is located within Climatic Zone 1.
- The site is level throughout.
- The site is predominantly grassed with some mature trees nearby.
- Poor drainage is observed on the site forming water ponding on the surface which has caused abnormal moisture conditions on the site.

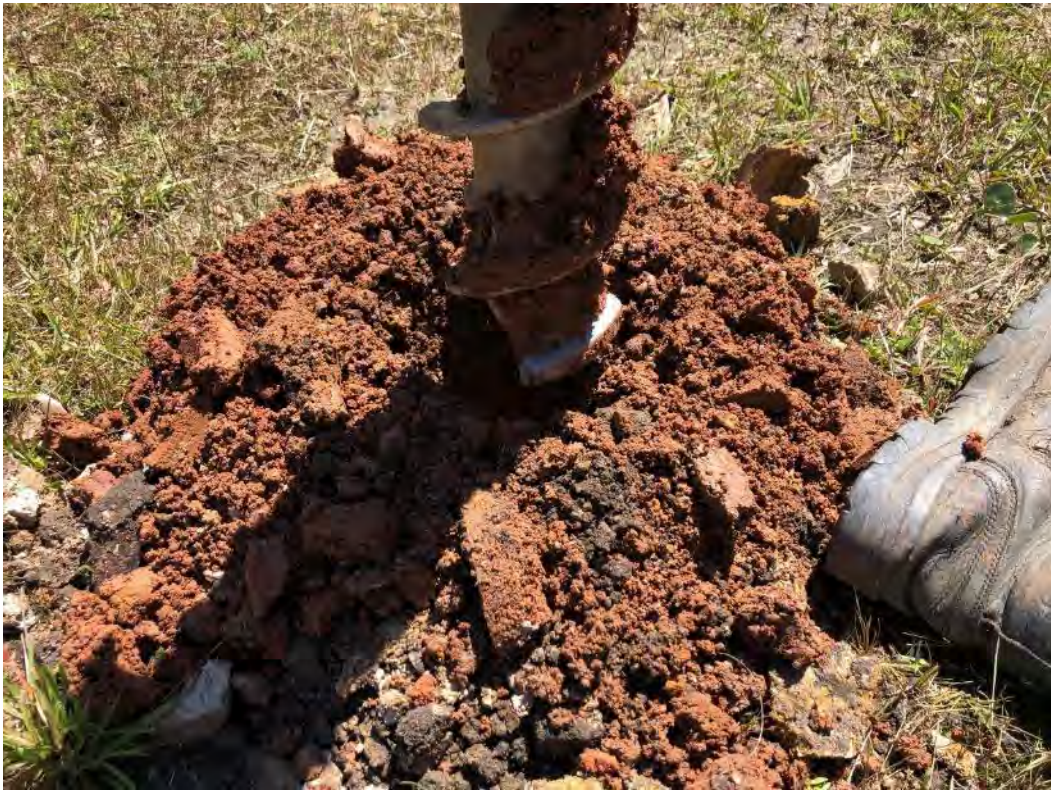
Photograph 6: Material encountered in BH01.

The test locations are named BH01 to BH04. The location of each test site is shown on Figure 4. The subsurface conditions encountered in the boreholes are summarised on Table 3.1. Engineering logs are provided in Appendix D. Images of the materials recovered are shown in Appendix C photographs 6 to 8.

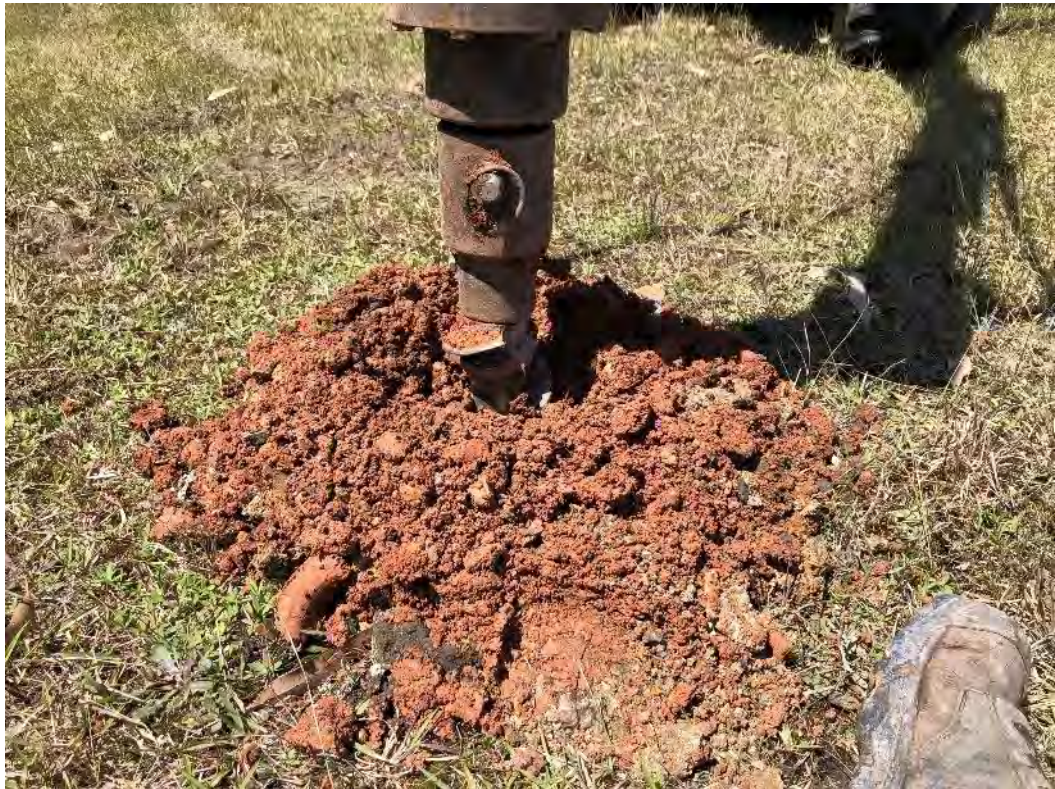
Photographs 7: Material encountered in BH02.

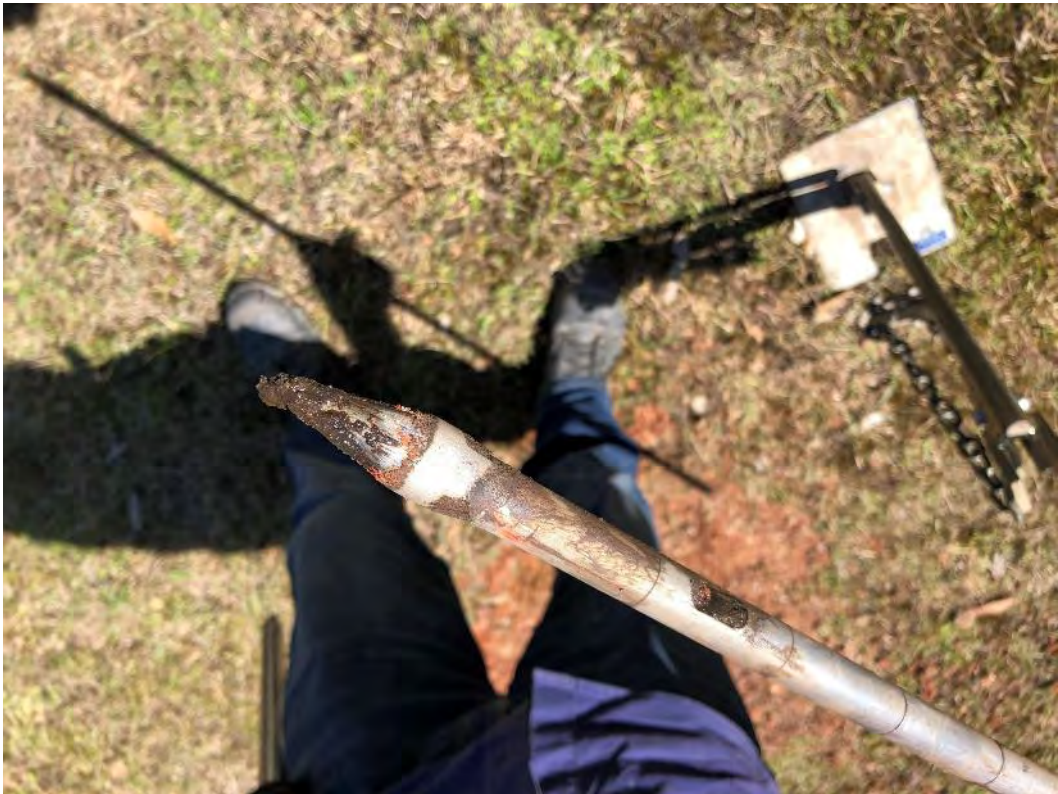
Photograph 8: Natural material encountered on DCP tip.

Extraction of the DCP from BH03 recovered wet sandy material on the DCP tip (refer photograph 8) which may be indicative of a sandy layer at about 2.5m to 3.5m depth with these sands being of medium density. Based on this DCP, a water level of about RL of 1.0m to 0.0m AHD may be present and this may be tidal. The subsurface soils were observed to be moist to target depth of 2.0m.

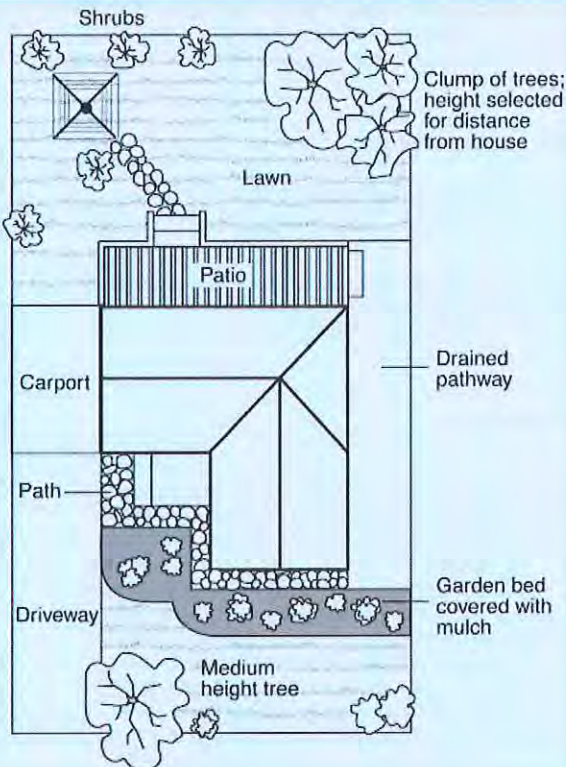
Gardens for a reactive site

should extend outwards a minimum of 900 mm (more in highly reactive soil) and should have a minimum fall away from the building of 1:60. The finished paving should be no less than 100 mm below brick vent bases.
