Broaden Management Pty Ltd
Former Black Hill Steggles Poultry Farm
Remedial Action Plan – Stage 2 Civil Works

John Renshaw Drive, Black Hill, NSW

14 August 2018

54892 - 116888 / Rev 0

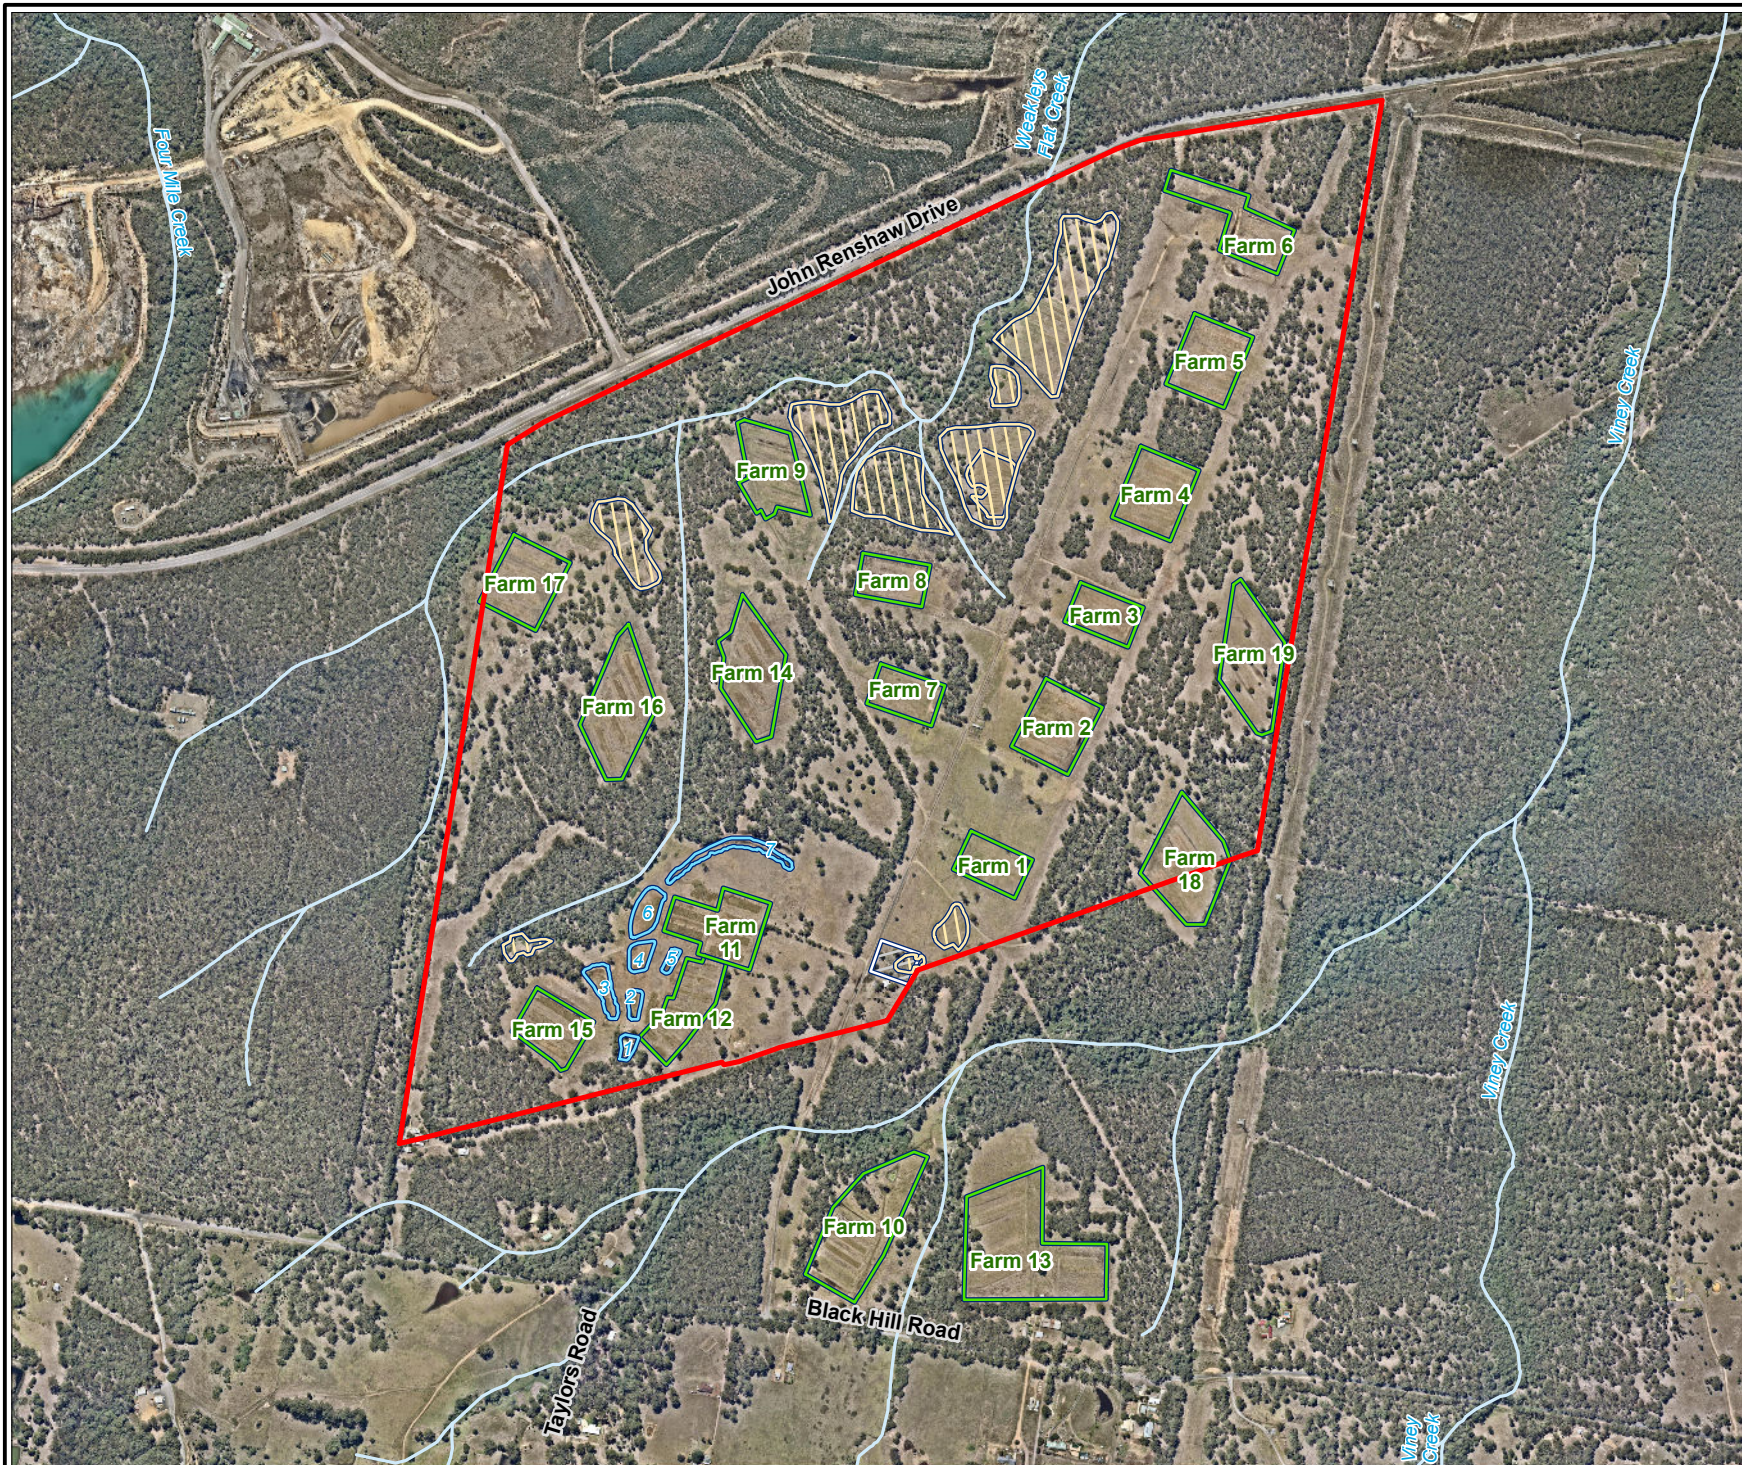
FIGURE 3

- Legend:**
- Site boundary
 - Infilled Pond
 - Disturbed areas
 - Concrete stockpile
 - Farm extents
 - Waterway

GENERAL SITE FEATURES

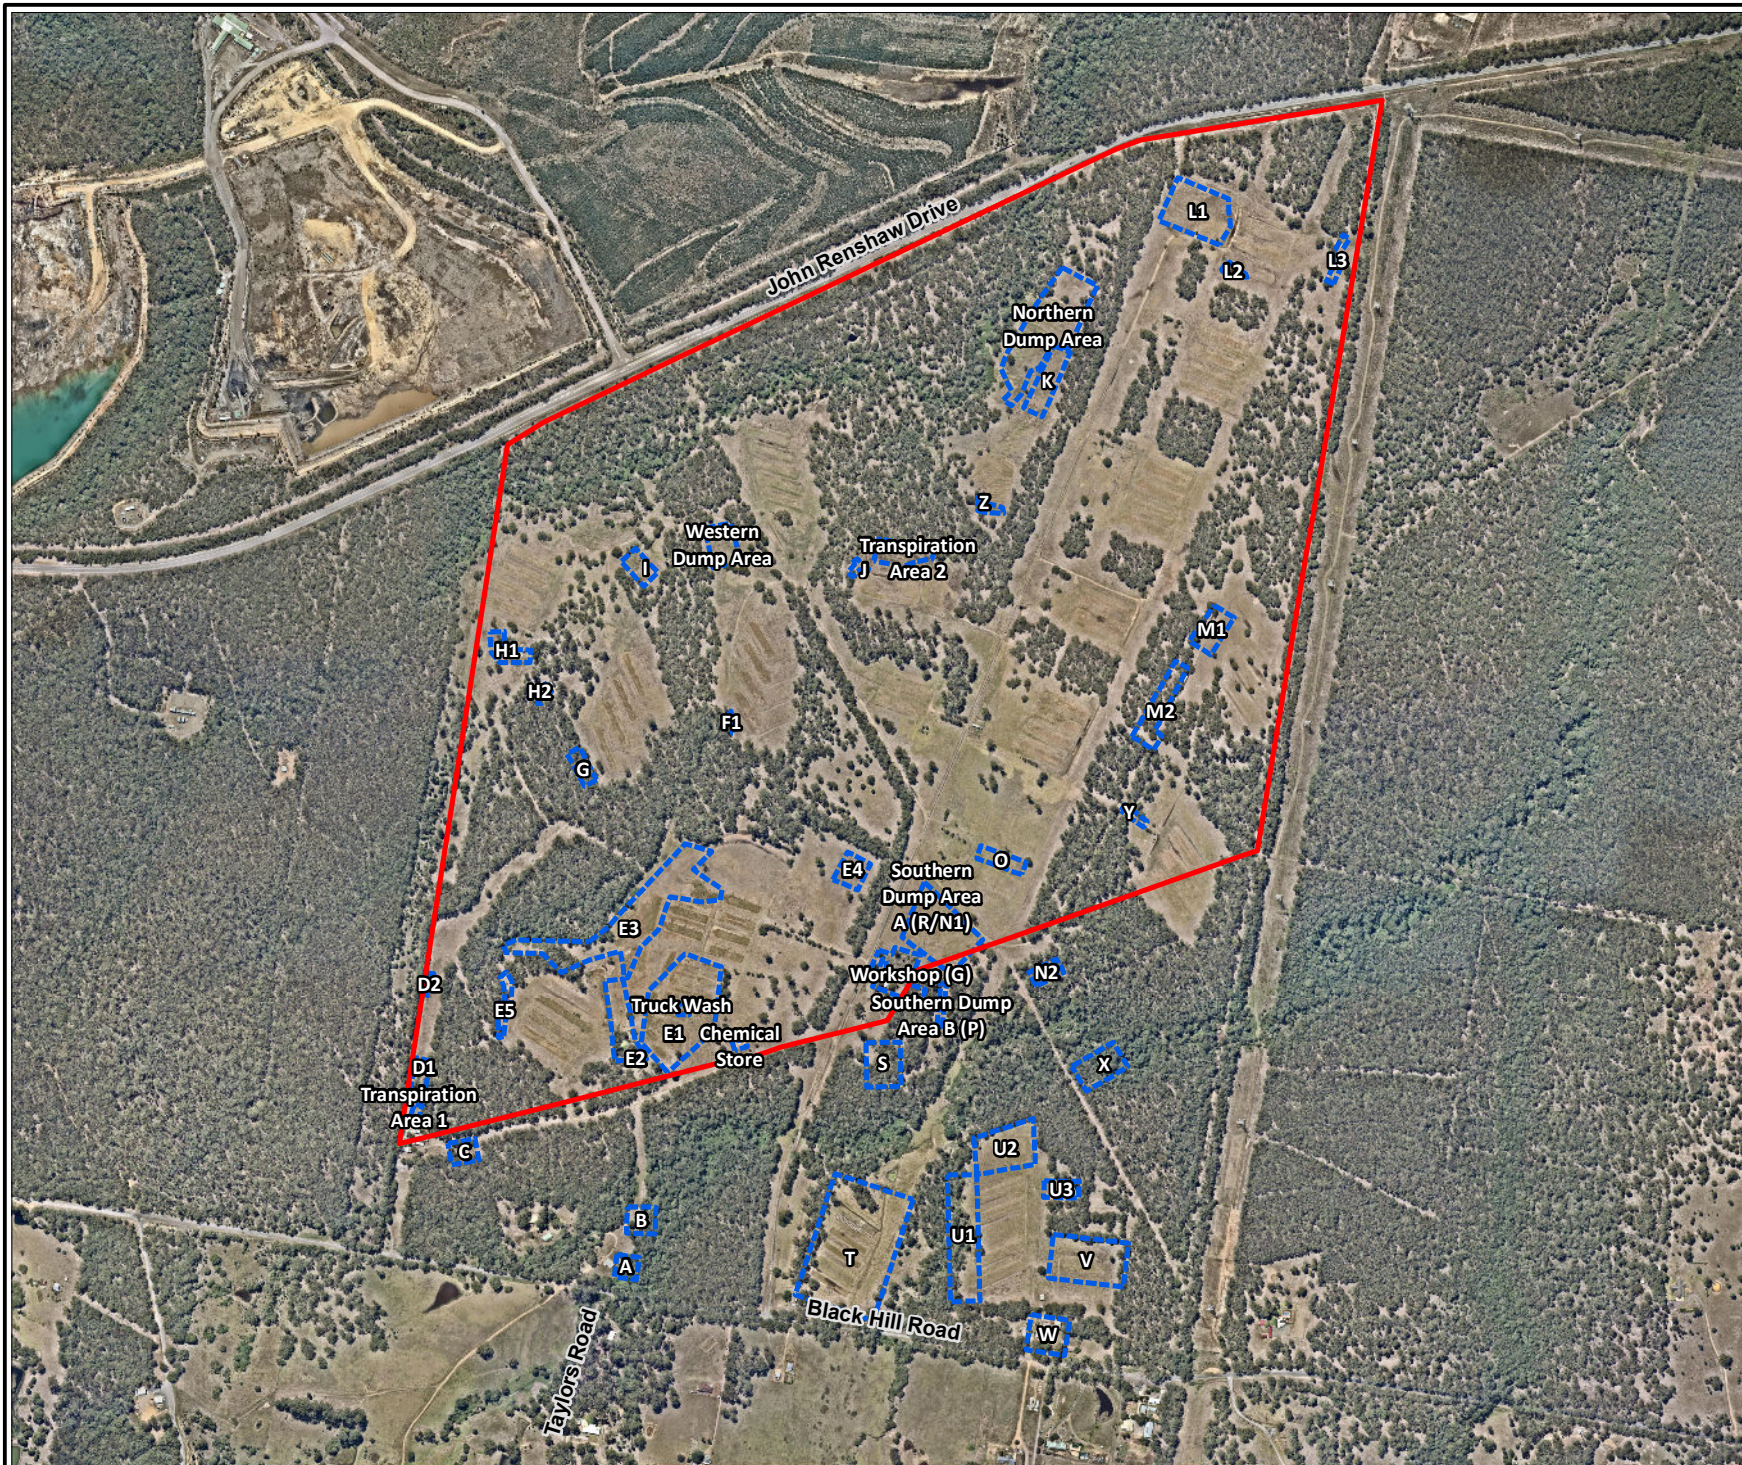
FIGURE 4

**AREAS OF ENVIRONMENTAL
CONCERN (DP,2017)**

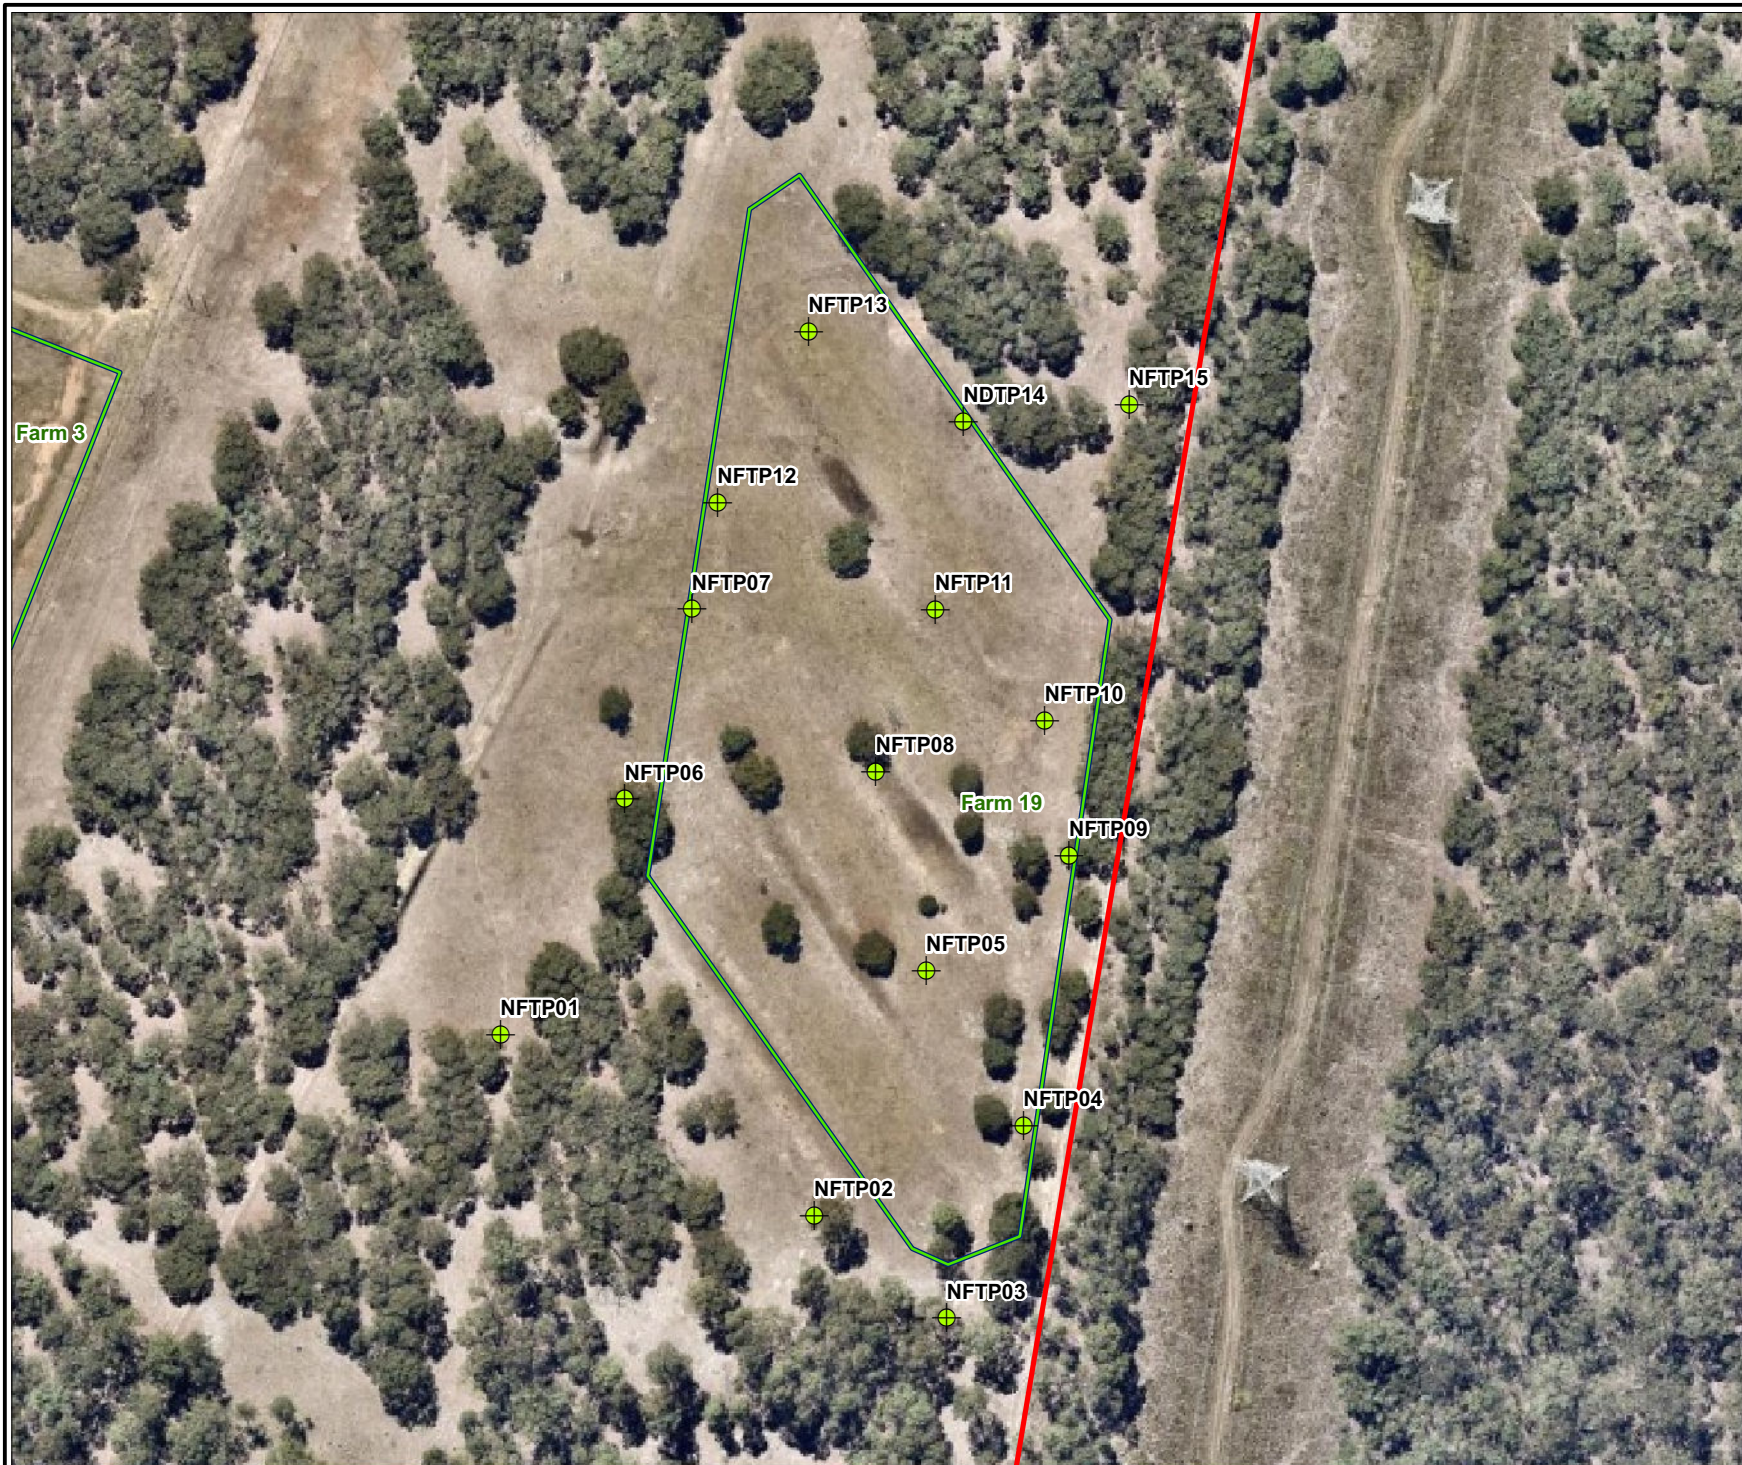
FIGURE 6a

**SAMPLE LOCATIONS
– FARM 19**

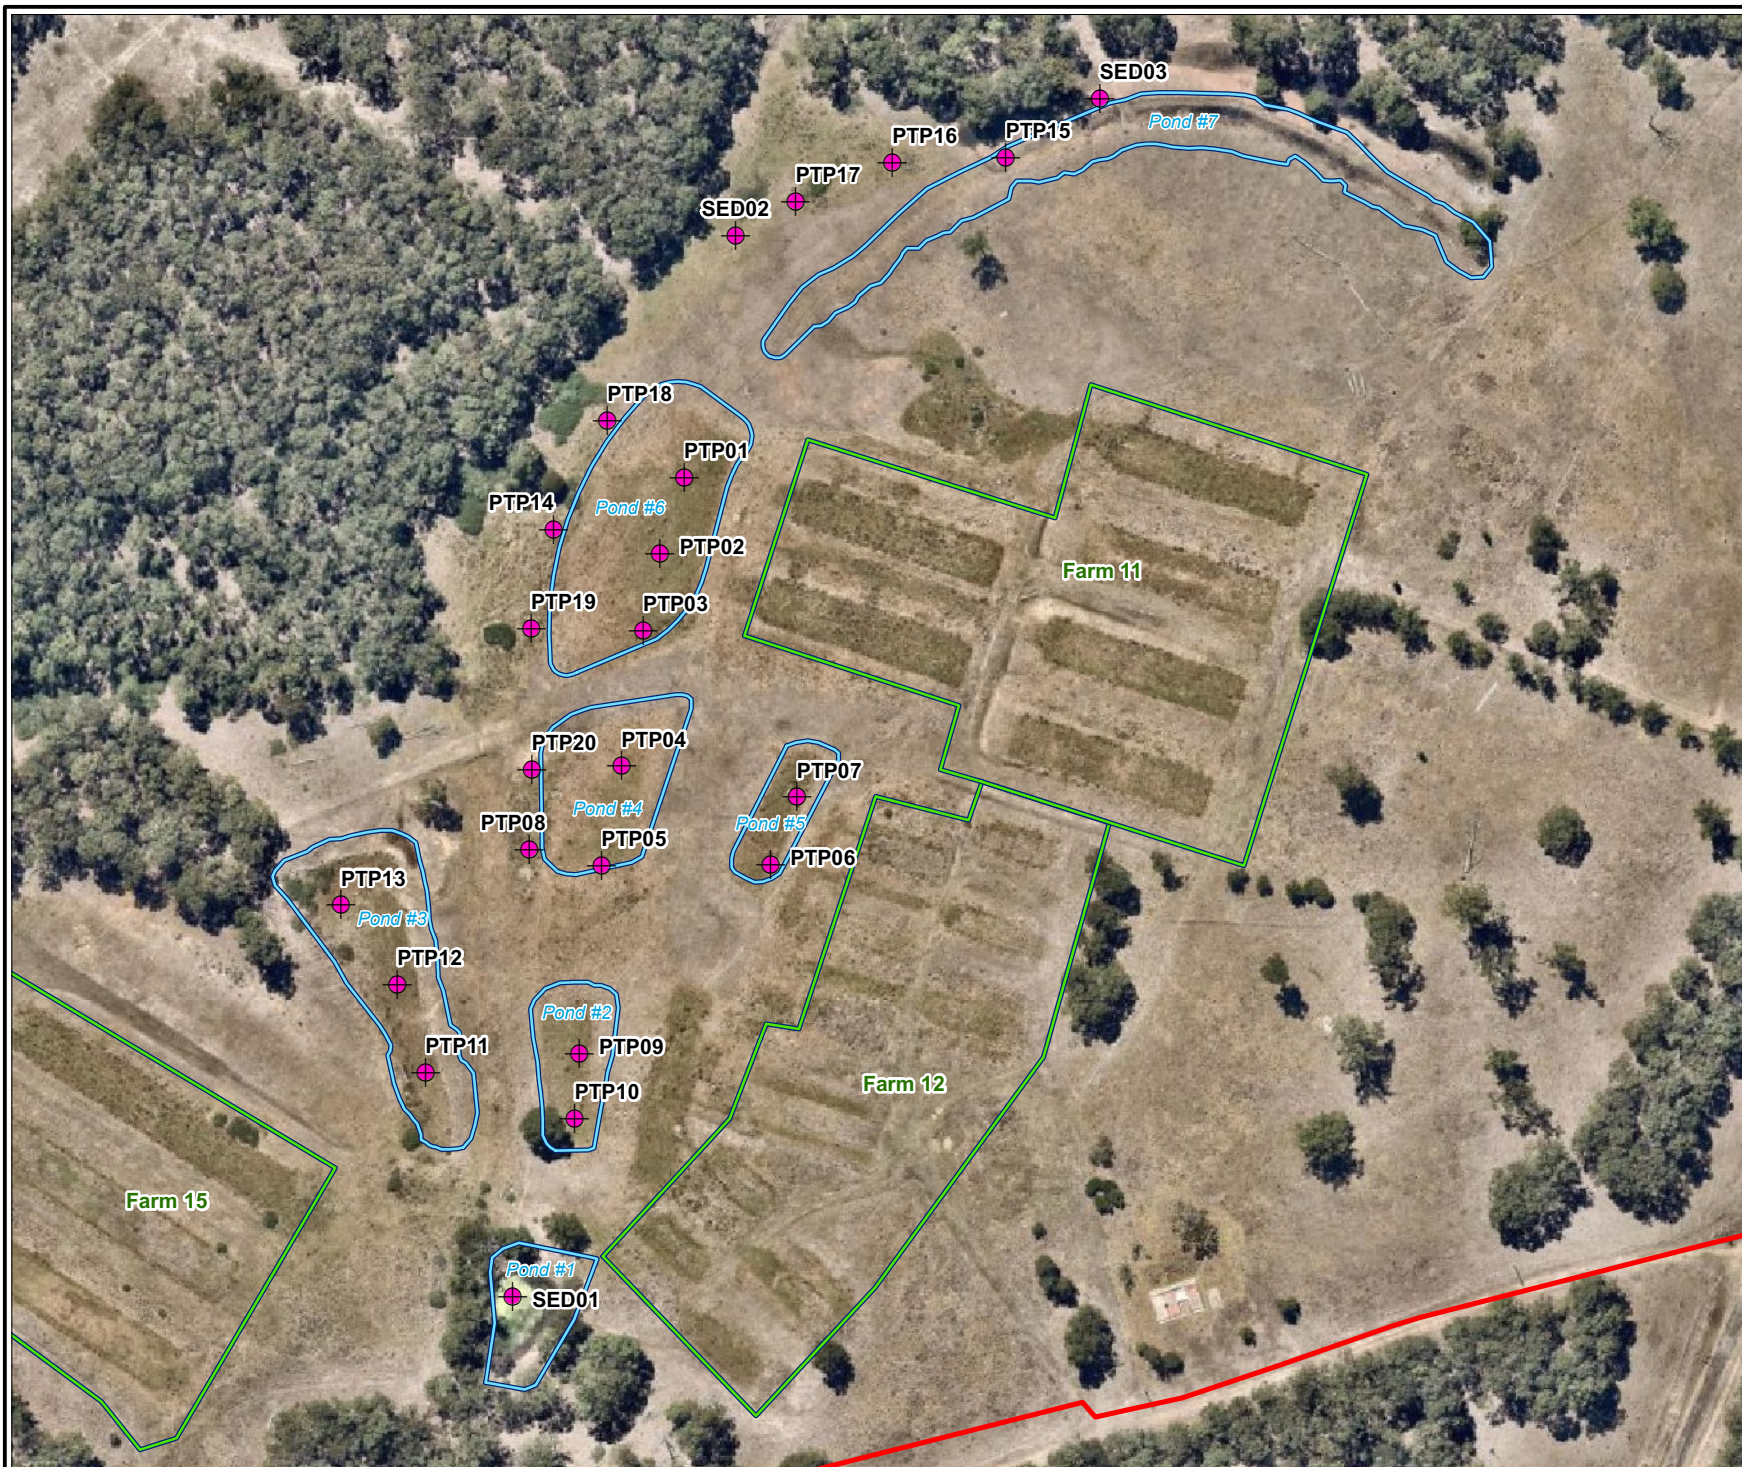
FIGURE 6b

**SAMPLE LOCATIONS
– INFILLED PONDS**

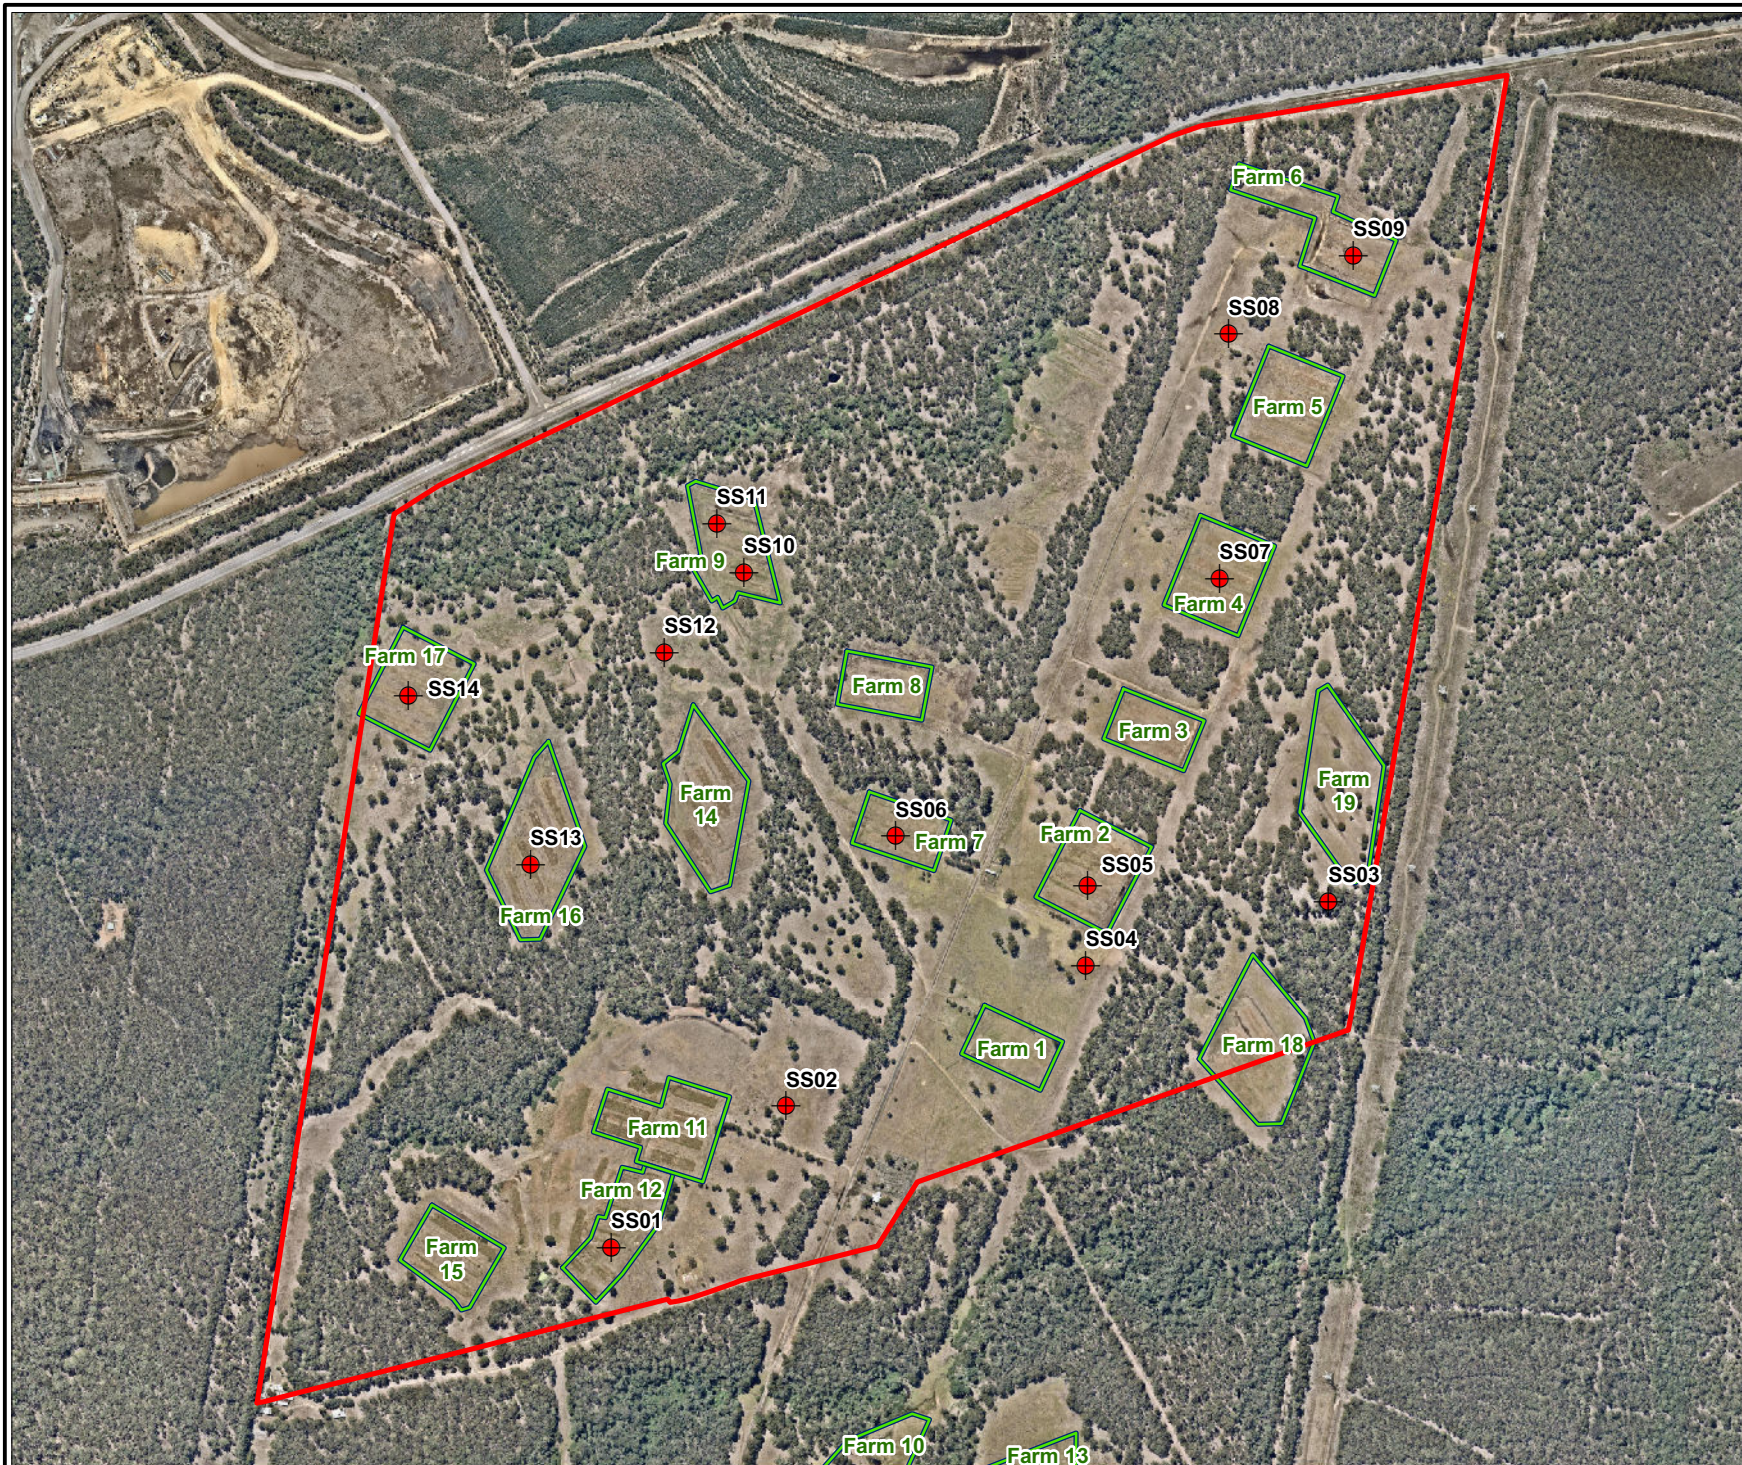
FIGURE 6c

**SAMPLE LOCATIONS
– SURFACE SAMPLES**

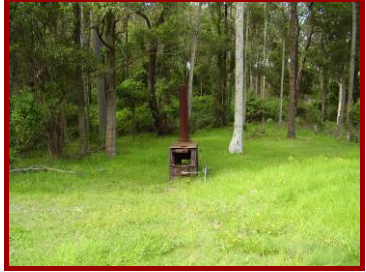
Area	Description	Photo
A	Former Diagnostic Laboratory.	
	Former diagnostic laboratory, incinerator present at rear, used to incinerate lab wastes? Dead birds? No historical information provided to confirm details of incineration activities.

Incinerator observed to contain ash materials, glass laboratory equipment (test tubes, vaccine bottles, foil).

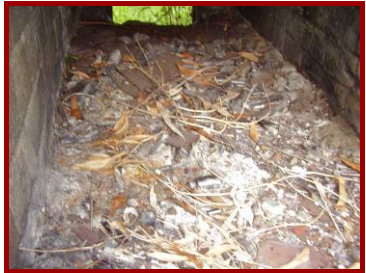
Ash materials also observed at surface behind the incinerator (including glass bottles, test tubes and foil).

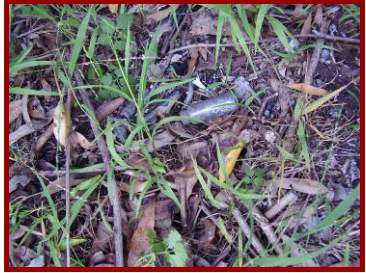
Some building rubble (bricks/concrete) also present behind incinerator area to the rear of the incinerator appears to have been used for dumping of lab wastes.

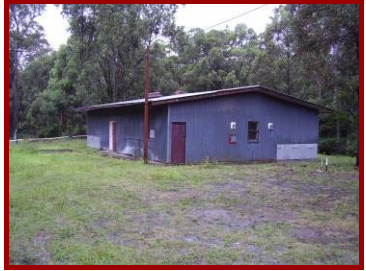
<p><i>Photo 5</i></p>

Area	Description	Photo
B1	<p>Boar Shed</p> <p>Boar Shed – used for experimentation on various animals? Filling (wastes?) present at rear of shed.</p> <p>Discharge of drainage waters from shed via PVC pipe to creek at the rear.</p> <p>Pile of fibro fragments, metal, red 44 gallon drum (empty) plus scattered fill (concrete footing, timber post etc)</p>

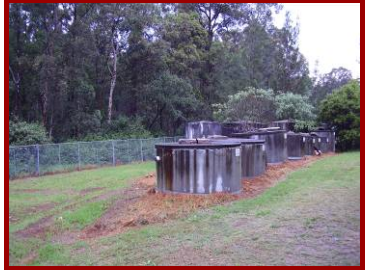
Bird digester tanks, details regarding contents and potential contamination not assessed.	<i>Photo 8</i>
D2	Burial trench north of Vaccine lab (contents unknown), between former sheds used to house birds for vaccine trials.

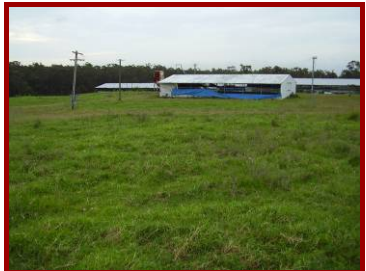
Truck wash located within Farm 12. Elevated contaminants/nutrients ground at the truck wash may be associated with the former pig farm activities.	
	Sheds with timber slatted floors were likely to have a subfloor pit, which have since been filled? May contain demo waste. Subfloor pits may have been lined with asbestos materials similar to Farm 10.	<i>Photo 10</i>

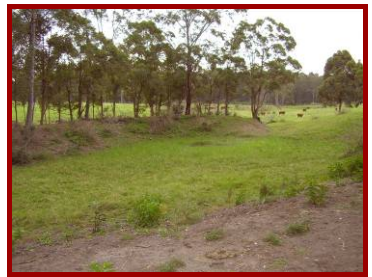
Area	Description	Photo
E1 Continued	Depressions (possible burial trenches) evident west of the existing shed within E1 (Note: Farm 15 and 11 may also have been utilised for pig farming prior to chickens)	
E2	Farm 11, 12 and 15 Former dams on pig farm. Collection of waste from pit farm and discharge to the gully? Series of dams (one large dam, several smaller dams). Some dams appear to be filled in, hummocky surface, possible demolition waste dumped. Dams likely to contain sludge/sediments from former site activities. Dam system appears to be similar to that at the Farm 10 (duck farm). Fibro fragments observed at top of large dam.

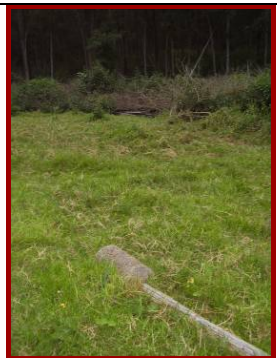
<i>Photo 12</i>

<i>Photo 11</i>
E3	Possible burial area west of Farm 11. Potential for former pig sheds to be buried. Hummocky surface, former shed post with concrete footing and timber slats observed at surface. Abundant metal sheets, pipe, gates, mesh, car tyre, fibro fragments, timber posts and concrete footing, hummocky fill, metal pig troughs (western part of E3)

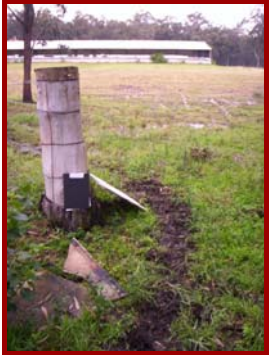
<p><i>Photo 12C</i></p>
E4	<p>Possible localised dump area for Farm 11. Hummocky surface, post with concrete footing at surface</p>

Area	Description	Photo
E3 continued	<p>Fibro sheet fragments (asbestos?) at surface adjacent to timber fence post (immediately south of E3)</p> <p>Building waste (roof sheets, timber, metal pipe/gate, wire, foam insulation, bricks, concrete, terracotta pipe within northern portion of E3)</p>

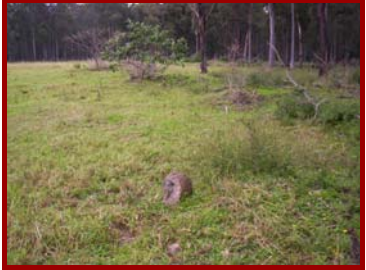
<p><i>Photo 12B</i></p>
F1	<p>Farm 14</p> <p>Burial trench at rear. Mass bird burial?</p>

<p><i>Photo 13</i></p>
E5	<p>Concrete footing, concrete, PVC pipe, steel wire, hummocky surface (building waste burial?)</p>

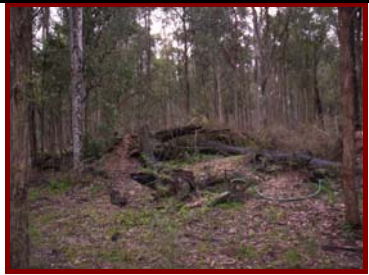
Area	Description	Photo
G	Farm 16 Dumped materials, building waste, metal gate, wire, concrete, metal, brick

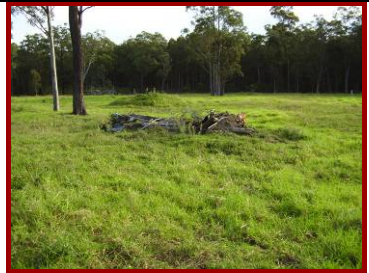
<i>Photo 16</i>
H1	Farm 17 Possible burial area, hummocky surface, grass covered mounds, roof sheets, wire, metal pipe etc.

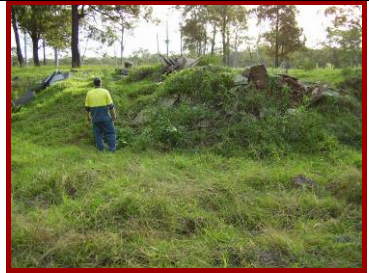
<i>Photo 18</i>
J	Farm 8 Possible burial west of sheds, hummocky surface.

<i>Photo 17</i>
H2	Building rubble, fibro fragments, metal, bricks, timber, hummocky surface	
I	East of Farm 17 Dump area, fill stockpile, with concrete, bricks, terracotta pipe, timber posts, plastic drum, brick footing, and fibro fragments at surface. At least 2.5 m high.

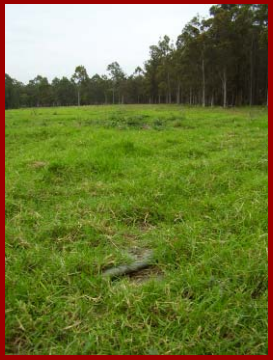
<p>Photo 20</p>
L1	<p>Farm 6</p> <p>Possible burial area, hummocky surface.</p>

Area	Description	Photo
K	<p>Northern dump area</p> <p>Rubber belting buried (formerly used above chicken grates).</p>

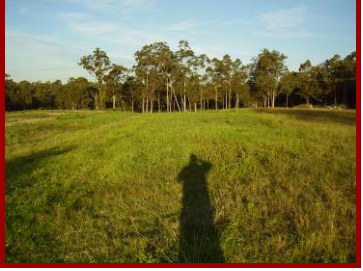
<p>Photo 22</p>
L3	<p>Possible burial area/trench, possible burial in auger hole.</p>

<p>Photo 21</p>
L2	<p>Possible burial area, fill mound, demolition waste buried?</p>

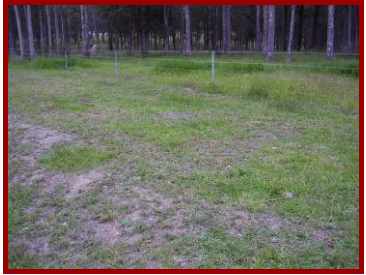
Area	Description	Photo
M1	North of Farm 18	
	Possible burial area, evidence of a series of auger holes? (depressions) may have been utilised for deceased bird burial. Also evidence of burial trench.

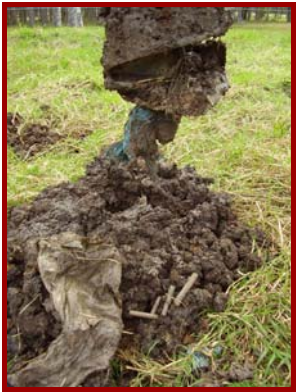
<p><i>Photo 25</i></p>
	Fill mound, clay filling, litter, plastic bags and test tubes observed in auger hole (laboratory waste?)

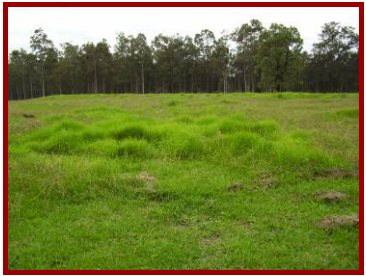
<p><i>Photo 25*</i></p>
	Hummock surface, possible burial (near M1)

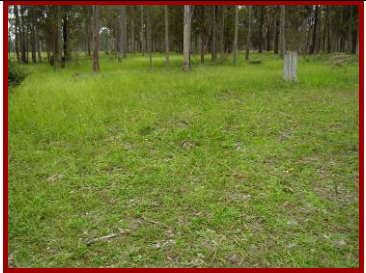
Area	Description	Photo
M2	<p>North of Farm 18</p> <p>Possible burial area – auger holes? Auger size depressions observed.</p>

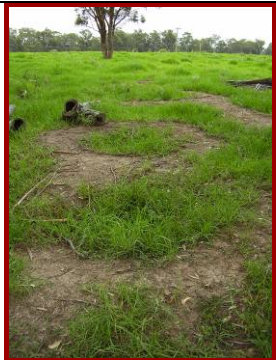
<p><i>Photo 28</i></p>
N2	<p>Dumped and partially buried vehicle and building waste, steel, wire, timber, vehicle parts etc (possible asbestos?). A number of trenches were observed within the area, which contains regrowth</p>

<p><i>Photo 27</i></p>
N1	<p>Southern Dump Area A</p> <p>Bird burial in auger holes, numerous holes evident within wooded area, additional burial trenches also evident.</p> <p>Southern Dump Area A more extensive than initially thought.</p>

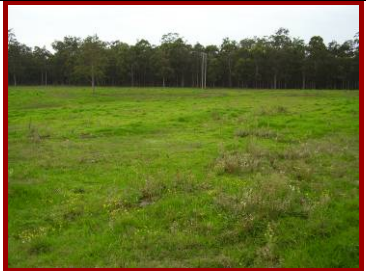
<p><i>Photo 29</i></p>

<p><i>Photo 28A</i></p>
O	<p>Farm 1</p> <p>former sheds (previously demolished) likely to be buried on the Farm 1 site, possibly containing asbestos materials.</p>

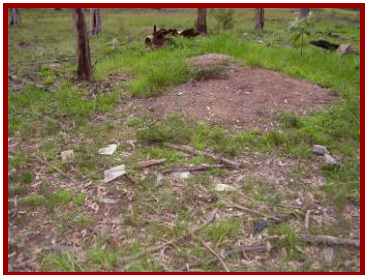
<p>Photo 30</p>

Area	Description	Photo
P	Southern Dump Area B History of burial of formaldehyde	
Q	Workshop Former incinerator at rear of workshop? (no longer present), used for incineration of deceased chickens? Fibro fragments present at surface, together with metal, concrete etc. Fibro fragments, mechanical parts etc observed at surface.

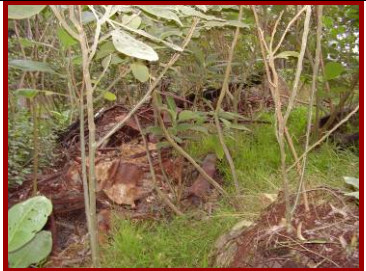
<p>Photo 32</p>

<p>Photo 31</p>
R	Southern Dump Area Building rubble buried within wooded area (demolition waste, metal roofing, steel, wire).

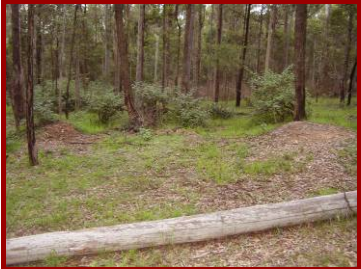
Area	Description	Photo
S	South of Workshop Possible burial area, hummocky surface.

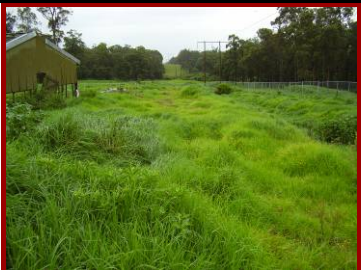
<i>Photo 34</i>

<i>Photo 33</i>
T	Farm 10 Fill mounds adjacent to sheds, likely to contain demolition waste including asbestos materials. Demolition waste may also be buried beneath concrete slab of northern most shed. Fibro fragments observed at the surface of fill, in addition to asbestos present at the former shed pits.

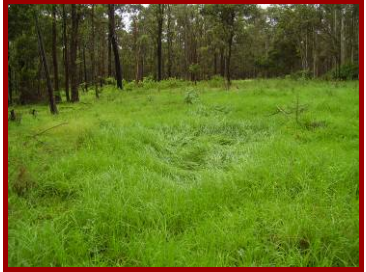
<p><i>Photo 36</i></p>
V	Farm 19 Former sheds possibly buried in this area, roof sheet evident at surface, hummocky surface.

Area	Description	Photo
U3	Possible burial area, depression.

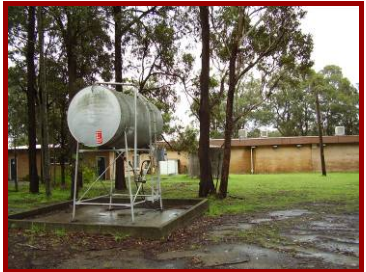
<p><i>Photo 38</i></p>

<p><i>Photo 37</i></p>
W	Turkey lab Aboveground diesel tank at front of turkey lab. Some hydrocarbon staining evident at base. Direct fuel line from tank to the turkey hatchery building (feeding heater/burner). Surface hydrocarbon spill evident

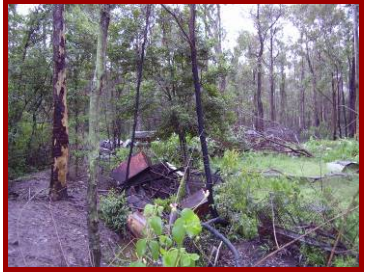
<p><i>Photo 40</i></p>
Y	<p>Farm 18</p> <p>Ash materials – imported? used on many access roads across the site (ash does not appear to be from on-site incinerators).</p>

Area	Description	Photo
X	<p>NE of Farm 19</p> <p>Dump site – trench and over land, metal parts, roof sheets cages etc, possible demolition waste.</p>

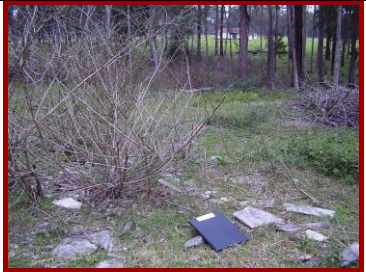
<p><i>Photo 42</i></p>

<p><i>Photo 41</i></p>
Z	<p>Northern Dump Area</p> <p>Southern end of Northern Dump Area contains fibro fragments at the surface and in the vicinity of burial trenches.</p>
