REPORT TO FORTIS DEVELOPMENT GROUP

ON DETAILED (STAGE 2) SITE INVESTIGATION

FOR PROPOSED REDEVELOPMENT

AT 2A COOPER STREET, DOUBLE BAY, NSW

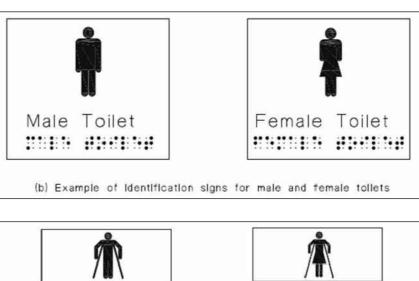
(c) Example of identification signs for ambulant accessible male and female toilets

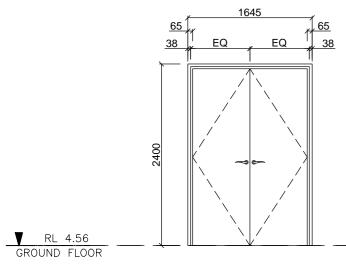
GF - D01 & GF - D02 FIRE DOOR FRAME & DOOR: Pyropanel PFDS 120/38 FINISH: Paint HARDWARE: Satin Chrome
