Preliminary Geotechnical Investigation Report

757-763 George Street, Haymarket NSW

Report No: E22293 GA_Rev3

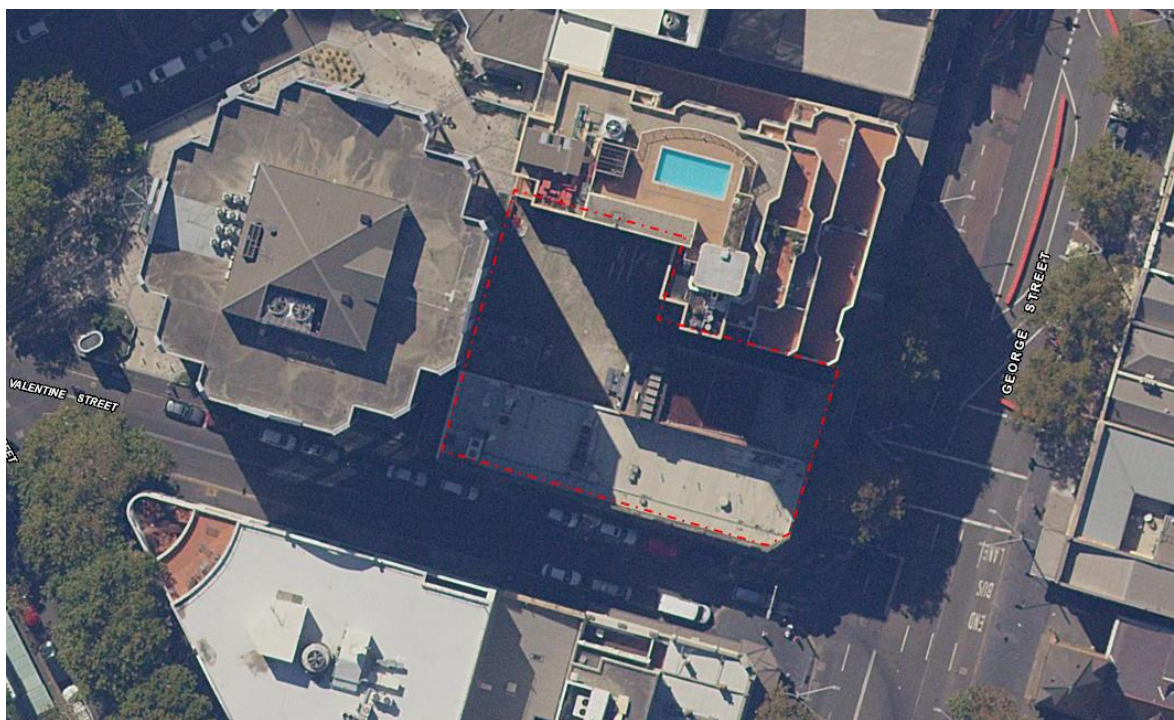
Plate 1: Aerial photograph of the site (source: SIX Maps, accessed on 24 June 2020)

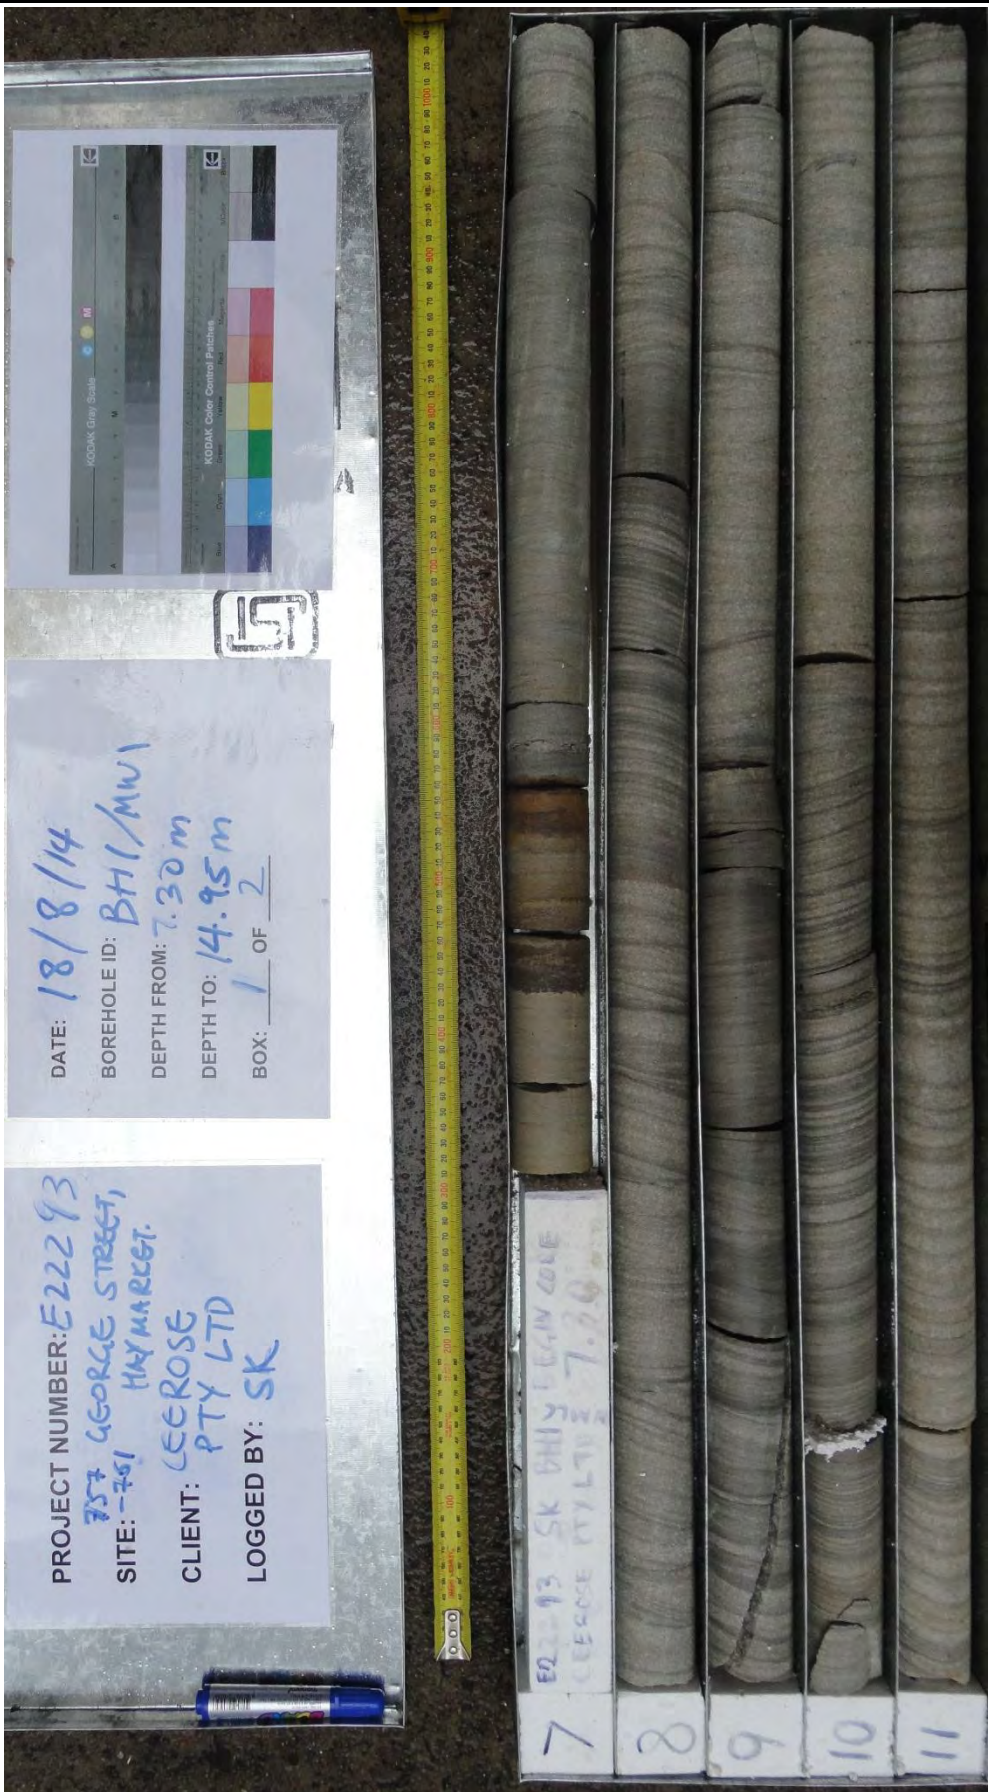
REPORT OF BOREHOLE: BH1/MW1

CLIENT: Samprian Pty Ltd	EAST: 333917.396 m	DEPTH RANGE: 7.30 m to 14.95 m
PROJECT: Preliminary Geotechnical Investigation	NORTH: 6249510.394 m MGA94 Zone 56	DRILL RIG: MD 3000
LOCATION: 757-763 George St, Haymarket NSW	INCLINATION: -90°	DRILLER: Traccess Pty Ltd
JOB NO: E22293	BOX: 1 of 2	LOGGED: SK DATE: 18/08/2014
	HOLE DEPTH: 14.95 m	CHECKED: RP DATE: 03/10/2014

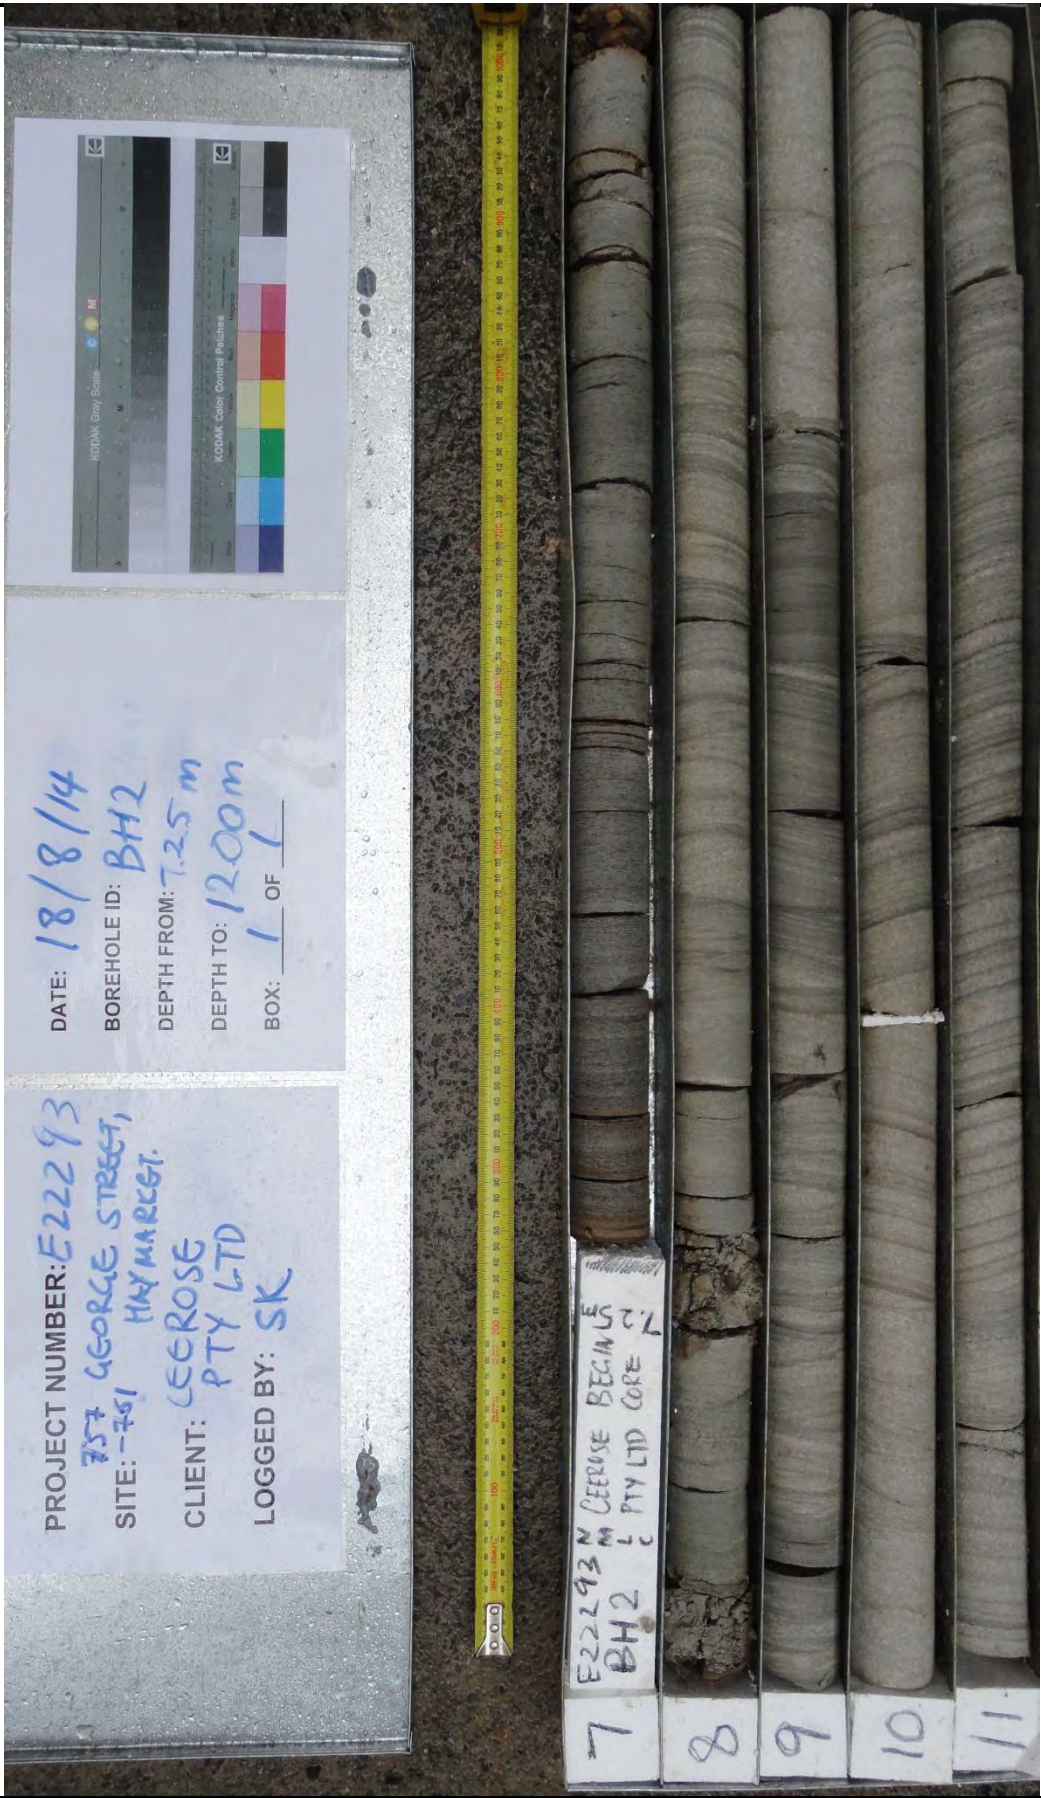
EAST: 333905.891 m
NORTH: 6249525.260 m MGA94 Zone 56
INCLINATION: -90°
BOX: 1 of 1
HOLE DEPTH: 12.00 m

DEPTH RANGE: 7.25 m to 12.00 m
DRILL RIG: MD 3000
DRILLER: Traccess Pty Ltd
LOGGED: SK DATE: 18/08/2014
CHECKED: RP DATE: 03/10/2014
