# Remediation Action Plan

757-763 GEORGE STREET, HAYMARKET  
NSW

EI Report No.: E22293 AB\_Rev2  
Date: 7 September 2020

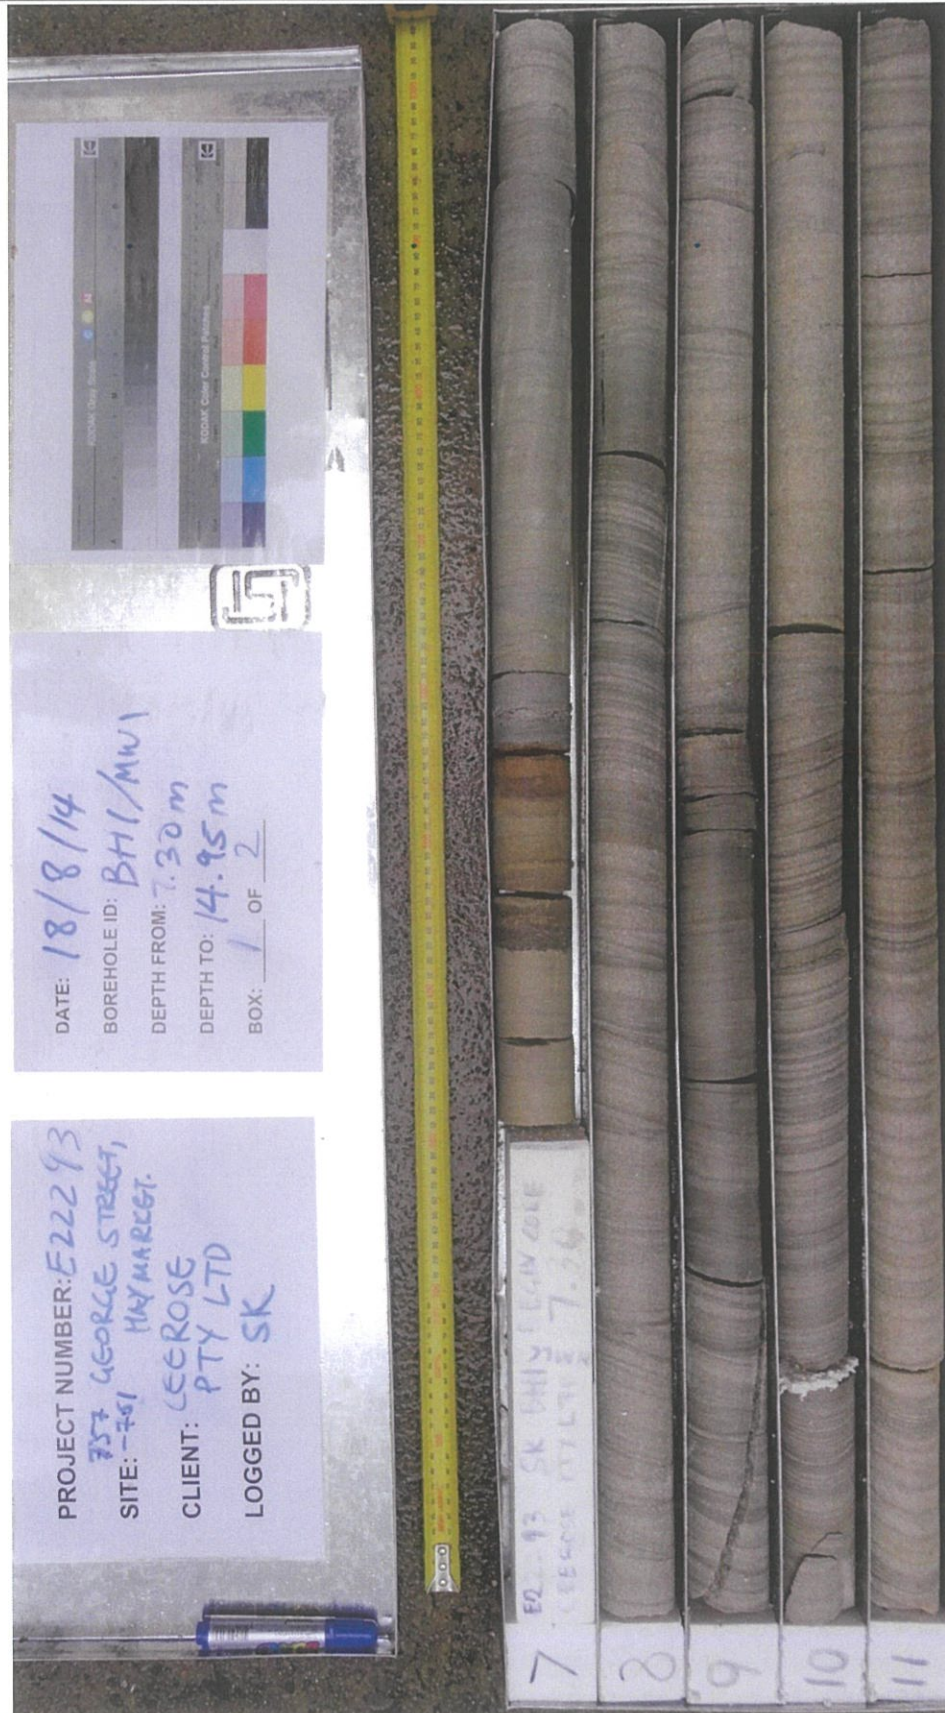
## REPORT OF BOREHOLE: BH1/MW1

CLIENT: Ceerose Pty Ltd  
PROJECT: Preliminary Geotechnical Investigation
