**Tier 1 Detailed Site Investigation**

The Killara Golf Club

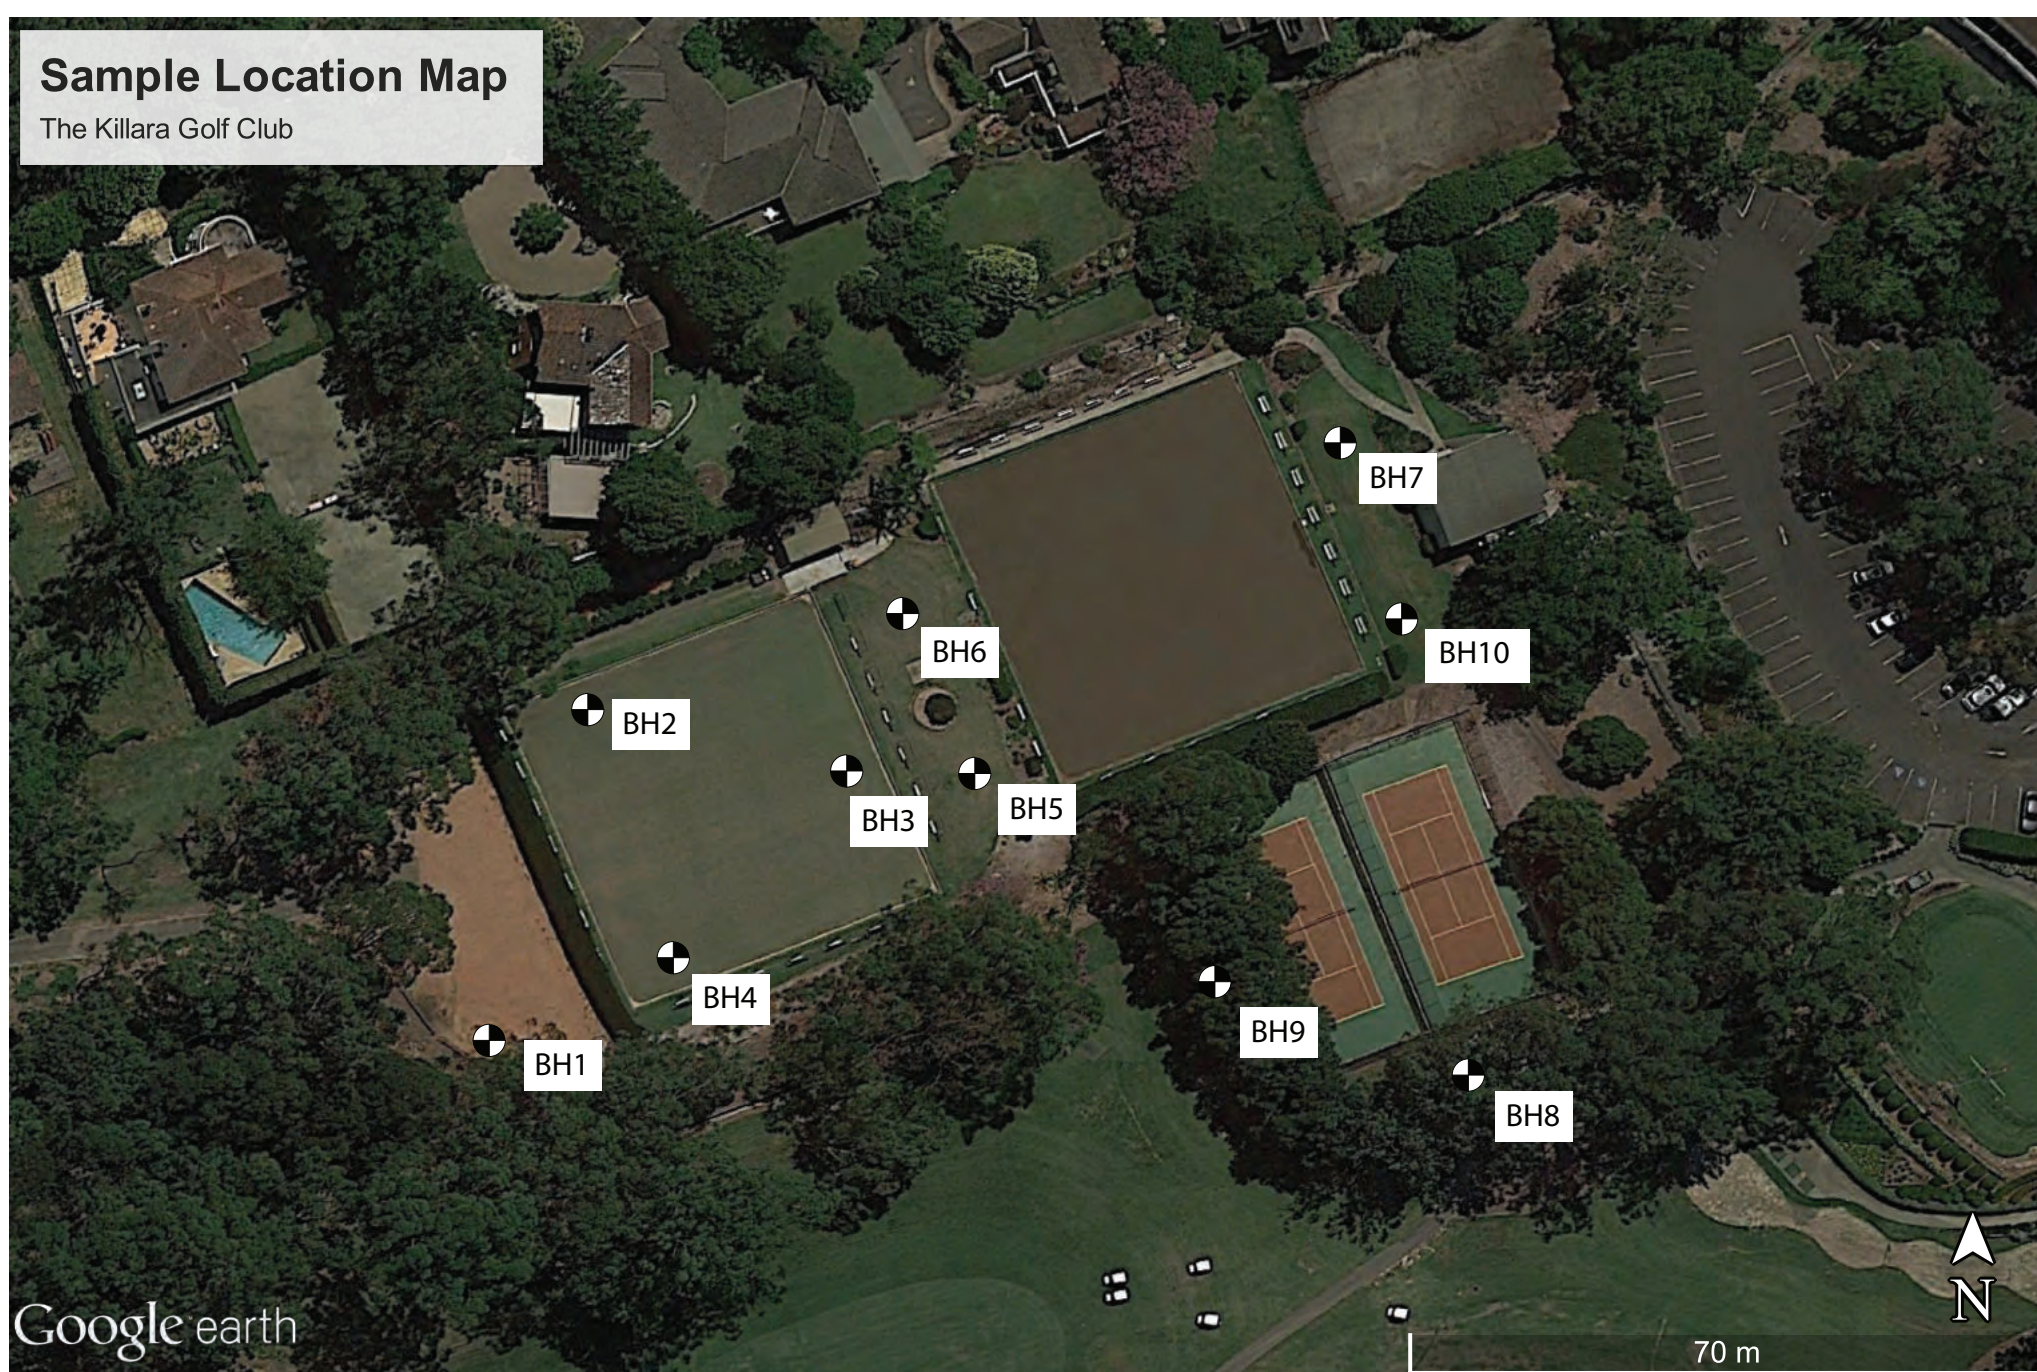
# Sample Location Map

The selection of the sampling locations was formed based on a judgmental sampling pattern. Sampling locations were based on areas where fill was observed. For this DSI sampling event (11/07/2017) a total of ten (10) sampling locations were investigated across the site, with forty-two (42) samples collected for the purpose of laboratory analysis. All samples were analysed for a contamination screening suite (heavy metals, TRH, OCP, PCB, PAH, BTEX & asbestos). Samples were collected directly from push tube liners and placed directly into laboratory supplies 20 mL glass jars. The samples were then placed into a chilled container and transported to a NATA accredited laboratory for the purpose of analysis, under Chain of Custody (CoC) procedures. Four (4) Quality Assurance/Quality Control (QAQC) samples were collected throughout this investigation. The summary of sampling location selection is show in Table 12.
