ENVIRONMENTAL INVESTIGATION SERVICES

**REPORT**

**STAGE 1 PRELIMINARY ENVIRONMENTAL SITE  
ASSESSMENT**

**PROPOSED COMMERCIAL/RETAIL DEVELOPMENT**

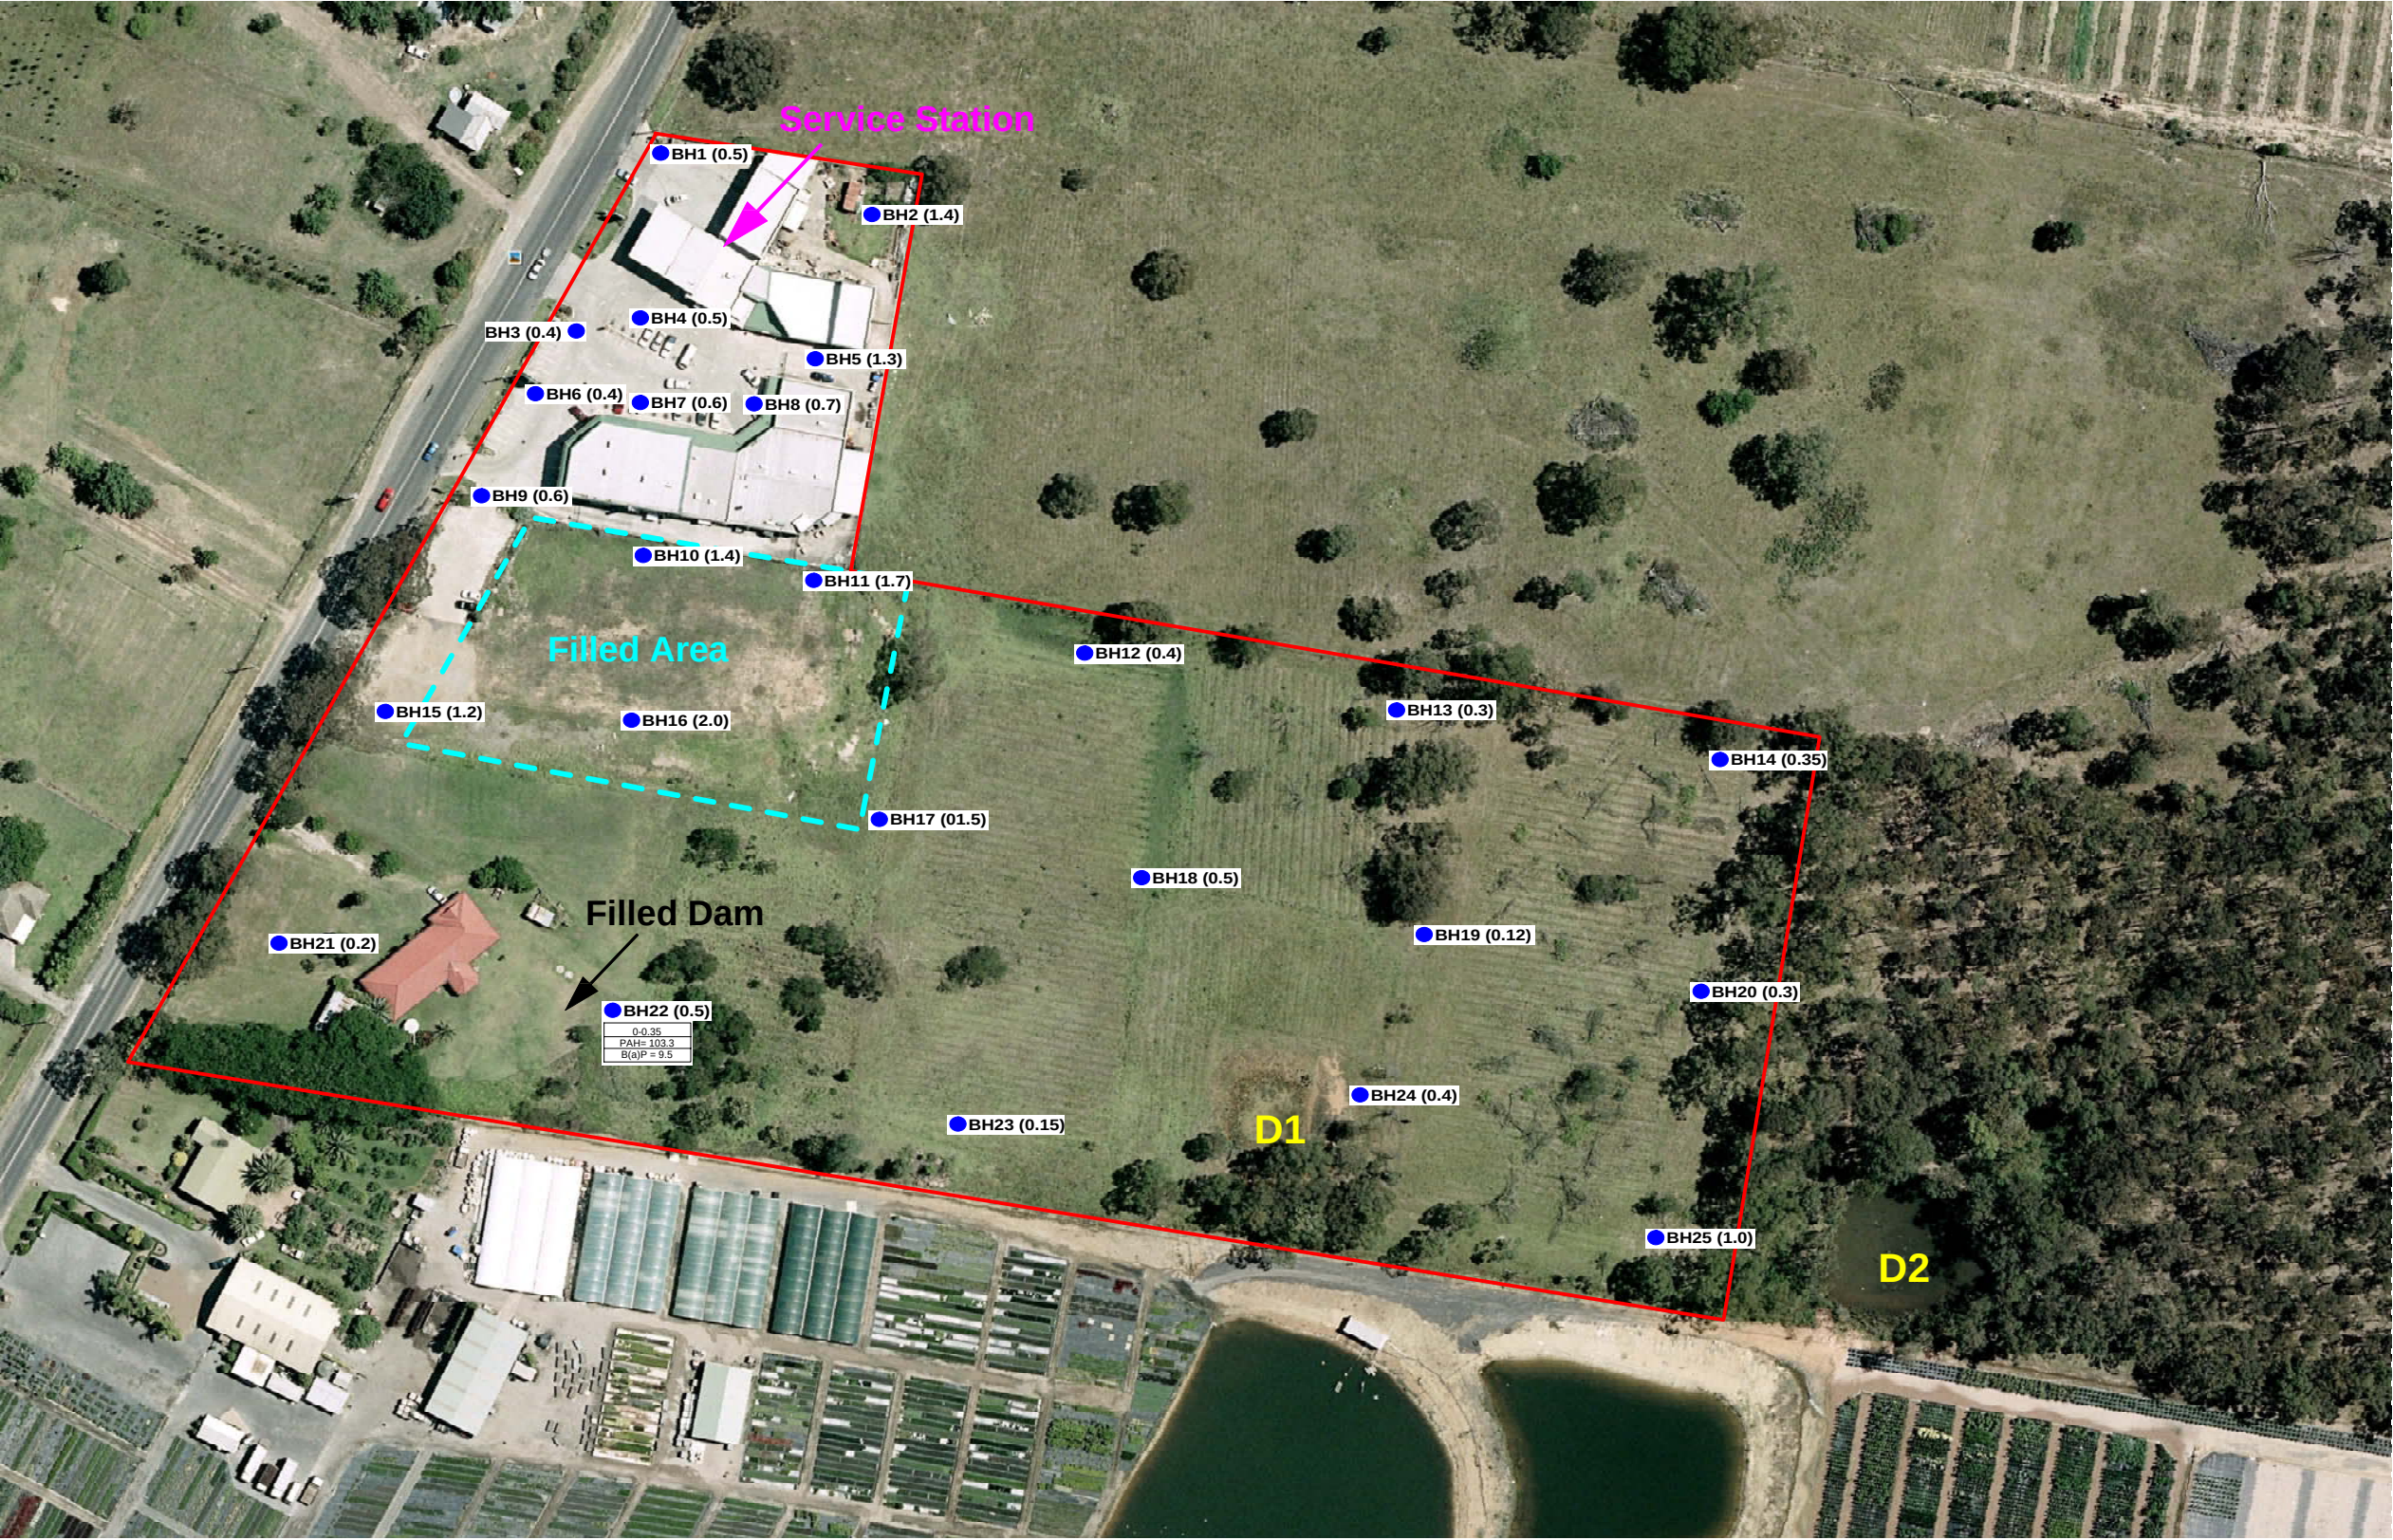
- LEGEND:
- Approximate site boundary
  - BH1 (0.2) Borehole location, number and depth of fill (m)

NOTES:  
Figure 2 has been recreated from a Google Earth Pro image

Borehole locations are shown on Figure 2. For details of the subsurface soil profile reference should be made to the borehole logs in Appendix A. A summary of the subsurface conditions encountered in the boreholes is presented below:
