# **‘RIVERSIDE’ Parramatta Development Project 12-14 Phillip Street and 333-339 Church Street Parramatta**

## **Assessment of Historical Archaeological Potential**

Report to PCC DevCo1 Pty Ltd

January 2014

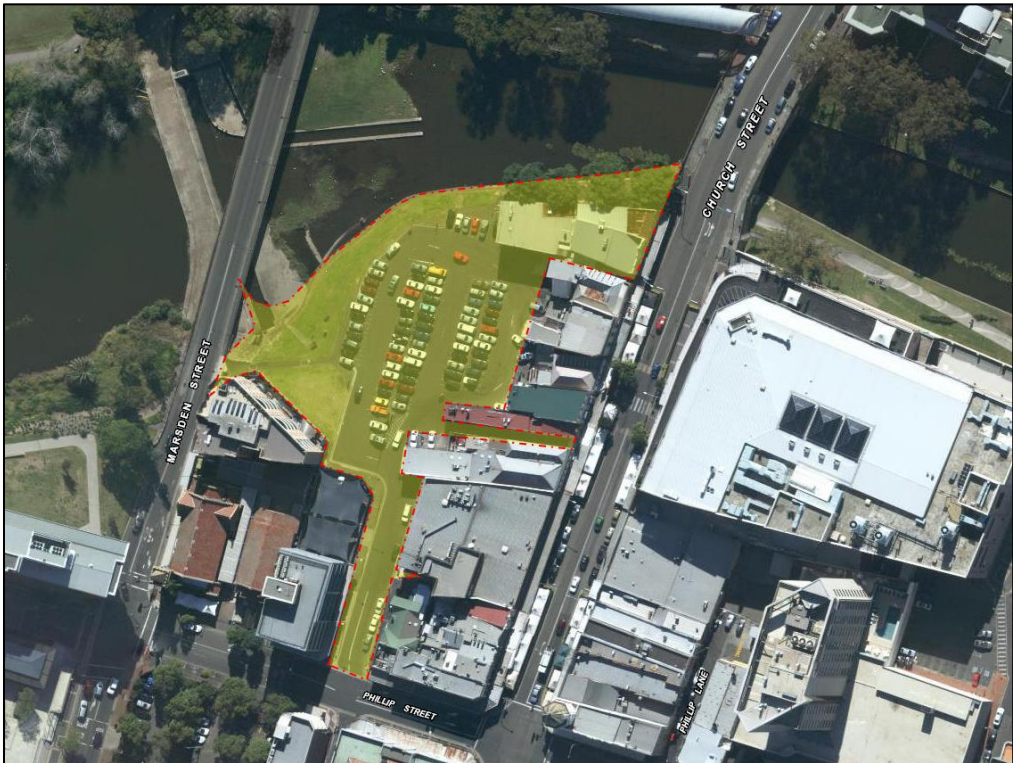
Figure 2: The subject site (base map © LPI – Department of Finance and Services)

The subject site is located on the south bank of Parramatta River between the Bernie Banton Bridge on Marsden Street and Lennox Bridge on Church Street (Figure 1). The site includes an irregular area covering 5993m<sup>2</sup>, with frontages on Church Street to the east, Marsden Street to the west, Phillip Street to the south, and Parramatta River to the north (Figure 2). The properties included within the site (Figure 3) are as follows:

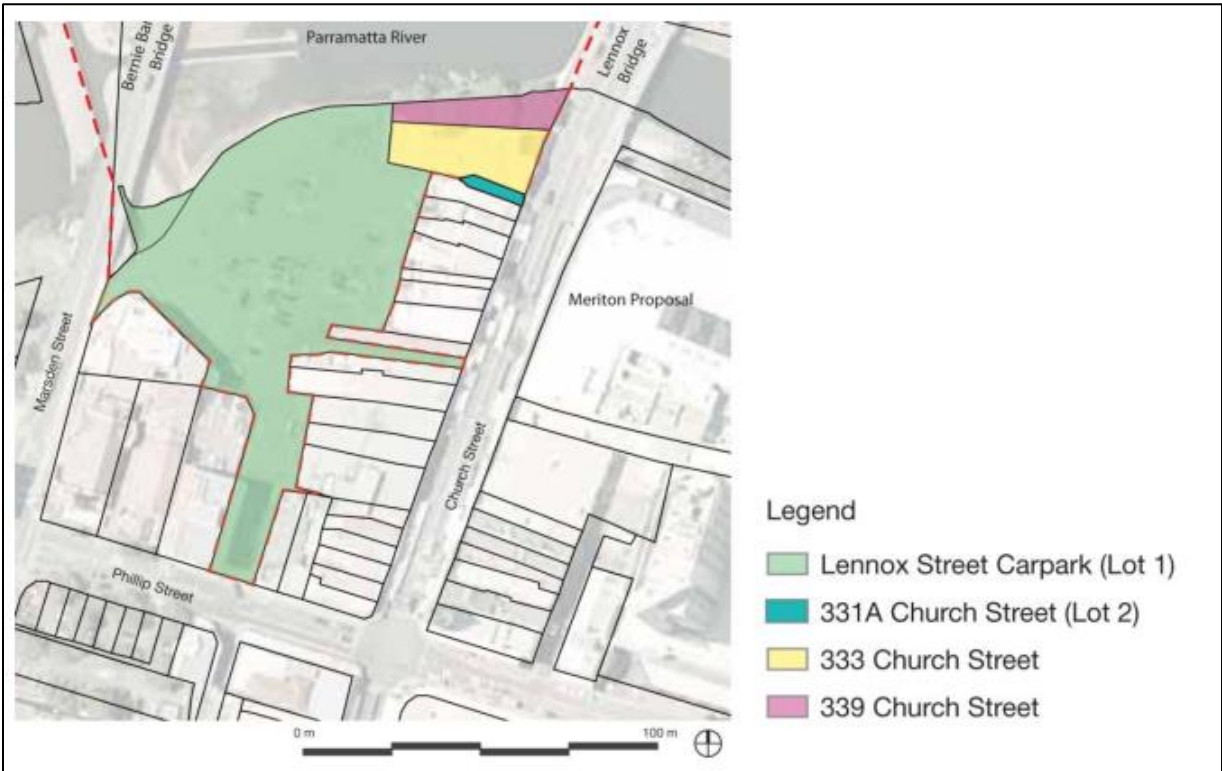
Figure 3: Properties within the subject site (from JBA 2013:5)

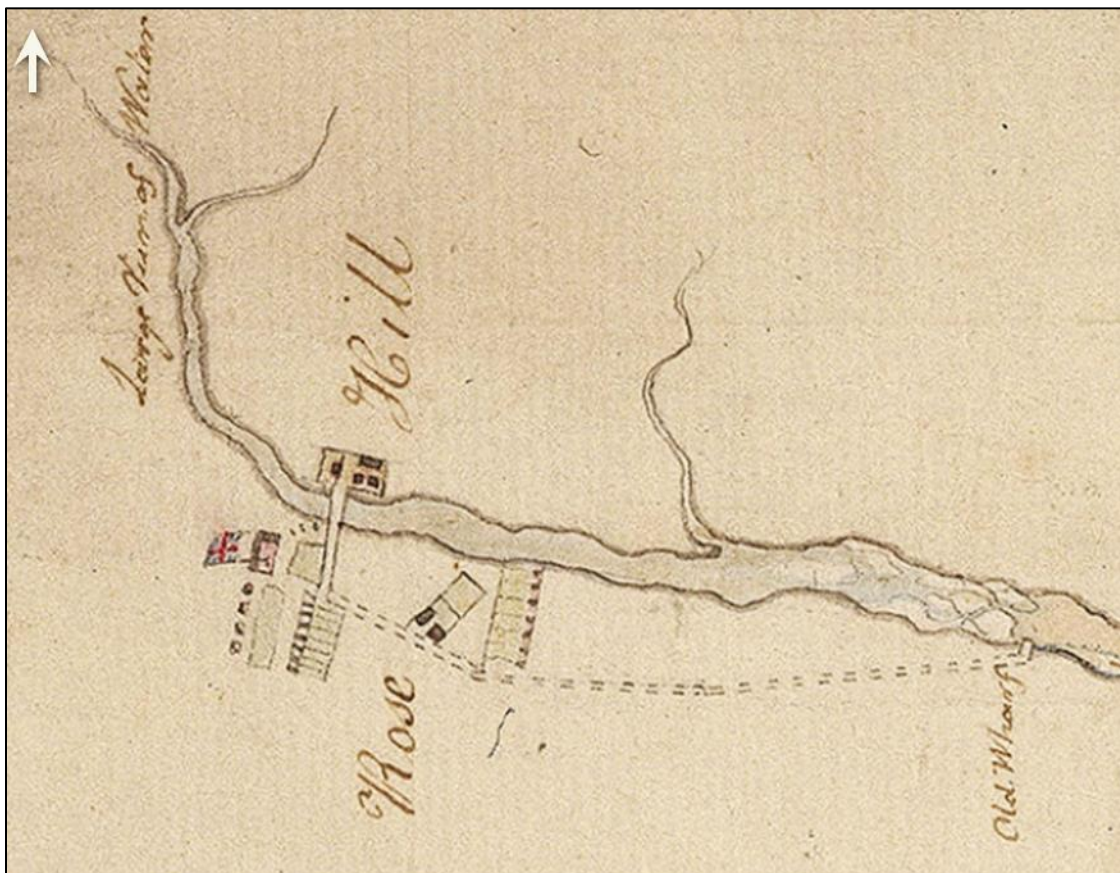
**Figure 8: William Bradley, *Flats at the head of Port Jackson & channel up to Rose Hill* 1789 (Mitchell Library a127082)**

A sketch map that was drawn by William Bradley in 1789 shows several buildings at the site of the government farm, including two rows of huts (Figure 8). The eastern row comprised seven huts, each located on an individual allotment, with an area behind for cultivation. This row appears to have been situated on the low ridge that was the later location for Church Street, in which case the gardens to the rear of the huts would have fallen within the eastern part of the subject site (AHMS 2011:98).

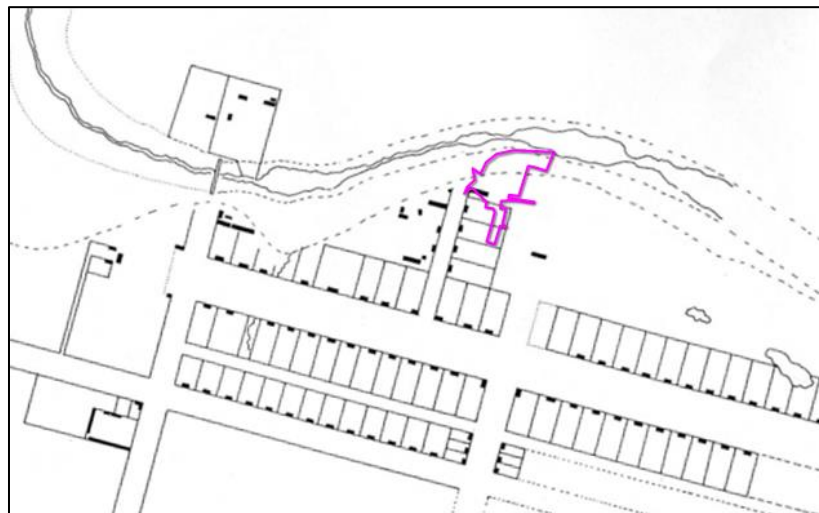
**Figure 10: Copy of 1792 plan of Parramatta (Higginbotham 1989) with overlay of the subject site boundary**

A plan of the town dating to 1792 shows four cottages fronting Marsden Street (then Hospital Lane) on its eastern side (Figure 10). These were located to the south of the subject site, although the yards of two of the huts extended into the southern part of the subject site. At the northern end of Hospital Lane, on its eastern side, was a larger rectangular structure (Item 1) which appears (based on documentary evidence) to have been the first hospital constructed in Parramatta. This structure fell within the current subject site. In December 1791, Watkin Tench noted that:

By 1792, the ‘First Hospital’ had been replaced by the ‘Second Hospital’, which consisted of a group of brick structures on the western side of Hospital Lane. The 1792 plan (Figure 10) shows the First and Second Hospitals as well as the open area to the north of Church Street which was set aside for the Town Hall and market place.

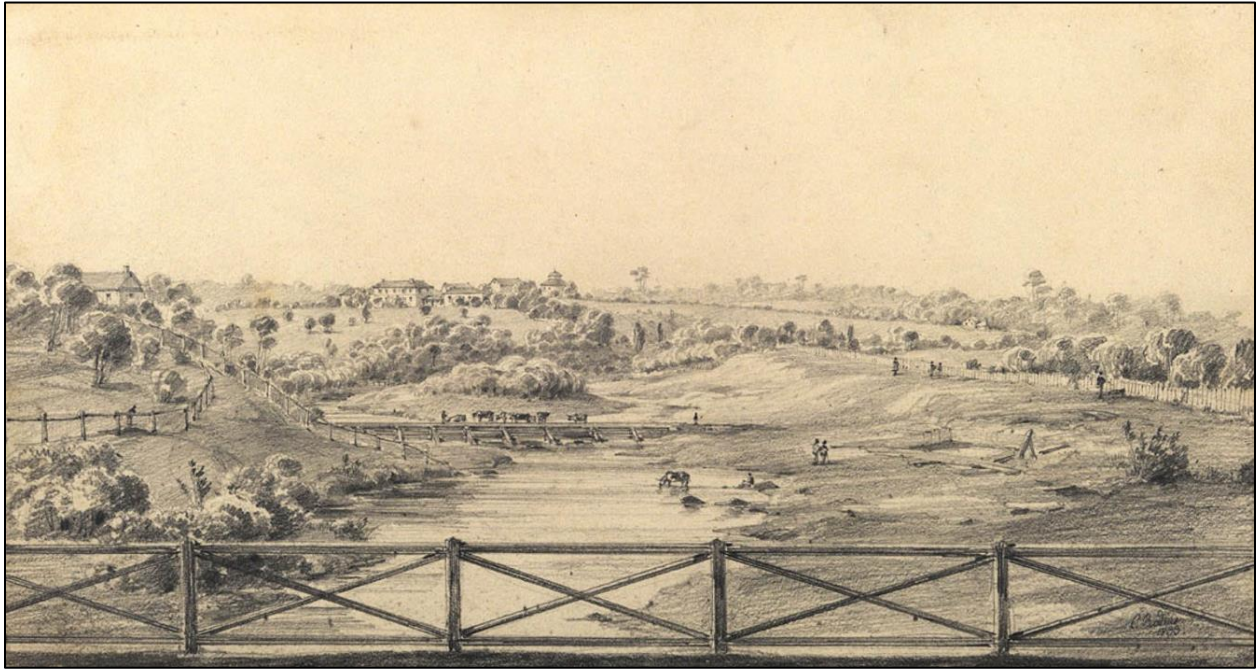
Figure 15: 1833 drawing showing the view west from the Church Street bridge, including the northern and southern banks of the river (Charles Rodius - views of Sydney and Parramatta, 1833, Mitchell Library a635006)

In 1833 Charles Rodius sketched the view toward Government House from the Church Street bridge. This drawing shows the Marsden Street weir and the southern riverbank within the subject site. The bank of the river was undeveloped aside from post-and-rail fencing (Figure 15).

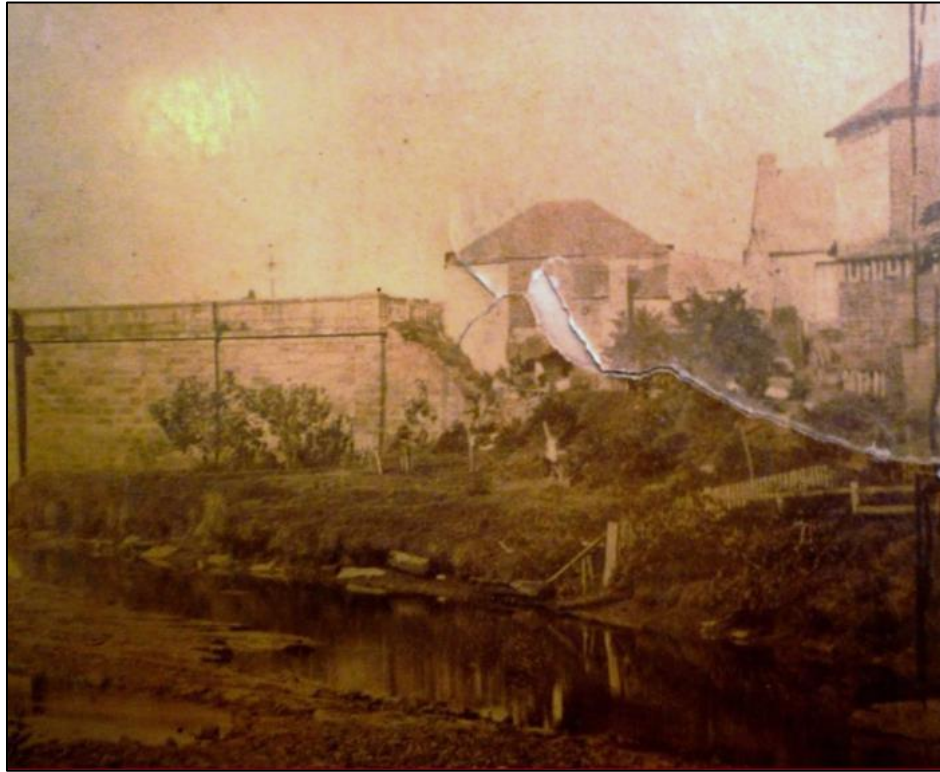
**Figure 20: Detail of an undated view of Lennox Bridge from the west. To the right of the bridge are the buildings occupying the eastern side of Allotment 1A (Items 7, 10 and 48). At the extreme right is a three storey building of unknown function (Item 47) (from AHMS 2011:119)**

Between c. 1870 and c. 1888, a large building (Item 47) was constructed at the rear of the property. This building is shown in Figure 20 and was a three-storey structure. The structure is poorly documented but AHMS (2011:119) have suggested that the presence of clerestory windows on the lower two floors may indicate that it was not a residential structure. Instead, it may have been associated with the storage or small-scale processing of agricultural produce. By 1895, this structure had been replaced by another building (Item 26), which appears to be a large tin shed as shown in a photograph dating to c. 1900 (Figure 19). The photograph in Figure 20 also shows what seems to be a small orchard on the river flat, and an additional structure (Item 10) to the south of the cottage. The orchard does not appear in later photographs and it is likely that they were uprooted by the flood of 1889.

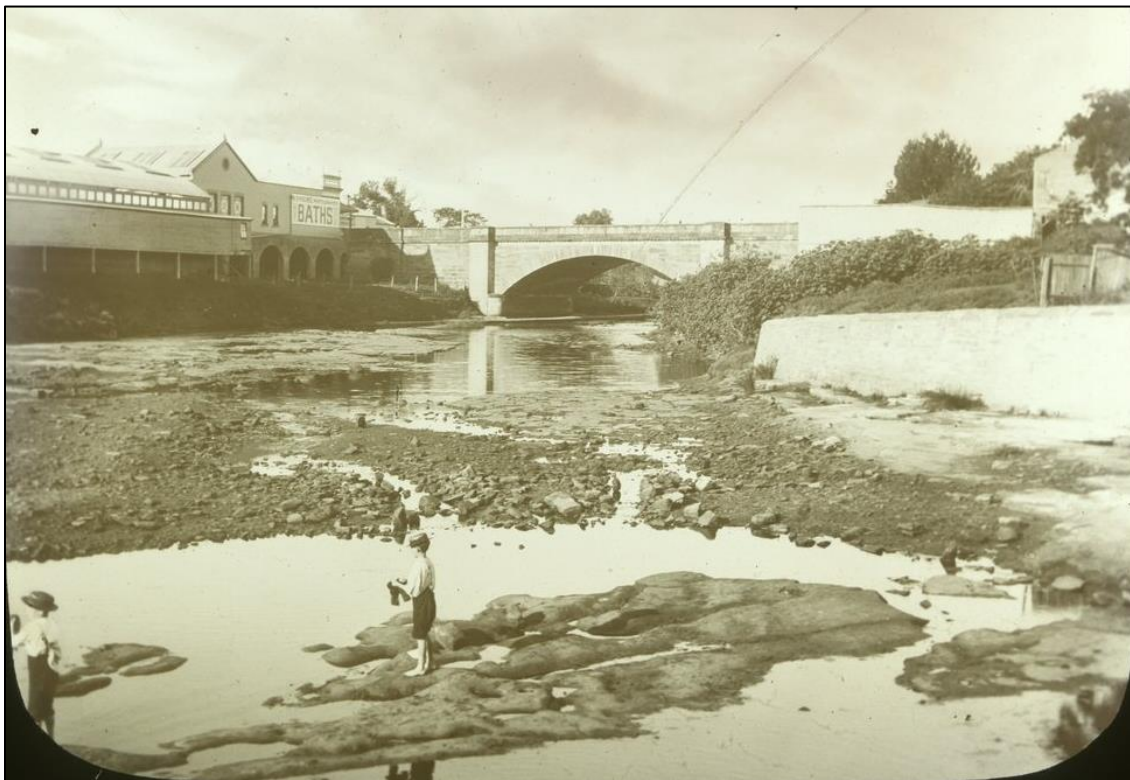
**Figure 21: View of Lennox Bridge from the west (c.1900). The study area is on the right.**  
(<http://handle.slv.vic.gov.au/10381/46231>)

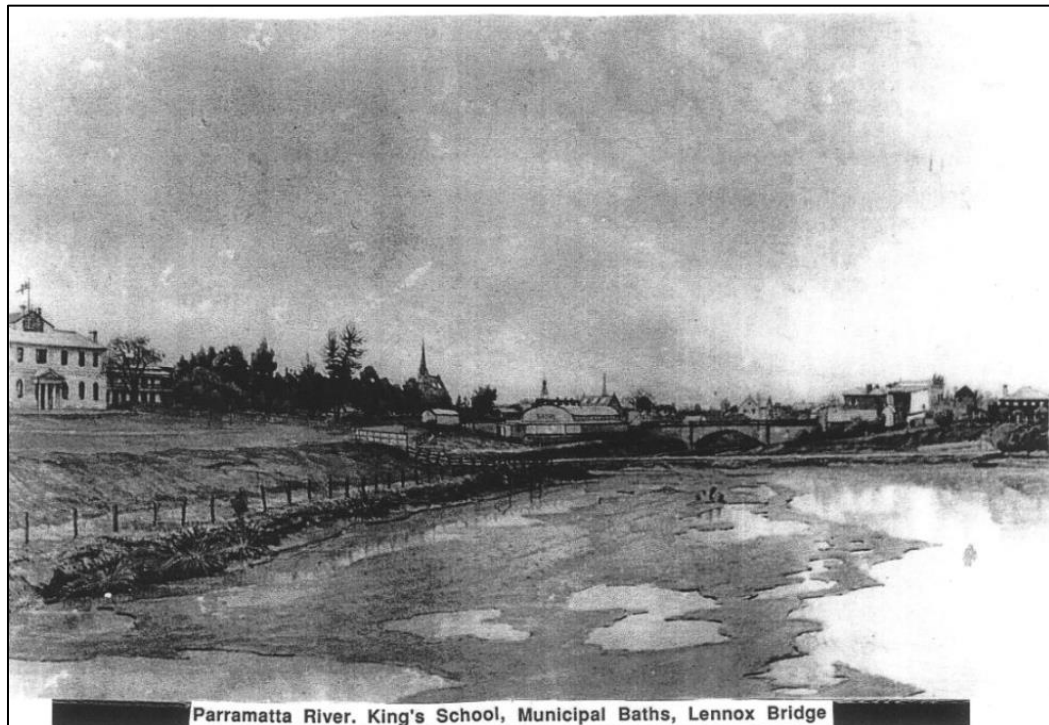
Figure 23: Undated illustration (1890-1894) looking towards the Marsden Street Weir from the west. Various structures can be seen of the southern bank. The rebuilt 'Riverside' residence is on the far right, with a striped verandah (Parramatta Heritage Centre, from AHMS 2011:127)

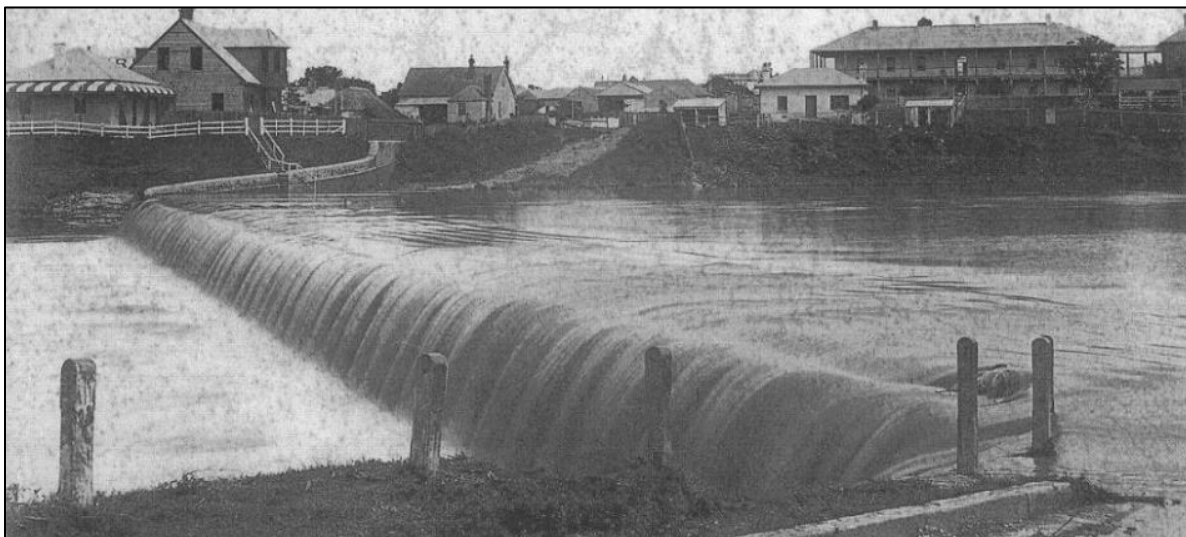
Figure 25: Undated photograph (c. 1890-95) looking south over the Marsden Street weir. The rebuilt 'Riverside' is visible on the left, while the 'Niagara' is the large building behind it (from AHMS 2011:128)

The floods caused a breach in the Marsden Street weir which led to the southern bank of the river between the weir and Lennox Bridge being scoured down to the bedrock. While the buildings along Church Street were flooded, the most significant damage was inflicted on the 'Riverside' estate of George Stone on **Allotment 2**. This damage included the collapse of the main (western) section of the house and the removal of a large portion of the river frontage of the property. Figure 22 shows this damage. Between 1890 and 1895, the foreshore was in-filled and the house was rebuilt as a single-storey house with a wide verandah (Item 11) (AHMS 2011:125). The rebuilt house is shown in Figures 22, 24 and 25.

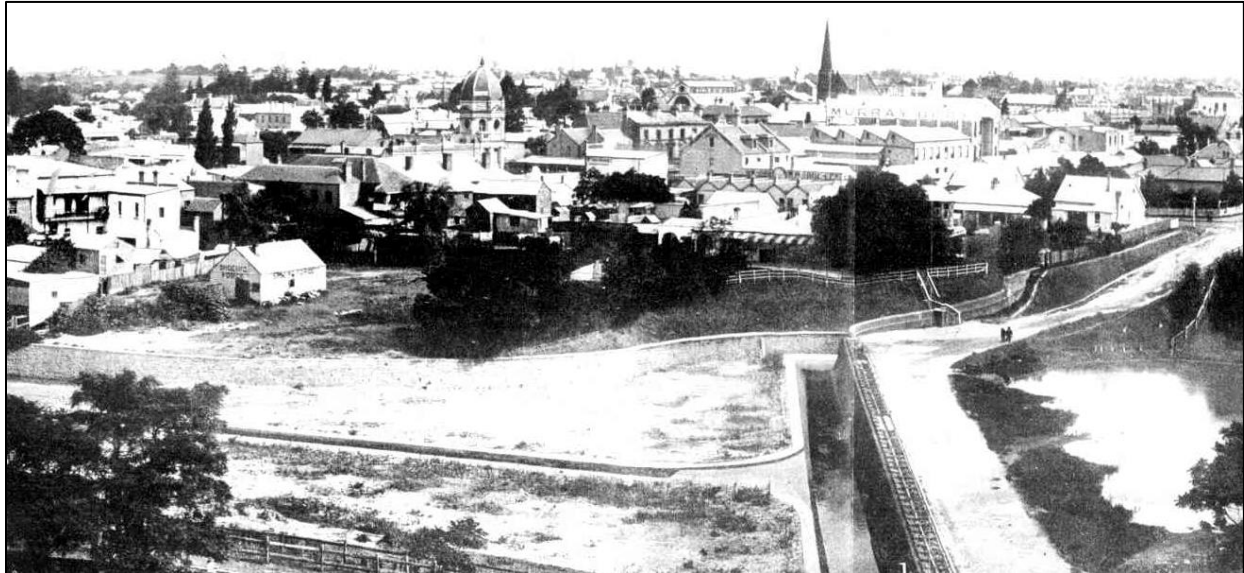
Figure 29: Panoramic view of the southern side of the Parramatta River (*The Cumberland Argus and Fruitgrowers Advocate* 17 December 1904: 1S).

Until 1920, development in Parramatta was slow and no significant changes occurred to the structures within the subject site. A panoramic view of the southern side of the river dating to 1904 shows the new works to the river, as well as structures within the subject site. The structures visible in the photograph (Figure 29) appear to correspond with those present on the 1895 plan of the subject site, including the rear of structures along the Church Street and Phillip Street frontages, the shoeing forge in the western part of Allotment 1A, the rebuilt 'Riverside' residence, 'Niagara' and other buildings along Marsden Street.

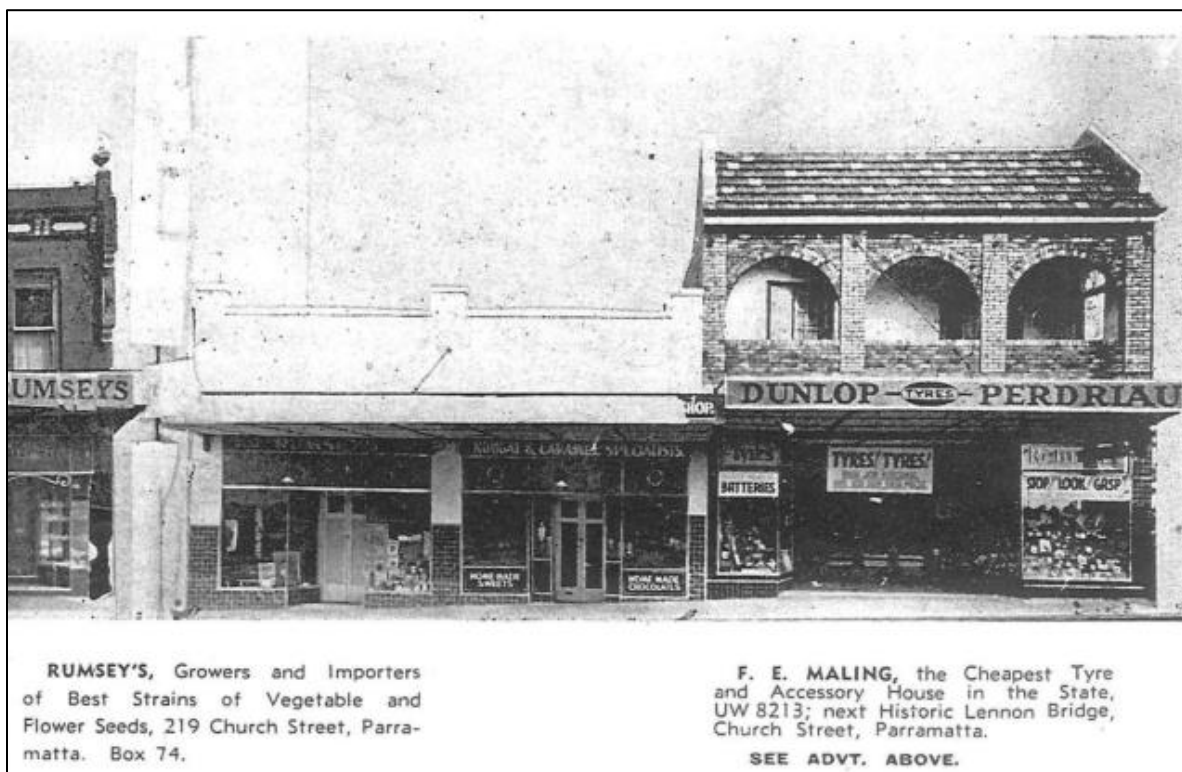
**Figure 30: 333-335 (left) and 337-337A (right) Church Street frontages, prior to the additional of a second storey at 333-335 (AHMS 2011:141)**

Between 1935 and 1938, the structures that had occupied the land at 333-335 Church Street (Items 7 and 10) had been demolished and replaced by a single-storey building that was divided into two shops (Item 31). A second storey was added between 1943 and 1946. Also during the late 1930s, the current building on 337-337A (Item 30) was constructed. Figure 30 shows both buildings, prior to the second-storey addition to the building at 333-335 Church Street.

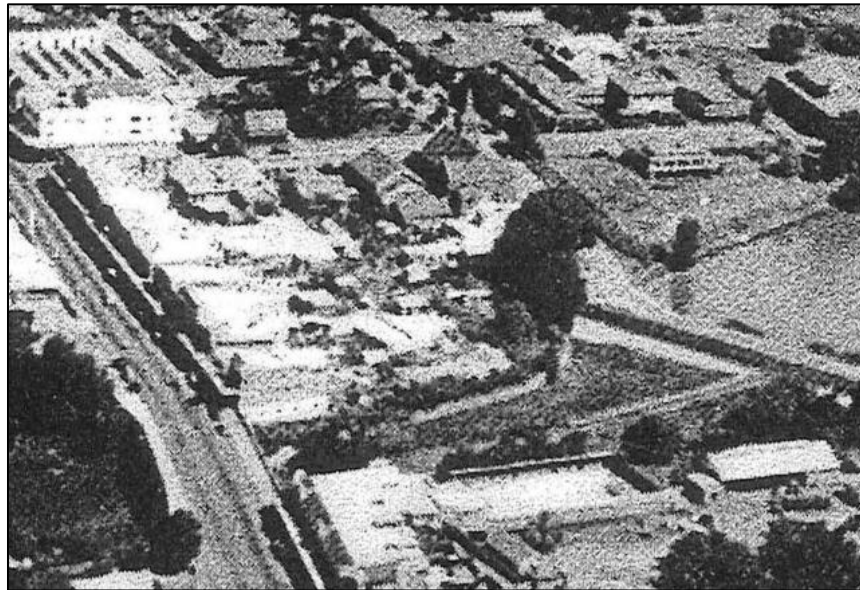
Figure 31: 1938 oblique aerial photograph looking south over the subject site. (AHMS 2011:142)

By 1938, the large area of land to the rear of the street frontages was predominantly occupied by a commercial yard that contained a number of sheds and an office (Items 29, 36, 43, 44, and 45). This site was accessed via a driveway off Church Street to the south of the present 325 Church Street (Figures 31 and 32).

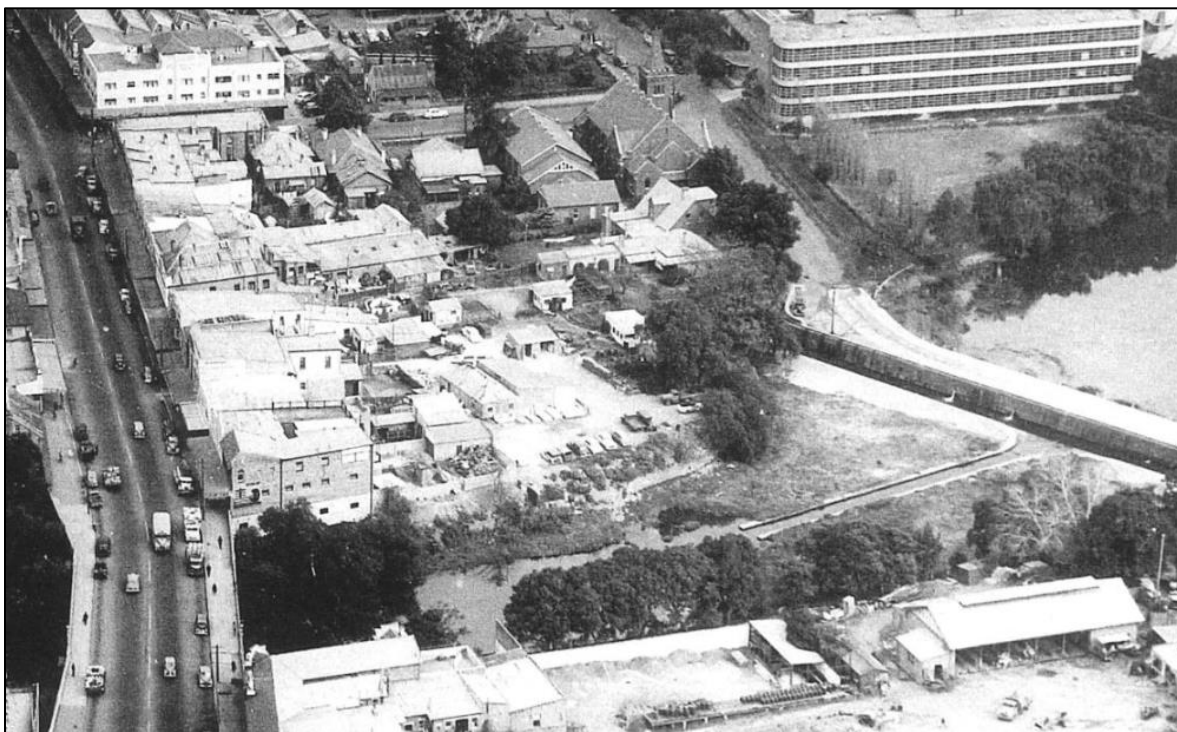
Figure 33: c. 1950 oblique aerial photograph looking south of over the subject site. (AHMS 2011:145)

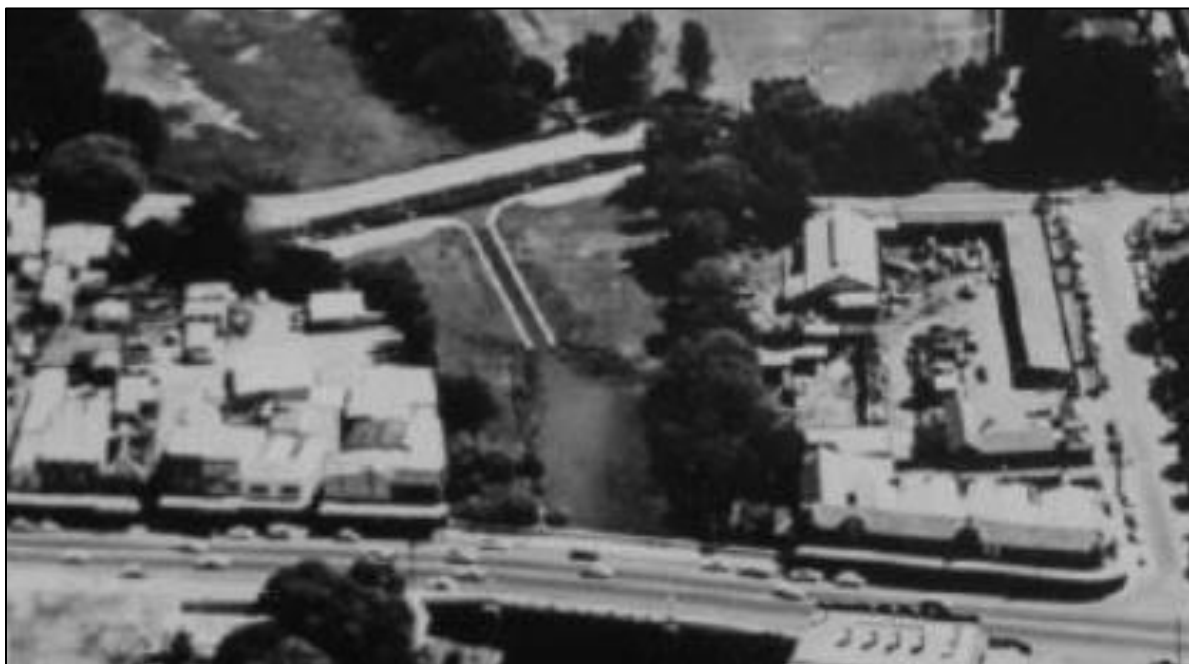
Figure 34: Oblique aerial photo facing west across the subject site. Dated to c. 1950 by the Parramatta Library, but argued to date to c. 1960 by AHMS (2011:146). Church Street and the Lennox Bridge are in the foreground, and the Marsden Street Weir is in the centre (Parramatta Local Studies Library LSOP 420)

Between 1950 and 1961 an additional structure (Item 46) was constructed at the rear of the block forming 333-337A Church Street (Figure 34). The original function of this structure is unknown, but it has housed a series of restaurants in subsequent years (AHMS 2011:141).

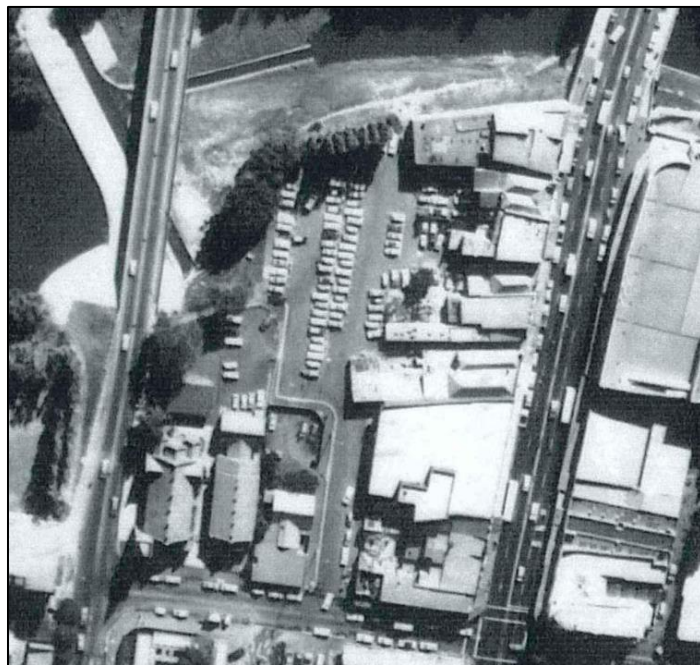
Figure 35: 1972 aerial photograph of the subject site showing the car park to the rear of the street frontages and the new bridge over the Marsden Street weir (from AHMS 2011: 147)

During the 1960s, the current Lennox Bridge car park was constructed in the area to the rear of the buildings along the street frontages. This required the demolition of a residence in Phillip Street to create an access driveway. 'Riverside' was demolished during the same period to accommodate car parking for St Andrew's Church and Hall (Figures 35 and 36).

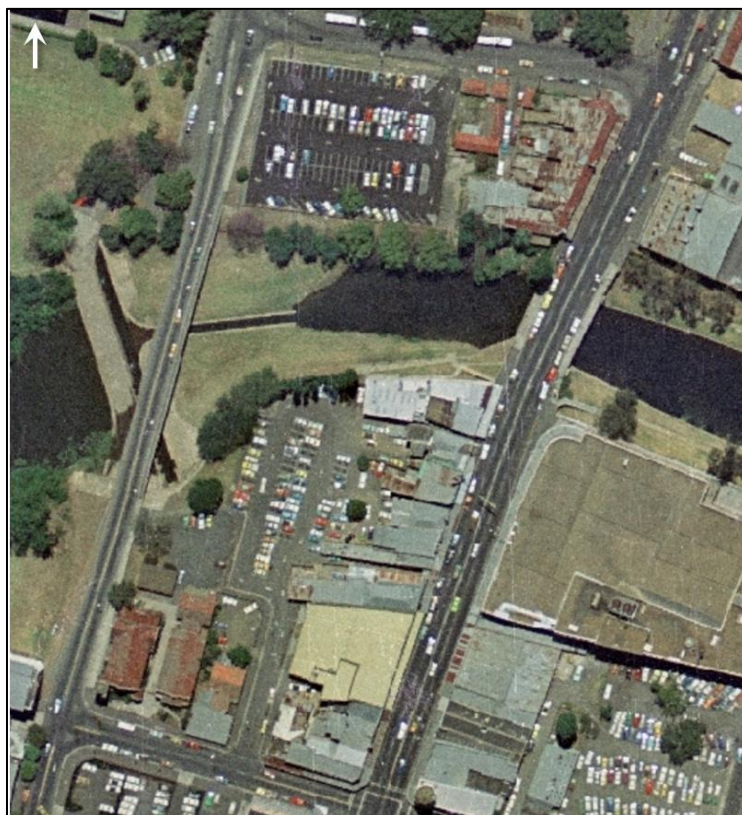
Figure 36: 1978 aerial photograph of the subject site (Parramatta City Library)
