# **Proposed Rural Residential Rezoning Oban Street, Guyra NSW**

## **Preliminary Site Assessment Under Contaminated Land Planning Guidelines**

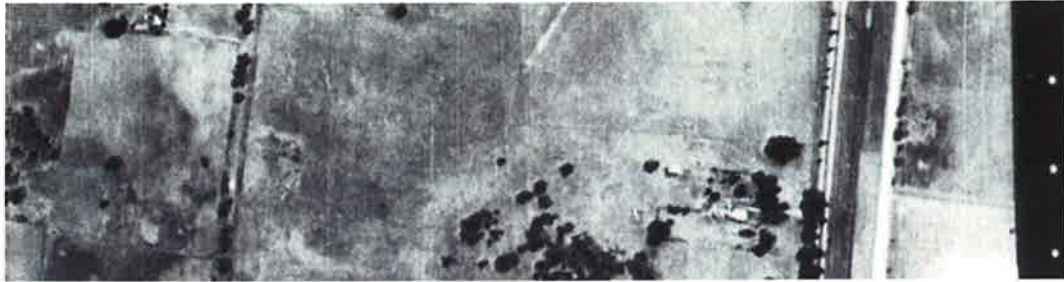
Fig 1 – 1965 Aerial Photo

This shows the land to the west of the ephemeral watercourse as cleared, with woodland to the east of the ephemeral watercourse.

The aerial photograph from 1965 shows a higher level of clearing than the 1970's topographic map; noting these were often based on considerably older aerial photography with limited ground truthing. The current map accords with the current aerial photo evidence.

Of importance is that the older topographic map and the aerial photograph do not indicate any yards, dips or similar features. This accords with information from historical owners.

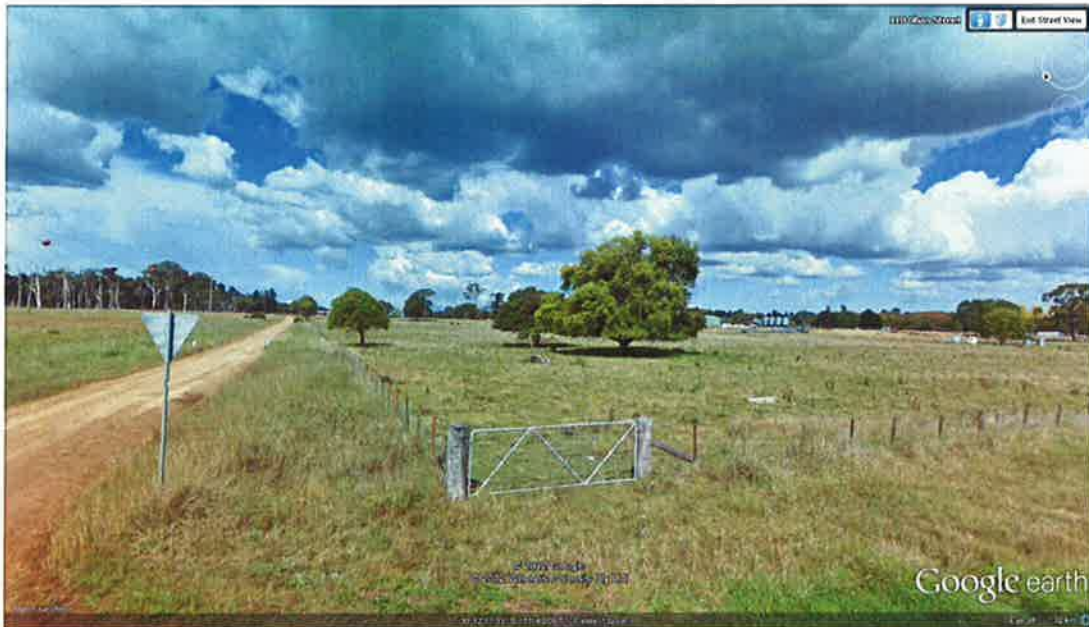
The following photos were taken of the site, showing its use as grazing land.

**Photo 1 – The land from Tuckeys Lane/Oban Street intersection looking South East**
