*Hilsyde, 56 Hilder Street, Elderslie  
Heritage Curtilage Study*

**FOR DBL PROPERTY**

*February 2006*

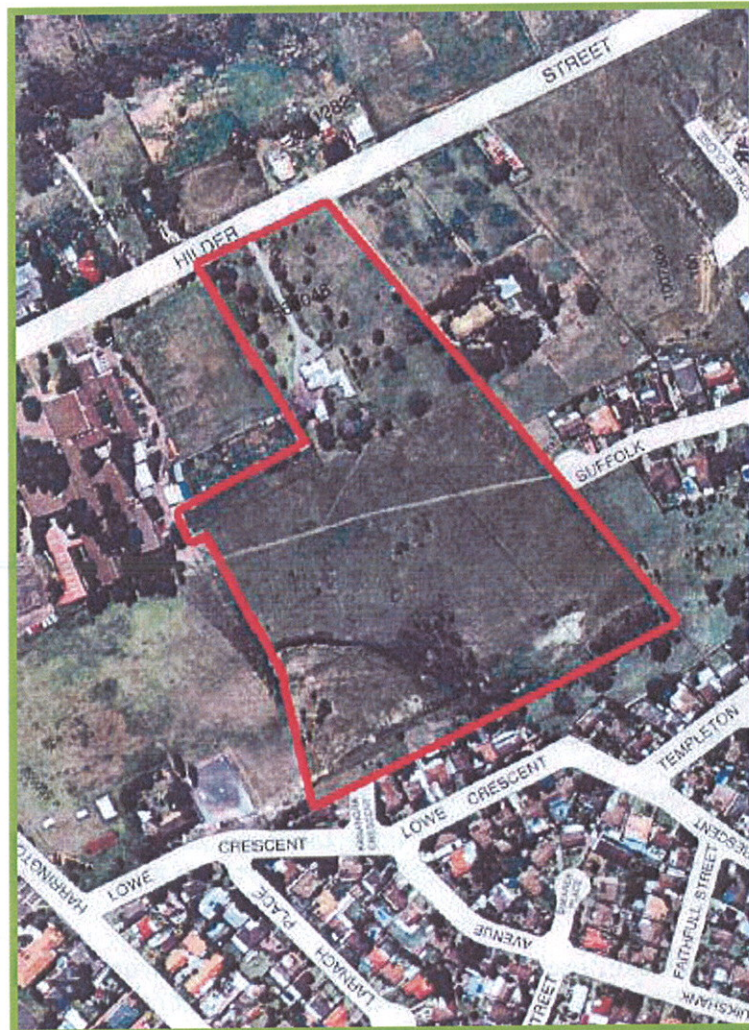
Figure 2: Site boundary<sup>3</sup>

The site is shown on the aerial photograph in Figure 2 below, with the existing property boundary indicated by the red line.

There is a planting of trees along the fence line of all four sides of the house which form a rectangular boundary and provide some screening of the house. This can be seen clearly in the aerial photograph, Figure 2.

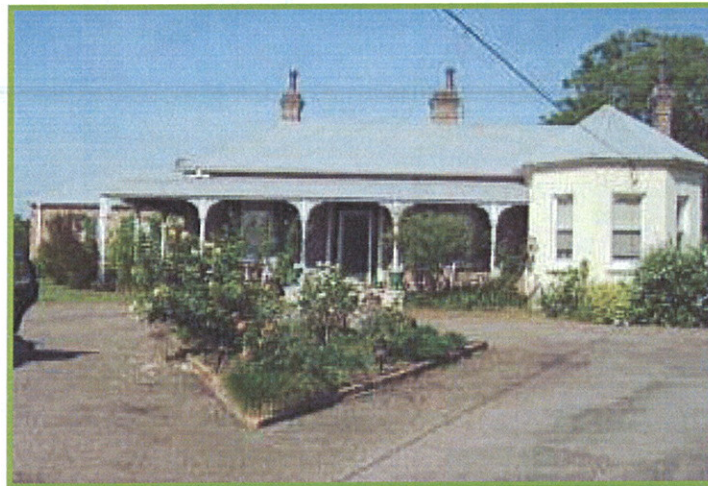
Figure 6 - Hilsyde homestead

The main building on the site is a Victorian single story brick residence. The dwelling has a galvanised iron roof, including a bull-nosed verandah with cast iron columns and brackets<sup>14</sup>.

It has a rendered brick bay window to the north façade, brick chimneys and a glass and timber entrance door with side and highlight windows. The house is in good condition and has had some brick extensions to the rear and a brick garage.

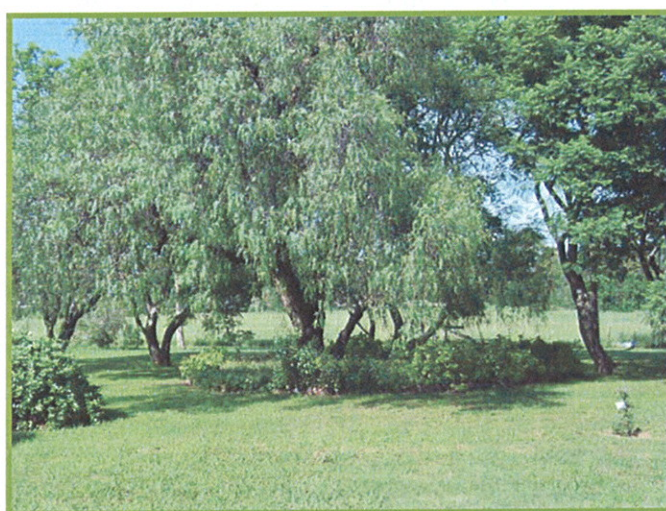
**Figure 8 - Rear garden of house, showing circular shrub planting, trees along back fence line and grassed area beyond back fence line**

To the rear of the house are some garden plantings, including a circular garden feature and a number of large trees.

The property has rural style fencing on the south and north boundaries, and also enclosing the tree boundary to the back of the house. Beyond the rear boundary is an open grassed area which slopes away from the house.

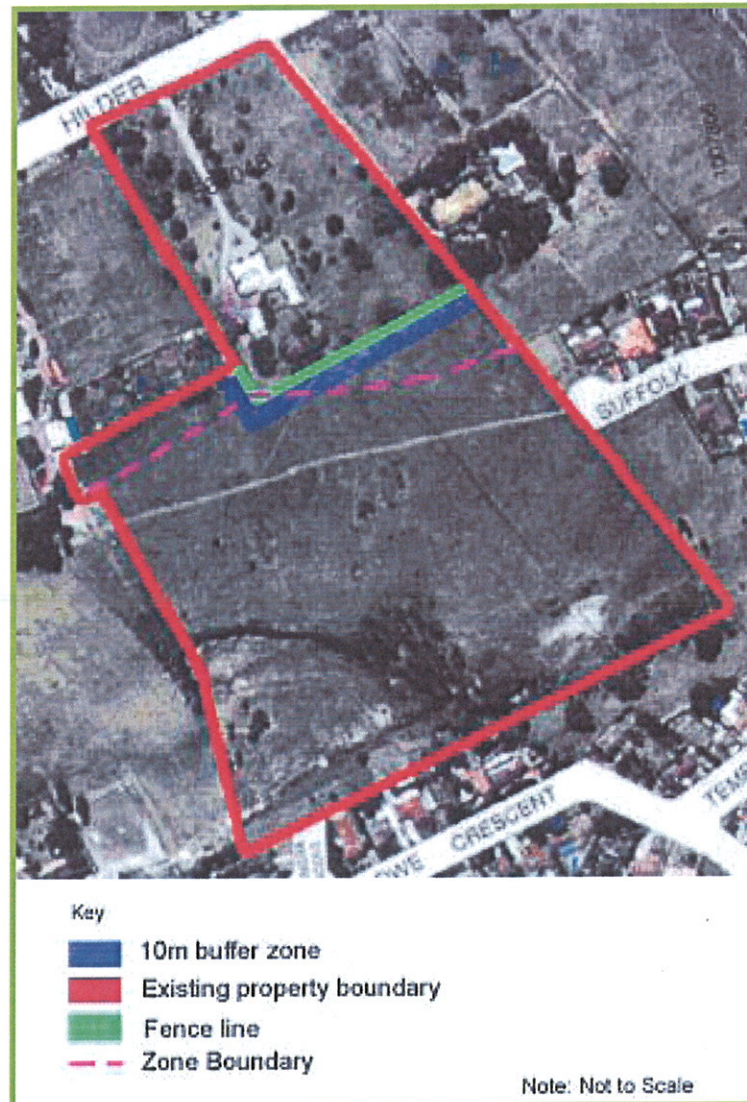
**Figure 9 – Figure showing recommended curtilage management**

If the above mitigation measures were implemented, it is considered that a reduced property boundary could be acceptable. This boundary would be at the existing back fence line and incorporate the perimeter plantings.

The plan in Figure 9 indicates the recommended curtilage management.

It is considered that this buffer zone should be in the order of 8-10 metres and should include vegetation suitable to screen the new development and maintain the natural surrounds of the house which contribute to its setting.

Beyond the vegetation buffer zone, a fence sympathetic in form and materials to the rural character of the area would provide further screening of the house from any proposed developments.

- A buffer zone of 8-10 metres should be established between the existing back fence line and the new development;
  - This buffer zone should provide a vegetation screening of the development;

- A fence of form and materials consistent with the rural nature of the area should be constructed where the buffer zone meets the new development; and
