**Telstra Corporation
Limited**

Report for Phase 1 and 2
Contamination Assessment,
8 O'Connell Street and
83-89 Marius Street, Tamworth

May 2007

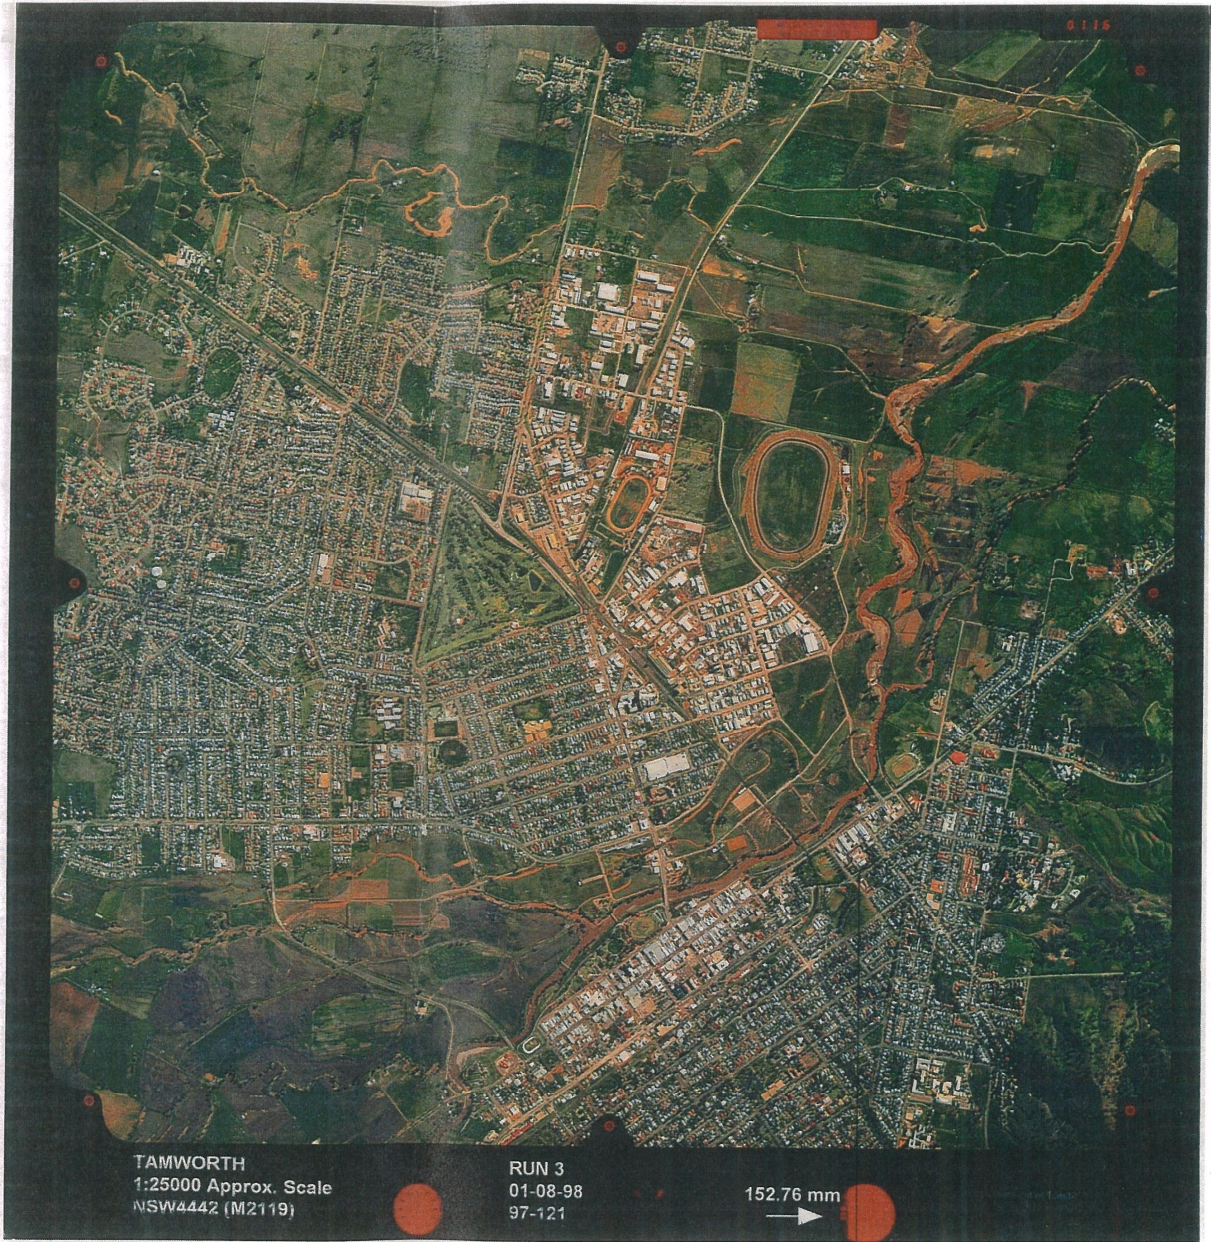
1998 Aerial Photograph

Photograph	Observations
01/08/1998	Site Observations
Run: 3	The site appears relatively unchanged from 1989. The demountable training room and an outdoor storage area are situated in the same configuration as observed during the site inspection.
Film: NSW4442	Site Surrounds Observations
	The surrounding land use appears relatively unchanged from 1989 with the exception of additional buildings located northwest and southwest of the site.
17/09/2004	Site Observations
Run: 2	The site appears largely unchanged from 1998.
Film: NSW4871	Site Surrounds Observations
	The surrounding land use appears largely unchanged from 1998.

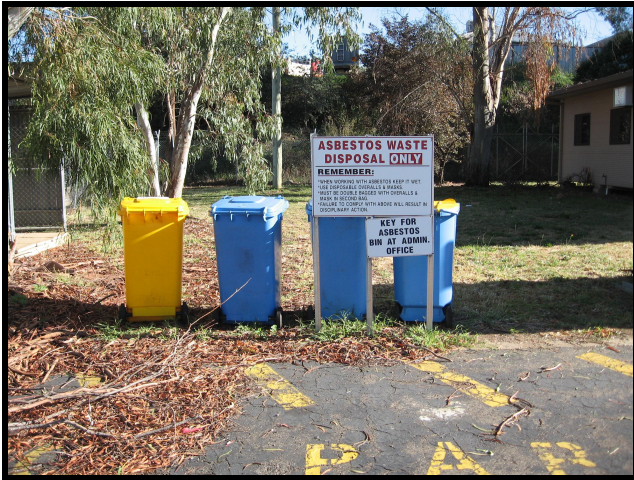
A covered steel garbage bin labelled 'asbestos waste' was observed on the northern side of the site between the metal classroom and air cylinder storage bund.

Photograph 1: Asbestos storage area

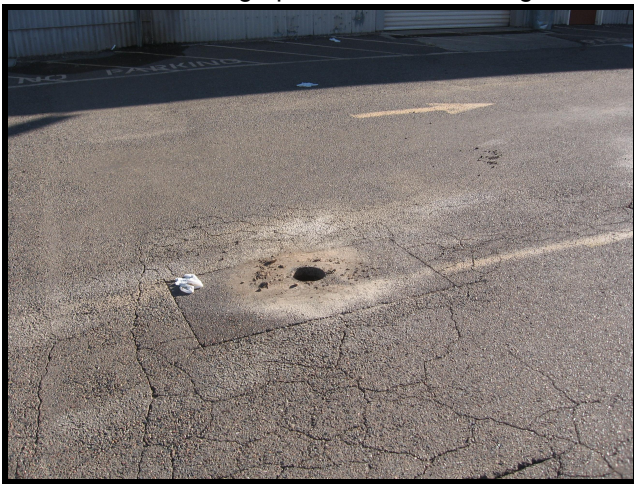
Volatile organic compound readings for all soil samples collected ranged from 2 ppm to 4.5 ppm. GHD notes that these concentrations are relatively low and do not generally indicate the presence of significant concentrations of volatile compounds. Despite these readings, a strong hydrocarbon odour was noted by GHD field personnel during augering and sampling at BH18.

- ▶ All other parameters for sample BH18-1 and its duplicate pair BH18-2 were well within the acceptable range (i.e., the next highest RPD was 16%), as were the RPDs for all other samples and parameters;
- ▶ The heterogeneous gravel stratigraphy may have caused the variable result; and
- ▶ The relatively high concentration of Total TPH in the sample and duplicate may have caused the variable result.

Photograph 3: BH18

In addition to the remediation of the area at BH18, it is recommended that:

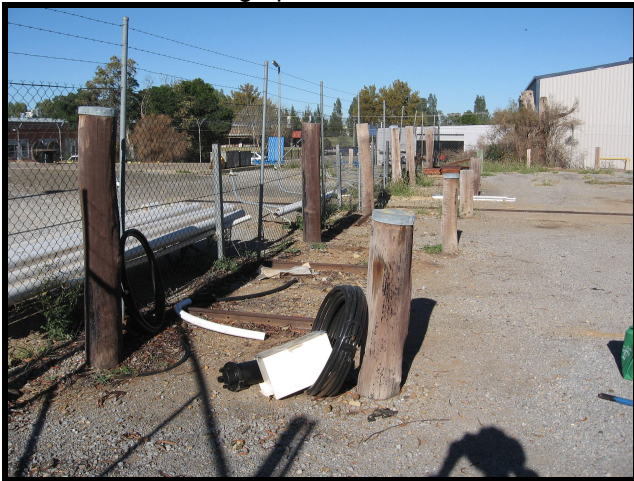
Photograph 5: Telegraph pole storage area

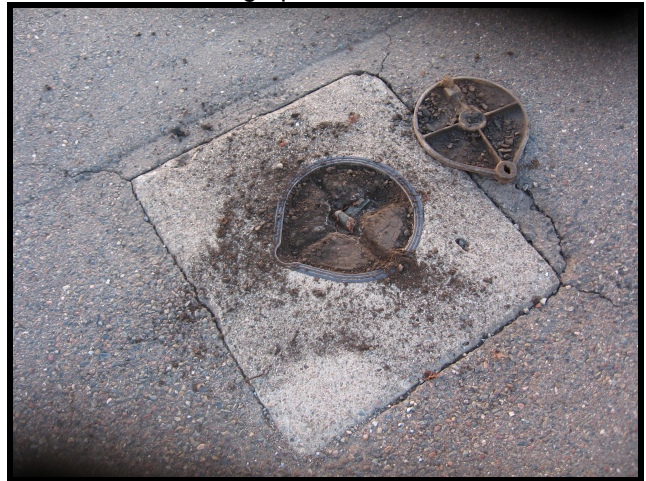
- No visual or olfactory observations of hydrocarbon impact were noted in four boreholes advanced in the vicinity of the UST up to 3 m below ground level. CH2MHill considers it unlikely that the surrounding soils have been significantly impacted by the contents of the decommissioned petrol UST, however, the report states that there may be a small quantity of soil adjacent and below the tank that has been impacted from leaks or spills from the tank that could not be assessed during fieldwork;

No hazardous materials were encountered during the site inspection, however a filler valve for an Underground Storage Tank (UST) was observed between the brick office building and the metal warehouse.

Photograph 6: UST cap

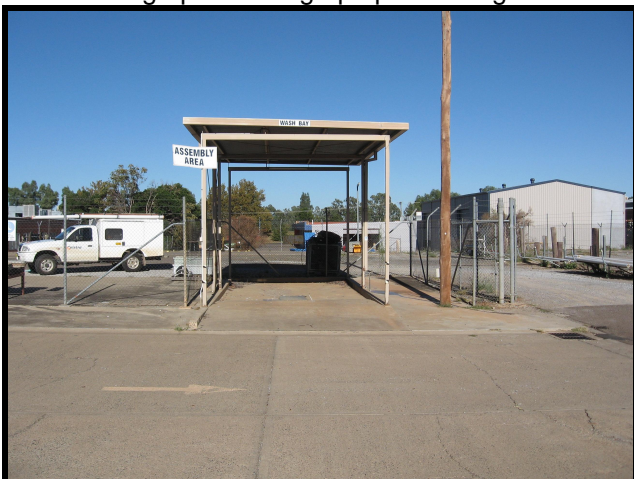
- CH2MHill considers the risk to groundwater from potential UST leaks or spills is small;
 - No surface hydrocarbon staining or cracks were observed in concrete in the vicinity of the washbay. CH2MHill considers it unlikely that the soils in the vicinity of the washbay have been significantly impacted; and

Photograph 7: Washbay

- CH2MHill recommends that a Remedial Action Plan (RAP) is prepared to decommission the washbay; and
 - The RAP should address issues including:
 - Sampling/testing the contents of the tank,

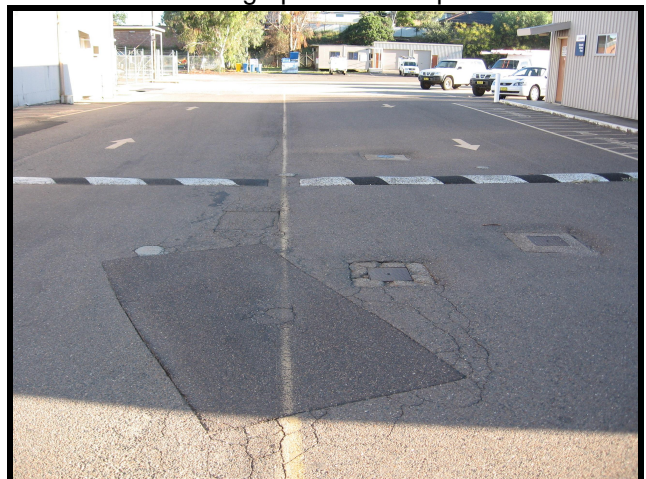
Photograph 8: Approximate location of old bowsers
