Monterey Equity Pty Ltd

Contamination Assessment:
Lot 2, DP857520,
119 Barton Street, Monterey, NSW

P1706332JR01V01
March 2018

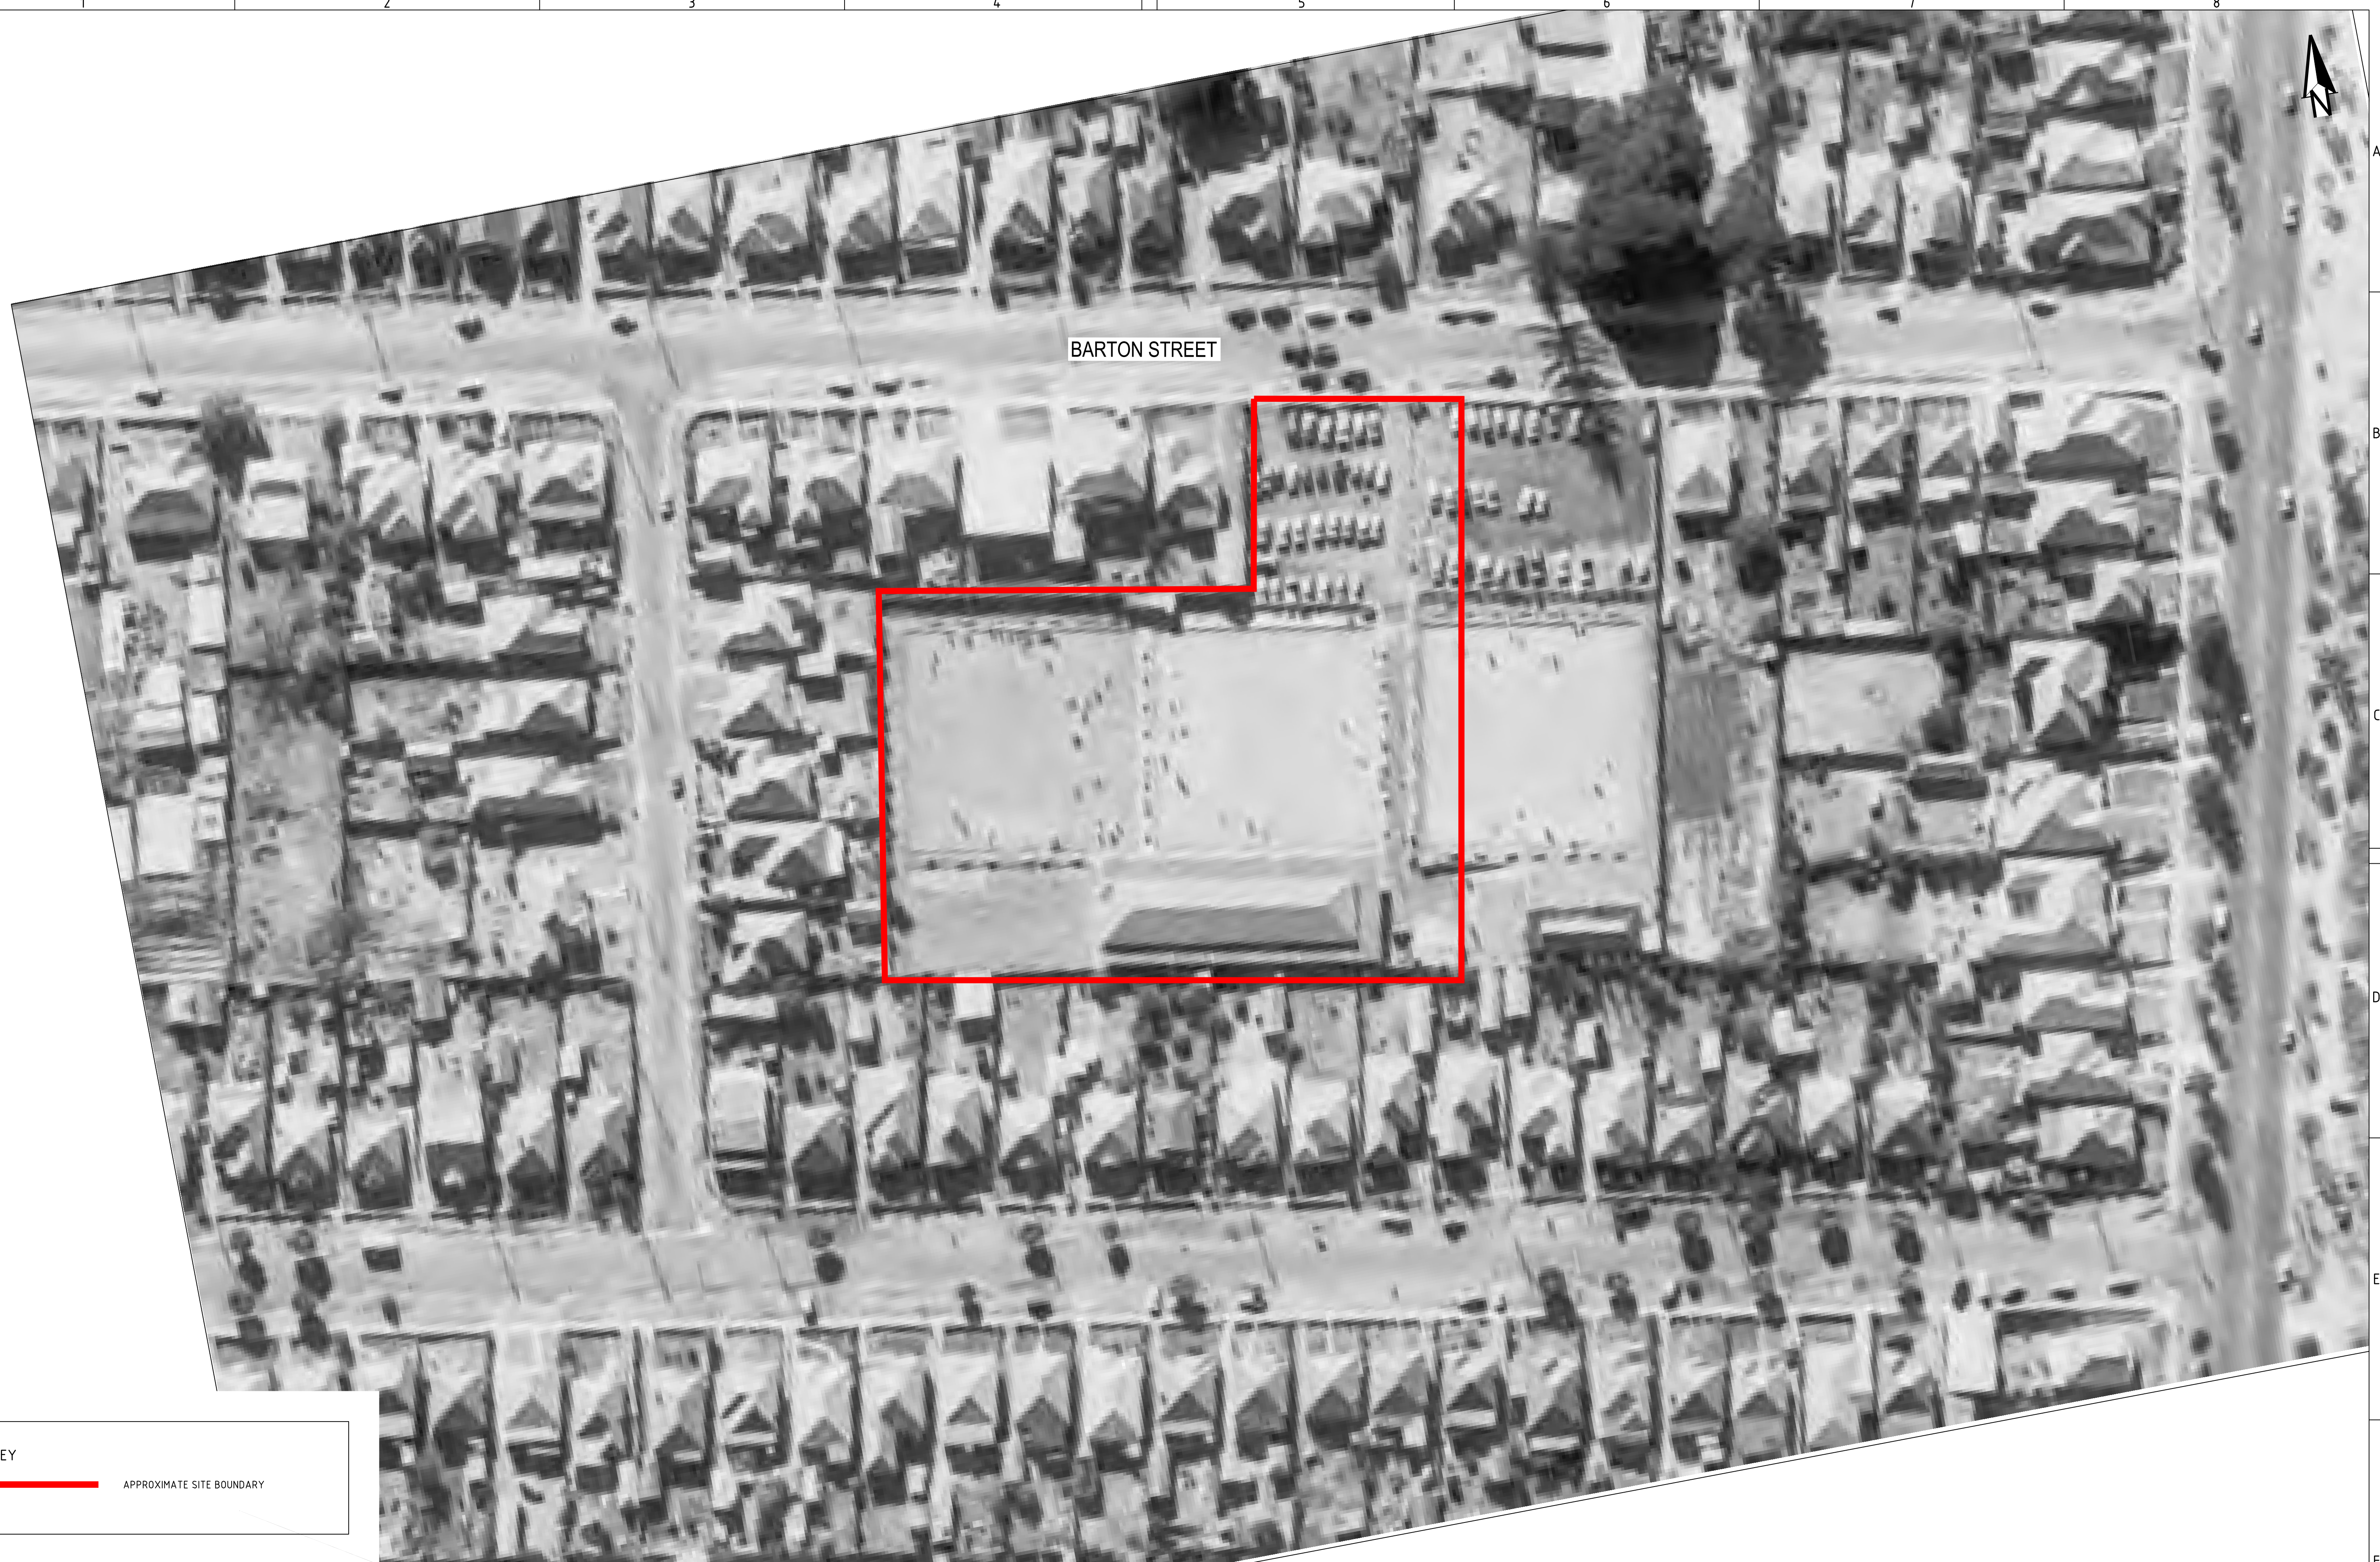
DRAWING TITLE				
HISTORICAL AERIAL 1961 SOURCE: LPI				
PROJECT NO.	PLANSET NO.	RELEASE NO.	DRAWING NO.	REVISION
P1706332	PS01	R02	PS01-AZ02	B

Year	Site	Surrounding Land Use
1943	The site appears unused, a potential pond (approximately 1500 m ²) is present in the eastern portion of the site. Rest of the site has scattered bushes and is undeveloped.	Residential properties to the north, east and south. Cleared, vacant land to the west and south east of the site.
1961	Site has been developed into bowling greens with bowling club in the southern portion of the site and carpark in the northern portion of the site.	Lot immediately east of the site is also being used as part of the bowling green development. Continued residential development in all directions.
1975	Little change from previous.	Little change from previous.
1991	Little change from previous.	Little change from previous.
2009	Bowling green area along the eastern boundary has been redeveloped into additional carpark space.	Lot immediately east of the site (previously part of the bowling green) has been redeveloped into residential housing.

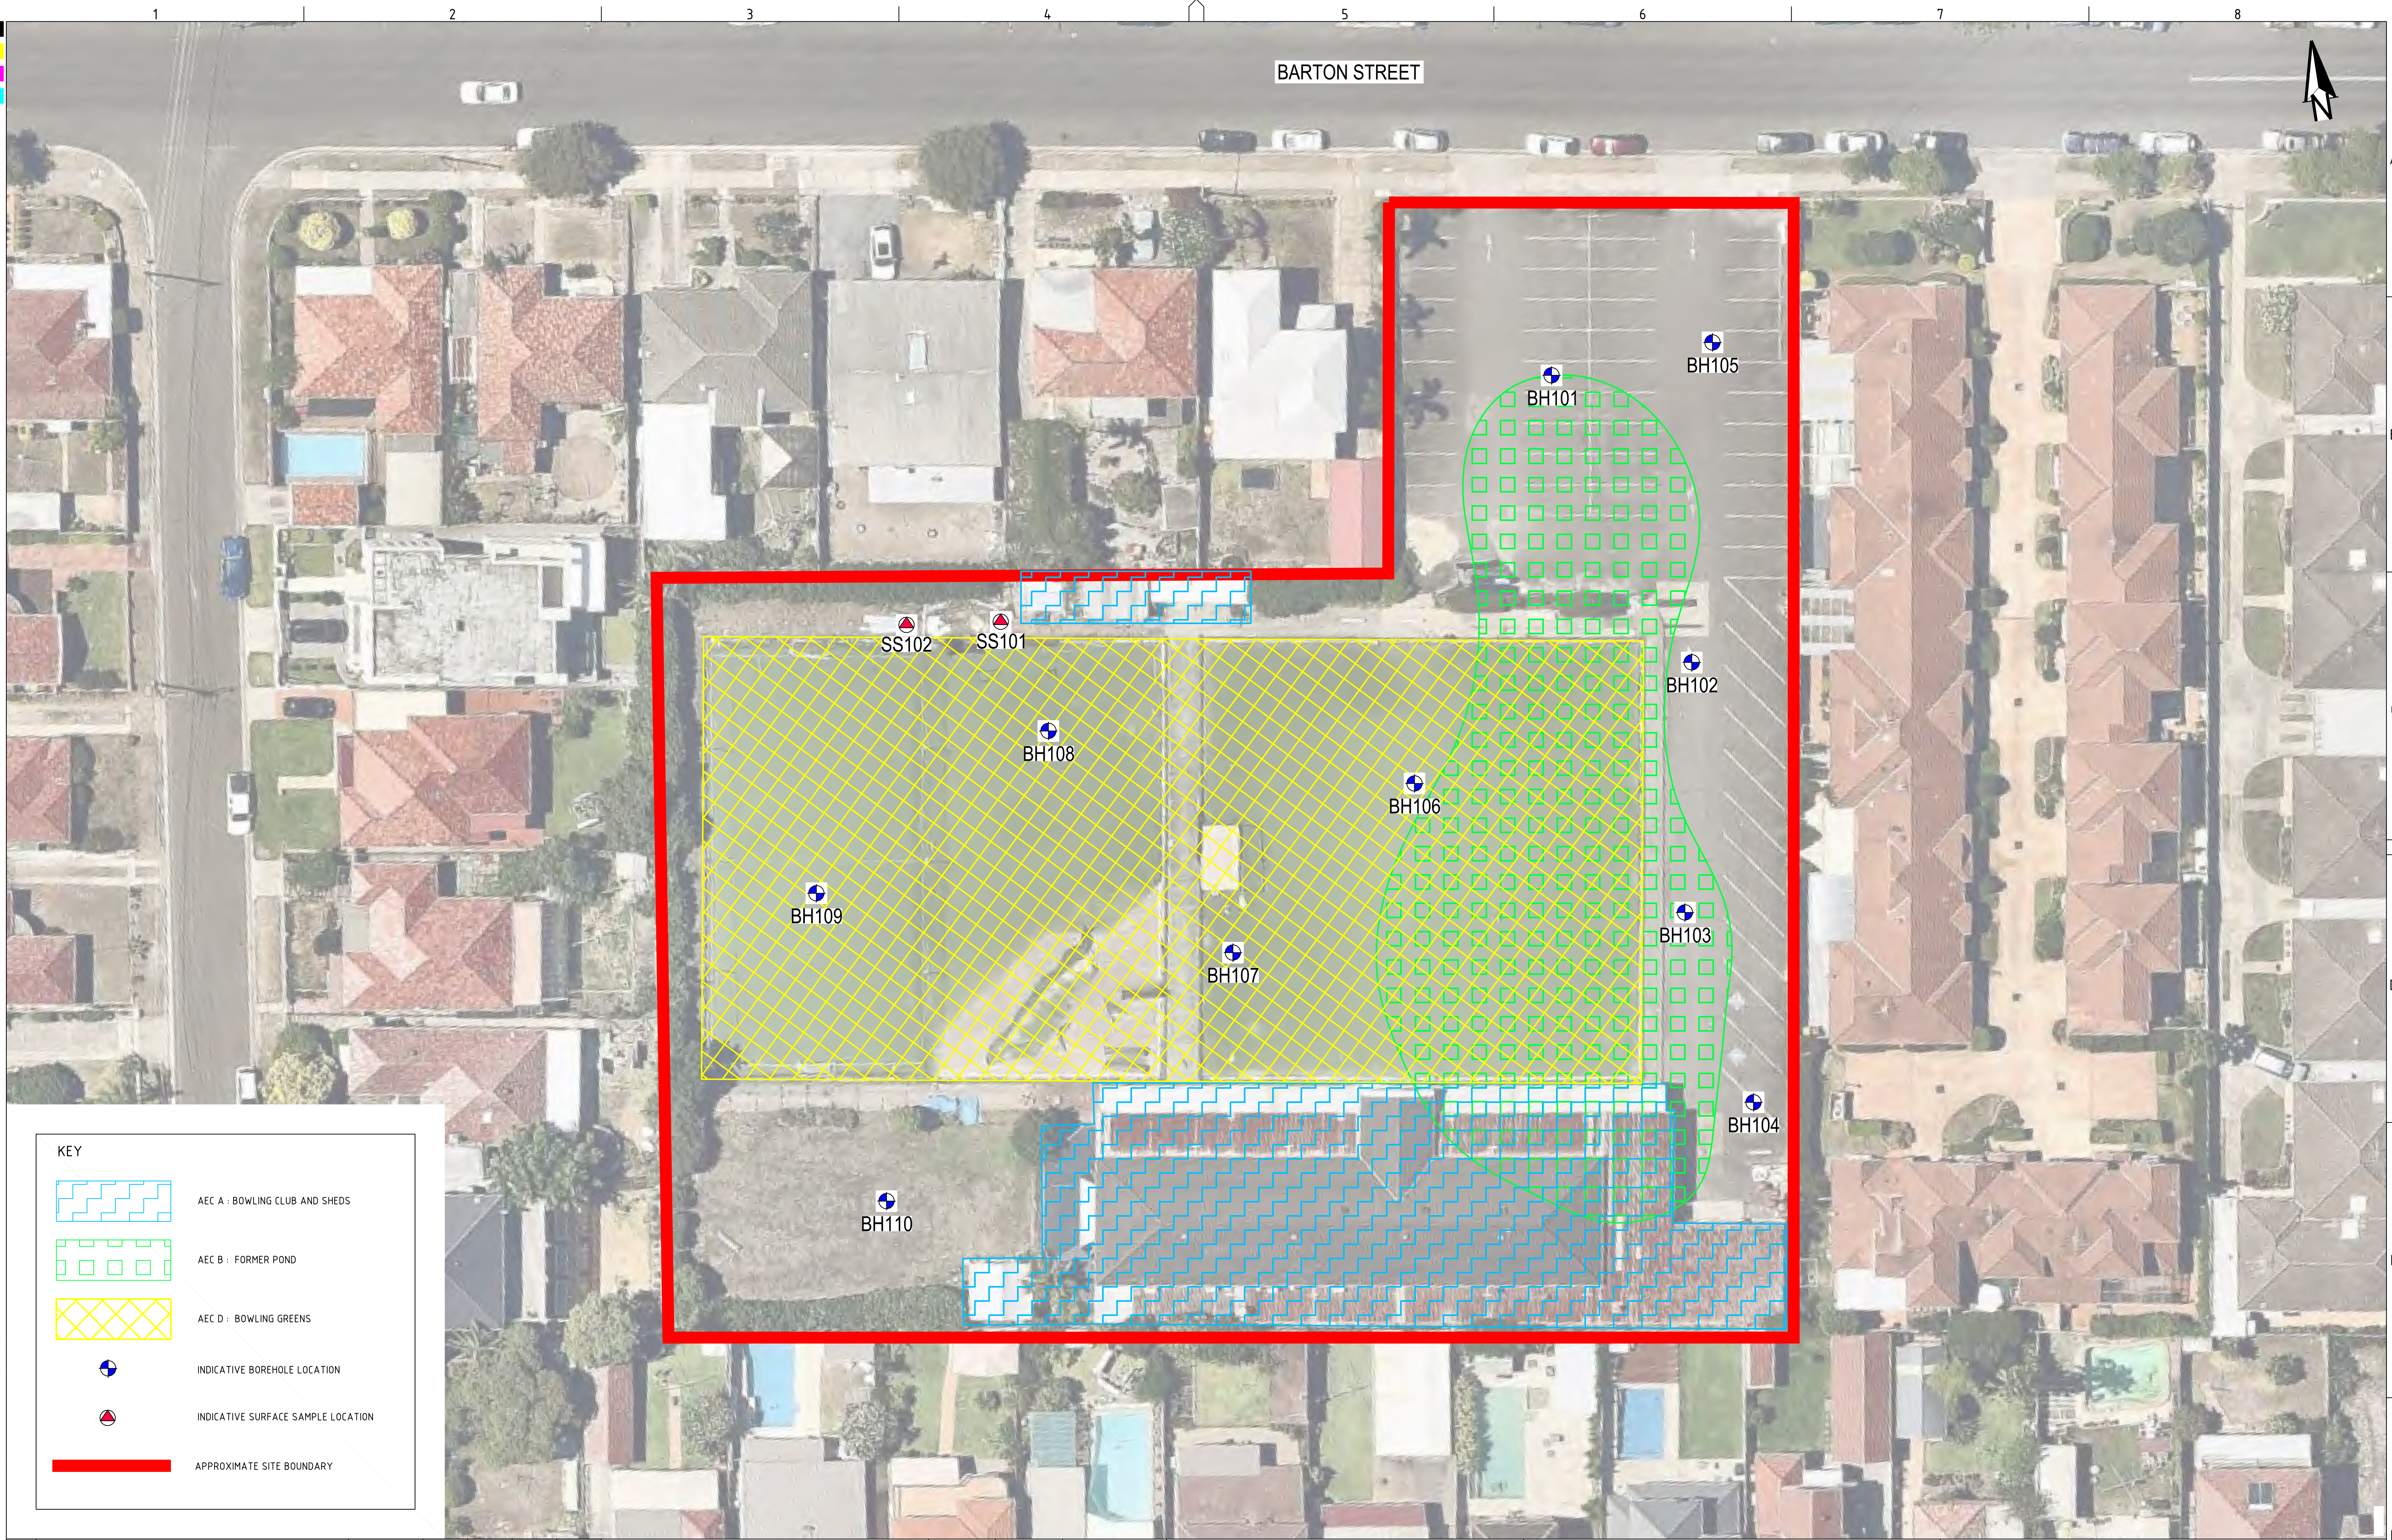
AEC A - BOWLING CLUB AND SHEDS

Soil sample 6332/BH101/1.5 (with SAC exceedances for heavy metals and PAH) was located within fill material underlying the existing carpark. Elevated contaminant concentrations are likely a result of anthropogenic material within the uncontrolled fill. Based on site testing, contamination was observed to be limited to this fill layer underlying the carpark. Soil sample 6332/BH101/2.0, located within natural soils beneath the contaminated layer was found to be below all adopted SAC.

No other exceedances of SAC were observed within fill material underlying the existing bowling greens or grassed area to the west of the bowling club.

It is noted that, due to access restrictions, soils underlying the existing bowling club at the site (AEC A) have not been tested. It is recommended that additional assessment and sampling of this AEC is undertaken following demolition of the existing structures. This can be completed during the remediation stage.

SAC exceedances for heavy metals (lead, copper and zinc) and PAHs (benzo(a)pyrene and carcinogenic PAHs) were observed within fill material at one sampling location (6332/BH101/1.5), which may pose a potential risk to future human and environmental receptors at the site. It is recommended that a remedial action plan (RAP) be prepared for the site to address SAC exceedances within fill underlying the existing carpark at the site.
