**re: Proposed Residential Development  
Castle Road, Orchard Hills North  
Preliminary Geotechnical Investigation Report**

**PROPOSED RESIDENTIAL DEVELOPMENT of LAND LOCATED at  
CADDENS ROAD, KINGSWOOD ROAD and CASTLE ROAD,  
ORCHARD HILLS NORTH**

**PRELIMINARY GEOTECHNICAL INVESTIGATION REPORT**

**REPORT NO 14447/1-AC 1 DECEMBER 2021**

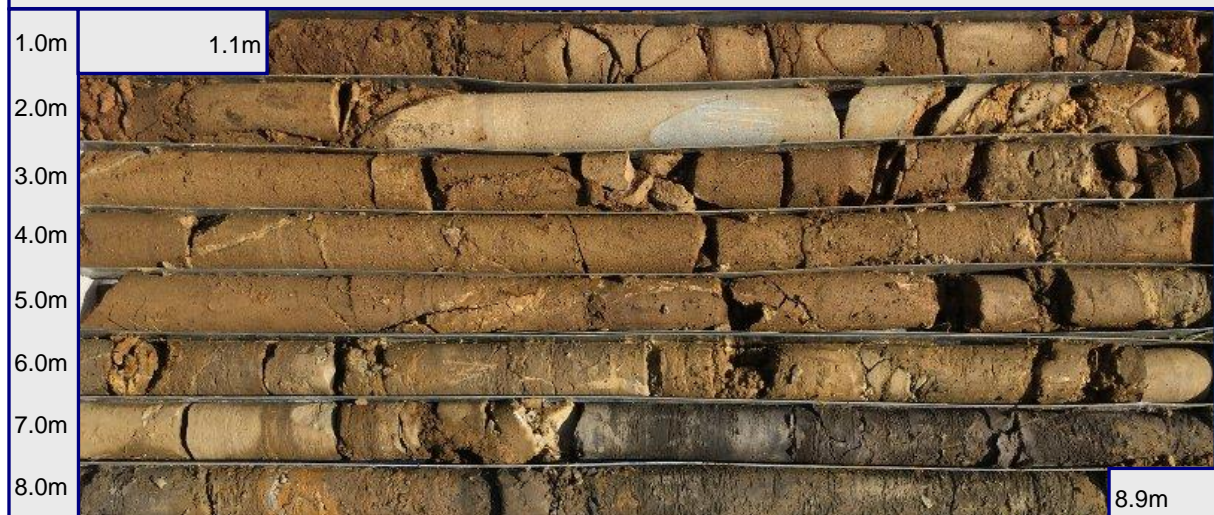
Job No 14447/1 BH1 Started Coring at 1.1m

BH1 terminated at 8.9m

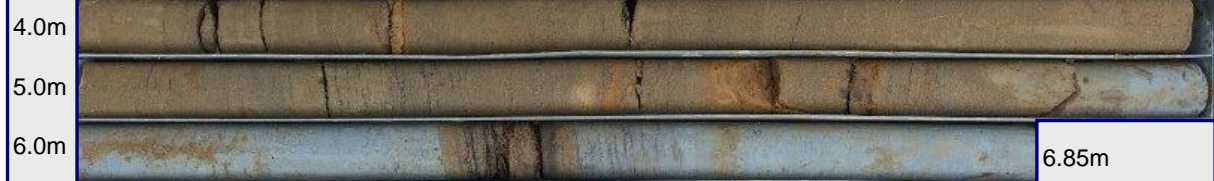
Job No 14447/1 BH6 Started Coring at 4.0m

BH6 terminated at 6.85m
