Staged Development Application  
Sisters of St Joseph  
**former Farmhouse Building**  
**64 Mackillop Drive**  
Baulkham Hills, NSW

## Heritage Impact Statement

**November 2010**  
**REF: 0732: HIS**  
**Issue 02**

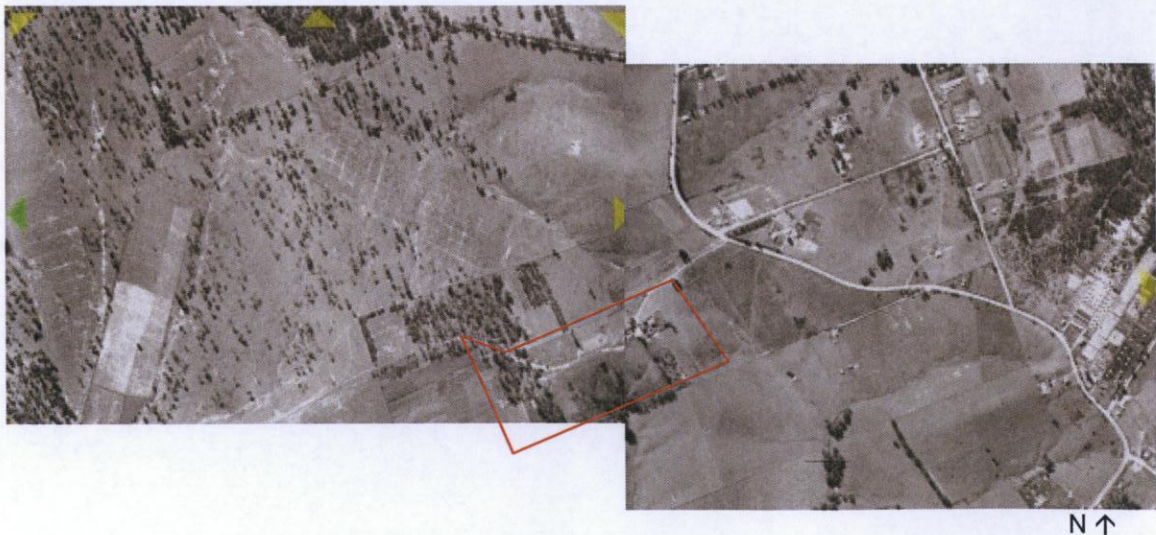
Figure 4: 1943 RTA aerial photograph of the area around and including the subject site. The approximate extent of the existing Sisters of St Joseph site is marked in red.

RTA aerial photographs of the area taken in 1943 indicate the early rural character of the Sisters of St Joseph site and the surrounding area. The photographs clearly show the former Farmhouse building and outbuildings and provide evidence of the early tracks through the property. The existing tree lined avenue is generally located along the same alignment of the early track through the property. The Novitiates began planting out and tending to the tree lined avenue in 1957. The aerial also shows that the original entry to the property near the Farmhouse was in the north-east corner of the site.

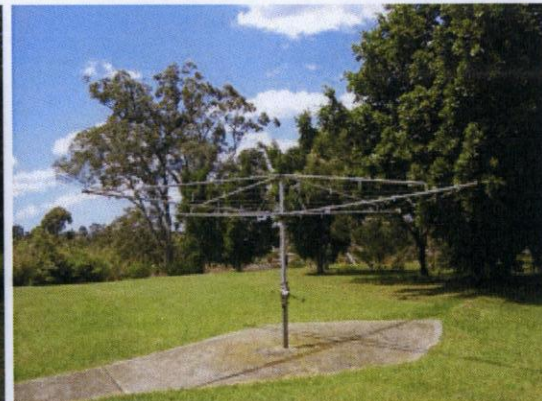
Figure 21: Clothesline with concrete path leading from the southern elevation of the former Farmhouse.

A concrete path runs around the building abutting the base of the building. A concrete path branches off to the clothesline on the southern side of the former Farmhouse.

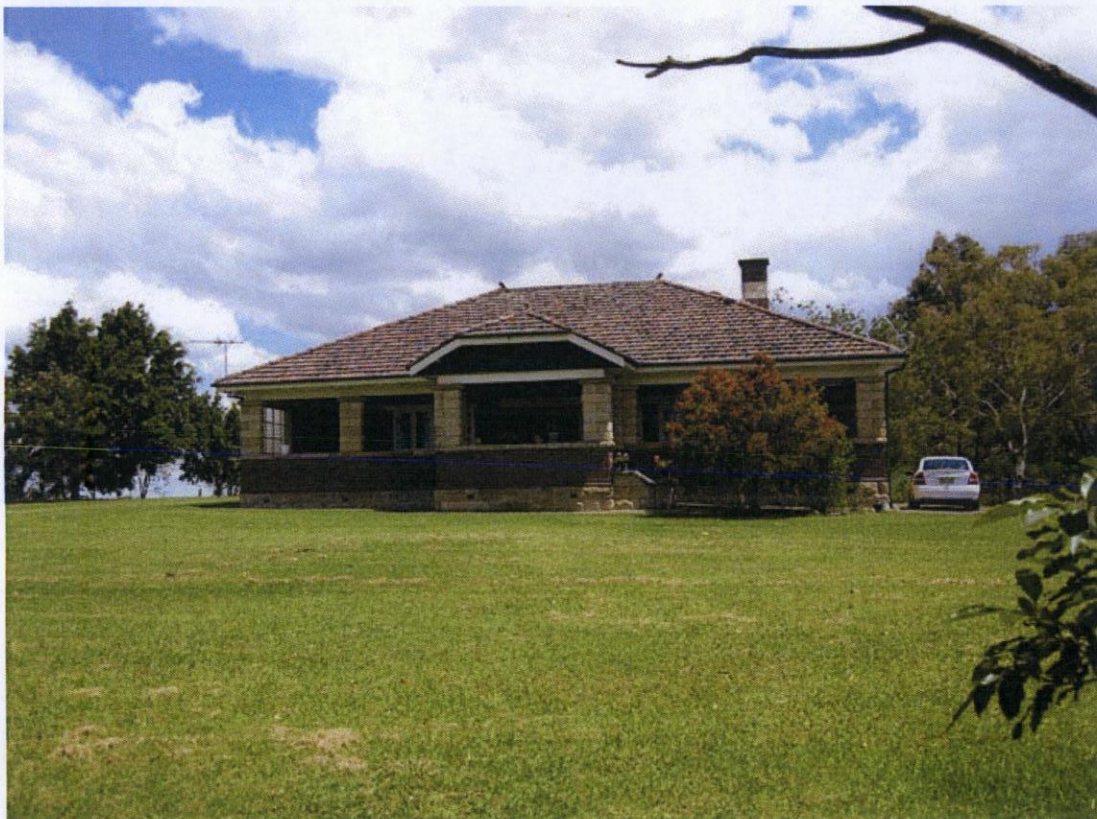
Figure 25: Front (east) elevation of the former Farmhouse.

The former Farmhouse building is a symmetrical, single storey, Inter-War period California Bungalow style brick residence constructed in c1930. The original house is generally square with a small rectangular building to the rear of the house which was later connected to the main building by an enclosed brick courtyard. The house has a front verandah which sits under the main roof. It has a central projection and returns part way along the north elevation. Visual inspection of the fabric suggests that the verandah also returned part way along the south elevation but this section was infilled at some stage. The former Farmhouse has a tiled, hipped roof with a flat topped brick and stucco chimney. A tiled mansard roof with timber shingled end is located over the central verandah projection.

The building is of face brick laid in a standard running (also known as stretcher) bond with sandstone footings and sandstone columns to the verandah. A header course of bricks laid in a soldier bond runs around the building.

A set of stairs lead up from the concrete path adjacent the driveway onto the northern side of the central projection of the verandah. The stairs have a skewed sandstone balustrade on the eastern side. The verandah floor and stairs are covered with pebblecrete.

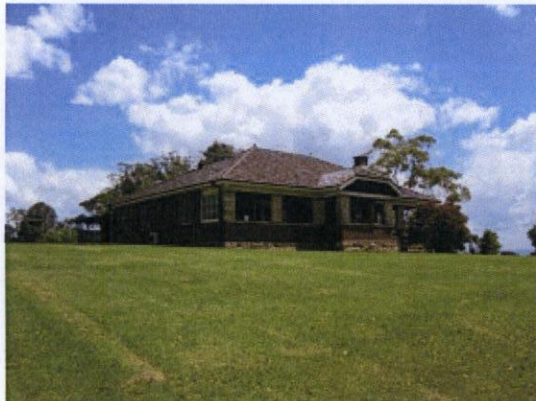
Figure 26: East (front) and south elevations of the former Farmhouse.

The building as a whole is in good condition and retains high integrity and fair intactness. Additions to the building have been added sympathetically and do not detract from the significance of the building.

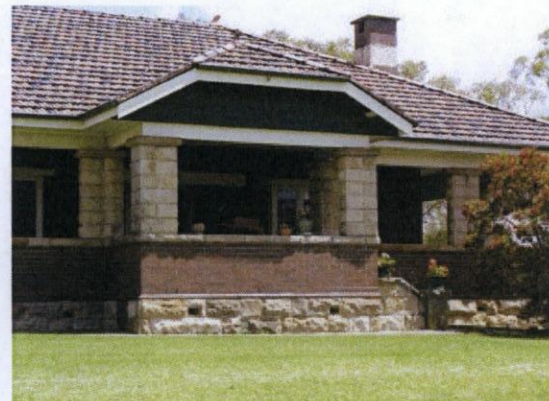
Figure 27: Detail of central verandah projection.

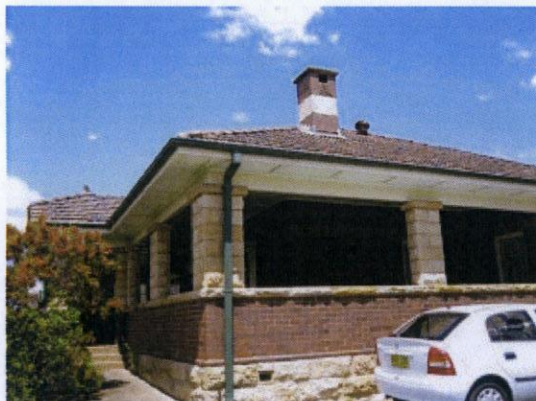
Figure 28: North elevation showing verandah stairs (to the left of frame) and chimney.

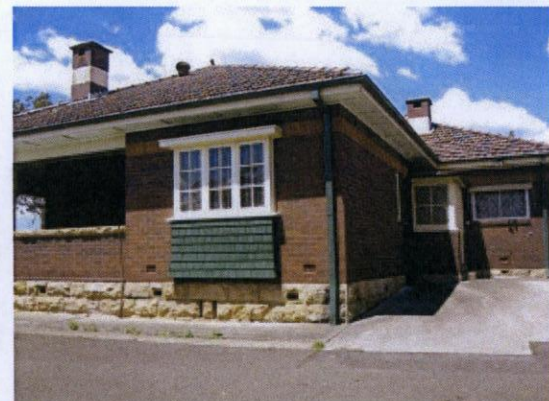
Figure 29: Detail of window at the end of the verandah on the north elevation with shingled bay.

The main entry door is glazed and timber panelled with sidelight and highlight windows. The leadlight glass in the door, side and highlight windows has a kookaburra motif. Tapered Doric columns flank the doorway and support the sandstone head. Four-bay decorative leadlight timber framed casement windows are located on the front elevation to the south of the front door. Three-bay decorative leadlight timber framed casement windows are located on the front elevation to the north of the front door. These windows have a projecting window frame which is mounted on the external wall with a decorative brick "sill" underneath. A three-bay timber framed window with multi-paned casement sashes and shingled bay is located on the north

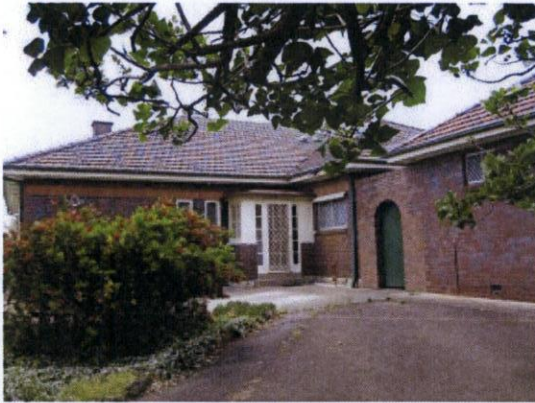
Figure 30: View to rear entry and enclosed courtyard linking the rear addition to the main house.

elevation. Many of the windows throughout the residence, particularly to the rear of the building, have been replaced with aluminium framed windows. An enclosed portico entrance is located to the rear of the main residence off the driveway on the north elevation of the building.

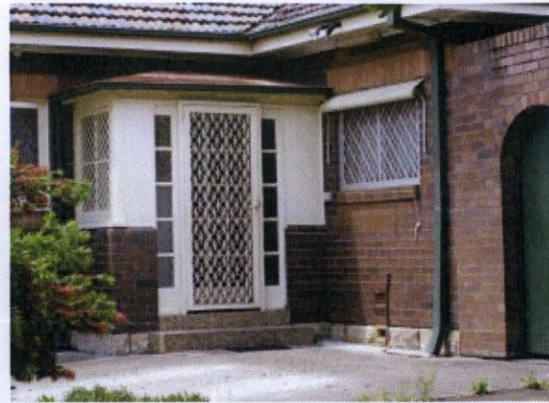
Figure 31: Detail of rear entry enclosed portico.

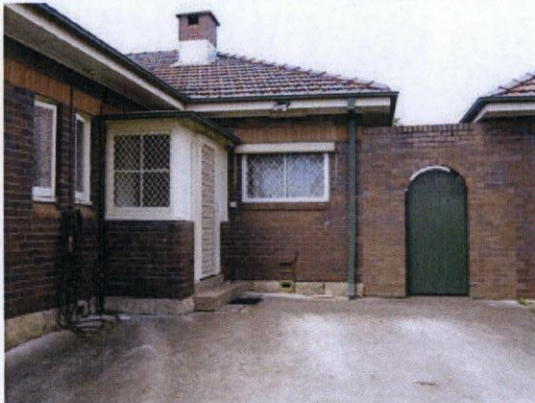
Figure 32: North elevation of rear entry and enclosed courtyard linking the rear addition to the main house.

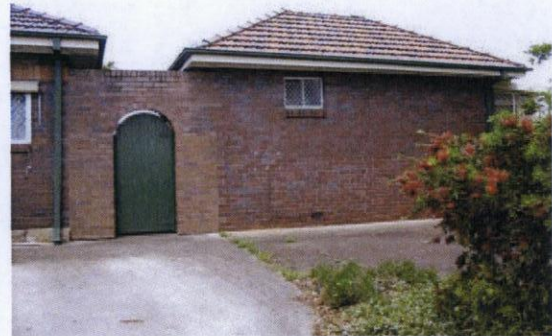
Figure 33: Enclosed courtyard and rear addition.

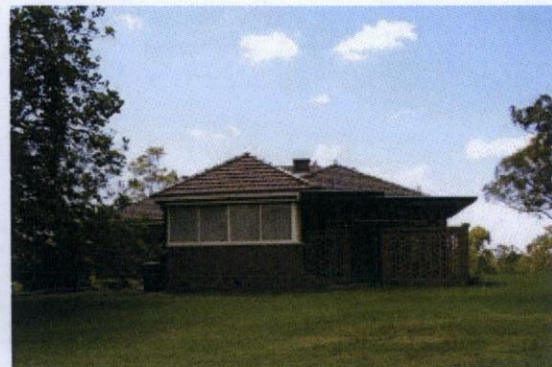
Figure 35: West elevation of the former Farmhouse.

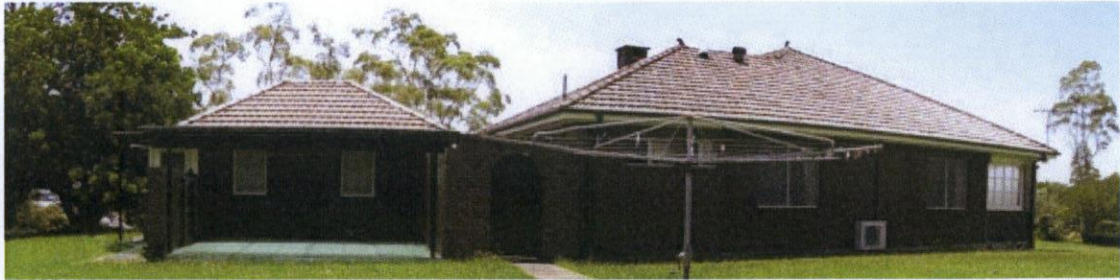
Figure 36: South elevation of the former Farmhouse building showing the rear addition.

The brick structure to the rear of the main residence is accessed via the enclosed courtyard or externally on the south elevation. It has a partially enclosed patio space on the south elevation. It appears that this structure may have been original to the house.

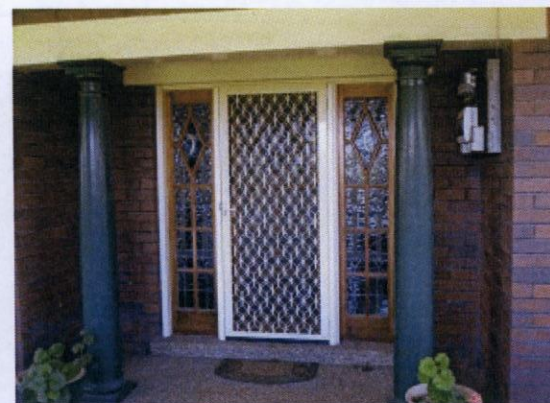
Figure 40: Front entry door with Kookaburra motif and Doric columns flanking the doorway.

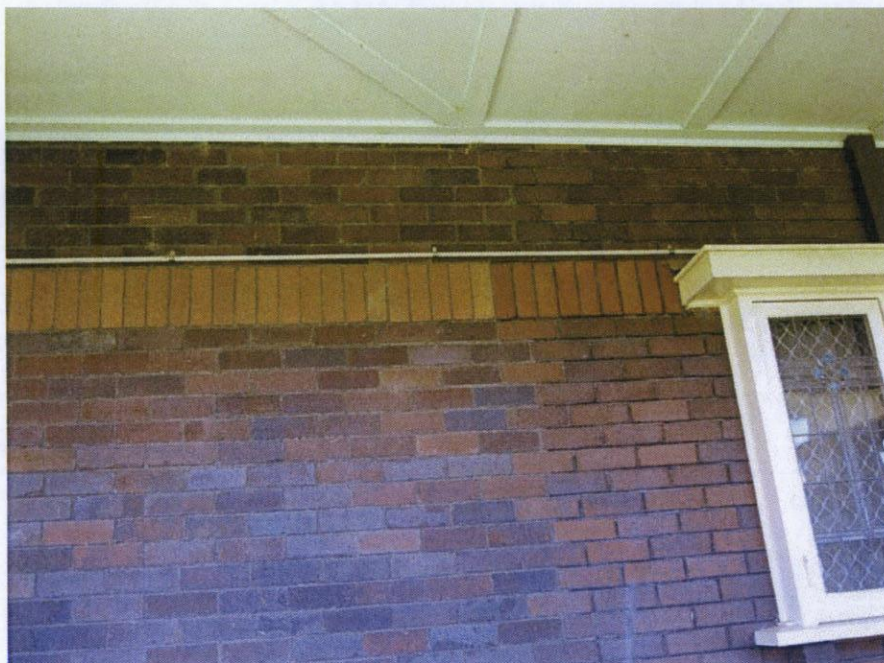
Figure 43: Detail of the join in the brickwork and soldier header row to the south end of the verandah showing location of infill.

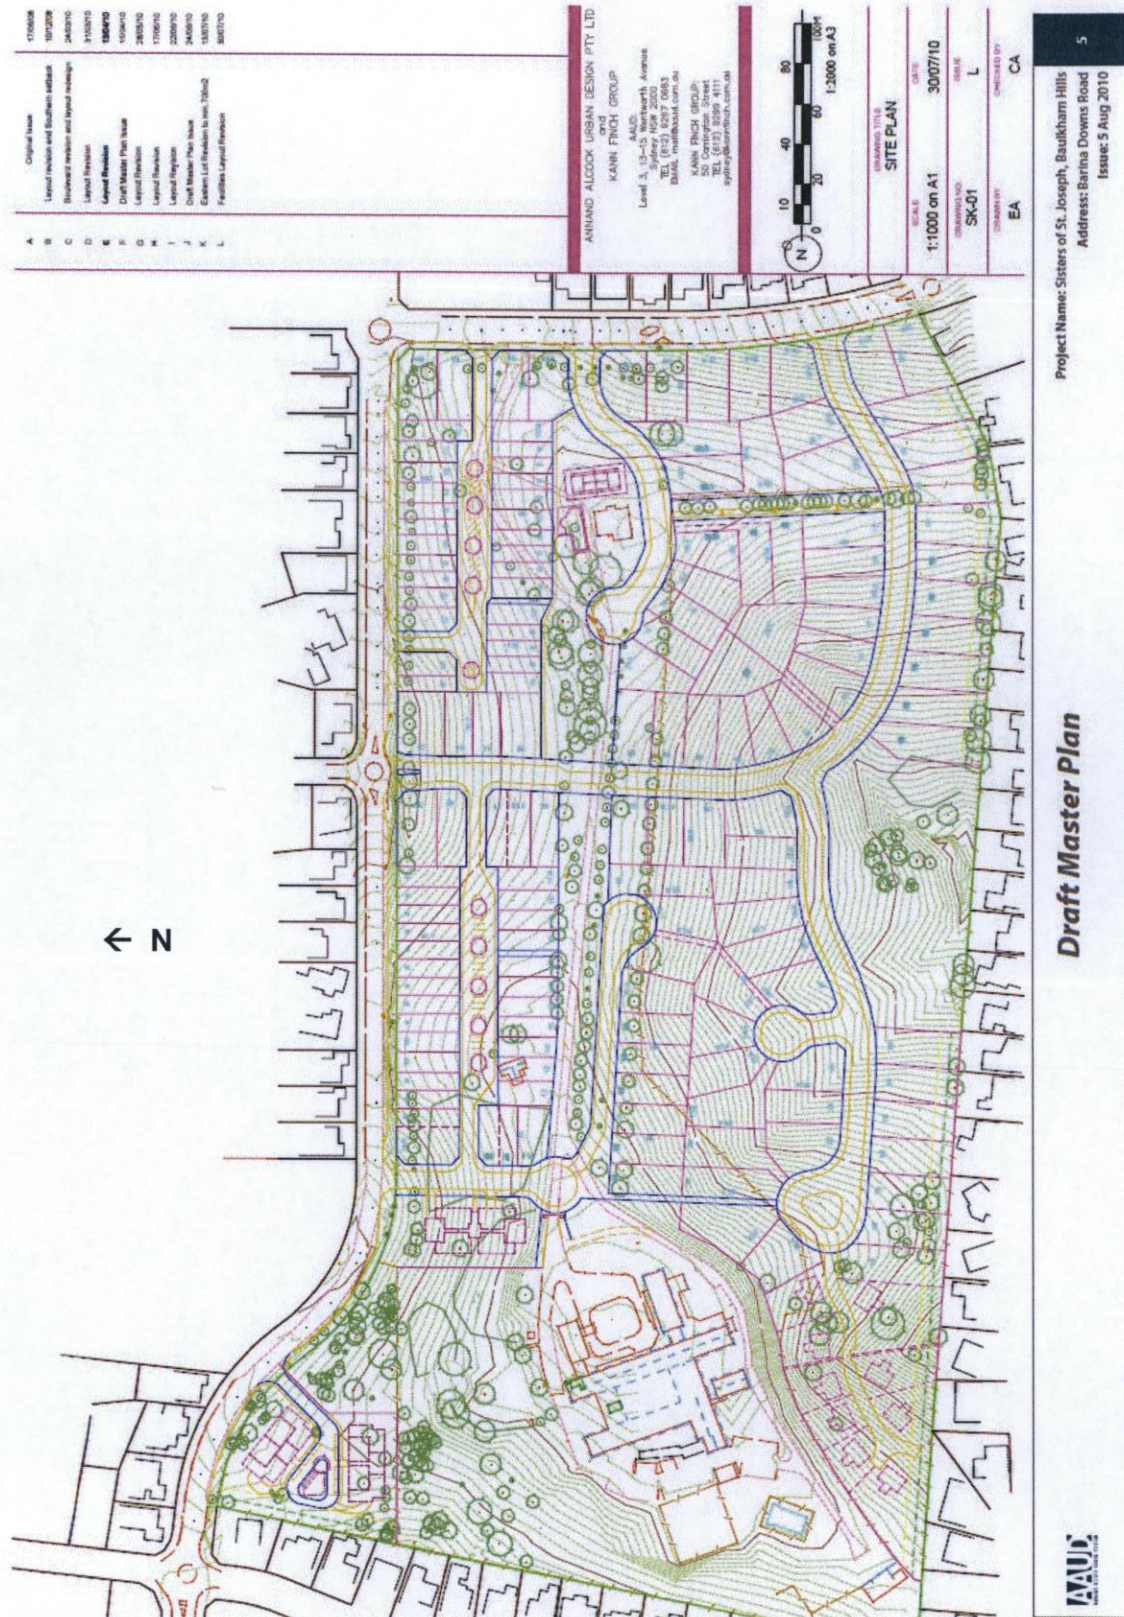
Figure 46: Draft Master Plan for the Sisters of St Joseph Site. Image provided by UPDM Pty Ltd.
