## GEOTECHNICAL INVESTIGATION REPORT

3-7 REGENT STREET, 13-17 REGENT STREET,  
& 287-309 TRAFALGAR STREET, PETERSHAM, NSW

El Report No. E22913 GA

Date: 24 May 2016

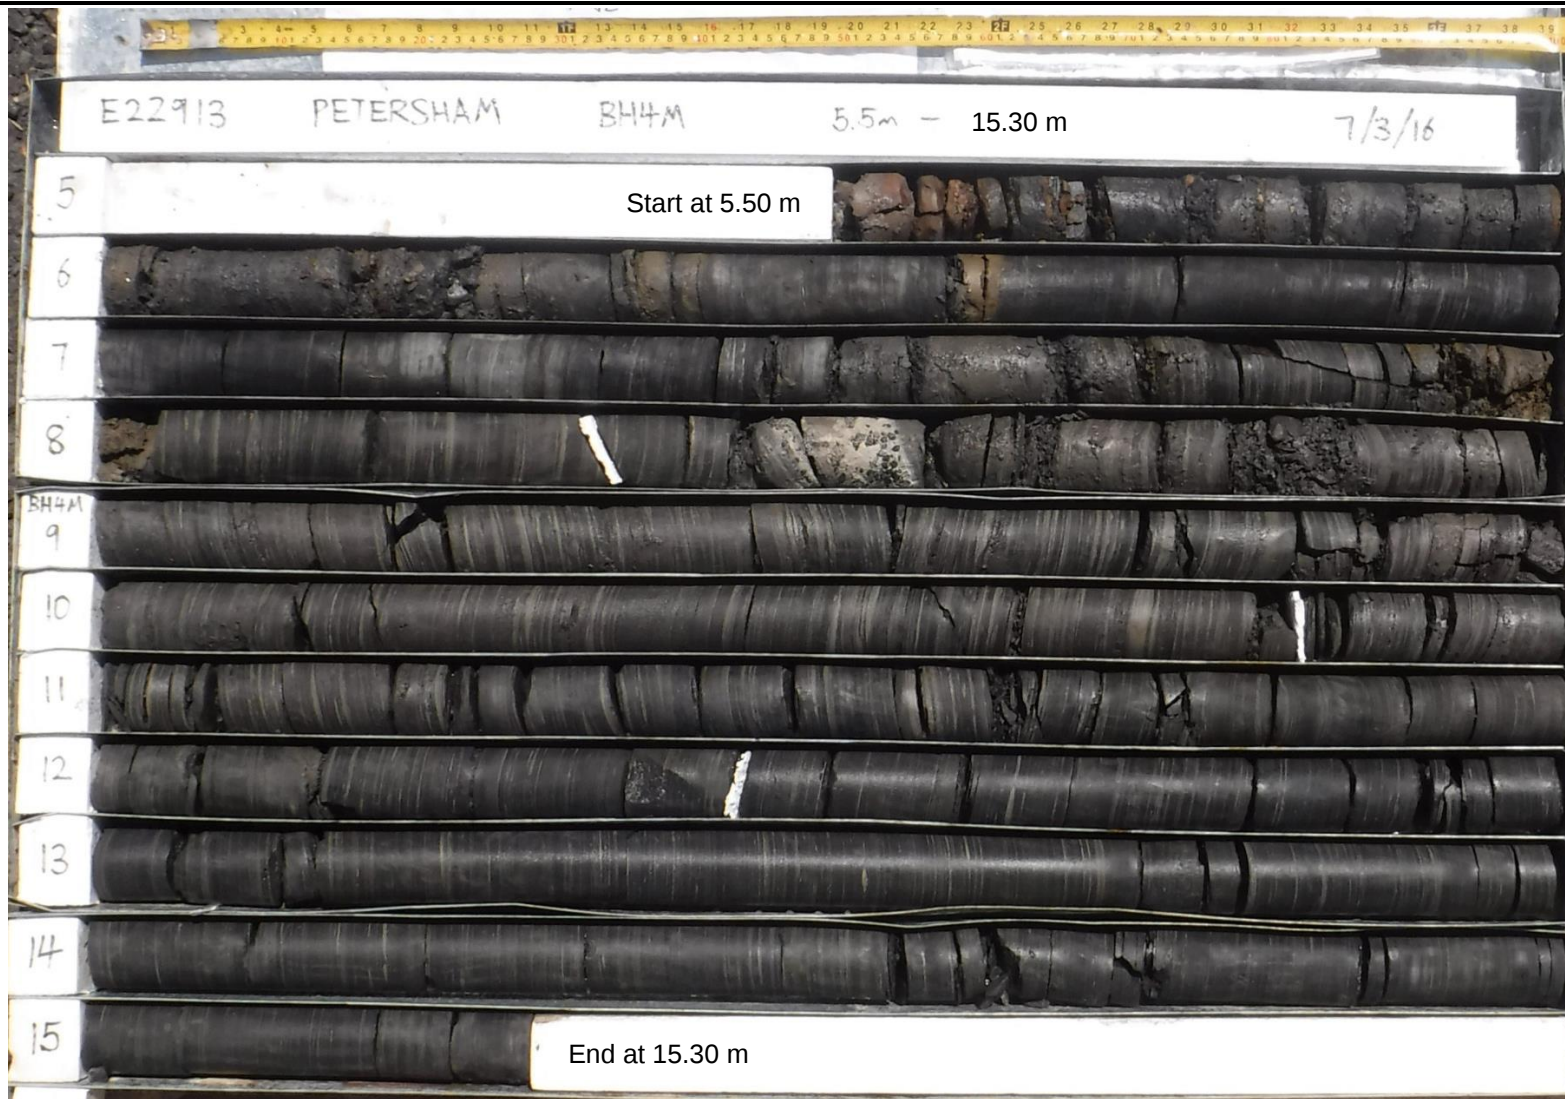
East: 329450.2 m  
North: 6248038.2 m MGA94 Zone 56  
Surface RL: 35.50 m AHD  
Inclination: -90°  
Box: 1, 2 & 3 of 3  
Hole Depth: 15.30 m

Depth Range: 5.50 m to 15.30 m  
Contractor: Rockwell Drilling Services Pty Ltd  
Drill Rig: Hanjin DB8  
LOGGED: JZ DATE: 7/3/16  
CHECKED: SK DATE: 24/5/16

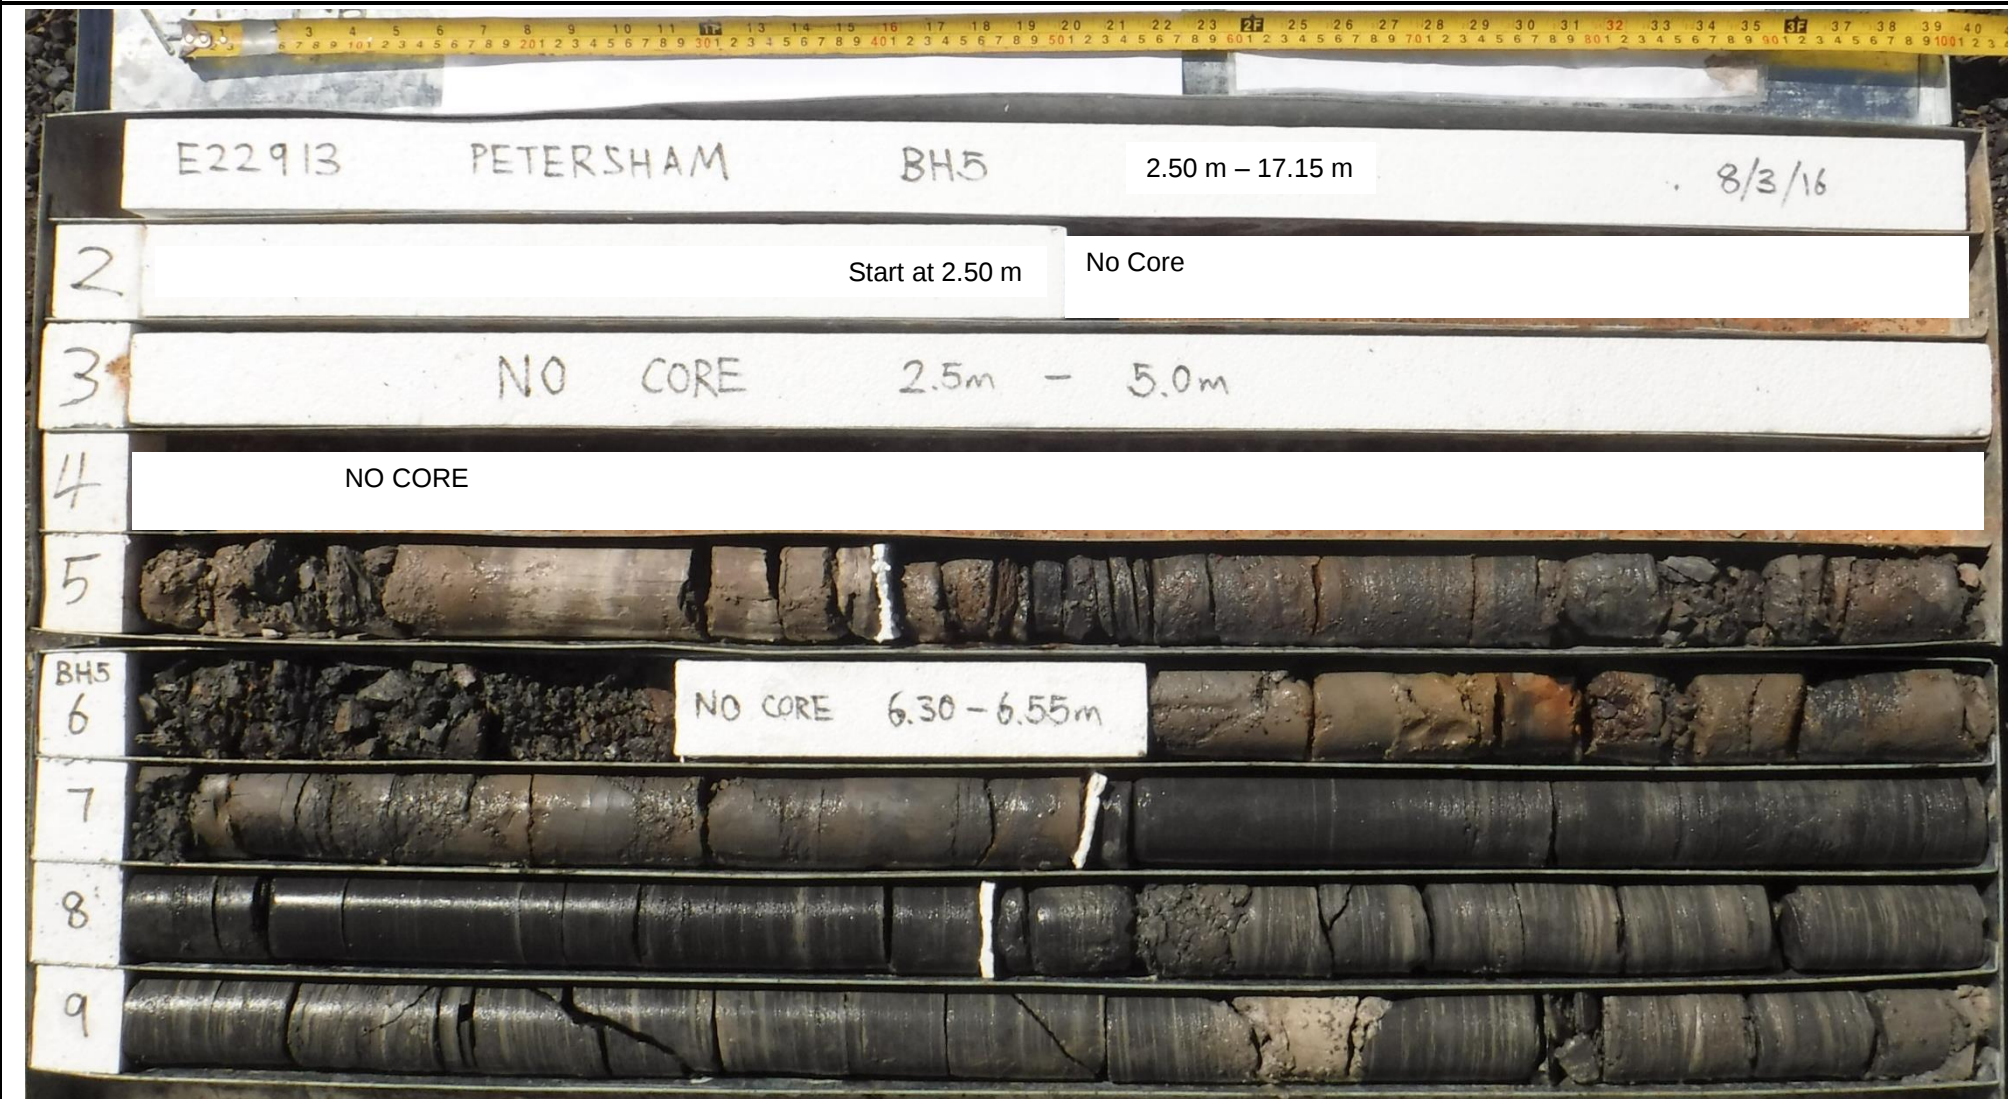
## CORE PHOTOGRAPH OF BOREHOLE: BH5

Project: Proposed Mixed Use Development  
Location: 3-7 Regent Street (Site 1), 13-17 Regent Street (Site 2) & 287-309 Trafalgar Street (Site 3), Petersham, NSW  
Position: Site 3  
Job No.: E22913  
Client: DeiCorp Projects Petersham Pty Ltd

East: 329446.6 m  
North: 6248007.5 m MGA94 Zone 56  
Surface RL: 36.40 m AHD  
Inclination: -90°  
Box: 3 & 4 of 4  
Hole Depth: 17.15 m

Depth Range: 10.00 m to 17.15 m  
Contractor: Rockwell Drilling Services Pty Ltd  
Drill Rig: Hanjin DB8  
LOGGED: JZ DATE: 8/3/16  
CHECKED: SK DATE: 24/5/16

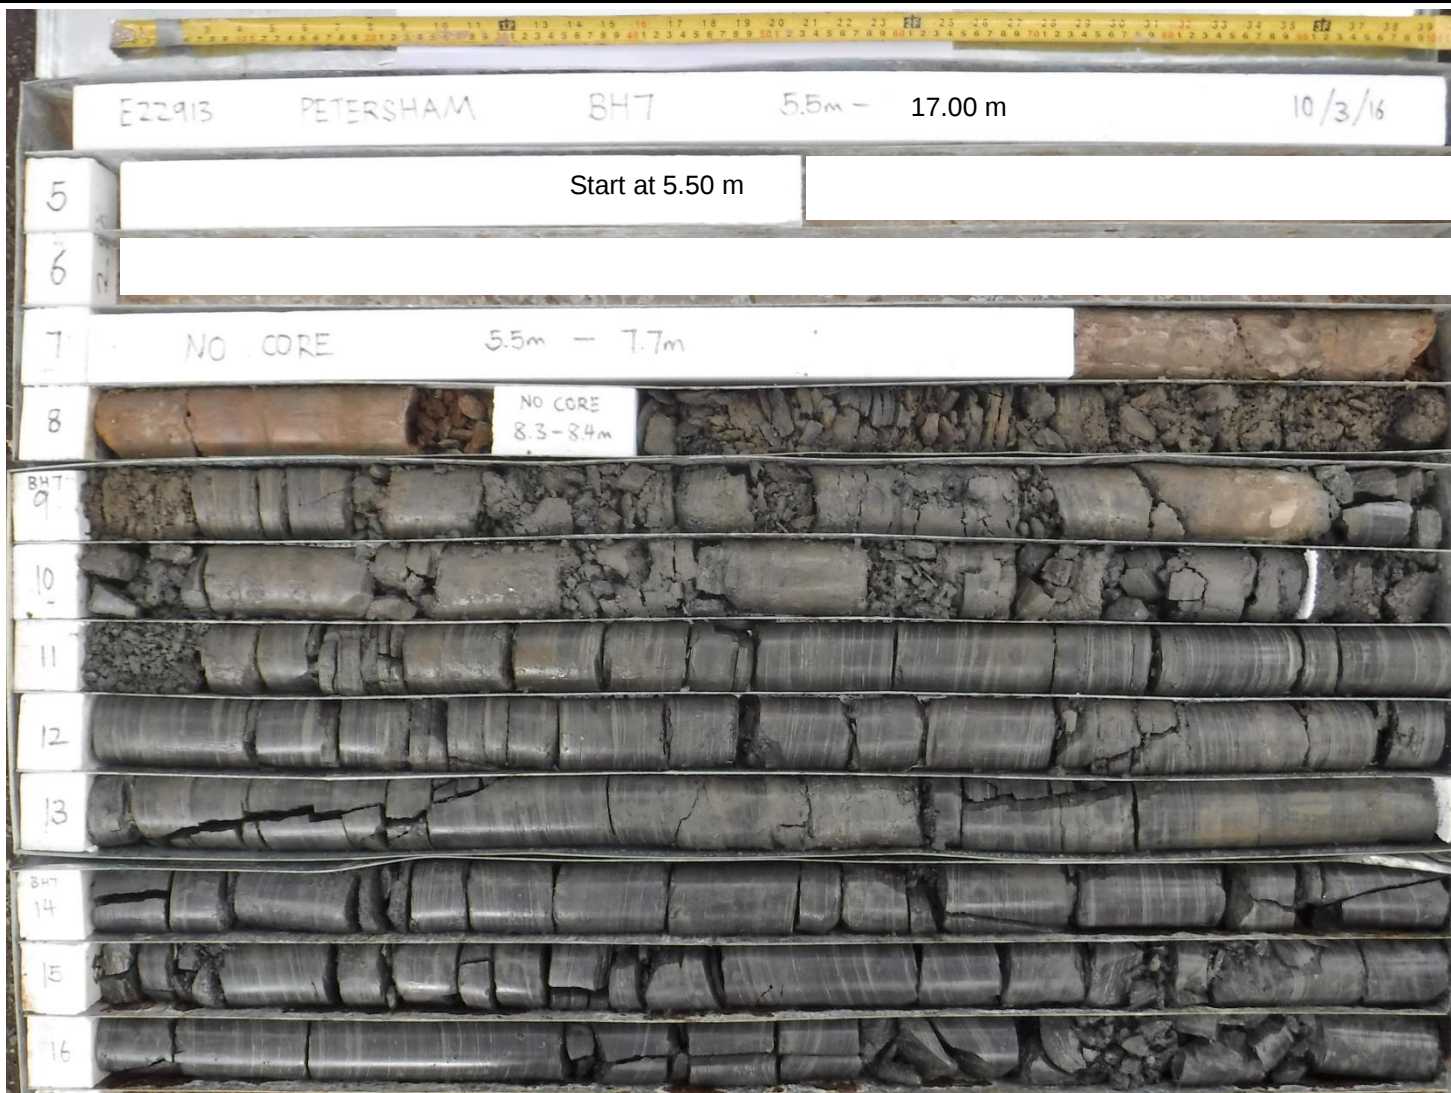
East: 329430.9 m  
North: 6247937.7 m MGA94 Zone 56  
Surface RL: 36.60 m AHD  
Inclination: -90°  
Box: 1, 2 & 3 of 3  
Hole Depth: 17.00 m

Depth Range: 5.50 m to 17.00 m  
Contractor: Terratest Pty Ltd  
Drill Rig: Hydropower Scout  
LOGGED: JZ DATE: 10/3/16  
CHECKED: SK DATE: 24/5/16

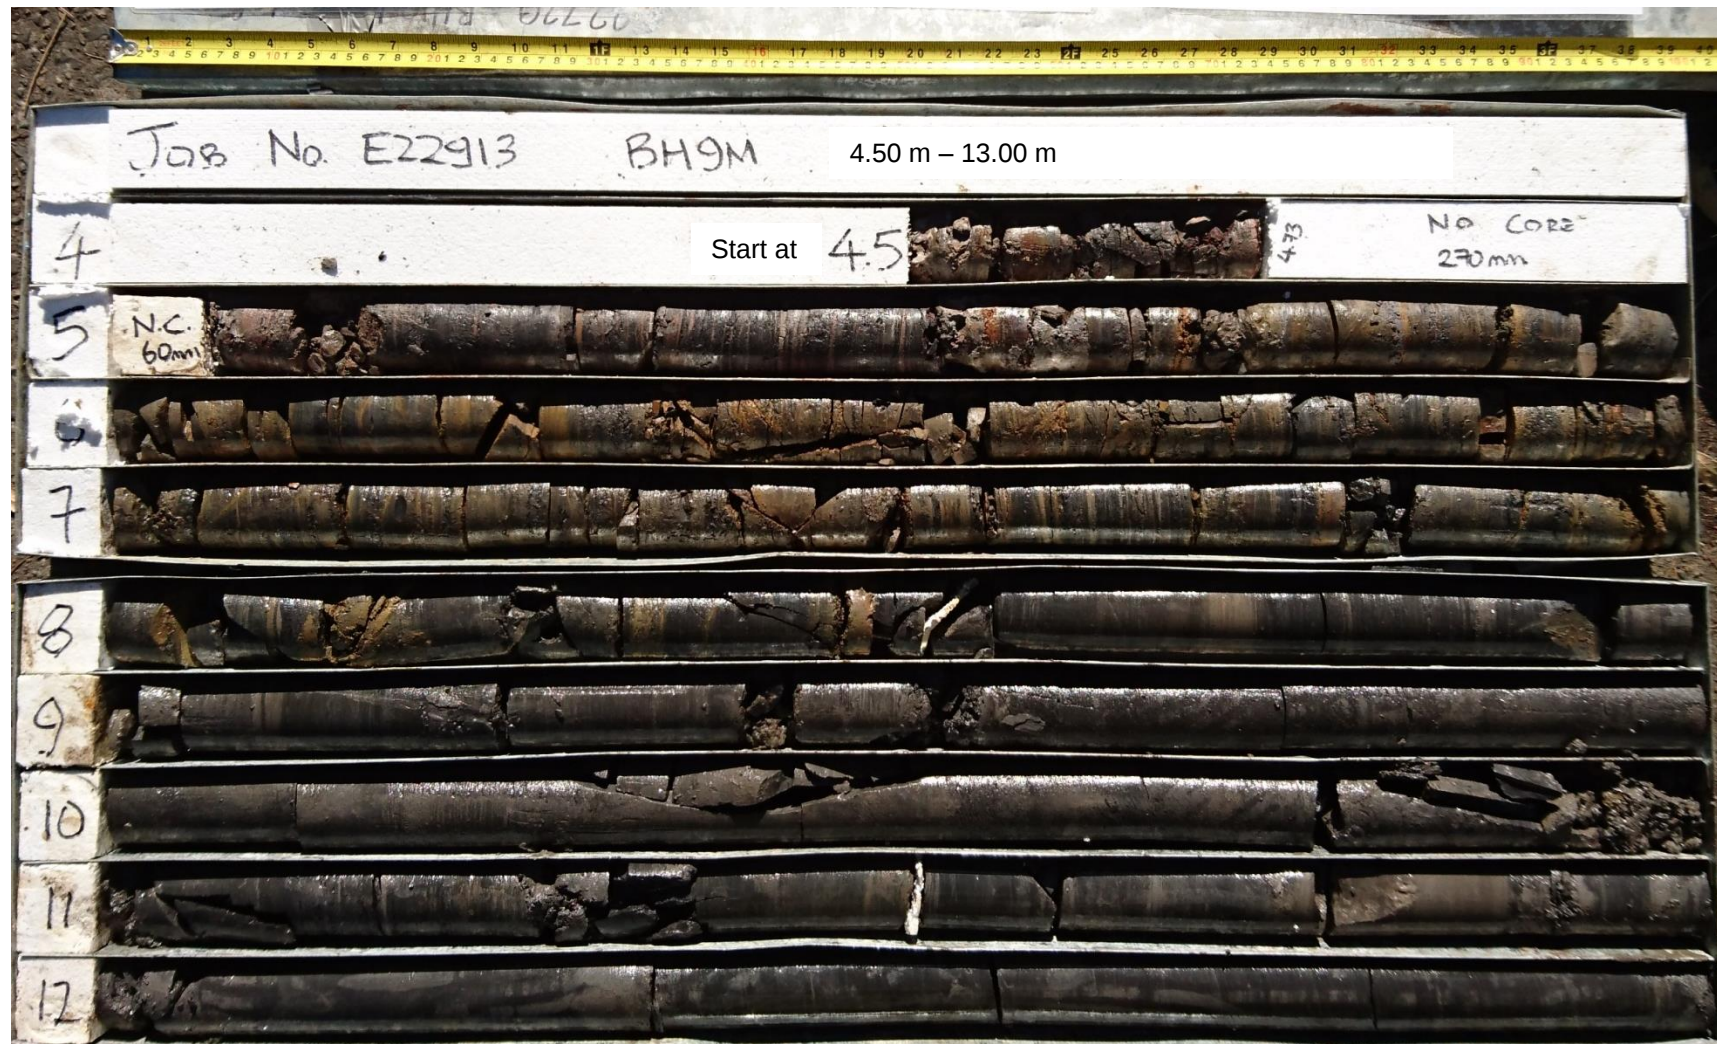
East: 329461.7 m  
North: 6247914.4 m MGA94 Zone 56  
Surface RL: 39.30 m AHD  
Inclination: -90°  
Box: 1 & 2 of 2  
Hole Depth: 13.00 m

Depth Range: 4.50 m to 13.00 m  
Contractor: Terratest Pty Ltd  
Drill Rig: Hydropower Scout  
LOGGED: JZ DATE: 8/3/16  
CHECKED: SK DATE: 24/5/16

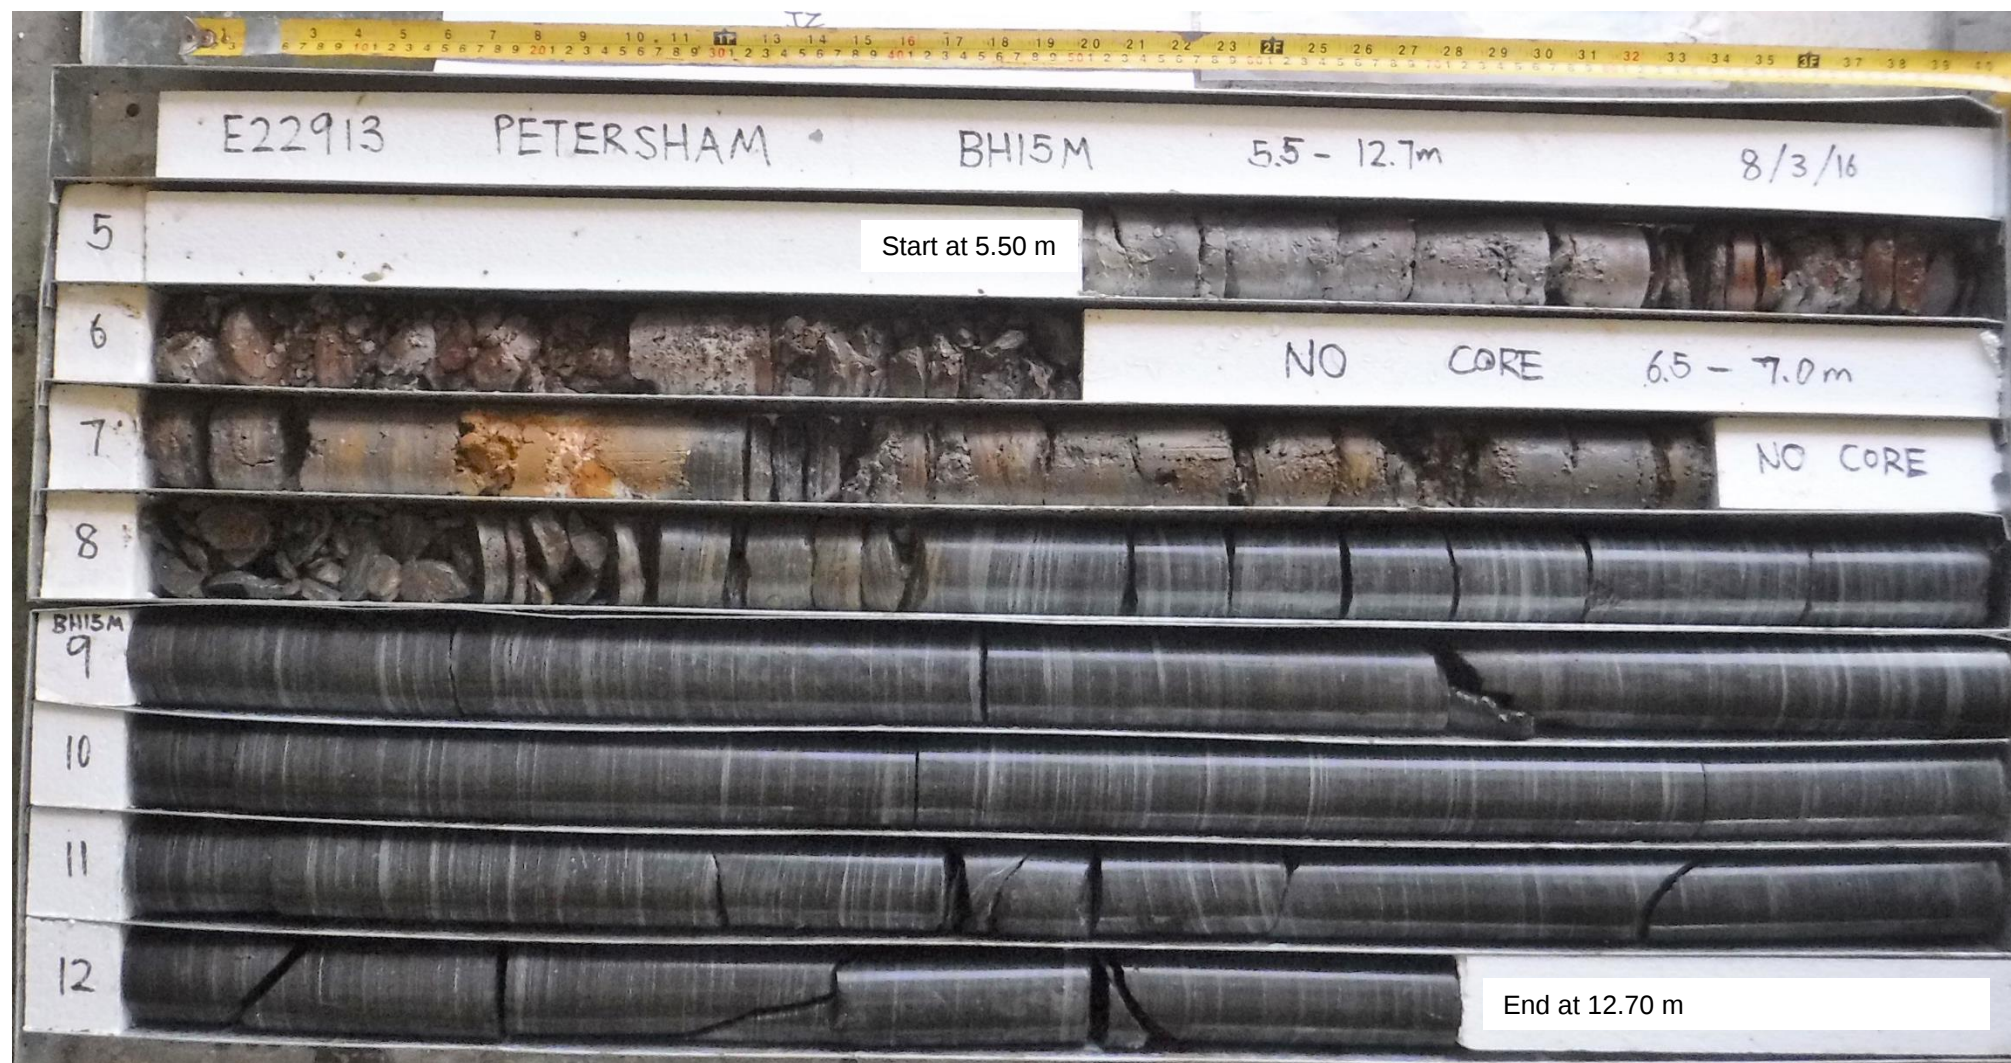
East: 329386.5 m  
North: 6248003.3 m MGA94 Zone 56  
Surface RL: 31.40 m AHD  
Inclination: -90°  
Box: 1 & 2 of 2  
Hole Depth: 12.70 m

Depth Range: 5.50 m to 12.70 m  
Contractor: Terratest Pty Ltd  
Drill Rig: Hydropower Scout  
LOGGED: JZ DATE: 8/3/16  
CHECKED: SK DATE: 24/5/16
