“The Gables”

69 Kissing Point Road, Turramurra  
Heritage Assessment

November 2017

prepared by Paul Davies Pty Ltd  
for Ku-ring-gai Council

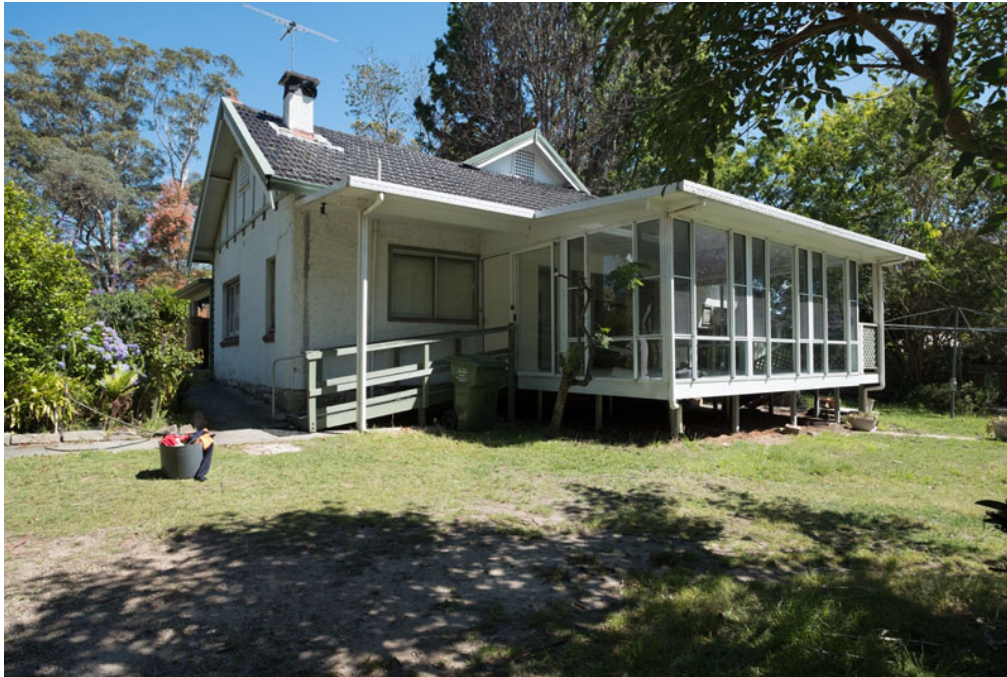
The rear kitchen wall is a later wall and it appears that this area may have failed and has been rebuilt, however the cracking has continued.

Figure 14: General view from the rear of the sunroom addition, ramp and rebuilt kitchen wall with aluminium framed window. This work removed the rear verandah and rear wall and re-purposed some rooms.

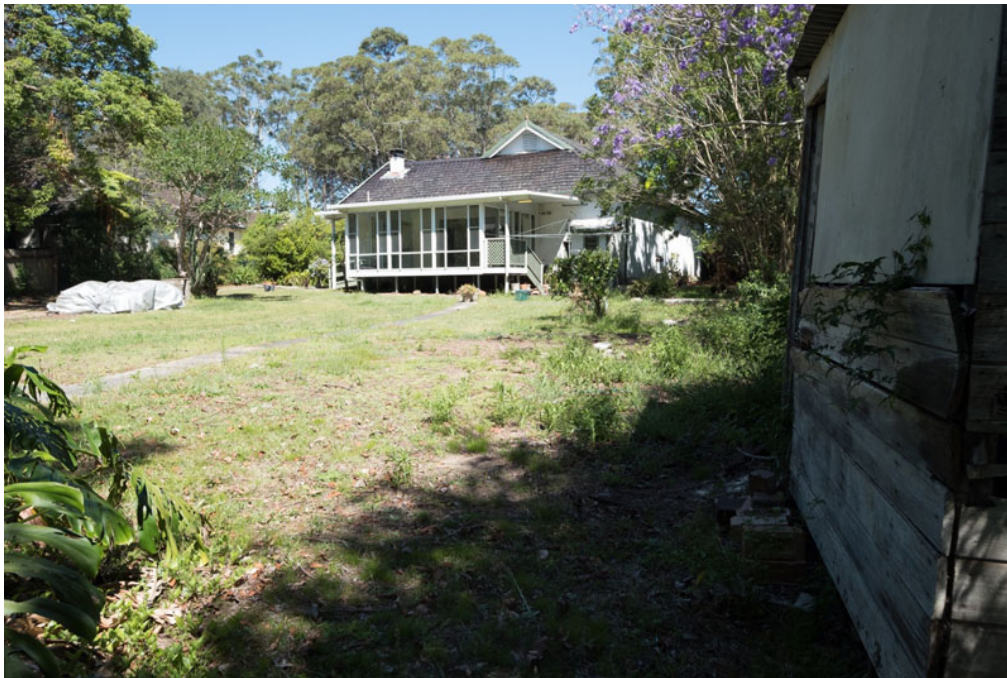
Figure 15: View from rear of property with failed shed in foreground. There is no setting to the rear of the building that is significant.

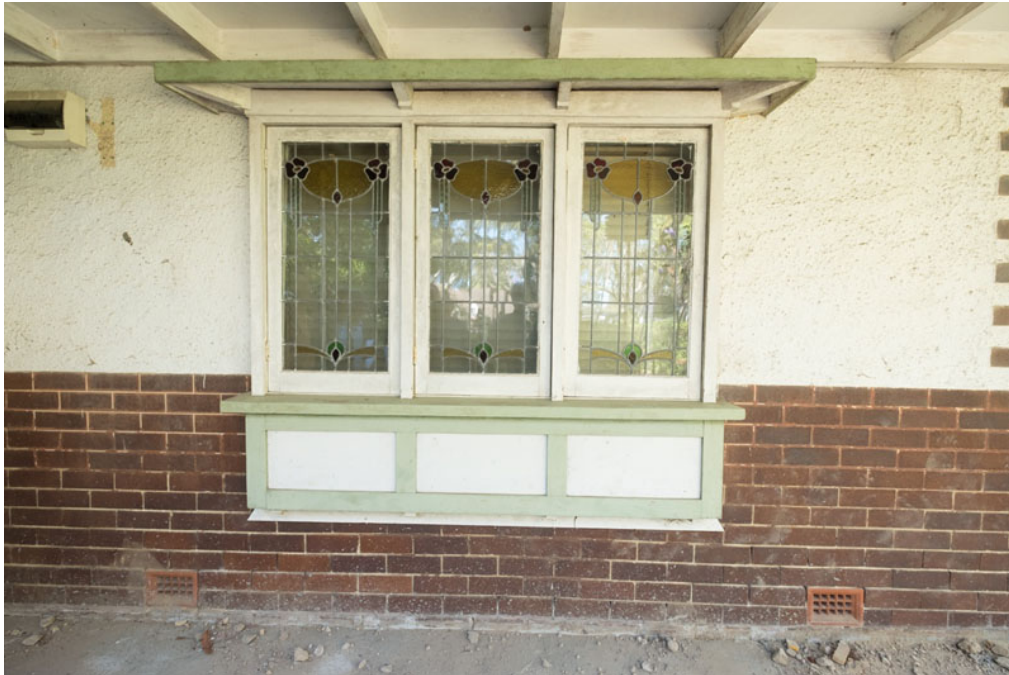
Figure 16: Detail of front verandah window. Note the unusual (odd) use of an awning roof over the bay window and the verandah roof immediately above it. This suggests the random addition of elements to the building without a resolved design.

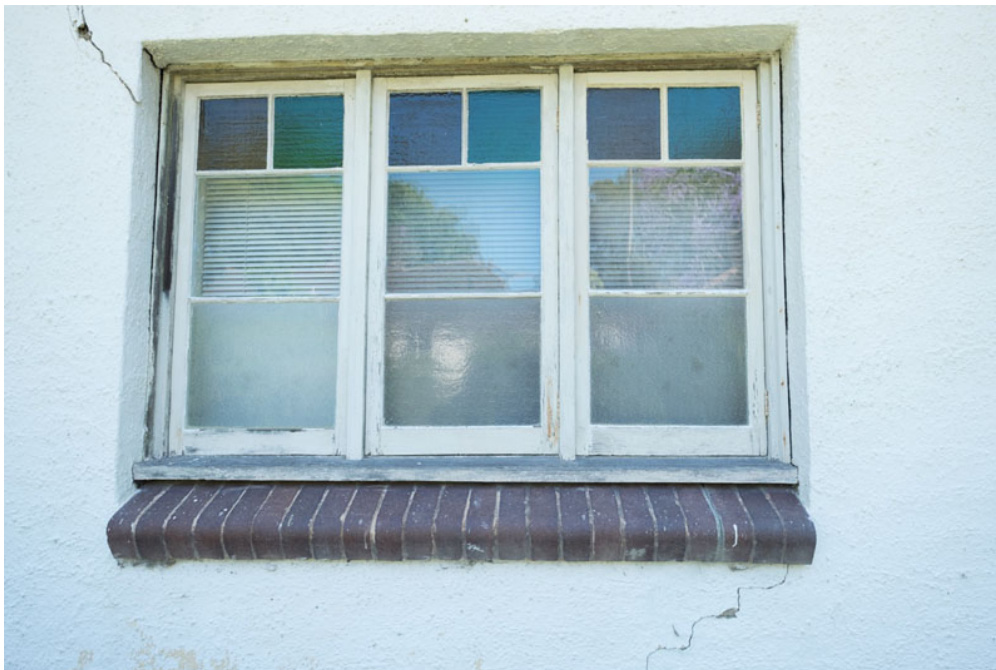
While an assessment of heritage value is separate to a structural assessment it is not possible to comment on the house without reference to its condition. It is in extremely poor condition with extensive and in places irrecoverable cracking. The house is out of level and alignment in many areas and whole sections of the building have moved and slumped.

Figure 17: Typical window (dining room). Note cracking at corners.

Walls have bellied out, sunk and dropped. As noted previously, this is not a reflection on significance but its' very poor condition does have to be addressed if the place were to have a useful future. From my experience of similar buildings, it is clear that much of the building would need to be rebuilt on new foundations for the building to remain.

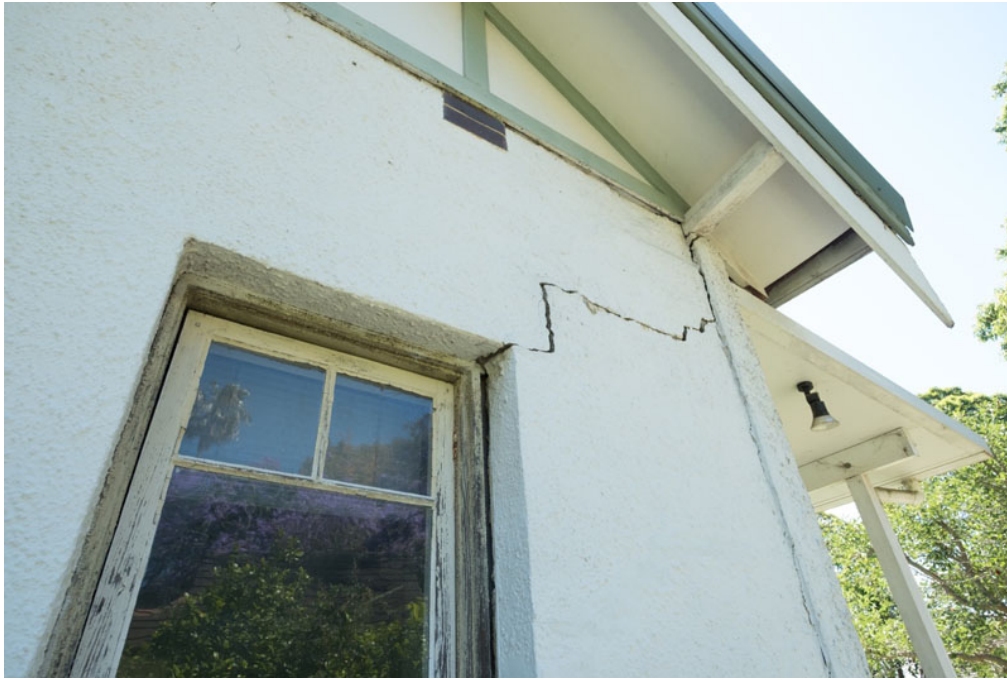
Figure 18: Kitchen window with corner crack, note the end wall is rebuilt.

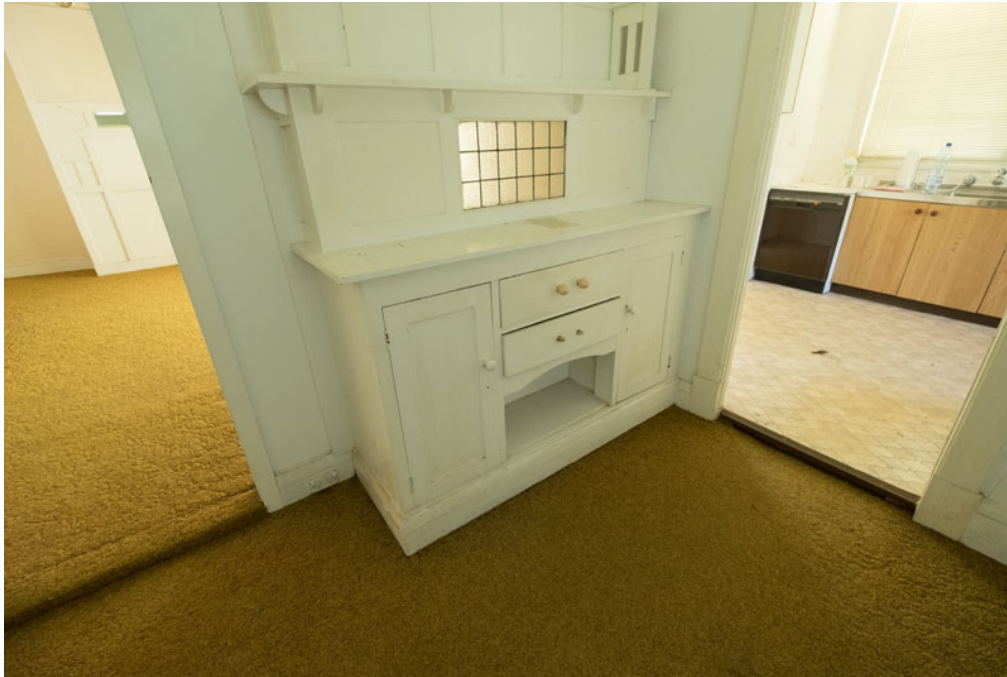
Figure 20: Servery unit between current dining and living rooms. Note the step down in floor to this space with timber thresholds. It is not clear why this step down takes place, although it is possible that this room was originally a kitchen.

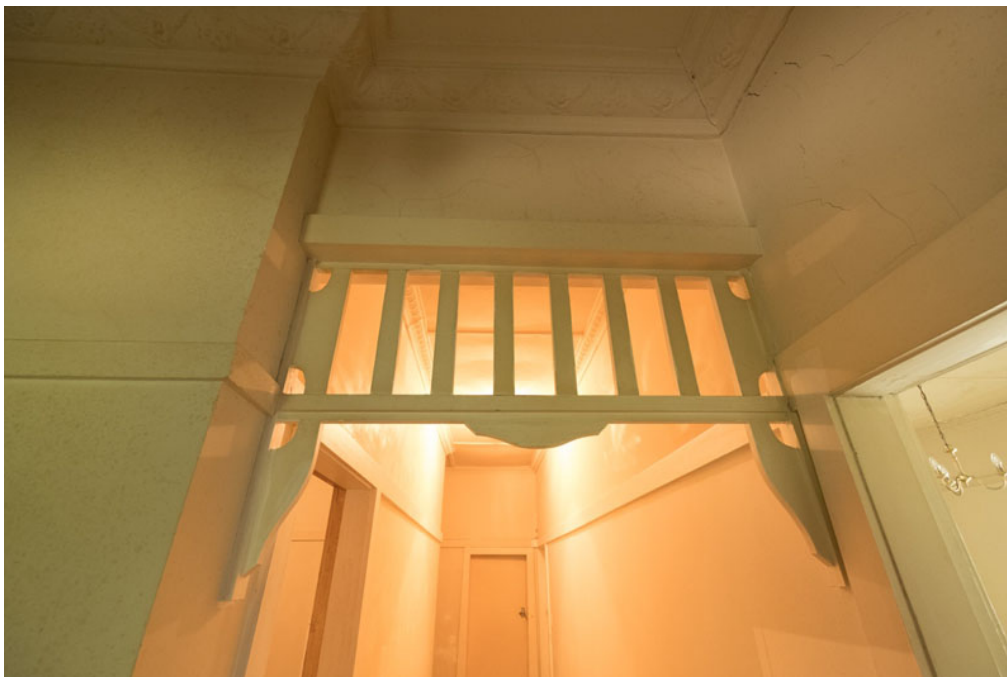
Figure 21: Timber screen in hallway. Note the step in the ceiling alignment so that the screen could fit next to the living room door. There has been no attention to detailed internal arrangement during construction, with doors oddly placed, off-centre and not contained within spaces such as the entry hall.

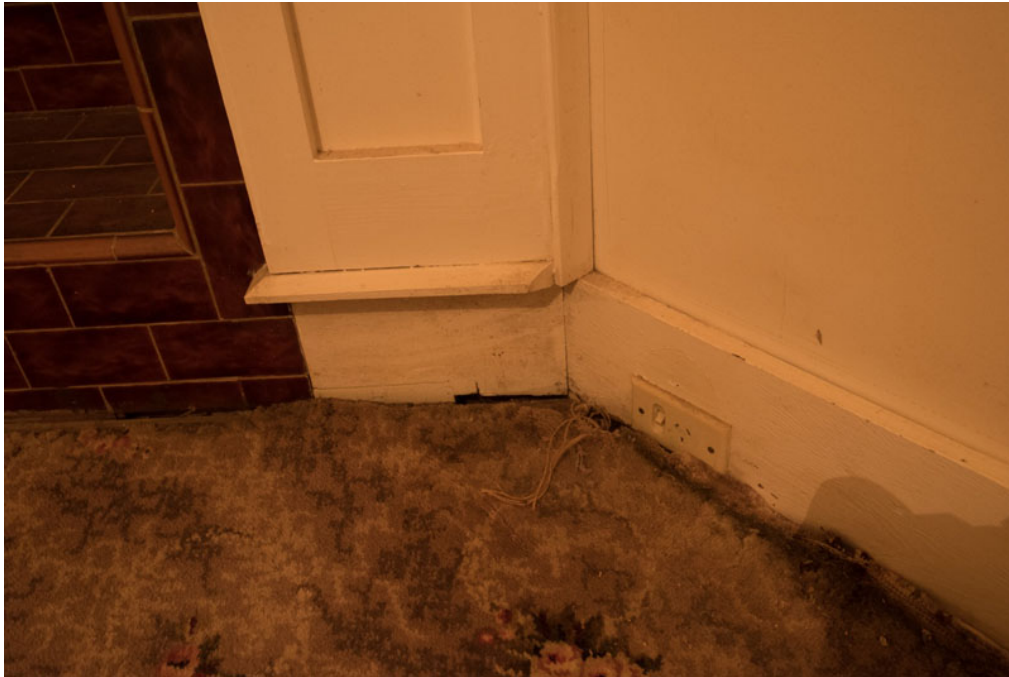
The joinery in the house requires comment as it is very basic and very poor quality. Even allowing for the extensive damage within the house that is evident and has affected some areas of joinery, its crudeness stands out. Most skirtings are simple squared timber with butt joints that are poorly executed, architraves are similar and extend to the ceiling with false panels above doors. The same detail is used on the cupboards noted. The workmanship is poor and appears to be almost home handyman in places.

Figure 22: Joinery detail in front room. Joinery is largely square section, butt jointed with odd splayed angles where elements intersect.

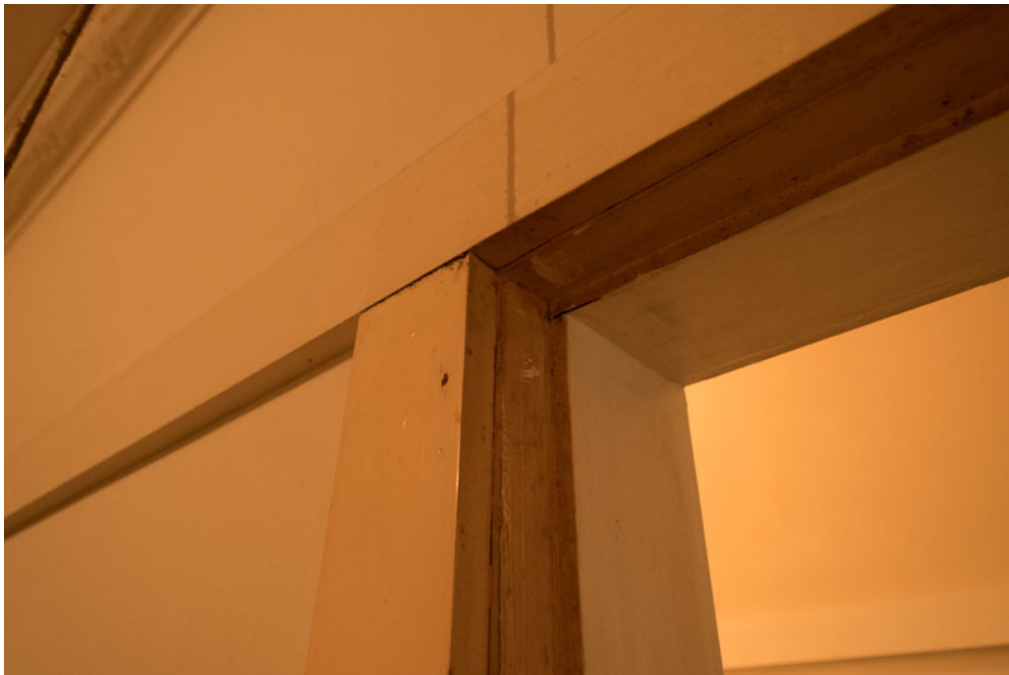
Figure 23: A further joinery detail showing squared timber crudely executed.

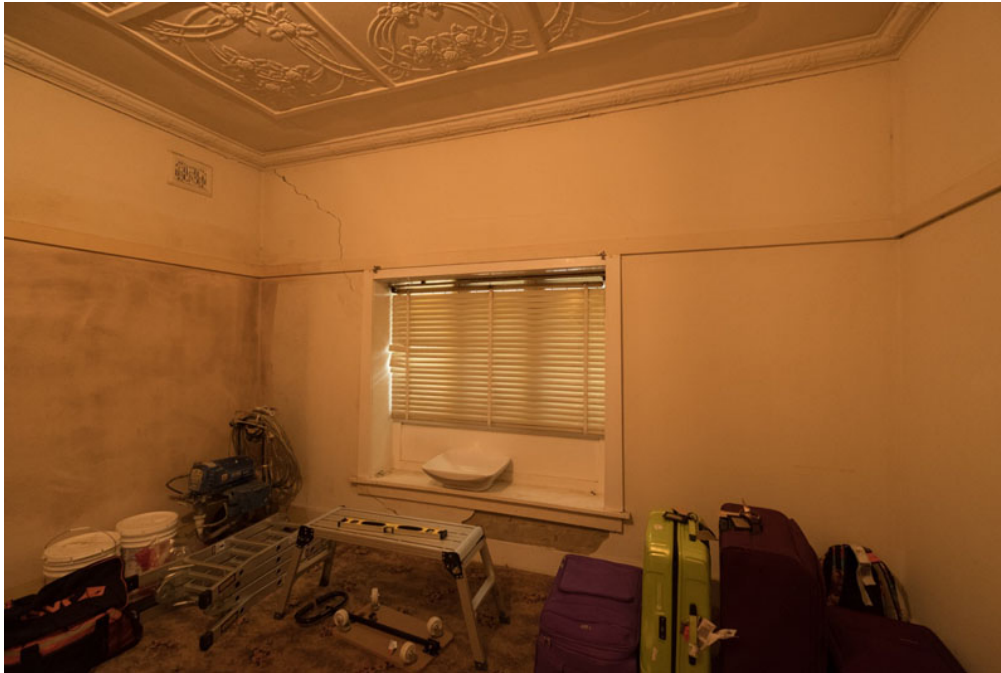
Figure 24: Main Front room, possibly a living space or a bedroom, the window opens to the front verandah. Note the very low railing height.

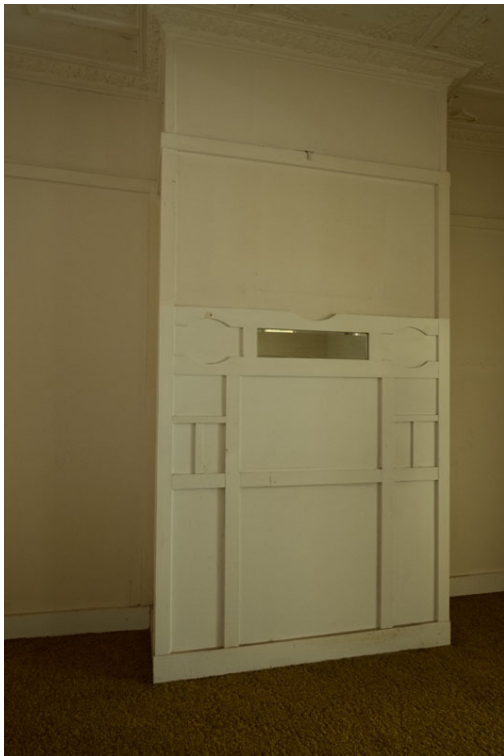
Figure 27: (Left) Altered display unit in the current living space. It roughly matches other joinery but has infilled openings.

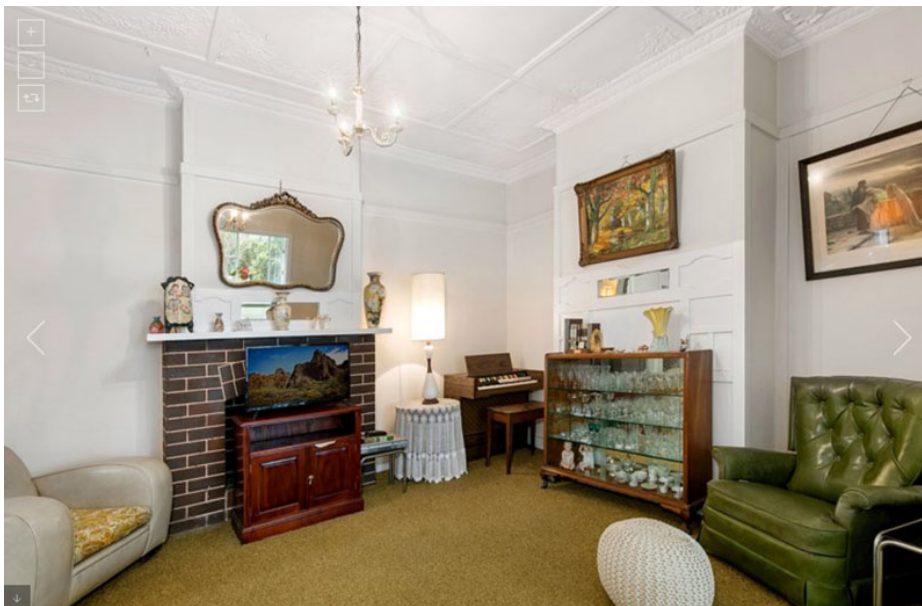
Figure 28: The lounge room with two chimney breasts but only one fireplace, illustrative of the peculiar layout/plan of the house.  
Image source: Domain website, relating to 2017 sale of the site.
