**PEER REVIEW OF A
HERITAGE ASSESSMENT OF
“THE GABLES”
69 KISSING POINT ROAD
TURRAMURRA**

**Graham Hall and Partners
Architects and Heritage Consultants**

FEBRUARY 2018

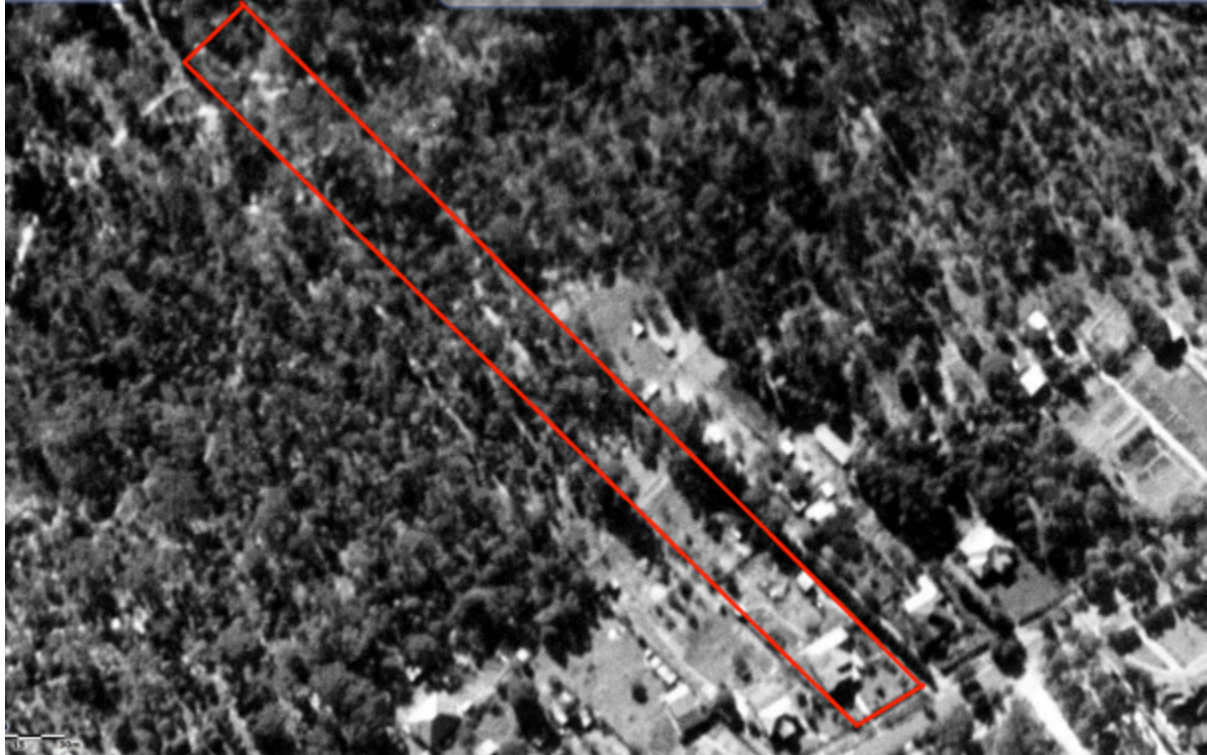
The extent of the site in 1961, overlaid on an aerial photo showing that the hinterland to the north of Kissing Point Road had not been opened up in 1943

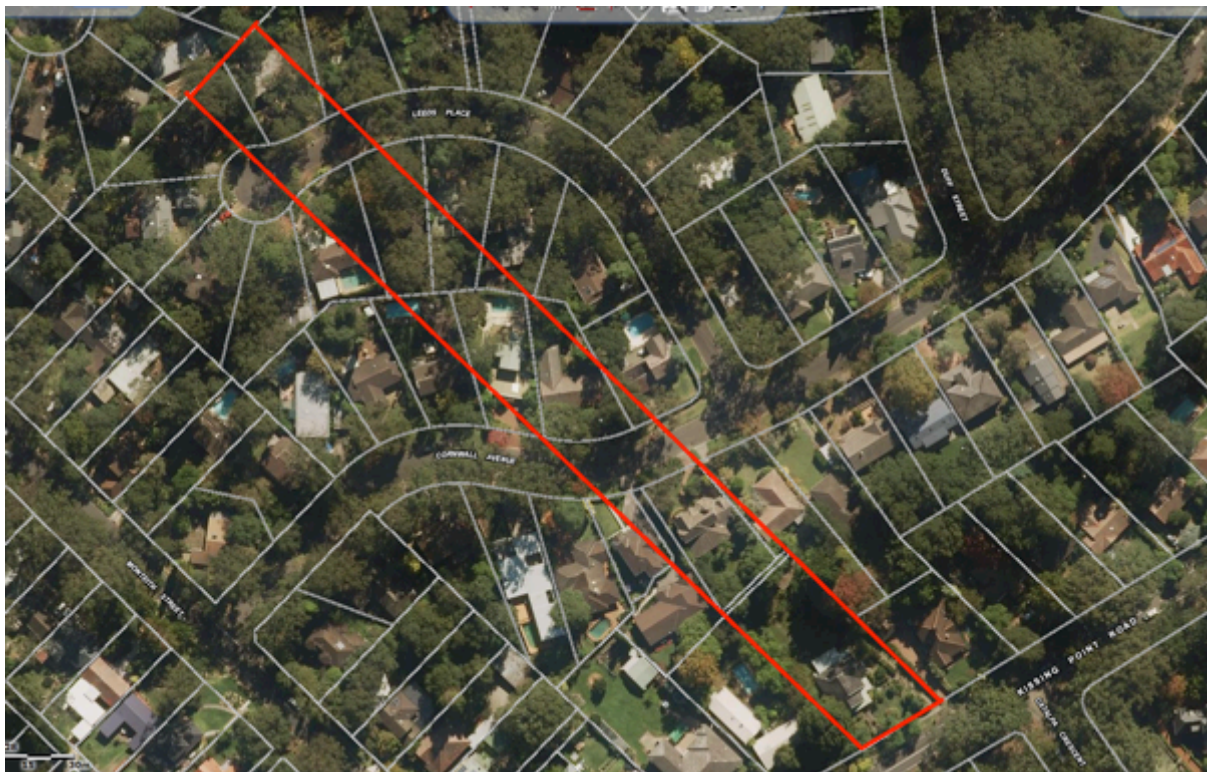
The extent of the site in 1961, overlaid on a recent aerial photo showing the subdivision pattern the north of Kissing Point Road

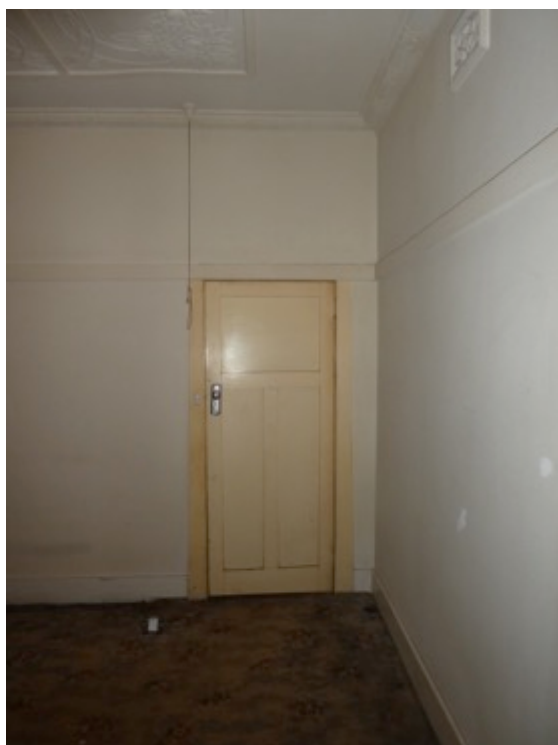
Typical three-panelled door, tapered architraves, picture rail at door head height and panelling over door. Originally stained

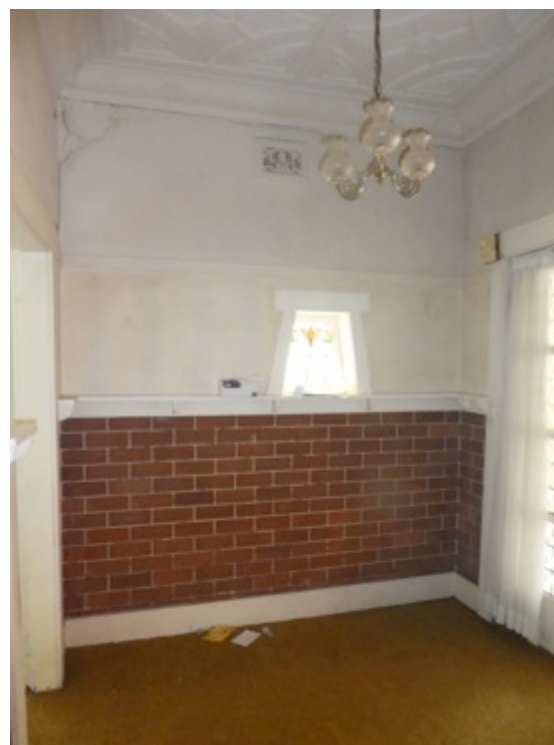
Entrance lobby with face brick continued from outside, glazed double doors and tapered leadlight window

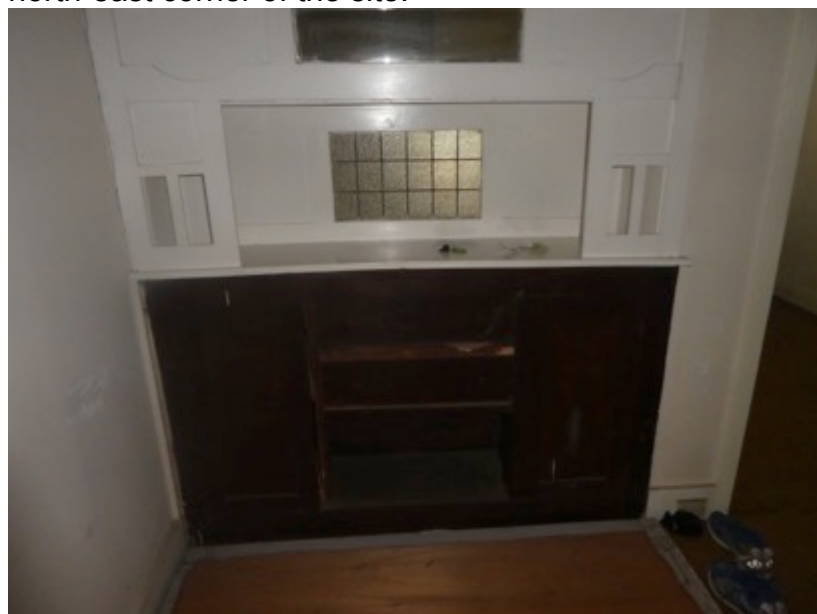
Servery seen from lounge room. Modern panel removed to reveal stained timber joinery. All joinery would have been stained originally.

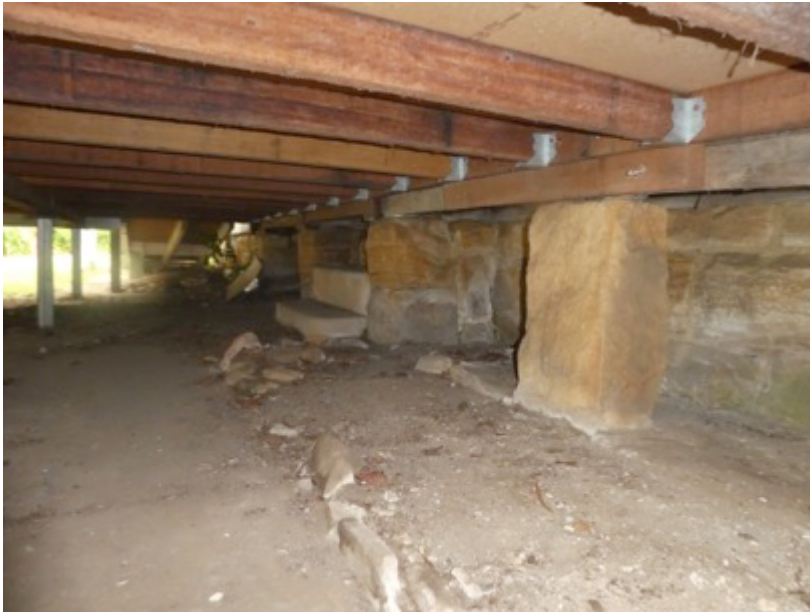
Original steps to veranda just left of centre

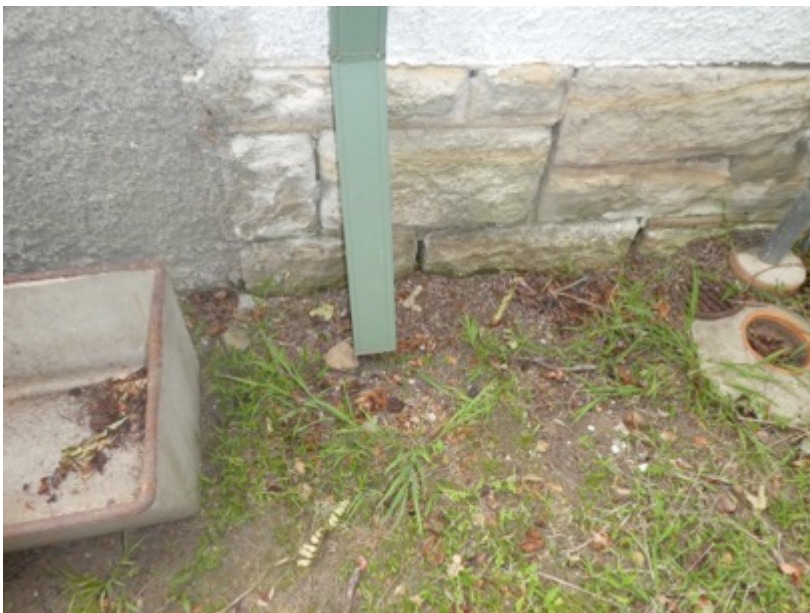
All downpipes discharge on to the ground. No evidence of stormwater drains was found.

The house is in poor condition. A minor issue is that the paint on the windows, which are original, is bare and powdery. The major problem is that the house suffers from some serious cracking in the brick walls, some floors are out of level, and there is minor rising damp. However there is no suggestion that it presents a danger. The timber-framed walls are not generally subject to cracking.

Council's consultant engineer attributes the cracking to stormwater from the downpipes, all of which discharge directly to the ground, and appear to have done so for a century. The erratic flow of water causes the clay substrate to swell and subside.

Even if the tree were not present, the flow from the downpipes still would induce an unacceptable degree of cracking. With the tree being adjacent, the flow appears to have attracted the roots. In my opinion, both factors have contributed.

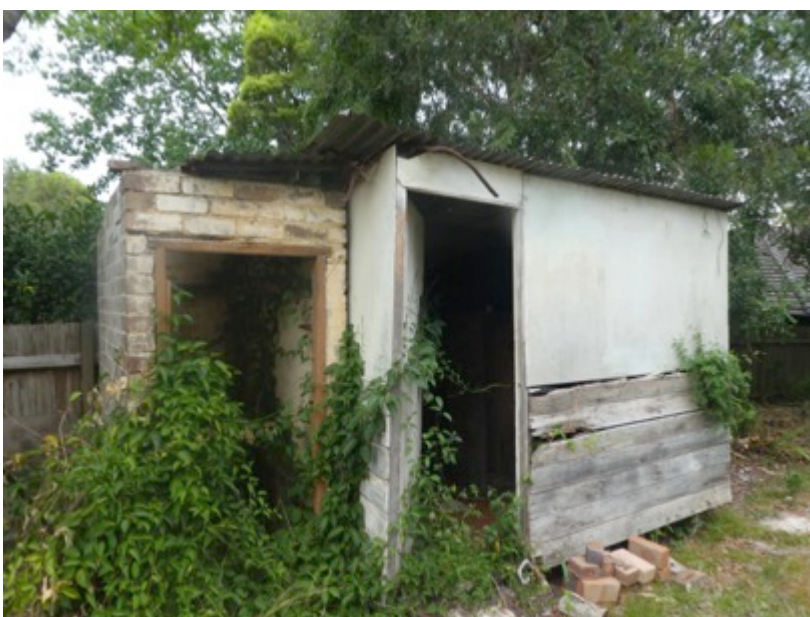
Weatherboards with battened fibro above on shed, left, and part of wall of former inset veranda, above

The asbestos cement sheets should not present a hazard if they are not damaged. However if any damage is observed or occurs, appropriate advice should be obtained. If required, the material may be replaced with modern fibre cement sheets without any heritage implications.

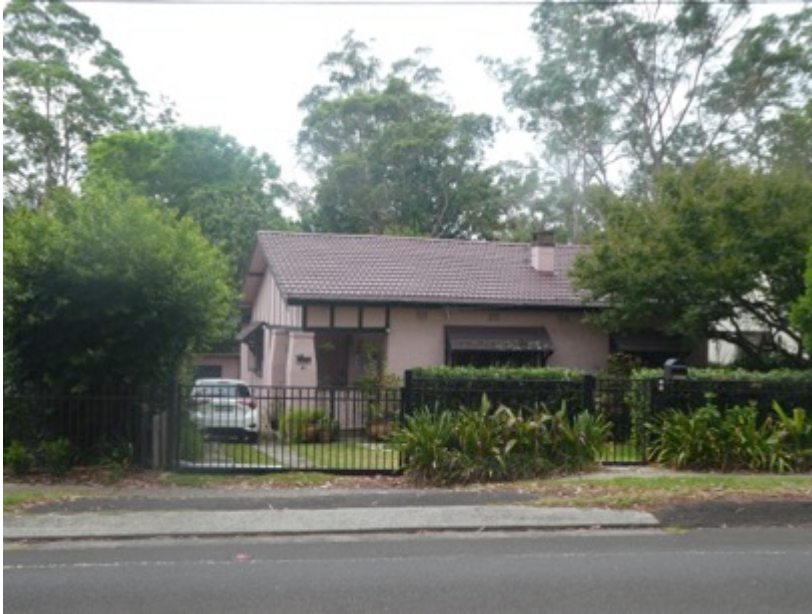
51 Kissing Point Road, "Bapaume," was probably named after the town in northern France where a battle took place towards the end of the First World War.

The nearest of these are No. 51, "Bapaume," (listed as item 775) and No. 53, "Rudyard," (item 776). These and No. 49 were built during the First World War and were originally similar or identical, and were relatively small. No.51 retains most of its Federation Arts and Crafts/inter-war Californian bungalow characteristics. No. 53 is considerably altered. The draft inventory form for Nos. 51 and 53 states that No. 49 was demolished, but it remains, unrecognisable, the original structure having been encapsulated in large extensions. Notes on the other nearby houses are in the captions.

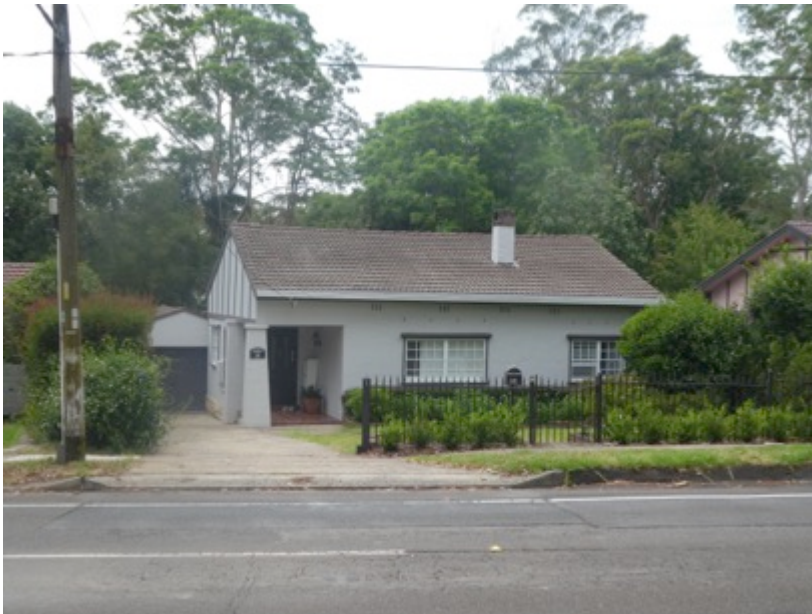
"Rudyard," 53 Kissing Point Road, probably named after Kipling, is only recognisable on close inspection and by reference to No. 51.

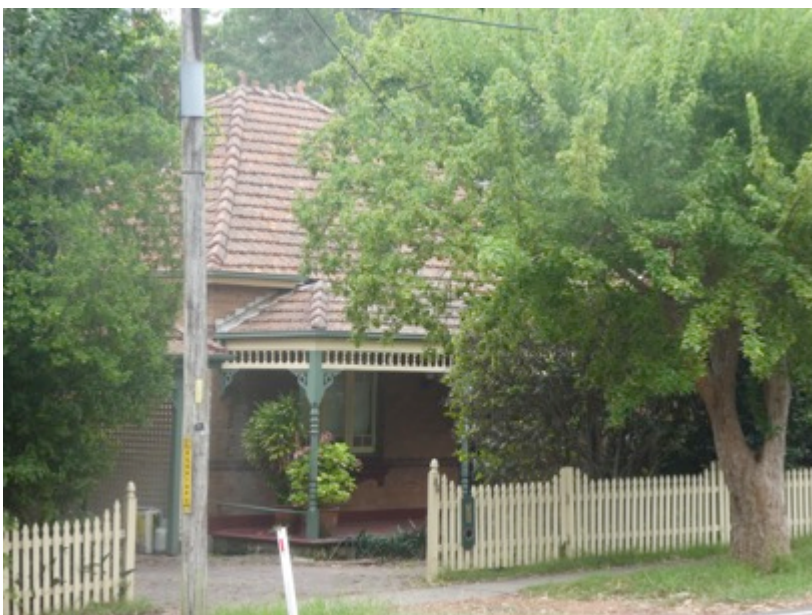
39 Kissing Point Road, also on the north side. Late Victorian/early Federation, symmetrical. Appears intact; not listed.

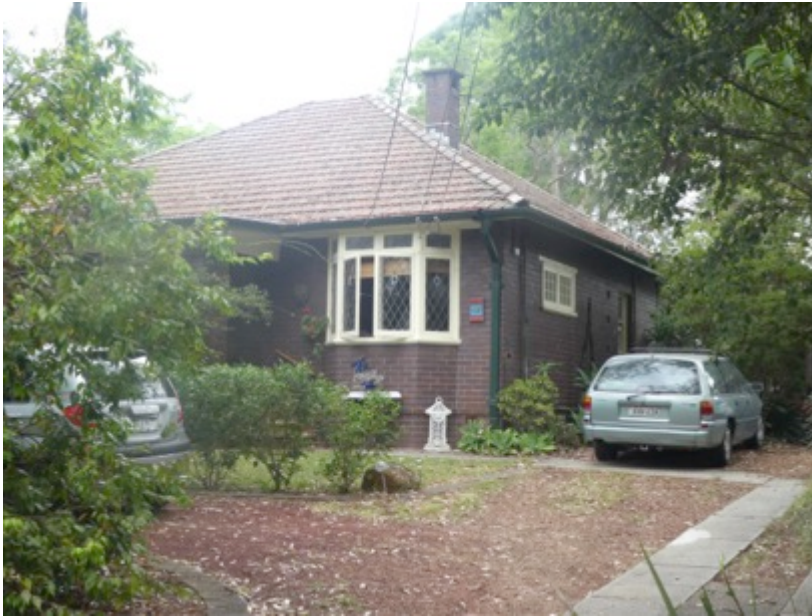
46 Kissing Point Road.
Symmetrical, arguably
Inter-War Georgian Revival,
possibly late 1920s – 1930s.
Appears intact from the
street. Not listed.

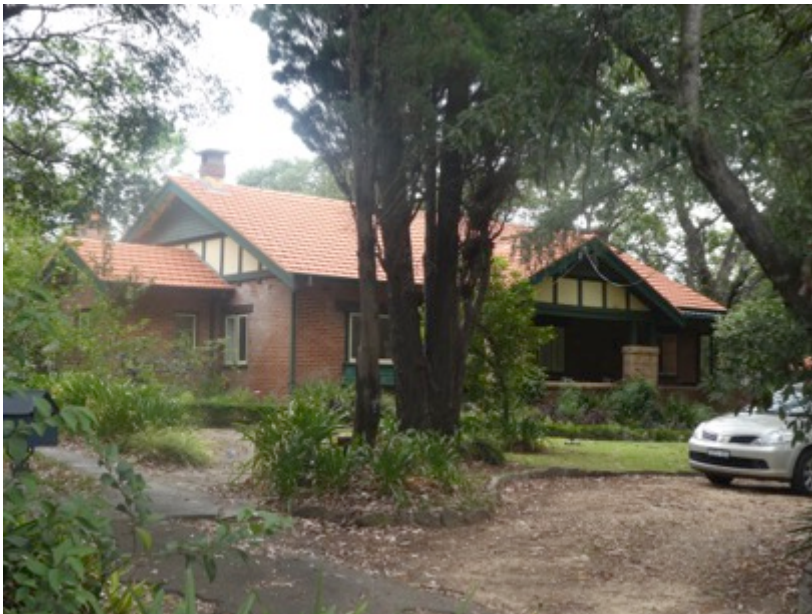
48 Kissing Point Road. An
Inter-war Californian
bungalow. Extended on left.
Not listed.

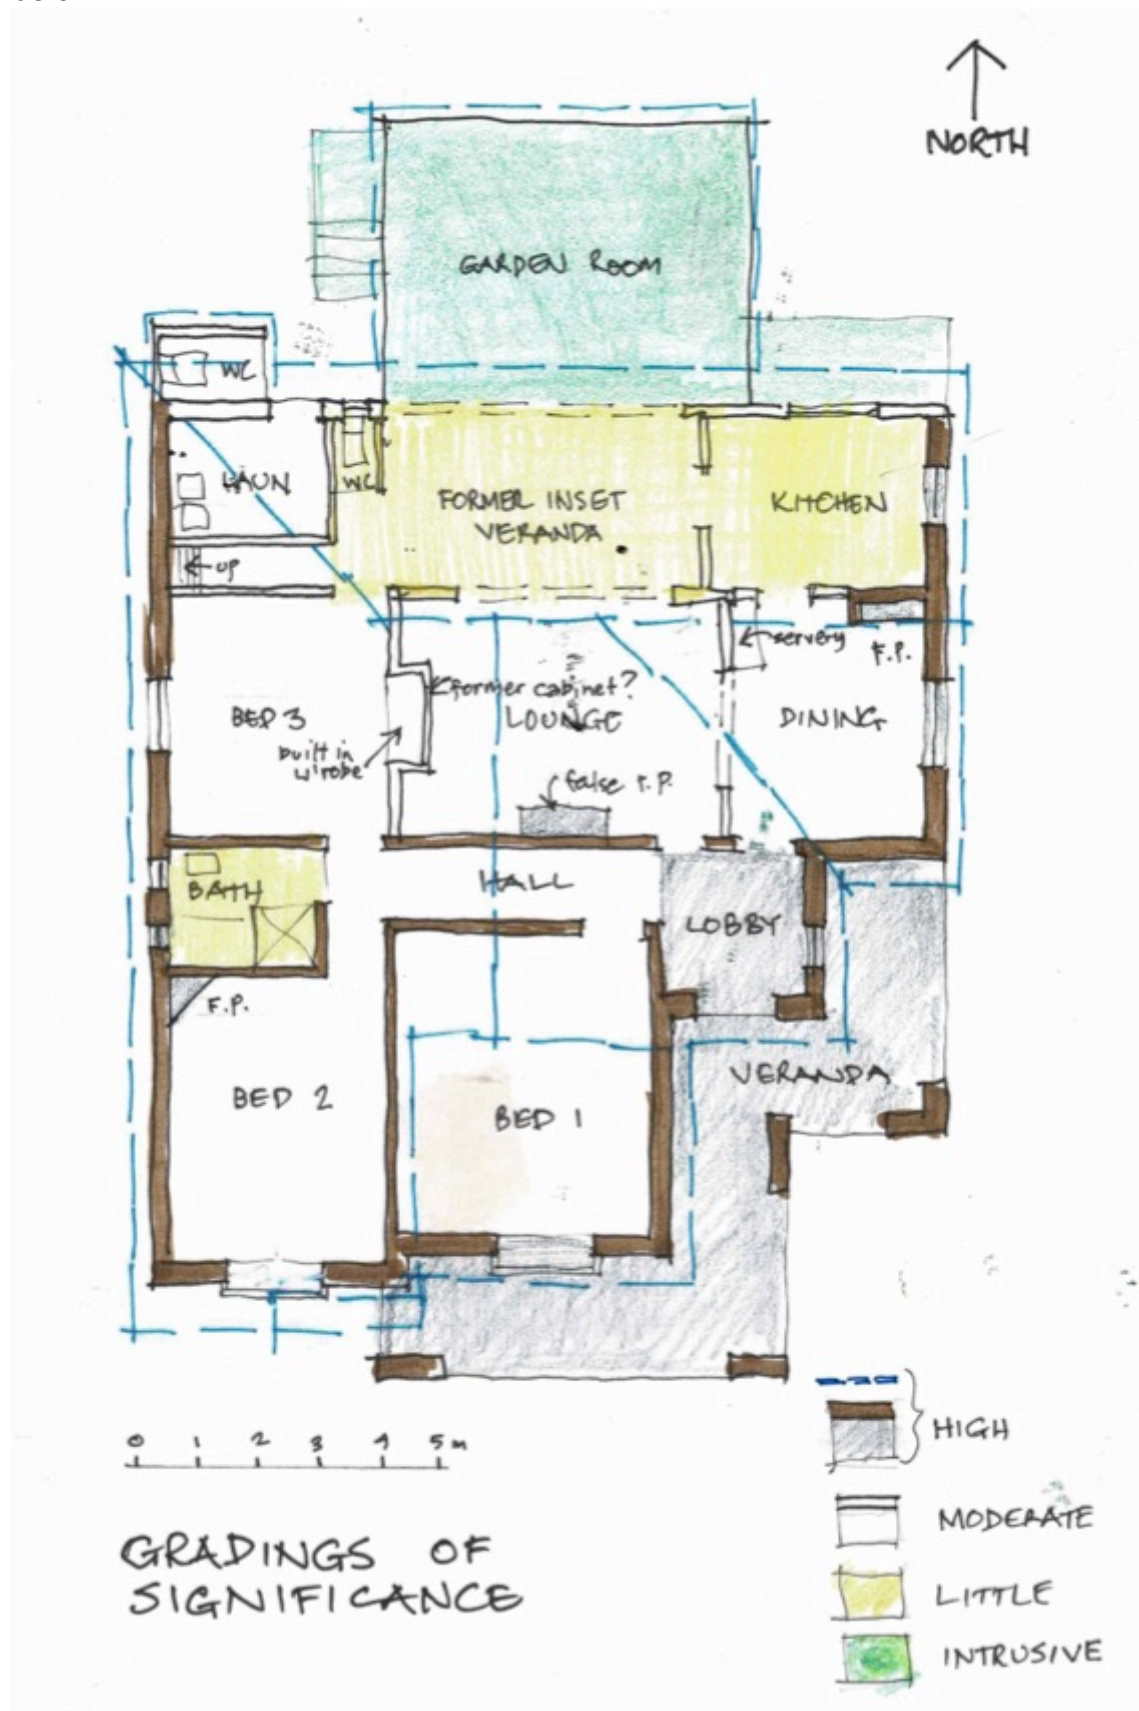
There is in this case a correlation between the intactness of the main components and their importance as elements in the design, resulting in the gradings illustrated below.

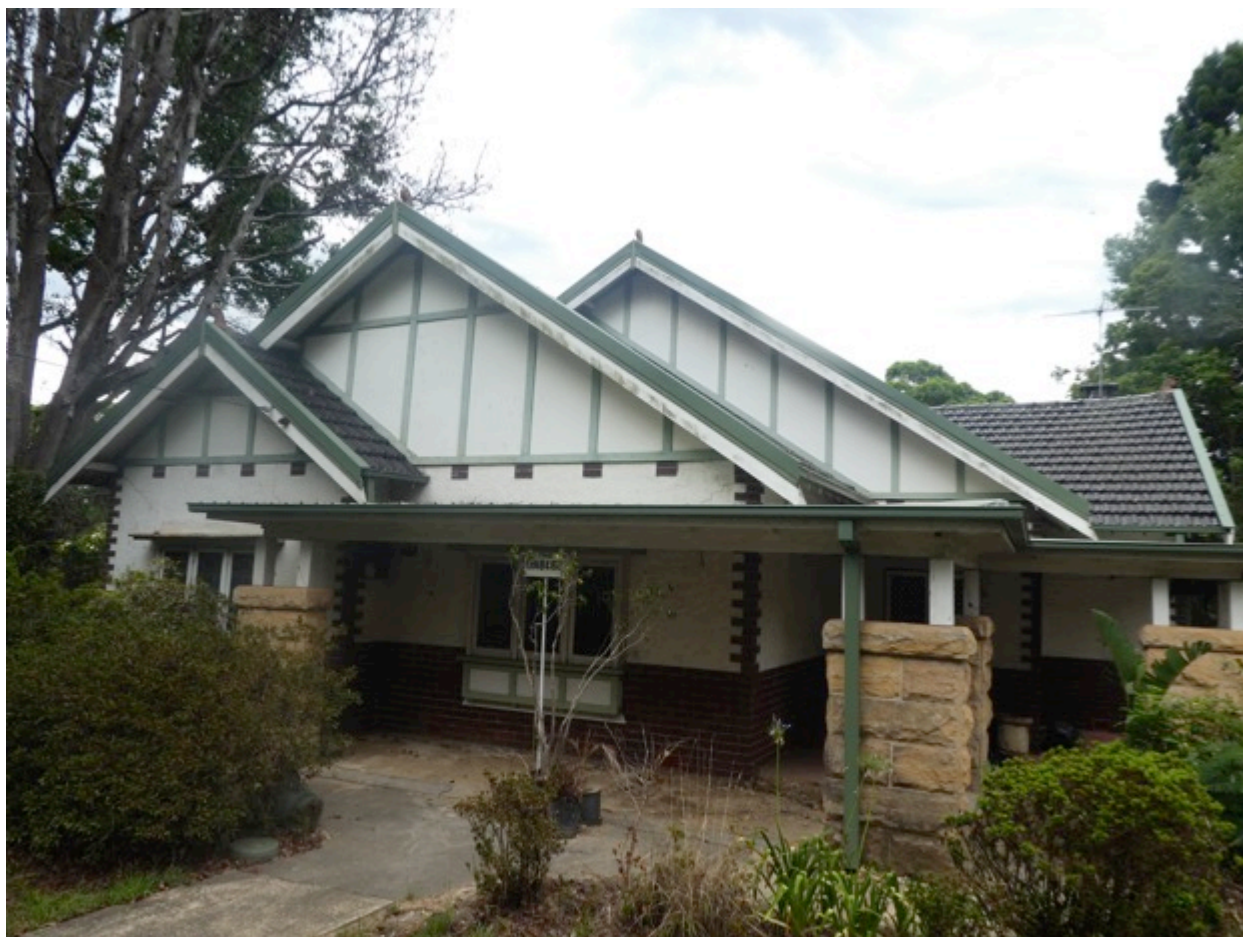
Image caption	“The Gables” – 69 Kissing Point Road, Turramurra, eastern elevation showing gable with timber battens, gable vent, taper-cut bargeboard, roughcast stucco and sandstone foundations				
Image year	2017	Image by	Shreeji Consultants	Image copyright holder	Shreeji Consultants / Ku-ring-gai Council

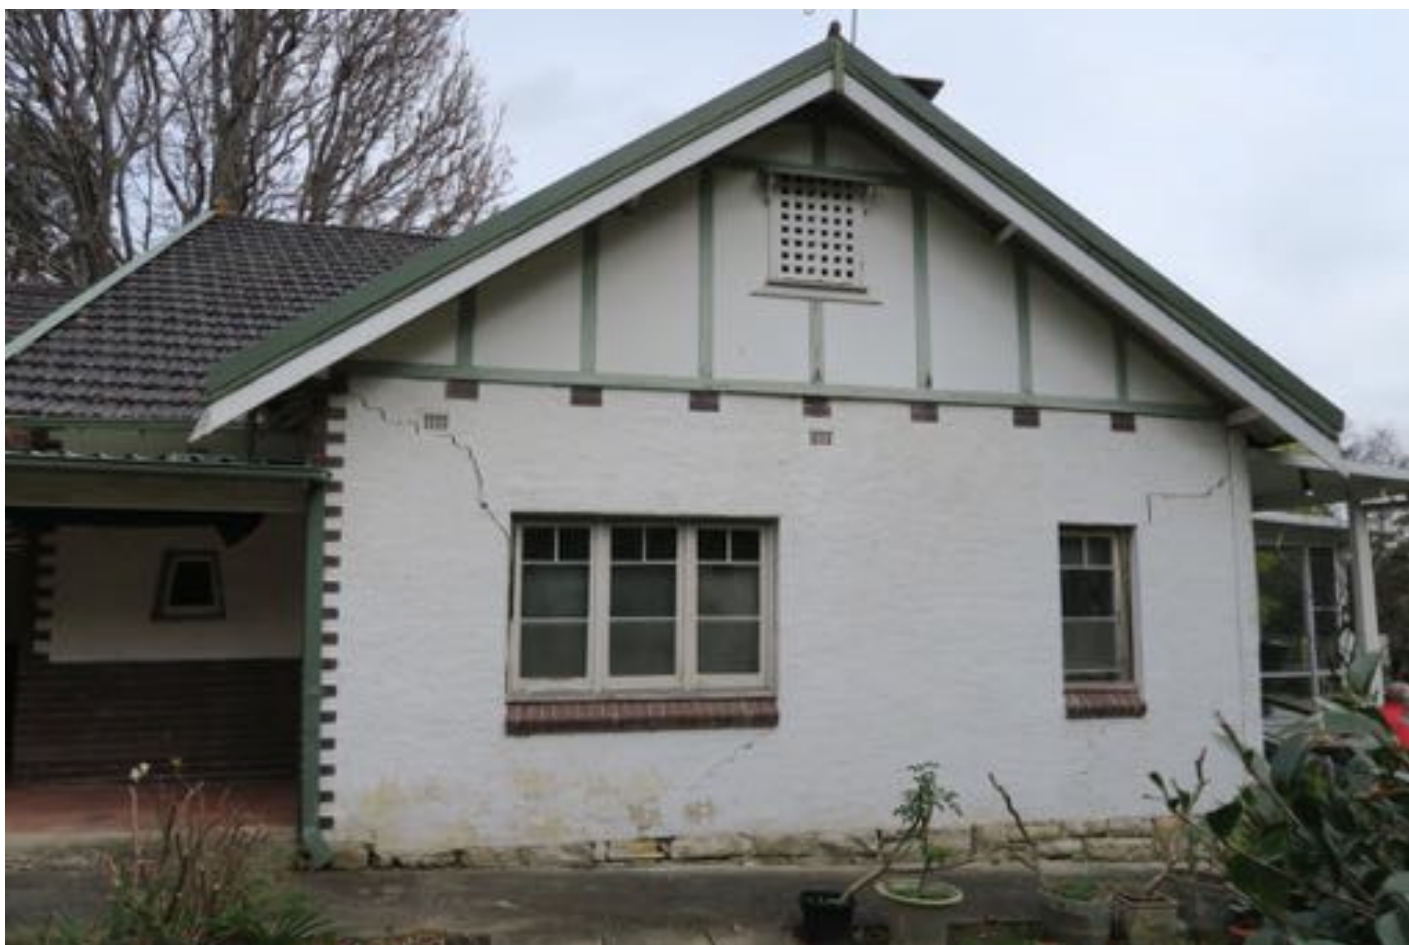
Image caption	Building eastern elevation and rear elevation showing sunroom addition, rear gablet and roughcast chimney				
Image year	2017	Image by	Shreeji Consultants	Image copyright holder	Shreeji Consultants / Ku-ring-gai Council

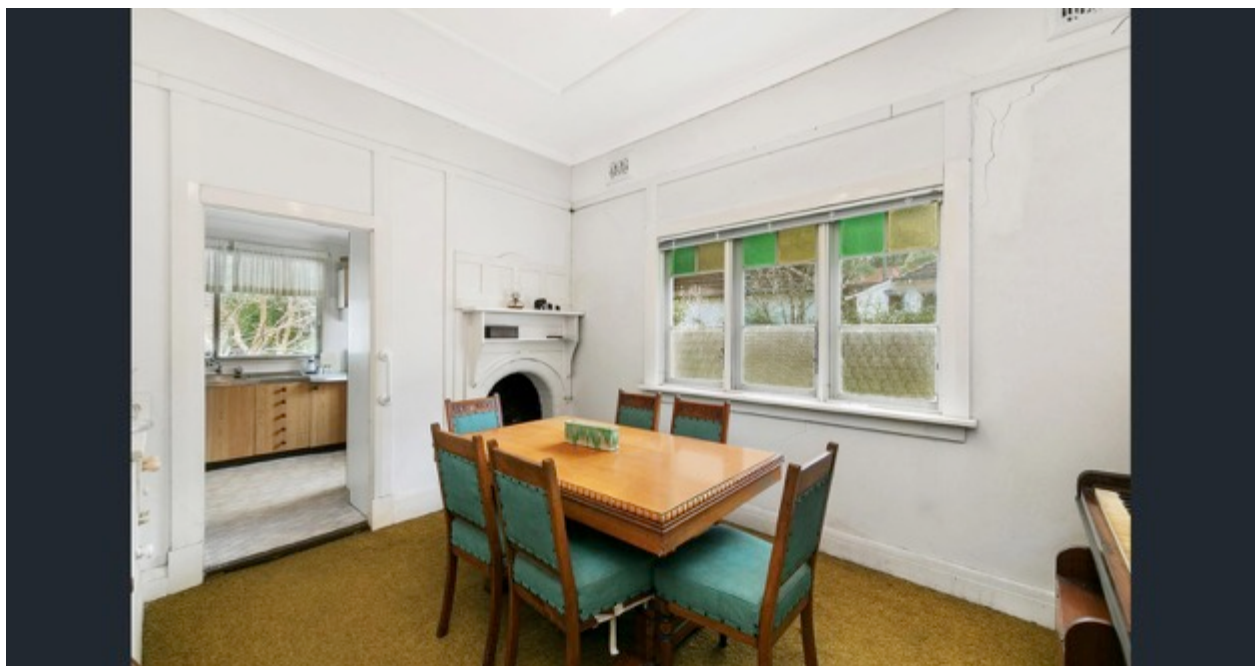
Image caption	Ceiling detail				
Image year	2017	Image by	Maxine Bayley	Image copyright holder	Ku-ring-gai Council
