**DETAILED SITE INVESTIGATION,  
65 – 67 MANDARIN & 38-42 SEVILLE STREETS,  
VILLAWOOD, NEW SOUTH WALES**

**MERHIS PTY LTD**

**PROJECT NO. 19852/4618C  
REPORT NO. 14/1786**

**SEPTEMBER 2014**

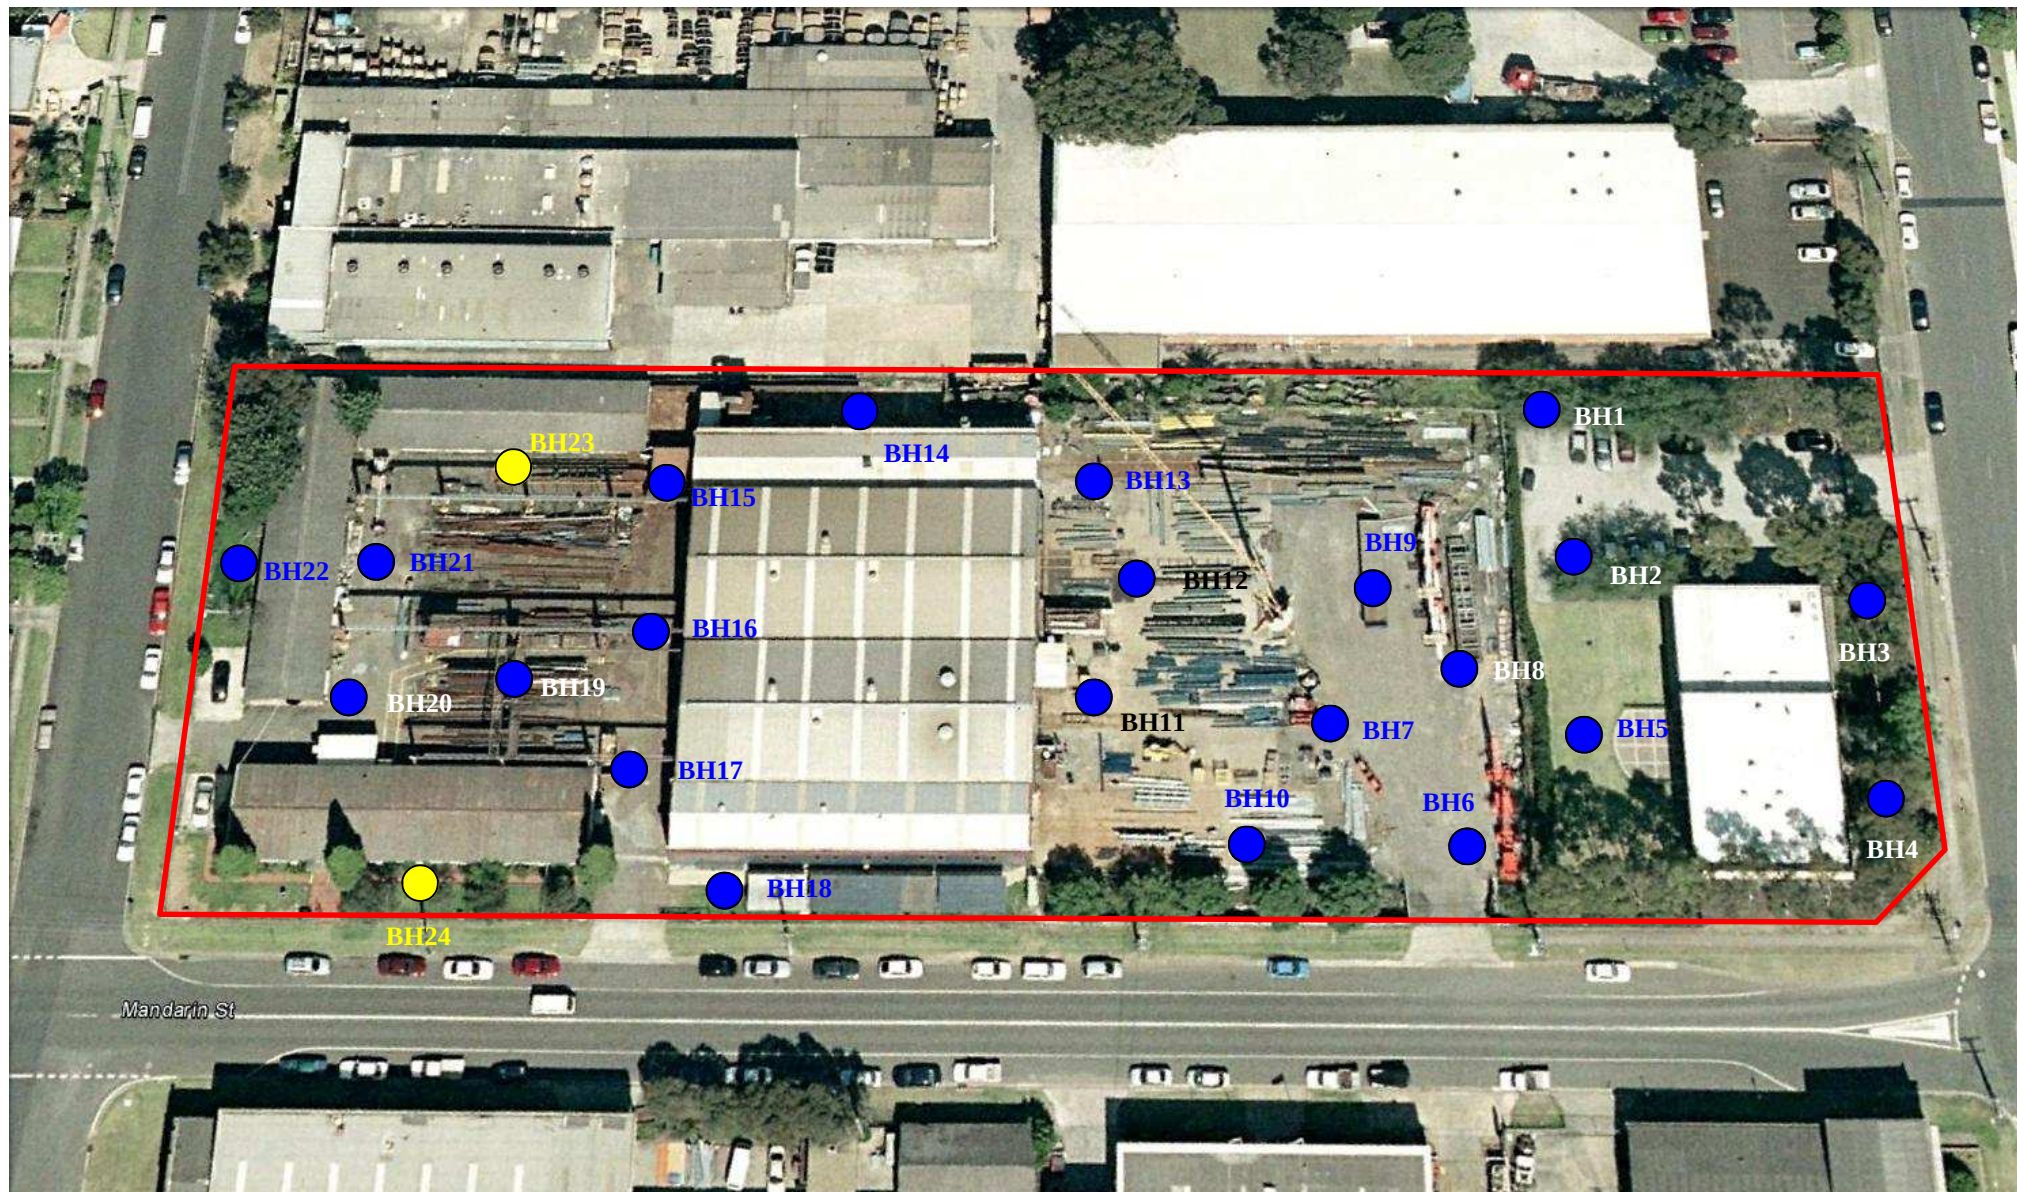
DRAWING NO. 14/1786/2 - SITE FEATURES AND SAMPLING LOCATIONS

The site was inspected on 19 August 2014 to confirm the condition of the land and to identify potential contamination sources. A plan showing the current site configuration is shown on Drawing No.14/1786/2. The key site features as determined by the site inspection are:

- A two story brick building used for officers is located at the site. The eastern portion of the site is covered with concrete and used for car parking.
- The boundaries of the site are lined with mature trees and the exposed ground covered in grass.

- The centre of the site is covered with a large warehouse building that is used for welding and painting of steel products. No sampling could be completed within the building due to access issues. The building is covered with hardstand surfaces.

- Three small buildings are located to the west of the main warehouse building and are used as site offices.
- The southern portion of the site has three long warehouse buildings constructed on each of the three boundaries. Two of the buildings are used for storage of various products including various oils and chemicals especially the building on the southern boundary. The building located on the eastern boundary is being used as an office. All three buildings are constructed with asbestos roofing and some walls appeared to be constructed of fibre cement sheeting which may contain asbestos fibres.

- The two areas, south and north of the warehouse, are used for the storage and distribution of a variety of metal products. Overhead cranes are located in the south of the site that directly enters the warehouse. A large crane is located in the centre of north section of the site and used to move steel products around the site prior to distribution.

- The area to the south of the main warehouse is covered in concrete and asphalt with no bare ground. Half of the area to the north of the warehouse is covered with concrete. The exposed ground which is in the north portion of the site is covered with gravel.

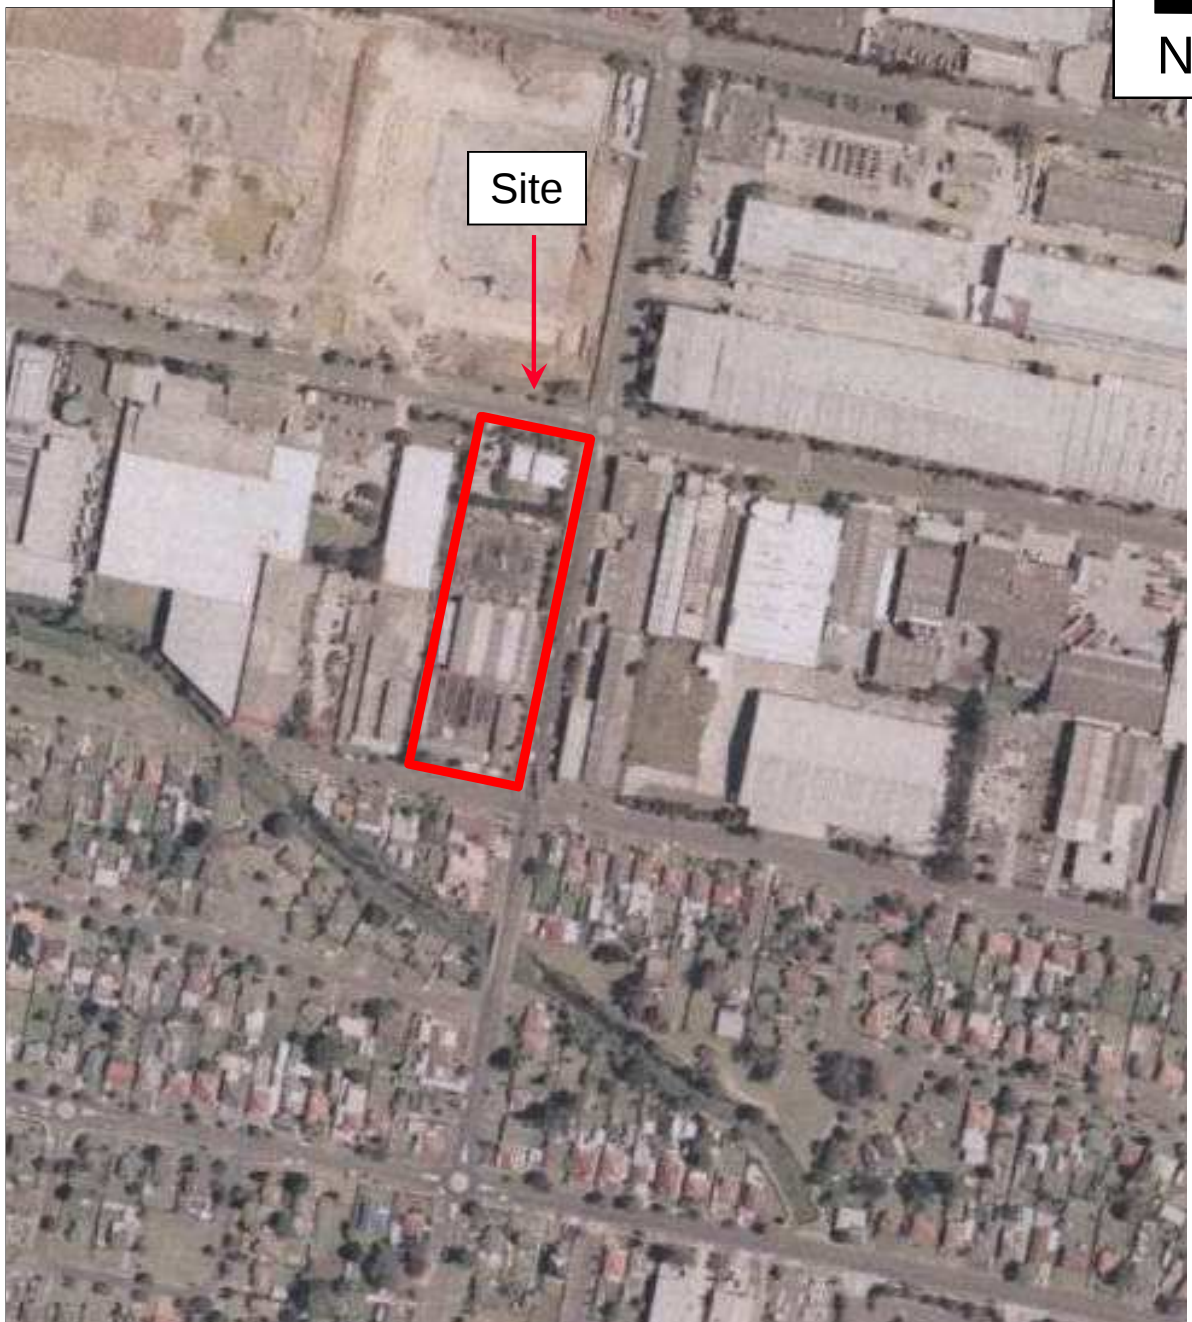
2005 Aerial Photograph Showing the Site and its Surrounds

| Year | Site Features | Surrounding Land Use |
|---|---|---|
| 2005 | The site features are essentially unchanged. | The land surrounding the site also remains largely unchanged. |

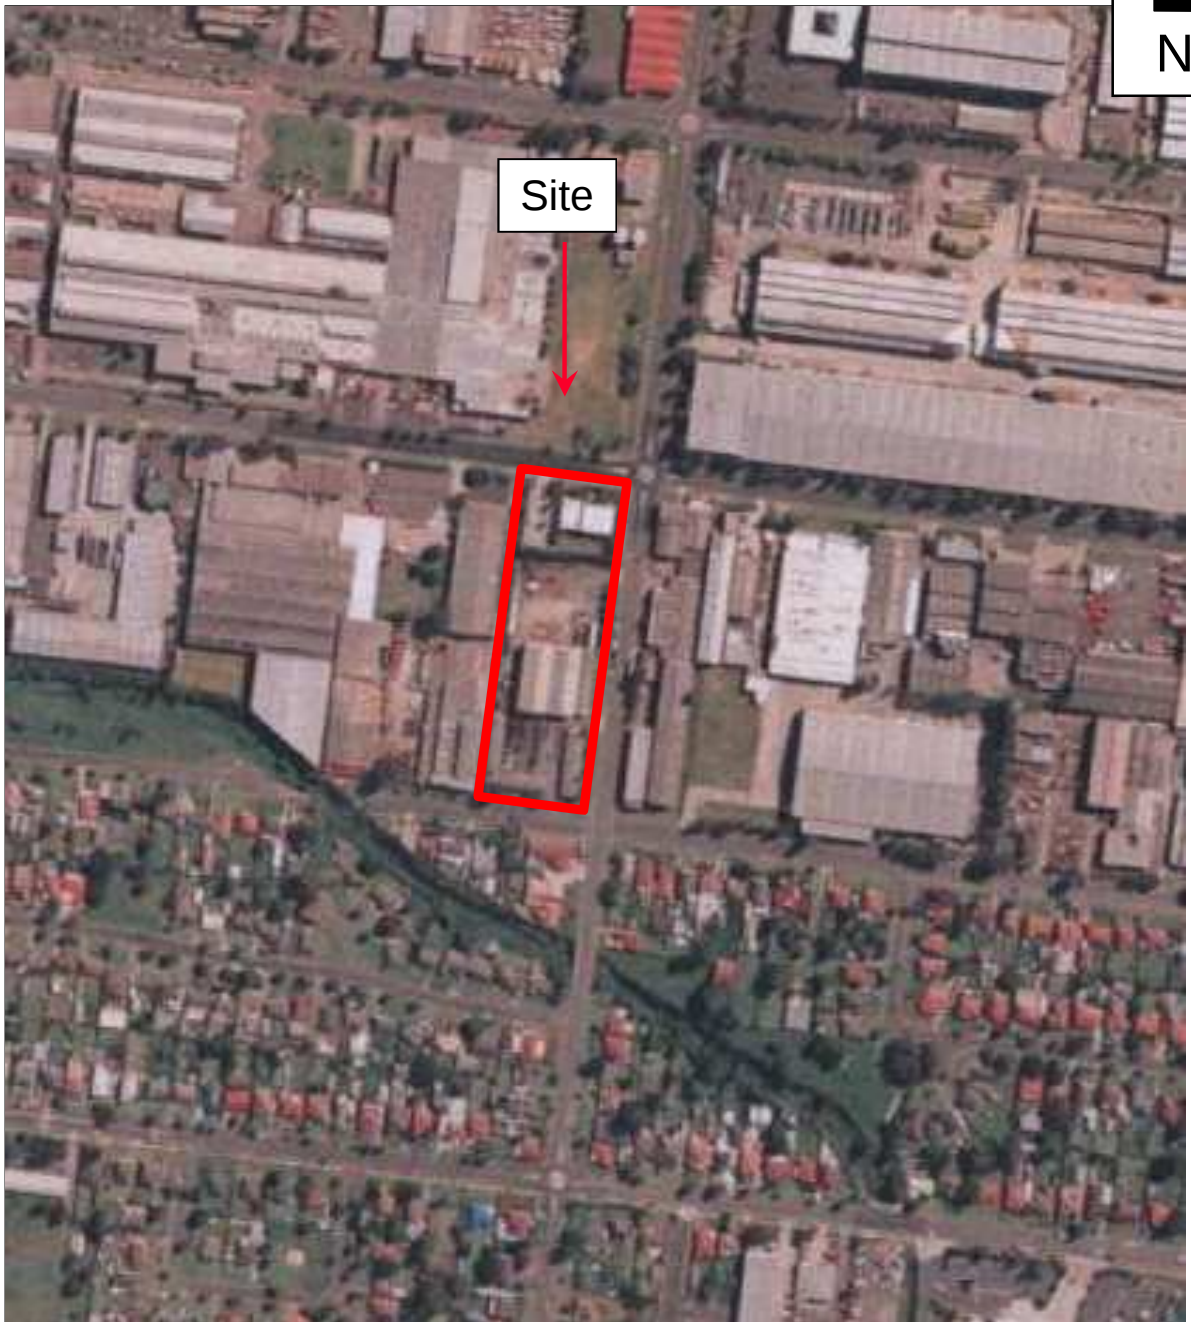
2002 Aerial Photograph Showing the Site and its Surrounds

| Year | Site Features | Surrounding Land Use |
|---|---|---|
| 2002 | The site northern portion of the site has been redeveloped with a commercial/industrial building. The remainder of the site is essentially unchanged. | The land surrounding the site remains largely unchanged. |

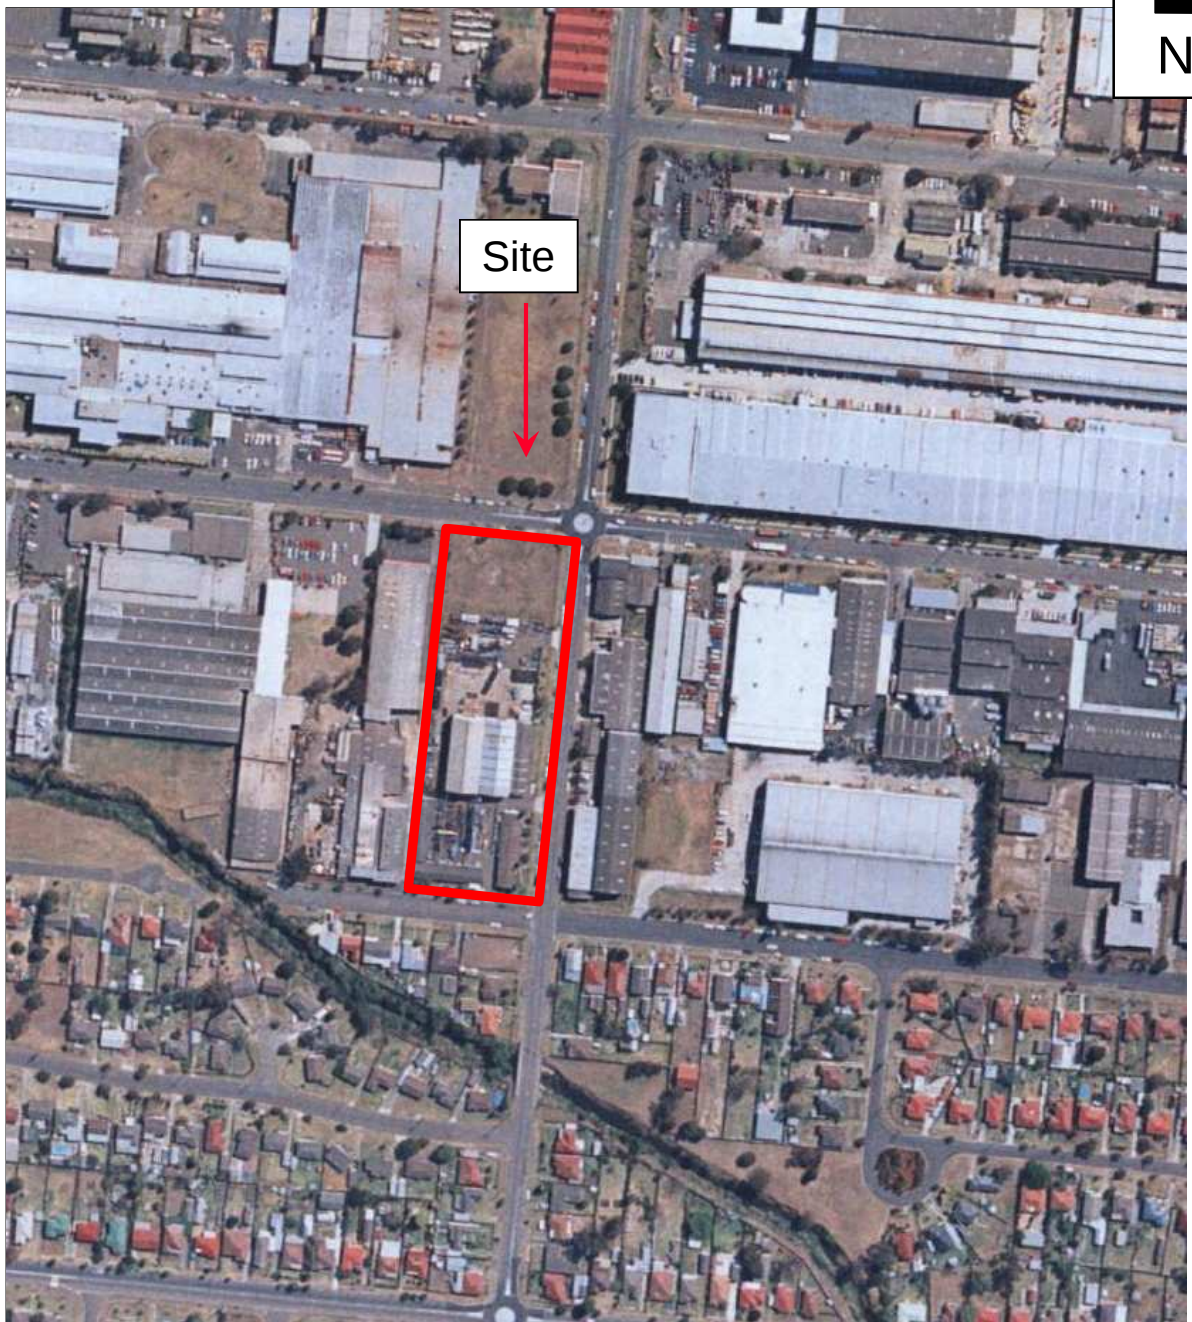
1994 Aerial Photograph Showing the Site and its Surrounds

| Year | Site Features | Surrounding Land Use |
|---|---|---|
| 1994 | The previously existing buildings in the northern portion of the site have been demolished and no infrastructure has replaced those buildings. The southern portion of the site is essentially unchanged. | The land surrounding the site remains largely unchanged. However an increase in the number of commercial/industrial buildings has occurred. |

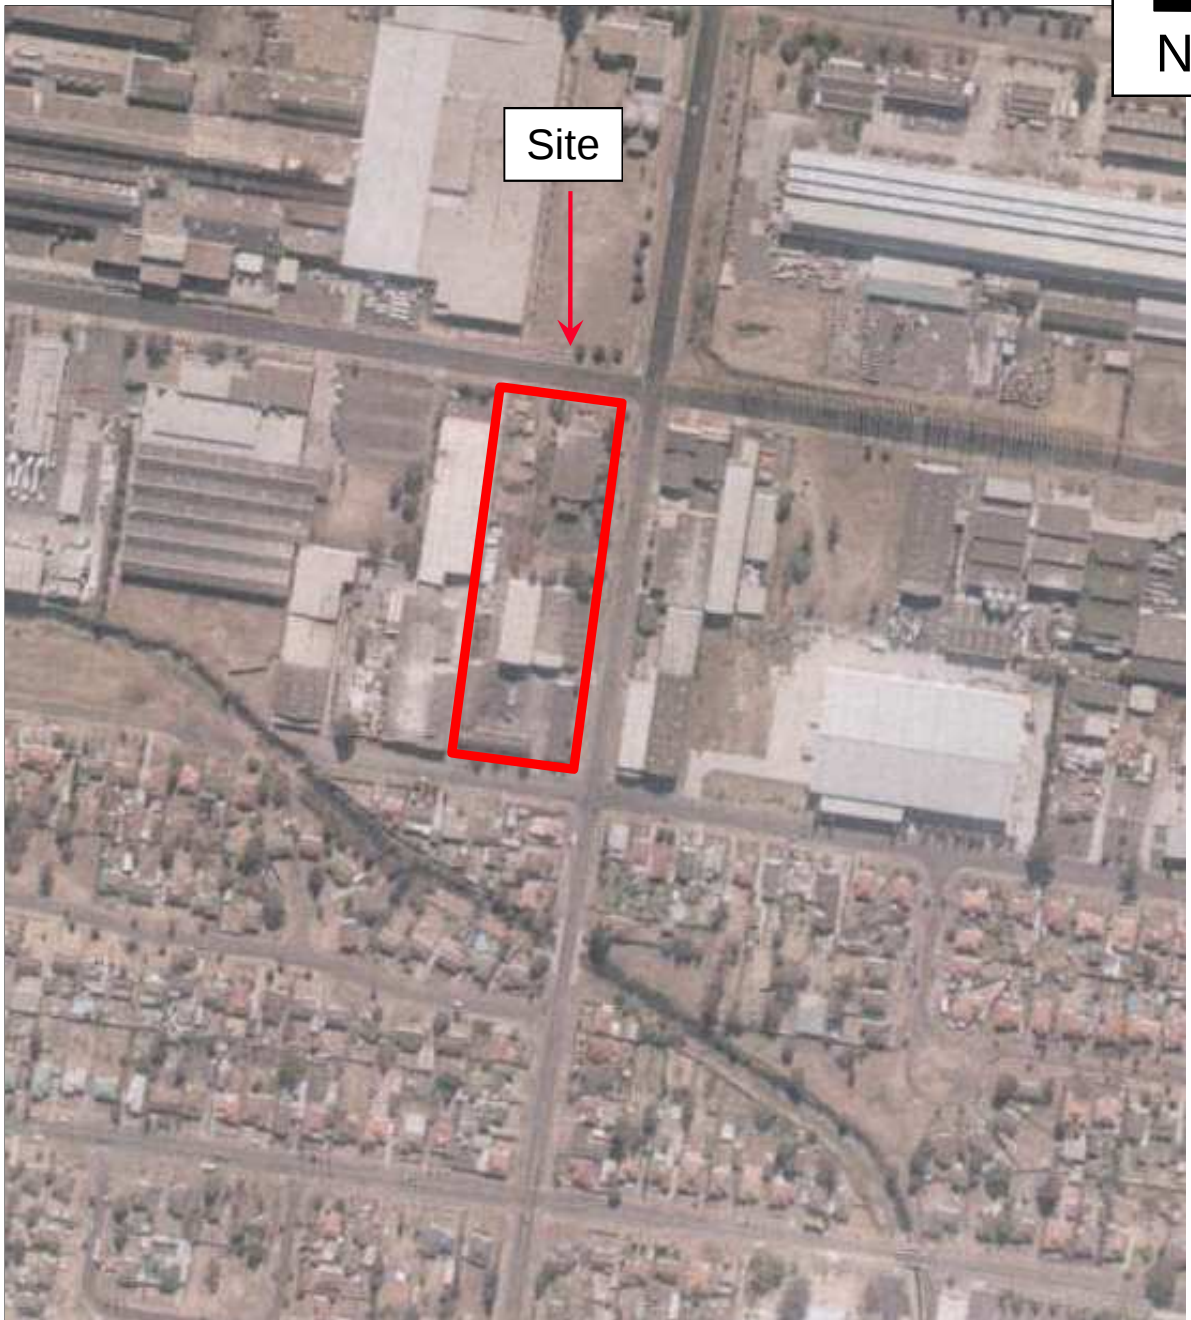
1986 Aerial Photograph Showing the Site and its Surrounds

| Year | Site Features | Surrounding Land Use |
|---|---|---|
| 1986 | The site features are essentially unchanged however; the commercial/industrial building located in the centre of the site has been extended. | The land uses surrounding the site remain largely unchanged. |
