Melrose Park

Initial Geotechnical Assessment

12 November 2015

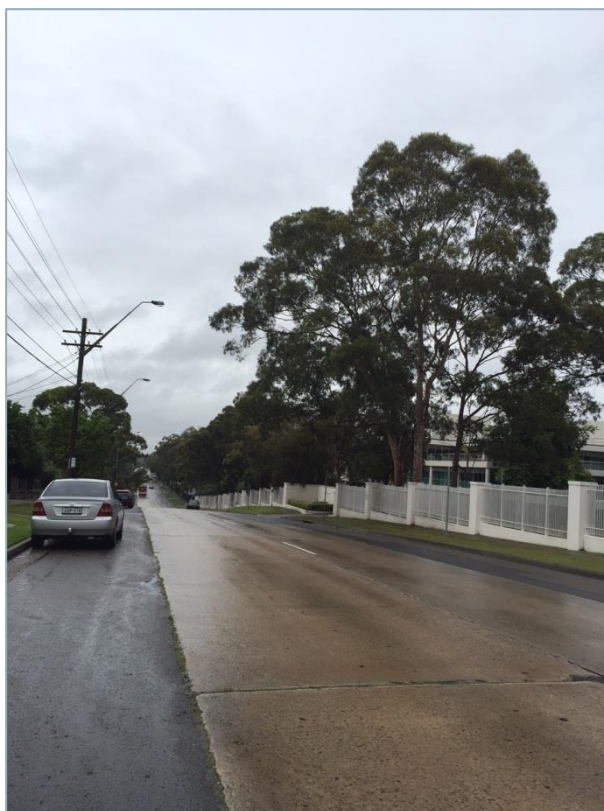
Topographic survey of the local region indicates the site sits on the southern end of a low ridgeline running from a high point at the intersection of Marsden Road and Stewart Street in West Ryde to the Parramatta River. The area surrounding the site typically falls gently to the south, with a drop to the east, towards the Ryde-Parramatta Golf Course. A localised depression runs through the site, from the north western extent to a position mid-way along Wharf Road, at the intersection with Taylor Avenue. This depression is likely associated with the drainage channel that runs along Codham Avenue to the golf course ponds.

Photograph 1 – Wharf Road looking south, the drainage channel depression in the distance

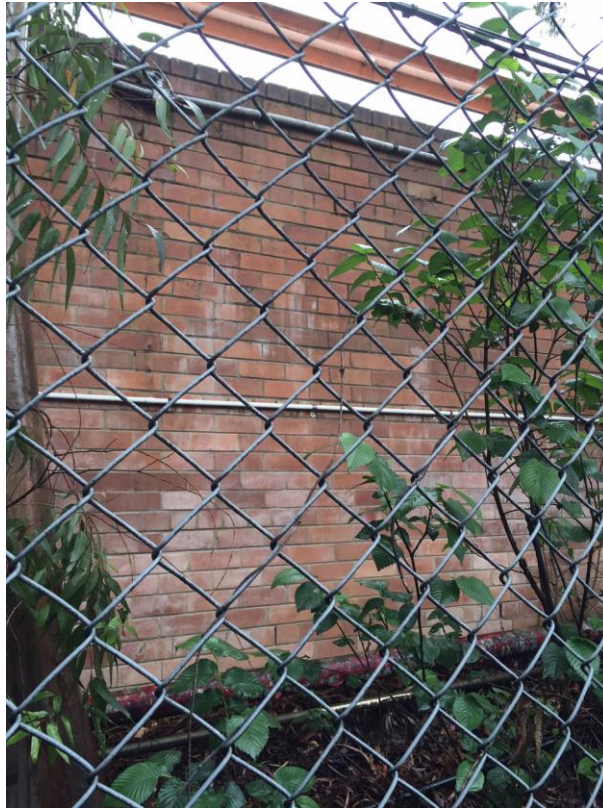
A series of retaining walls form the southern, Hope Street, boundary. These retaining walls were observed up to 2.5m high and consisting of a mixture of brick masonry, concrete crib and sandstone block walls, as shown in the following photographs.

Photograph 2 – Brick masonry wall along Hope Street

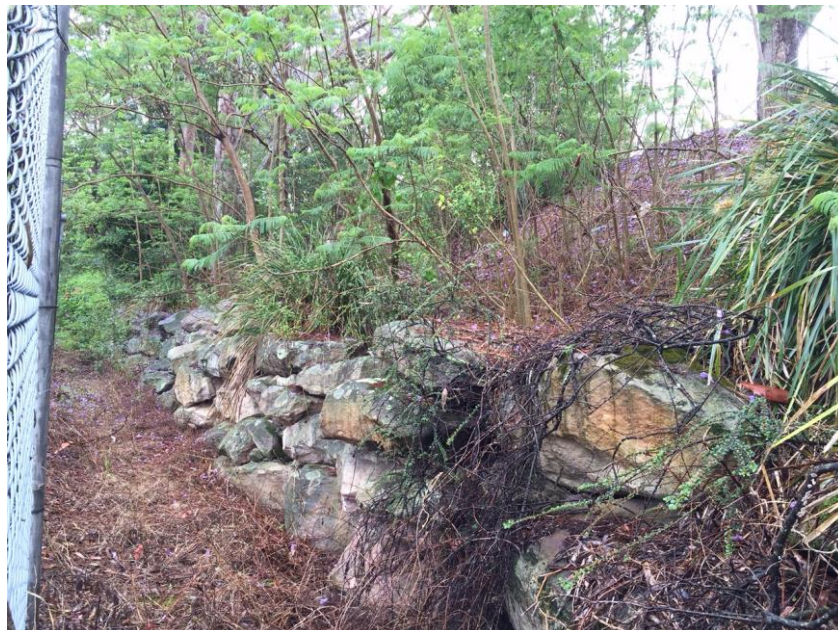
Photograph 3 – Sandstone block wall

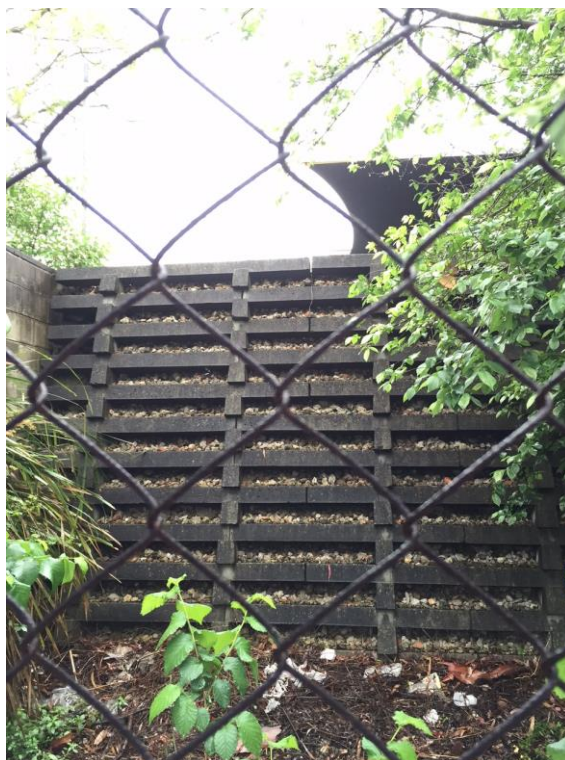
Photograph 4 – Concrete crib wall

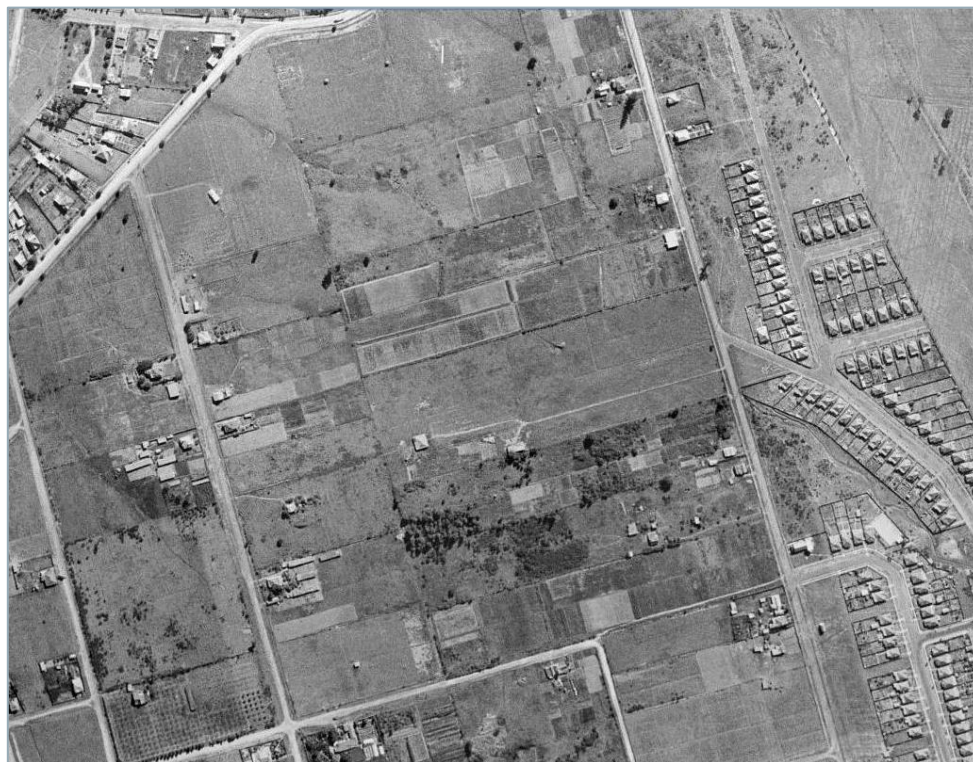
A review of the publically available 1943 aerial photograph of the site (accessible on the NSW SIX database) indicates the site was used predominantly as market gardens with houses on large plots. The photograph also shows the original course of the, potentially ephemeral, creek running along the alignment of the north-west to south-east trending topographical depression. The aerial photograph is reproduced below:

Photograph 5 – 1943 Aerial photograph (reproduced from www.maps.six.nsw.gov.au)

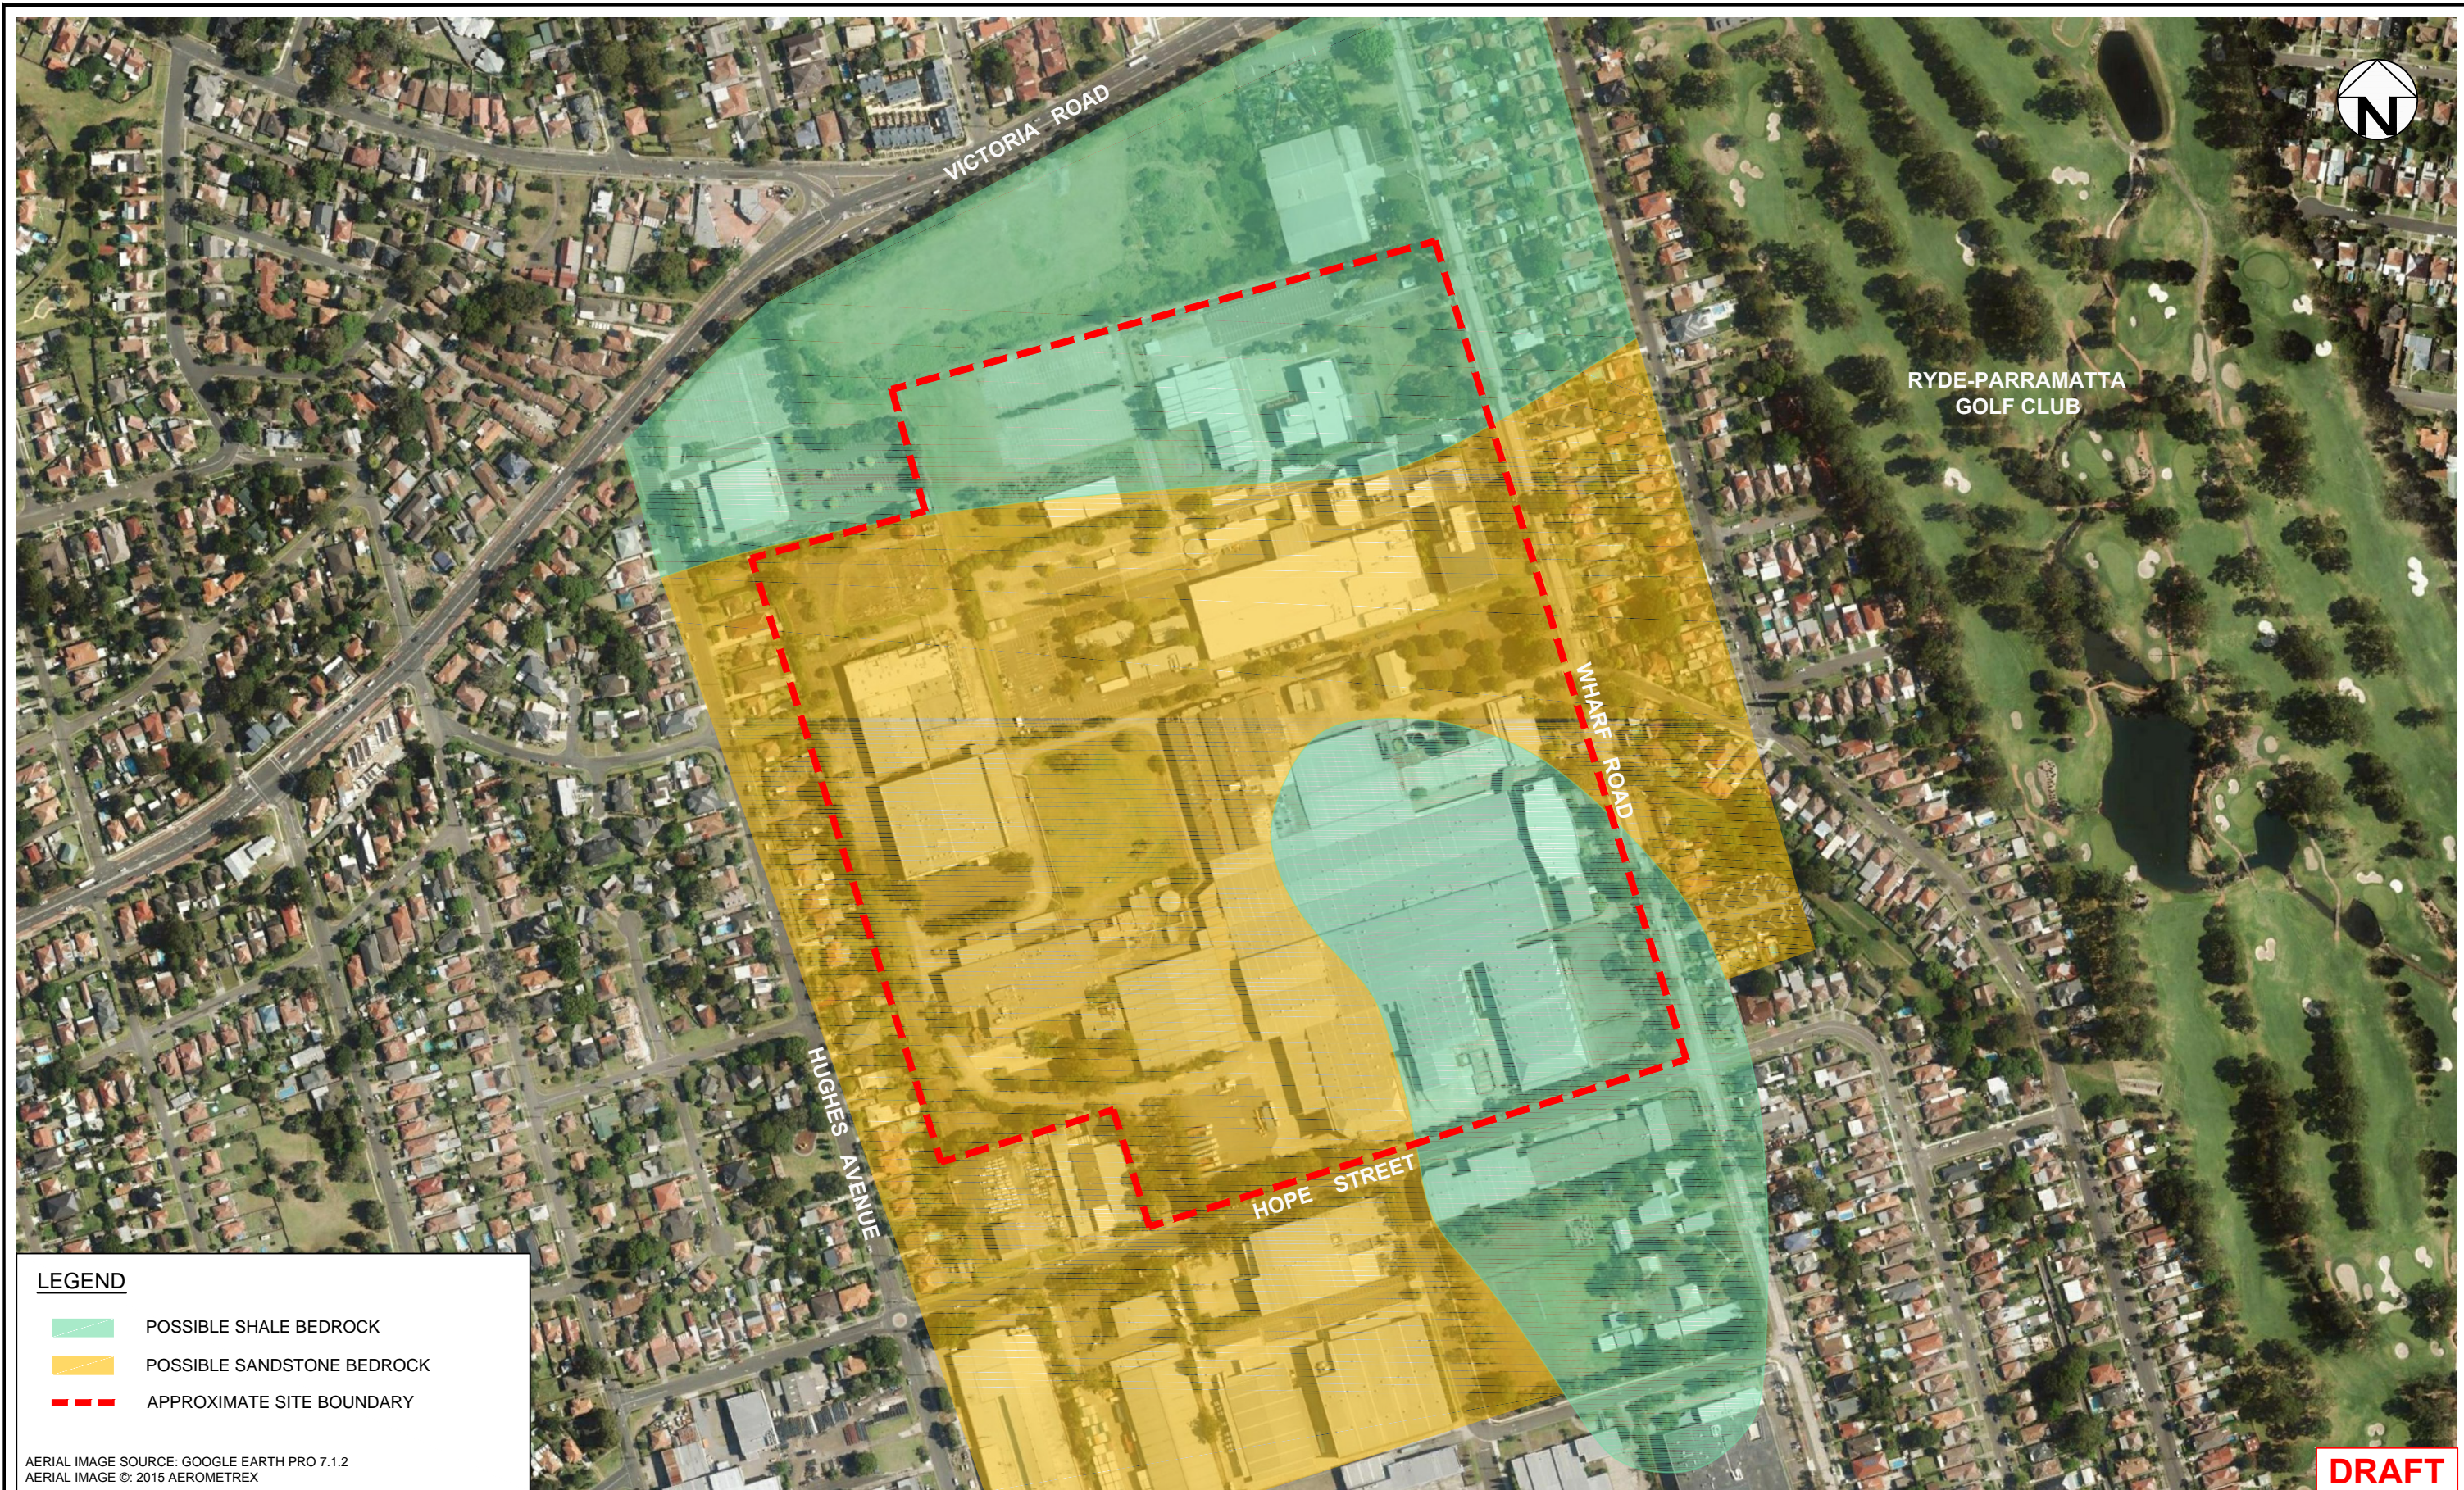
Figure 1 – Initial Assessment of Subsurface Geology

The Sydney 1:100,000 Scale Geological Sheet indicates that the site is mainly underlain by Triassic age Hawkesbury Sandstone, with the younger Ashfield Shale extending below the northern extent of the site. The Mittagong Formation is found between the two main geological units, which is typically observed as an interbedded fine grained sandstone and mudstone representing transition beds between the two depositional events. Within the Sydney Basin the Mittagong Formation is typically observed to range from a couple of metres to up to 8m thick, however it is sometimes not detectable.

During the site walkover a number of recent, shallow excavations were observed, with cuttings of bedrock found along both Hope Street and Hughes Avenue. These bedrock samples indicate the presence of shale, potentially derived from Mittagong Formation bedrock, along the eastern section of Hope Street, and sandstone along Hughes Avenue. Figure 1 has been prepared showing the likely subsurface conditions based on the results of the site walkover and nearby borehole drilling. Due to the significant reprofiling and filling of the site for the construction of the industrial units we have chosen not to show the man made fill across the site. Additionally, due to this working of the site we have not shown the presence of alluvium within the local depression, as this material may have been removed during construction.
