HERITAGE ASSESSMENT

Meriden Anglican School for Girls Senior Campus

October 2013

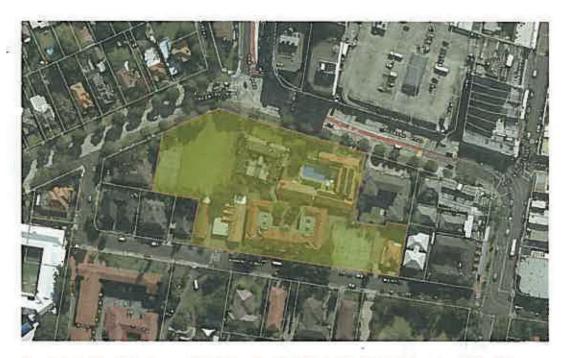
Figure 2: Meriden School Senior Campus at 10-28 Redmyre Road, Strathfield, Lot 101, DP 862040 (image from NSW Land & Property Information Six Maps)

The real property description of the Senior Campus of the Meriden Anglican School for Girls site at 10-28 Redmyre Road, Strathfield is Lot 101, DP 862040. The site is located on the southern side of Redmyre Road, fronting Redmyre Road along its northern boundary, and fronting Margaret Street along its southern boundary. The site also has a secondary address, 3-13 Margaret Street. Figure 1 below is a simple image of the site with the majority of the existing buildings shown, taken from the school's website. Figure 2 shows a satellite view of the existing Senior Campus.

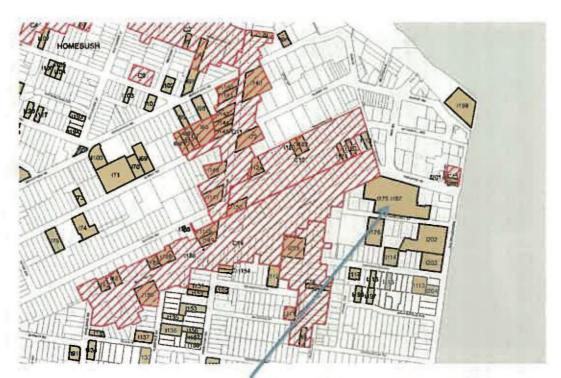
Figure 3: Extract of Strathfield LEP 2012 Heritage Map No. 5 showing the site (indicated with arrow) and nearby Redmyre Road Conservation Area No. C14 (hatched red). Also note Heritage Item No. 1176 to the south (this is No. 16 Margaret St).

The site is adjacent to the Redmyre Road Strathfield Conservation Area No. C14 (as shown hatched red on Figure 3 above), and in the vicinity of a heritage item No. I176 located at No. 16 Margaret Street (Lot 1, DP 723946), which is a Victorian house and garden known as "Lingwood", formerly "Branxton", and is of Local significance. Note that "Lingwood" is owned by Meriden School and is referred to as the "Lingwood Campus" of the school.

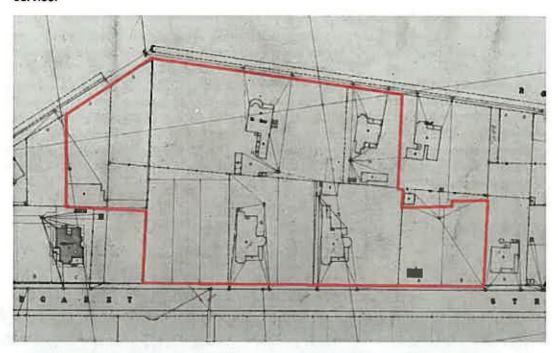
Figure 4: Survey of the Meriden School site as at 1893 Source: Sydney Water

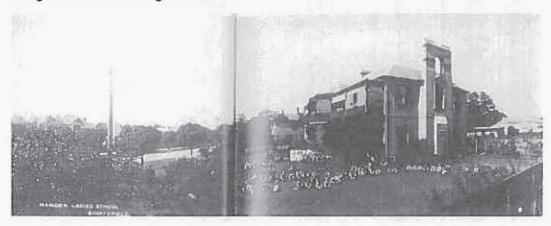
Figure 5: The Briars with Wariora (now demolished) in the background. Not dated (1920s). Source: Cooke, A, Visions of Parnassus: Meriden's first 100 years, Strathfield, 1997, p.22

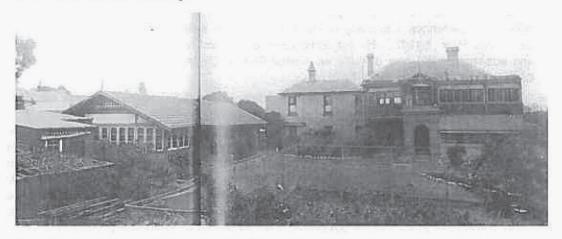
Figure 6: The Bungalow (now demolished) and Briars in 1929. Source: Cooke, A, Visions of Parnassus: Meriden's first 100 years, Strathfield, 1997, p.34-35

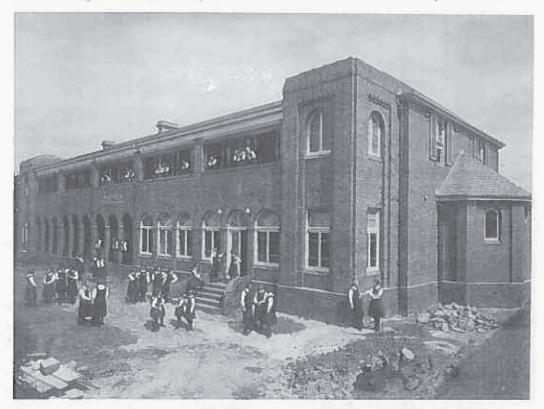
Figure 7: Wallis Hall shortly after completion in 1936. Note this photo is taken from the western end, with the chapel at right. Note there is no clock tower on the corner in foreground (the north-western corner of the building), The clock tower was added when the building was refurbished in 1992. Source: Cooke, A, Visions of Parnassus: Meriden's first 100 years, Strathfield, 1997, p.56

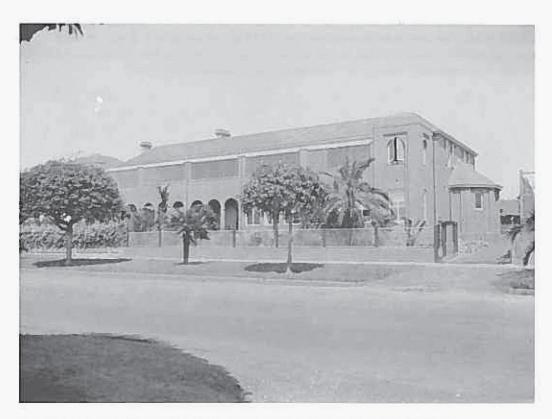
Figure 8: The Redmyre Road frontage of Wallis Hall, c.1940 Source: National Library of Australia (vn3095541-v)

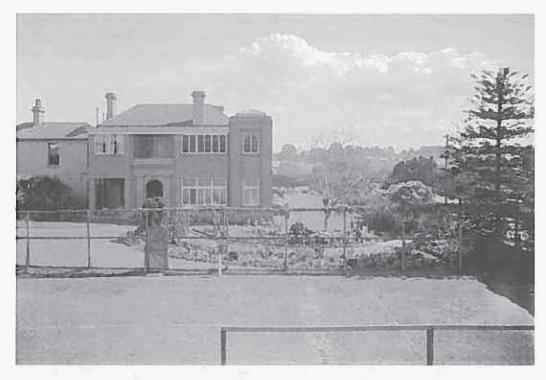
Figure 9: The east elevation of Wallis Hall, c.1940. Note the former service wing of *The Briars* at left. Also Norfolk Island Pine at right. Source: National Library of Australia (vn3101025-v)
