Our Reference: 13730-Soils final

**Re: Soils and Salinity Investigation, Ulan**

### **1.1 Background**

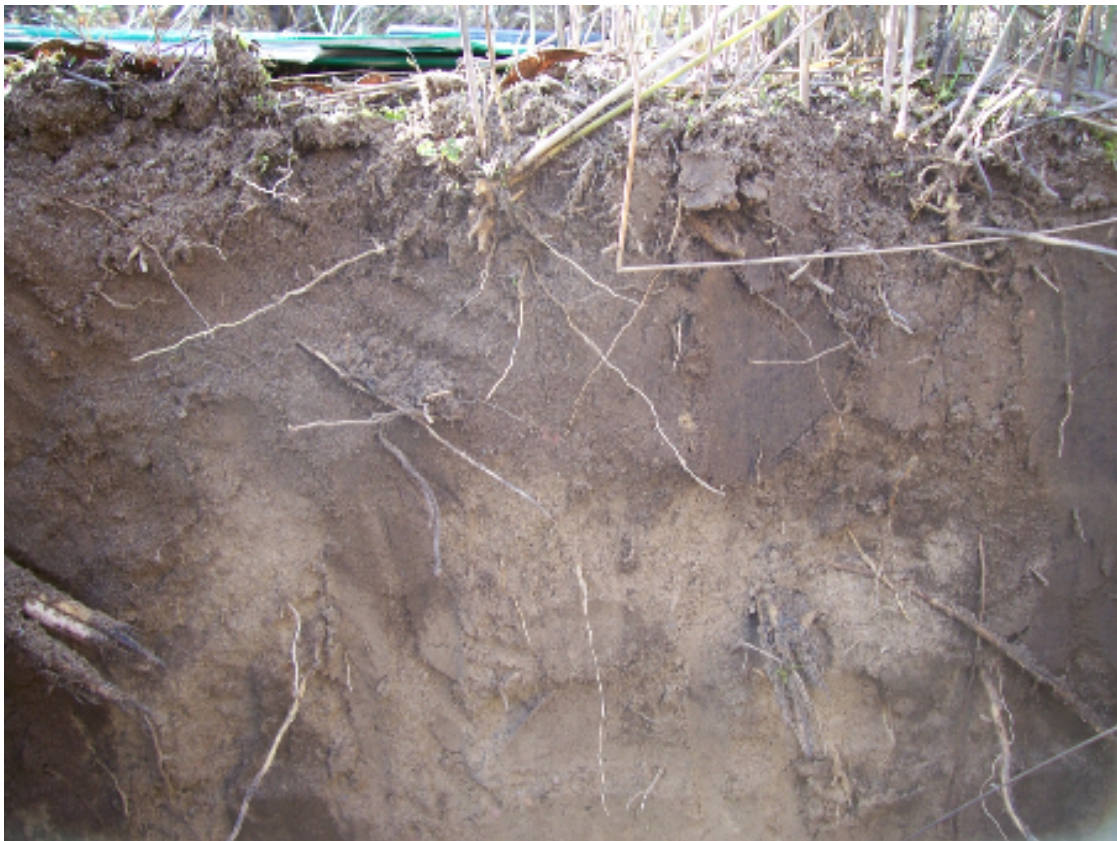
**Table 3 - Summary Survey Site 1**

| HORIZON | DEPTH | BOUNDARY | FIELD TEXTURE | FIELD pH | FIELD COLOUR | PLASTICITY | ROCK FRAGMENTS |
| A | 0-0.1m | Clear | Loamy Sand | 6 | 10YR 4/2 | Non plastic | None |
| B1 | 0.1-1m | Gradational | Loamy Sand | 6 | 10YR 5/4 | Non plastic | Small pebbles <5% |
| B2/C | 1-1.5m | | Pebbly Sand | 6-6.5 | 2.5 Y 7/4 | Non plastic | Med – Large pebbles 60-80% |

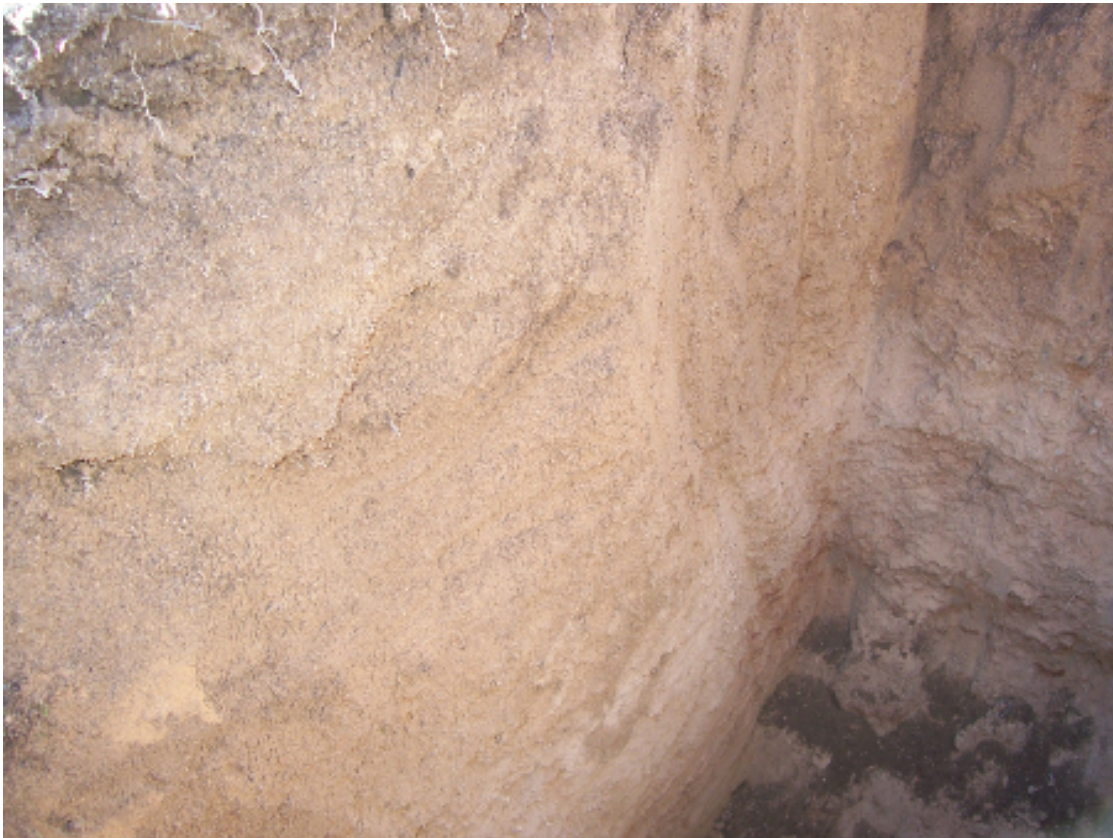
**Table 4 - Summary Survey Site 2**

| HORIZON | DEPTH | BOUNDARY | FIELD TEXTURE | FIELD pH | FIELD COLOUR | PLASTICITY | ROCK FRAGMENTS |
| A | 0-0.1m | Clear | Sandy loam | 6 | 10 YR 3/3 | Slightly plastic | Nil |
| B1 | 0.5m | Gradational | Sandy Loam | 6 | 10YR 4/4 | Slightly plastic | Nil |
| B2 | 0.5- 1m | | Loamy Sand | 6 to 6.5 | 10YR 6/4 | Non plastic | Nil |

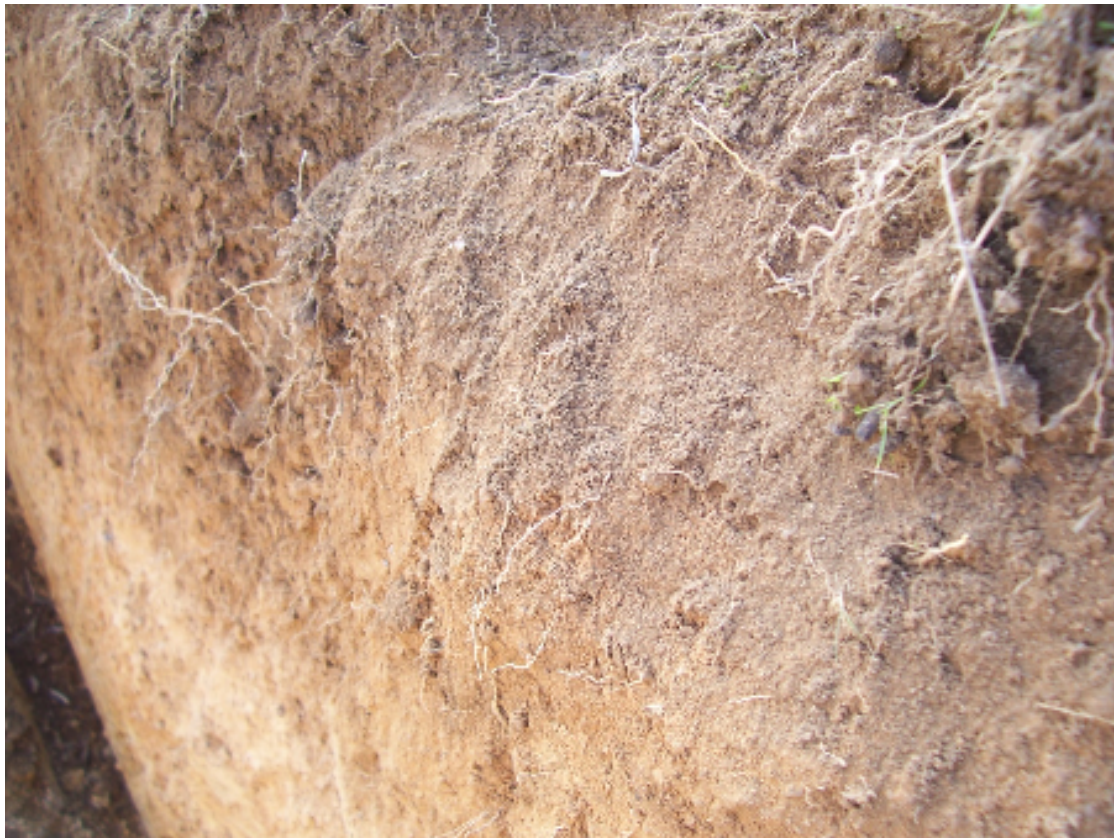
**Table 5- Summary Survey Site 3**

| HORIZON | DEPTH | BOUNDARY | FIELD TEXTURE | FIELD pH | FIELD COLOUR | PLASTICITY | ROCK FRAGMENTS |
| A | 0-0.1m | Gradational | Loam | 5.5 – 6 | 10 YR 3/3 | Moderately Plastic | Nil |
| B1 | 01.-0.2m | Gradational | Clayey sand | 6 | 7.5 YR 4/6 | Slightly plastic | Pebbles small to large – 40% |
| B2 | 0.2-0.7m | | Medium Silty Clay | 6 | 10 YR 5/6 | Very plastic | Small fragments 40-60% |

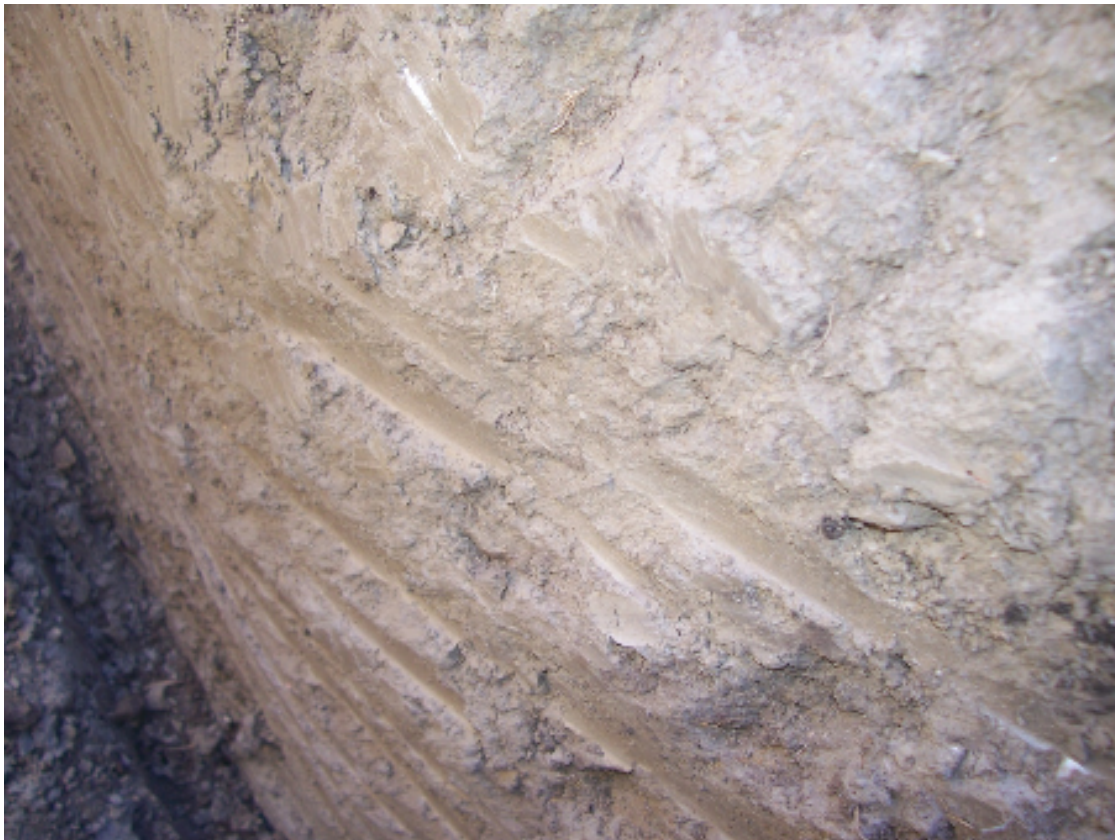
**Table 6 - Summary Survey Site 4**

| HORIZON | DEPTH | BOUNDARY | FIELD TEXTURE | FIELD pH | FIELD COLOUR | PLASTICITY | ROCK FRAGMENTS |
| A | 0-0.2m | Gradational | Sandy Loam | 6 | 10YR 3/2 | Slightly plastic | Nil |
| B | 0.2-1m | | Heavy clay | 7.5 | 2.5Y 5/2 | Very plastic | Nil |

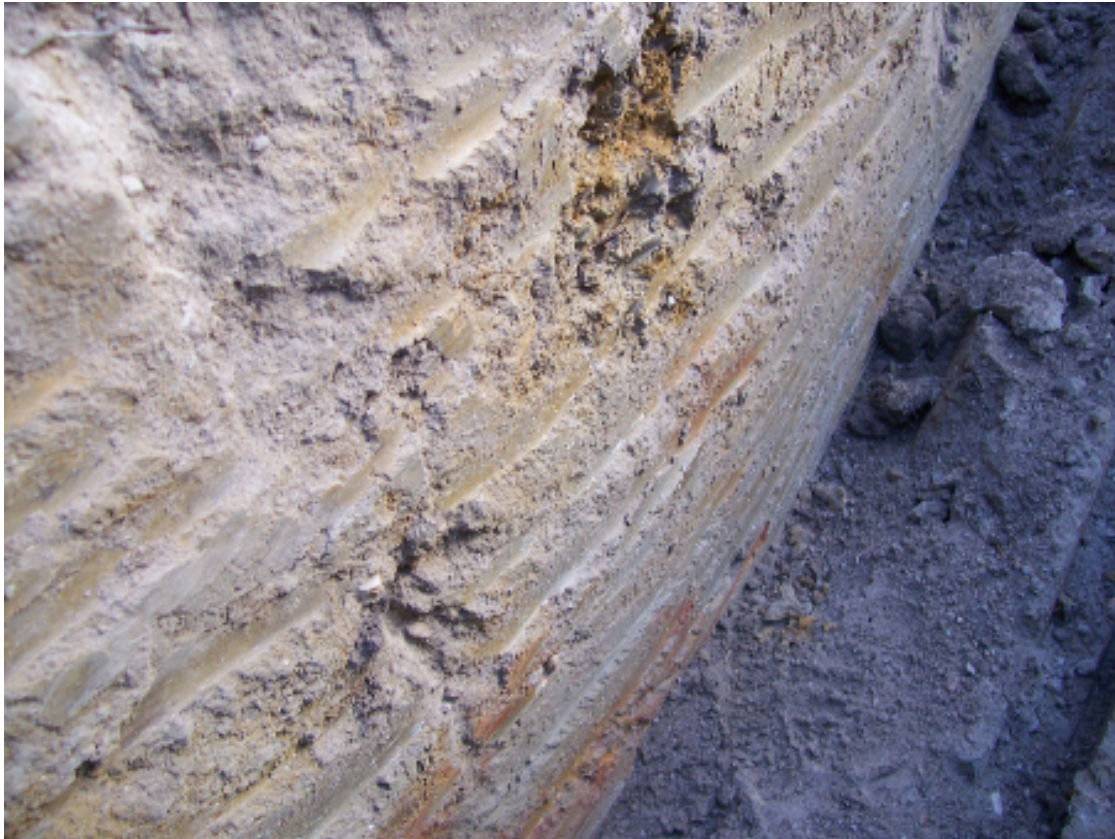
**Table 7 - Summary Survey Site 5**

| HORIZON | DEPTH | BOUNDARY | FIELD TEXTURE | FIELD pH | FIELD COLOUR | PLASTICITY | ROCK FRAGMENTS |
| A | 0-0.1m | Gradational | Loamy sand | 6 | 2.5 Y<br>4/2 | Slightly plastic | Nil |
| B1 | 01.-0.3m | Gradational | Clayey sand | 7 | 10YR<br>5/3 | Slightly plastic | Nil |
| B2 | 0.3-0.8m | | Medium heavy clay | 7.5 | 2.5Y<br>6/3 | Moderately plastic | Nil |

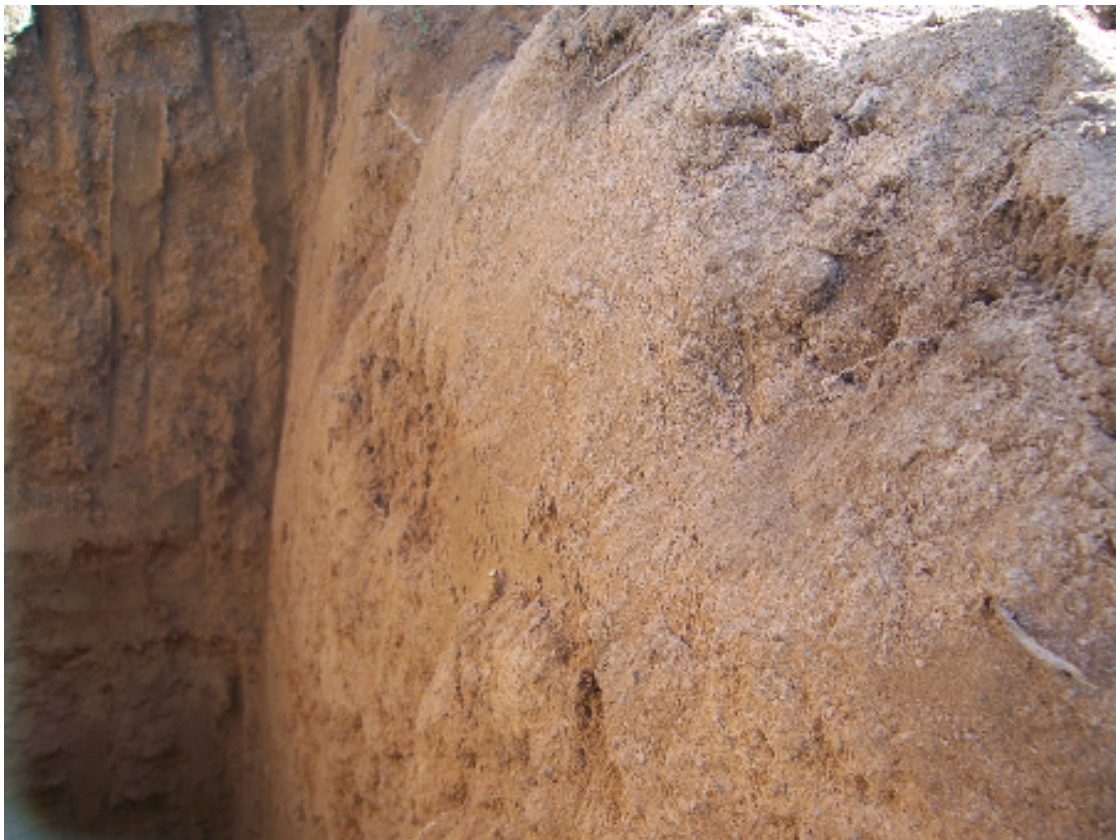
**Table 8 - Summary Survey Site 6**

| HORIZON | DEPTH | BOUNDARY | FIELD TEXTURE | FIELD pH | FIELD COLOUR | PLASTICITY | ROCK FRAGMENTS |
| A1 | 0-0.1m | Gradational | Loamy sand | 6 | 10YR 3/3 | Slightly plastic | Nil |
| A2 | 0.1-0.5m | Clear | Loamy sand | 5.5 | 10YR 4/3 | Non plastic | Nil |
| B | 0.5-1m | | sand | 6.5 | 10YR 6/4 | Non plastic | Small pebbles <10mm 30% |

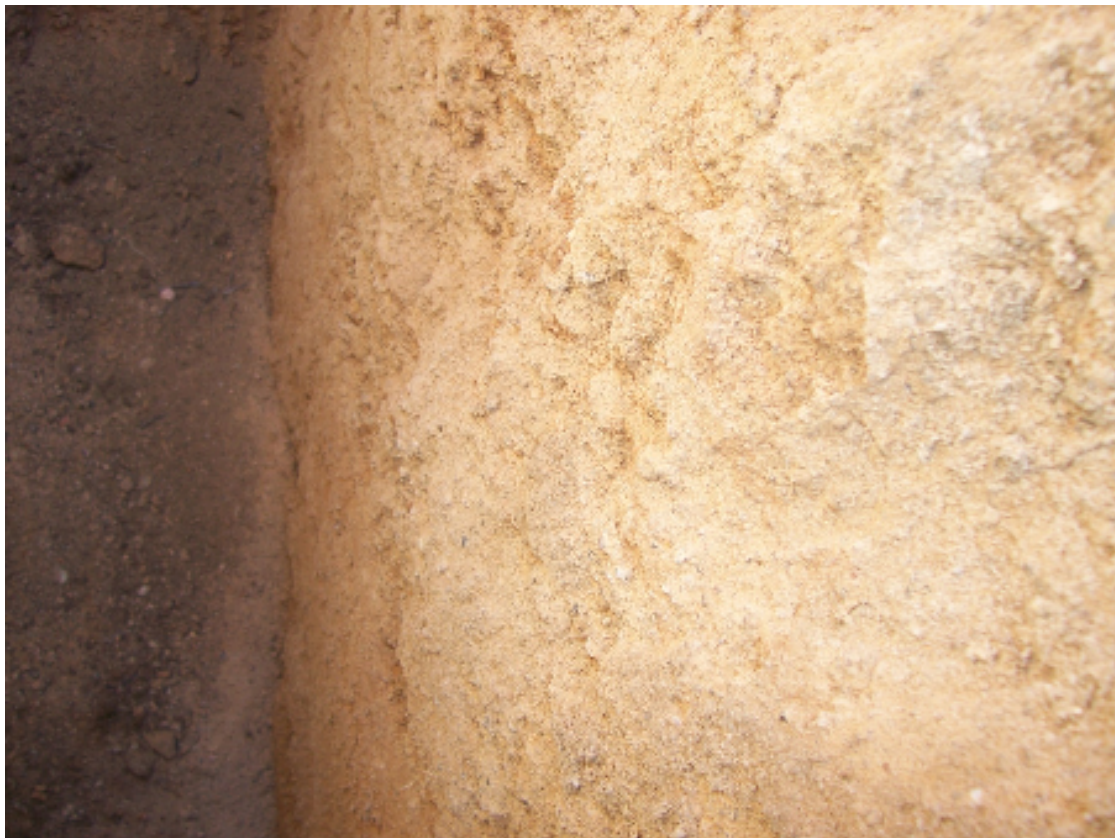
**Table 9 - Summary Survey Site 7**

| HORIZON | DEPTH | BOUNDARY | FIELD<br>TEXTURE | FIELD<br>pH | FIELD<br>COLOUR | PLASTICITY | ROCK<br>FRAGMENTS |
| A | 0-0.1m | Gradational | Sandy<br>loam | 5.5-6 | 10YR<br>4/3 | Moderately<br>plastic | Nil |
| A2 | 0.1-0.5m | Very<br>gradational | Loamy<br>sand | 6.5 | 10YR<br>5/4 | Slightly<br>plastic | Nil |
| B | 0.5-1m | | Clayey<br>sand –<br>little<br>cohesion | 5.5-6 | 7.5 YR<br>5/4 | Non plastic | Small to medium<br>pebbles – 40% |
