## **PHASE 1 SITE CONTAMINATION ASSESSMENT**

Rezoning of Lot 1 DP517111, Lennox Head  
NSW

Ballina Island Developments Pty Ltd

GEOTALST03192AC-AB  
30 May 2013

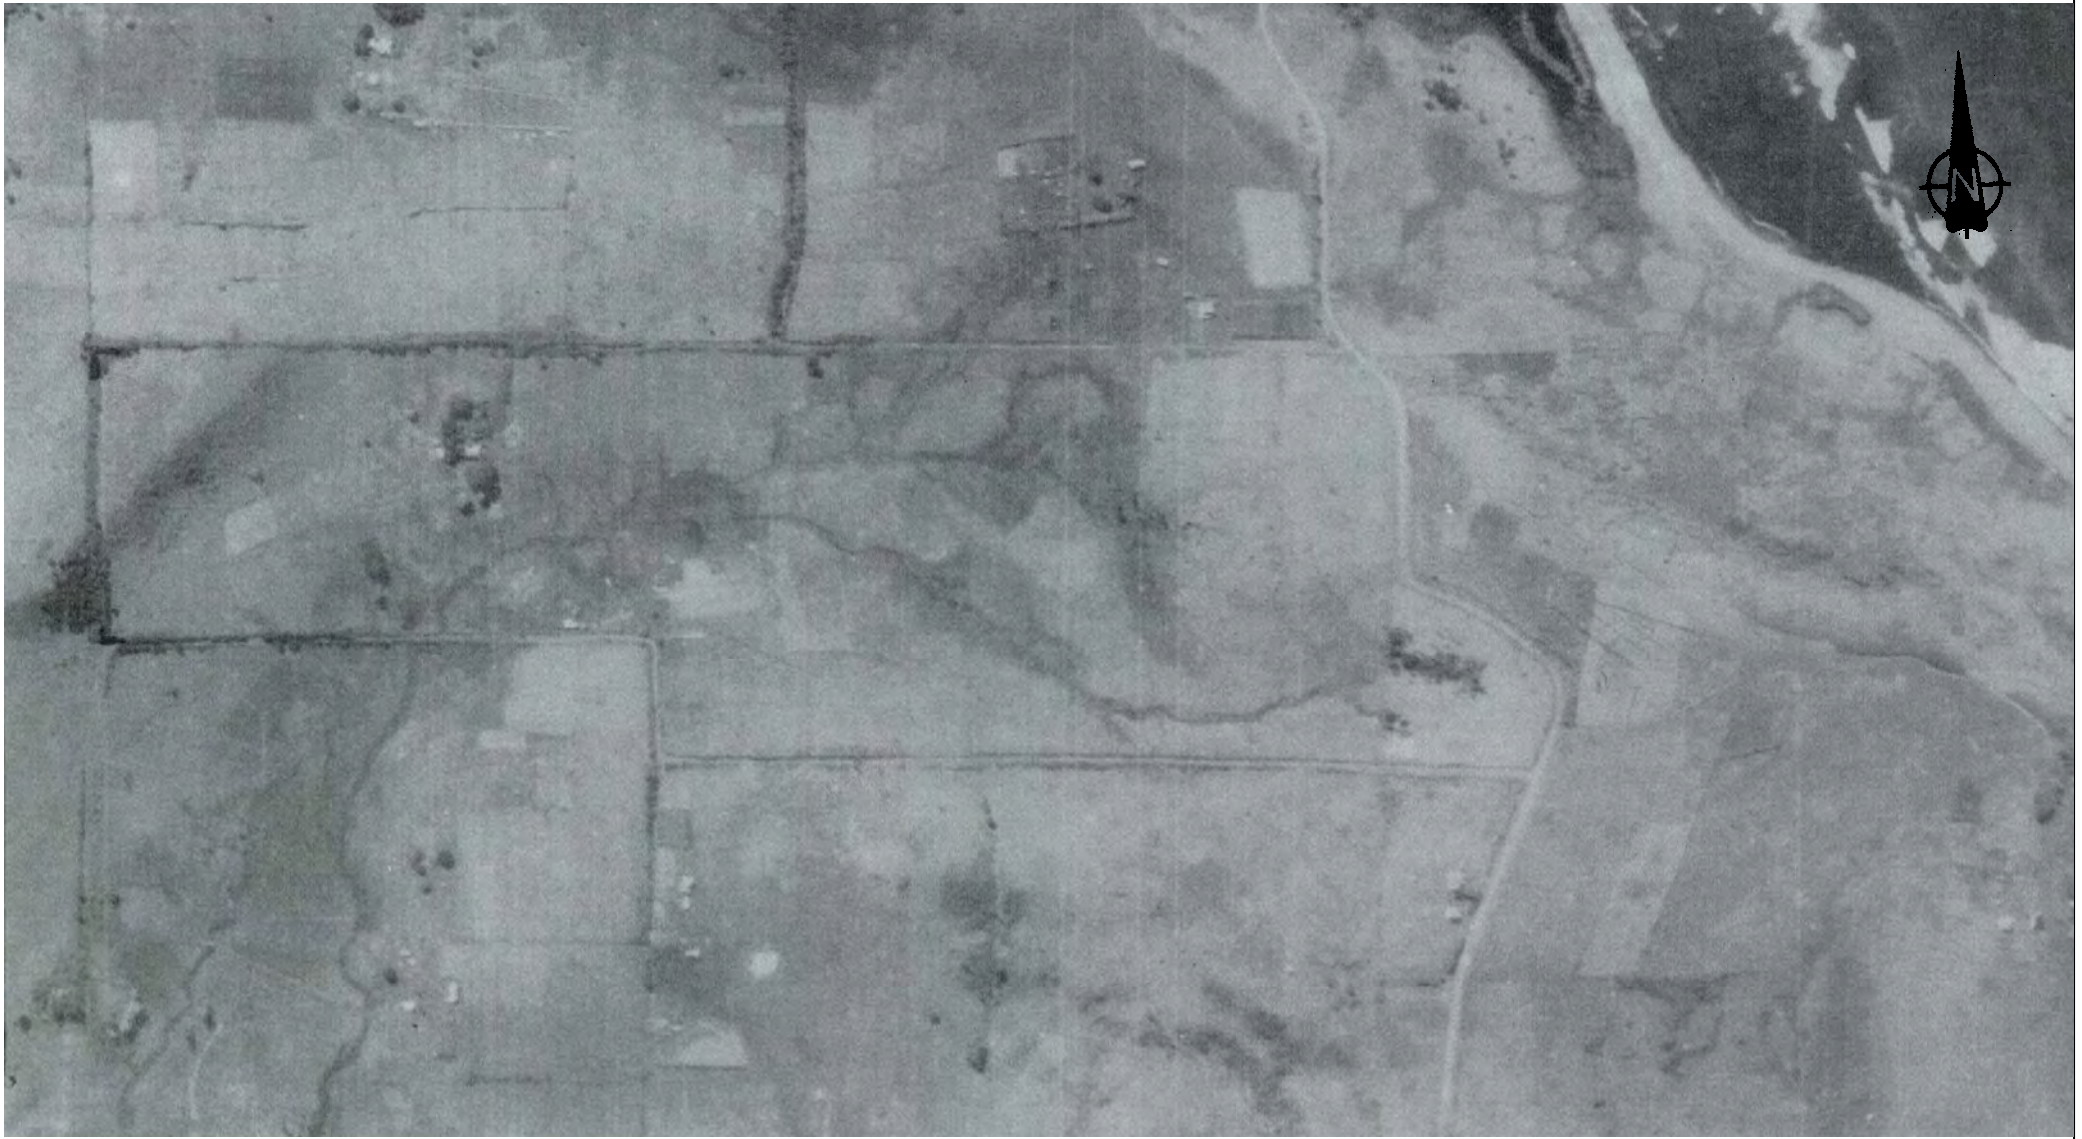
client:	Indigo (Lennox Head) Developer Pty Ltd	
project:	Phase 1 Site Contamination Assessment for Proposed Rezoning, Lennox Head NSW	
title:	Extract Aerial Photograph - 1947	
project no:	GEOTALST03192AA-AC	figure no: A1

**Run: 2**  
**Photo: SVY122**  
**Date: 27/5/47**  
**Location: Byron Bay**

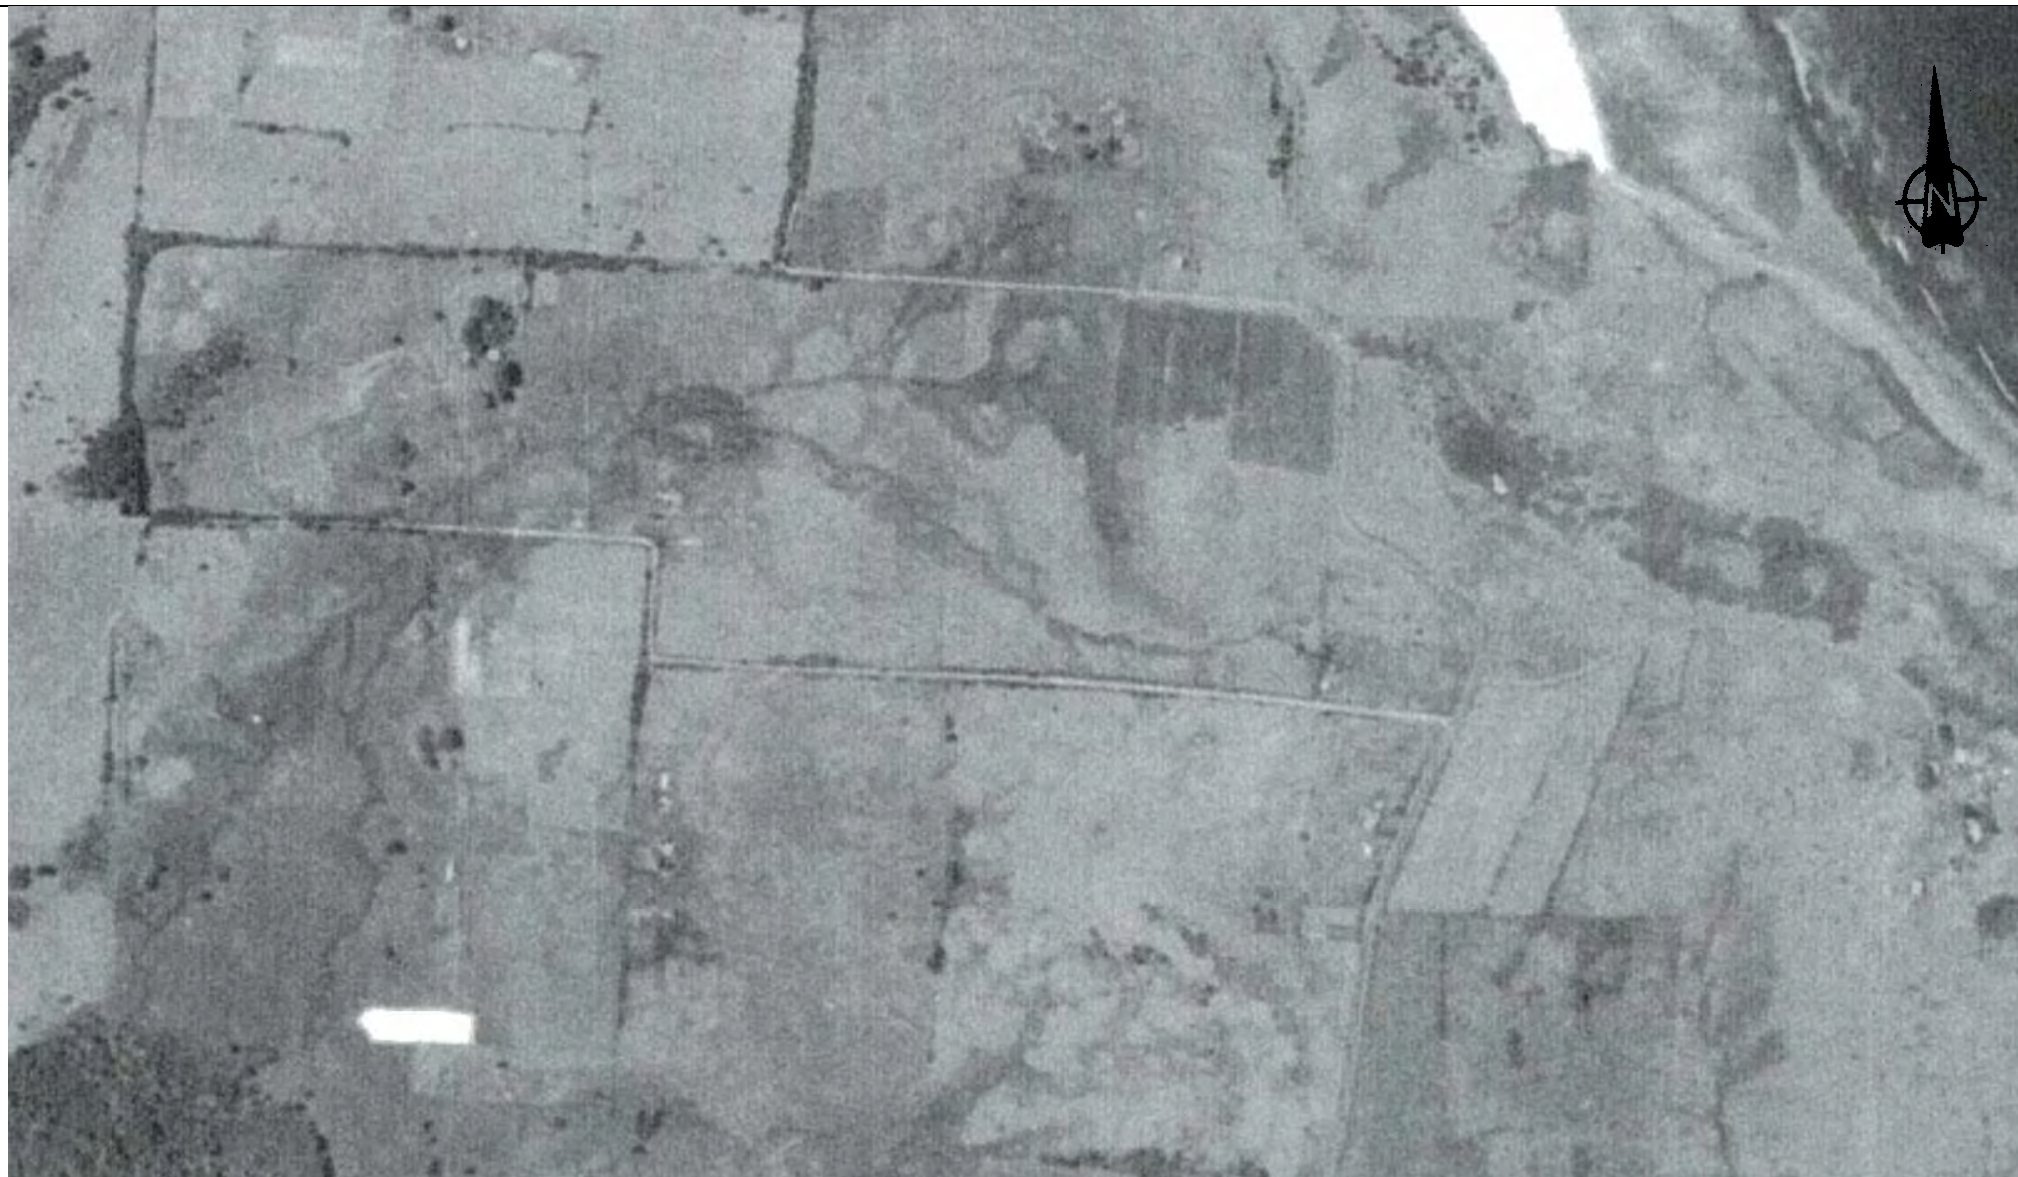
client:	Indigo (Lennox Head) Developer Pty Ltd	
project:	Phase 1 Site Contamination Assessment for Proposed Rezoning, Lennox Head NSW	
title:	Extract Aerial Photograph - 1958	
project no:	GEOTALST03192AA-AC	figure no: A2

Run: 5  
Photo: 326 5067  
Date: 12/10/58

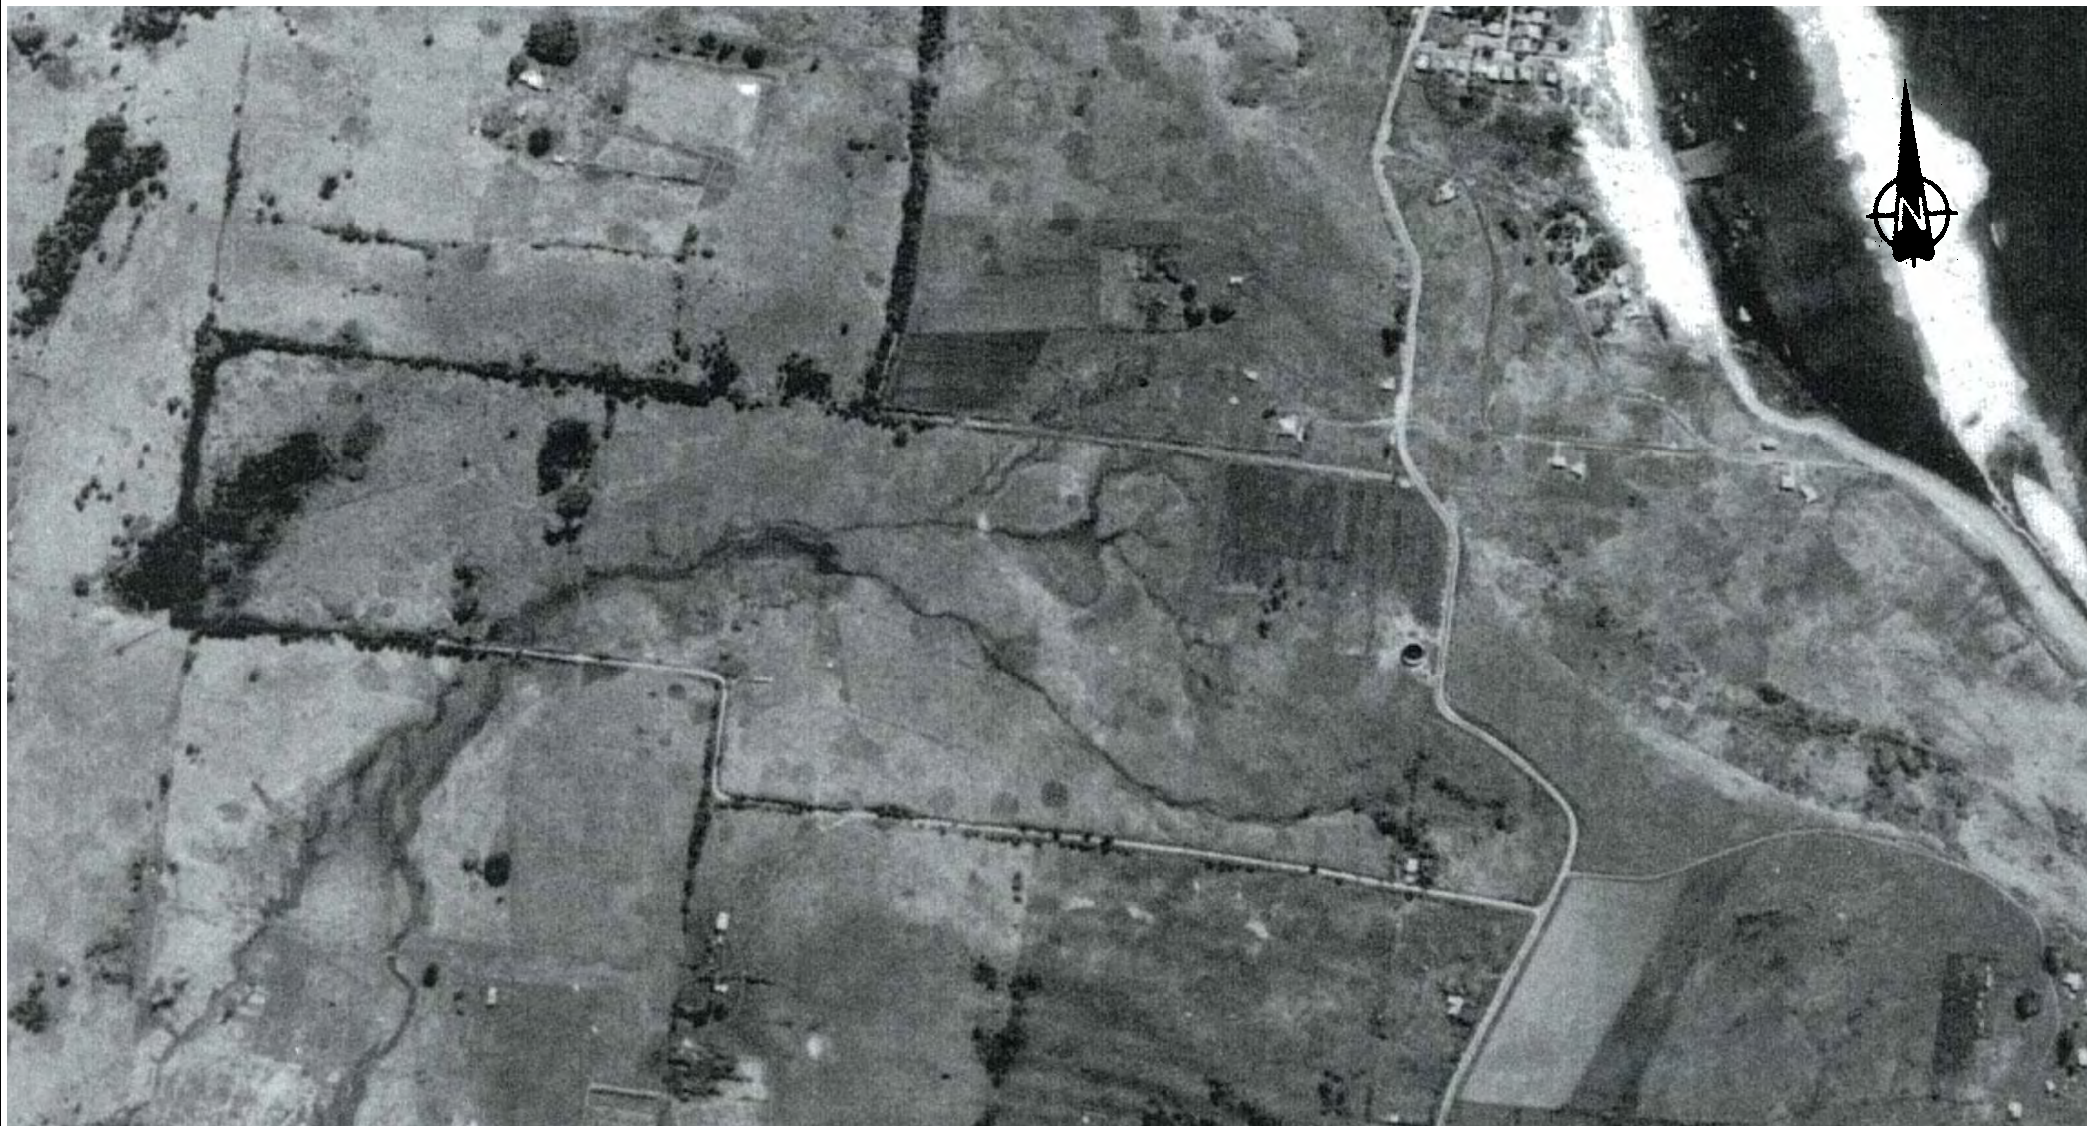
client:	Indigo (Lennox Head) Developer Pty Ltd	
project:	Phase 1 Site Contamination Assessment for Proposed Rezoning, Lennox Head NSW	
title:	Extract Aerial Photograph - 1967	
project no:	GEOTALST03192AA-AC	figure no: A3

Run: 7  
Photo: 1520 5121  
Date: 29/5/67

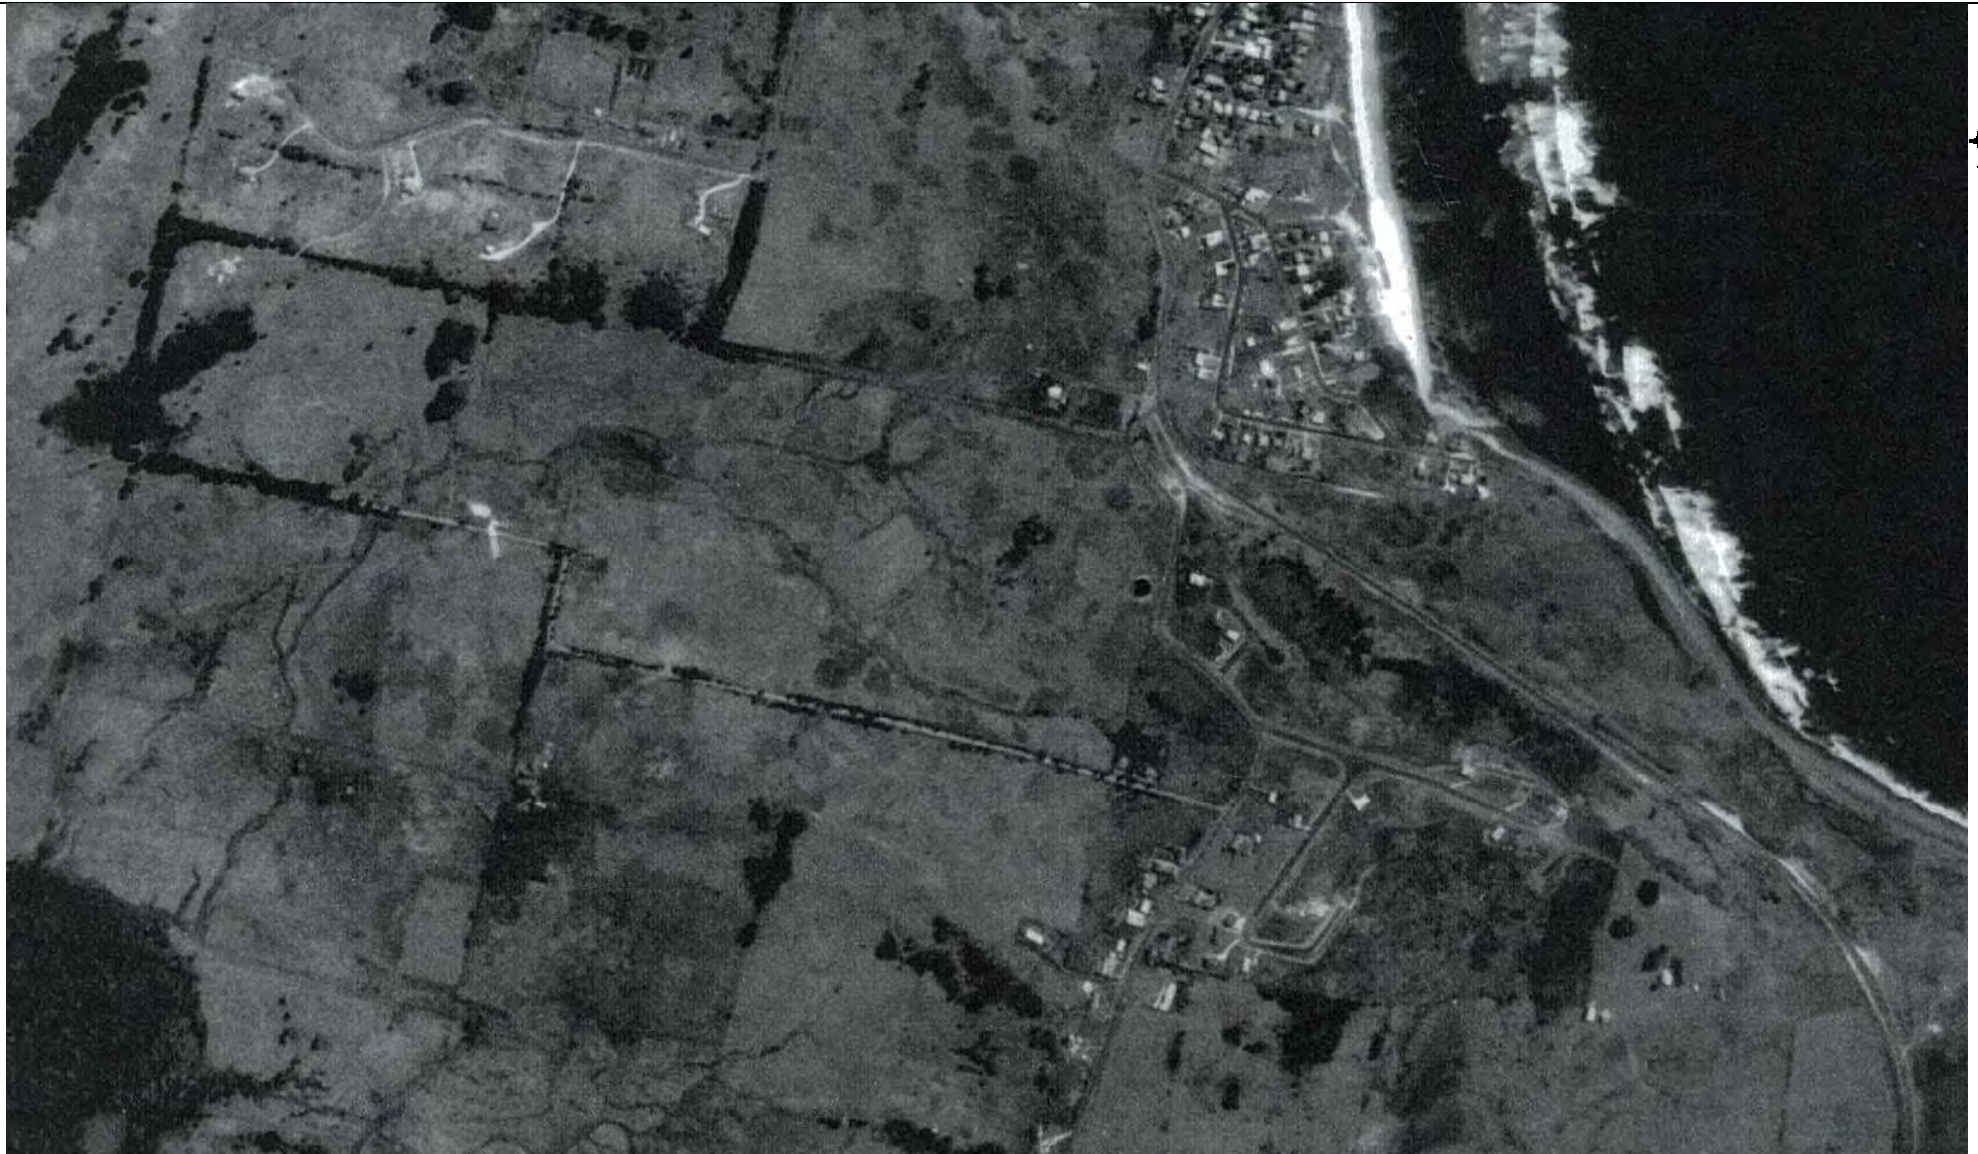
client:	Indigo (Lennox Head) Developer Pty Ltd	
approved			project:	Phase 1 Site Contamination Assessment for Proposed Rezoning, Lennox Head NSW	
date	22/04/09		title:	Extract Aerial Photograph - 1979	
scale	NTS		project no:	GEOTALST03192AA-AC	figure no: A4
original size	A4

Run: 5  
Photo: 2771 207  
Date: 3/4/79

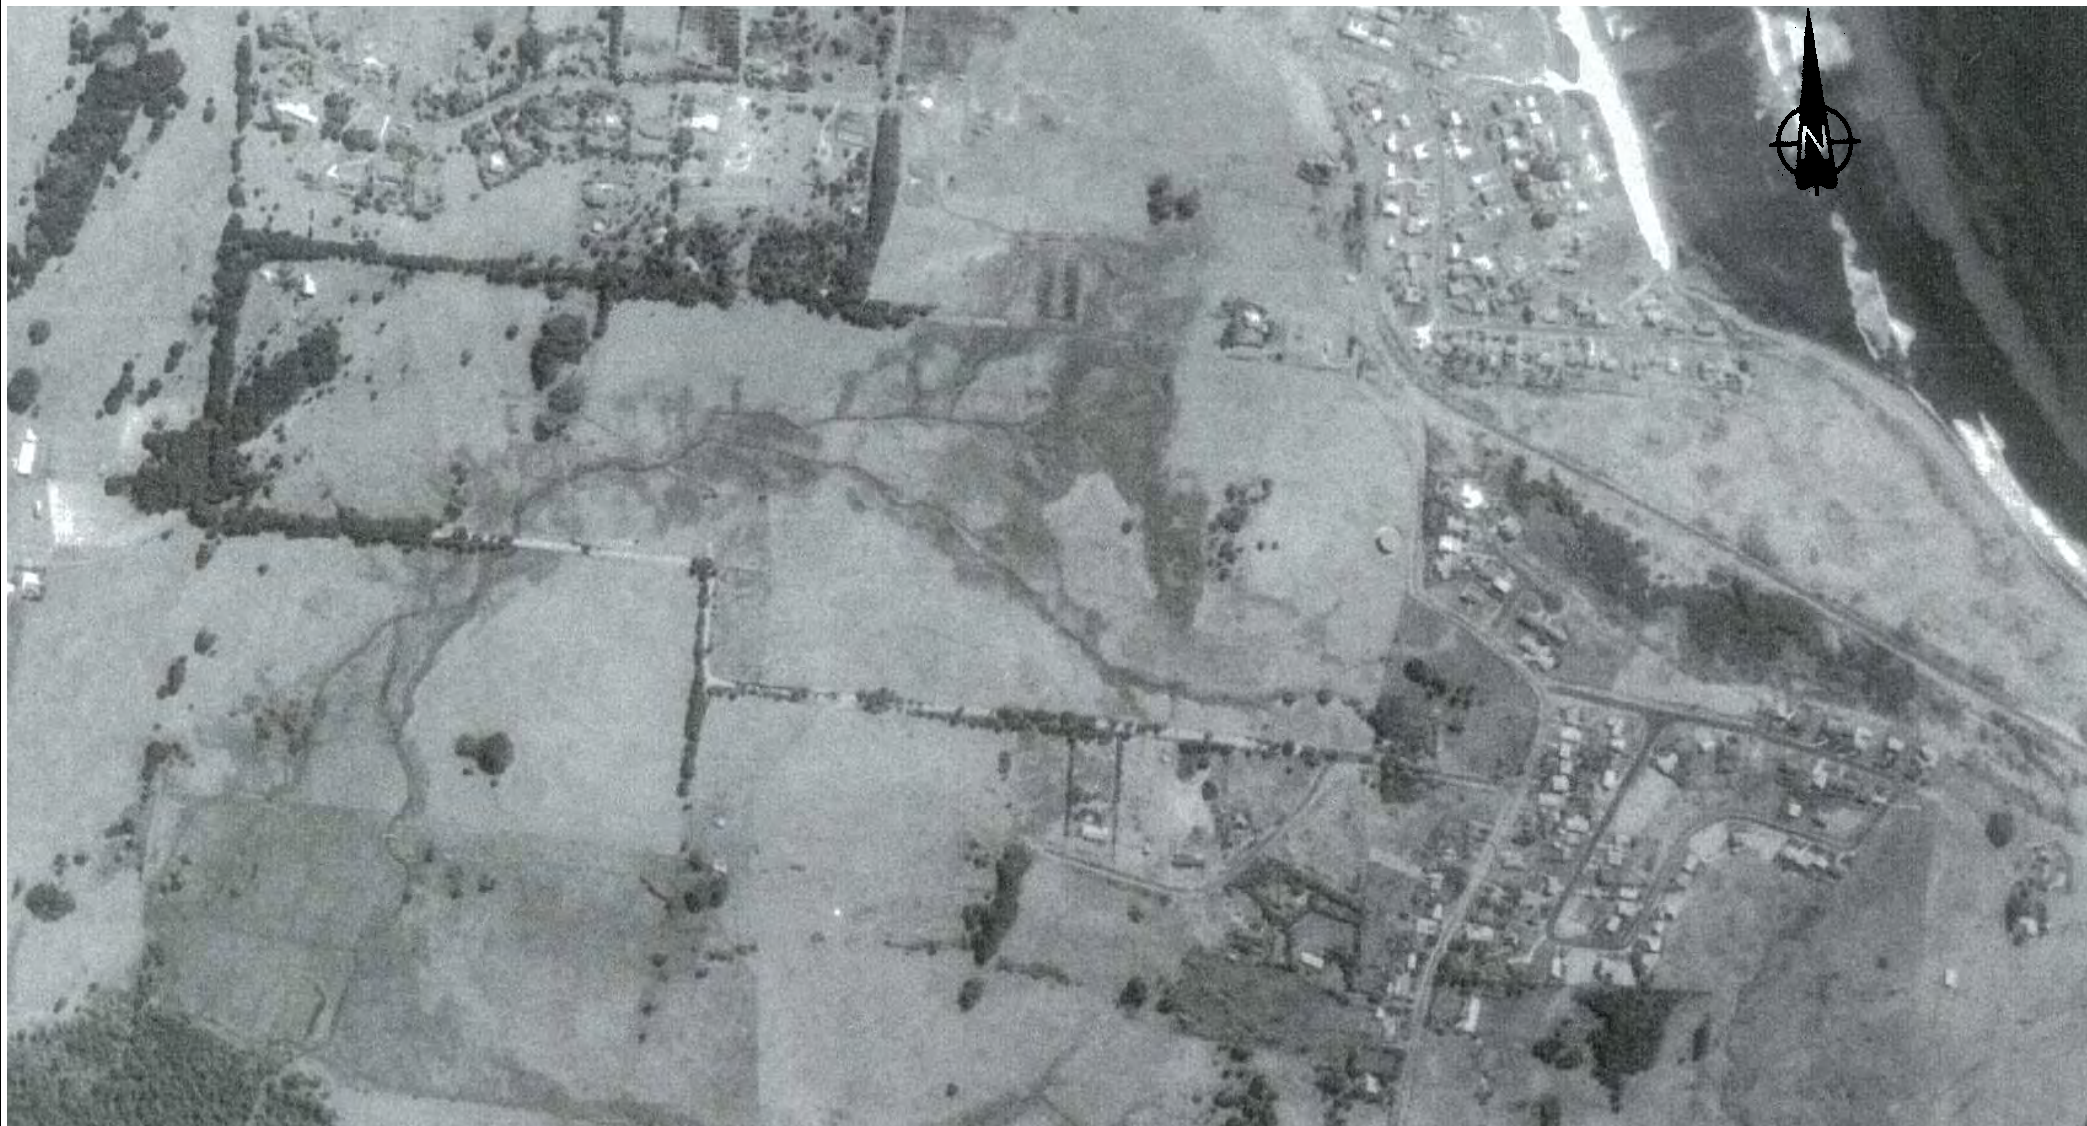
client:	Indigo (Lennox Head) Developer Pty Ltd	
project:	Phase 1 Site Contamination Assessment for Proposed Rezoning, Lennox Head NSW	
title:	Extract Aerial Photograph - 1987	
project no:	GEOTALST03192AA-AC	figure no: A5

Run: 5  
Photo: 3584 223

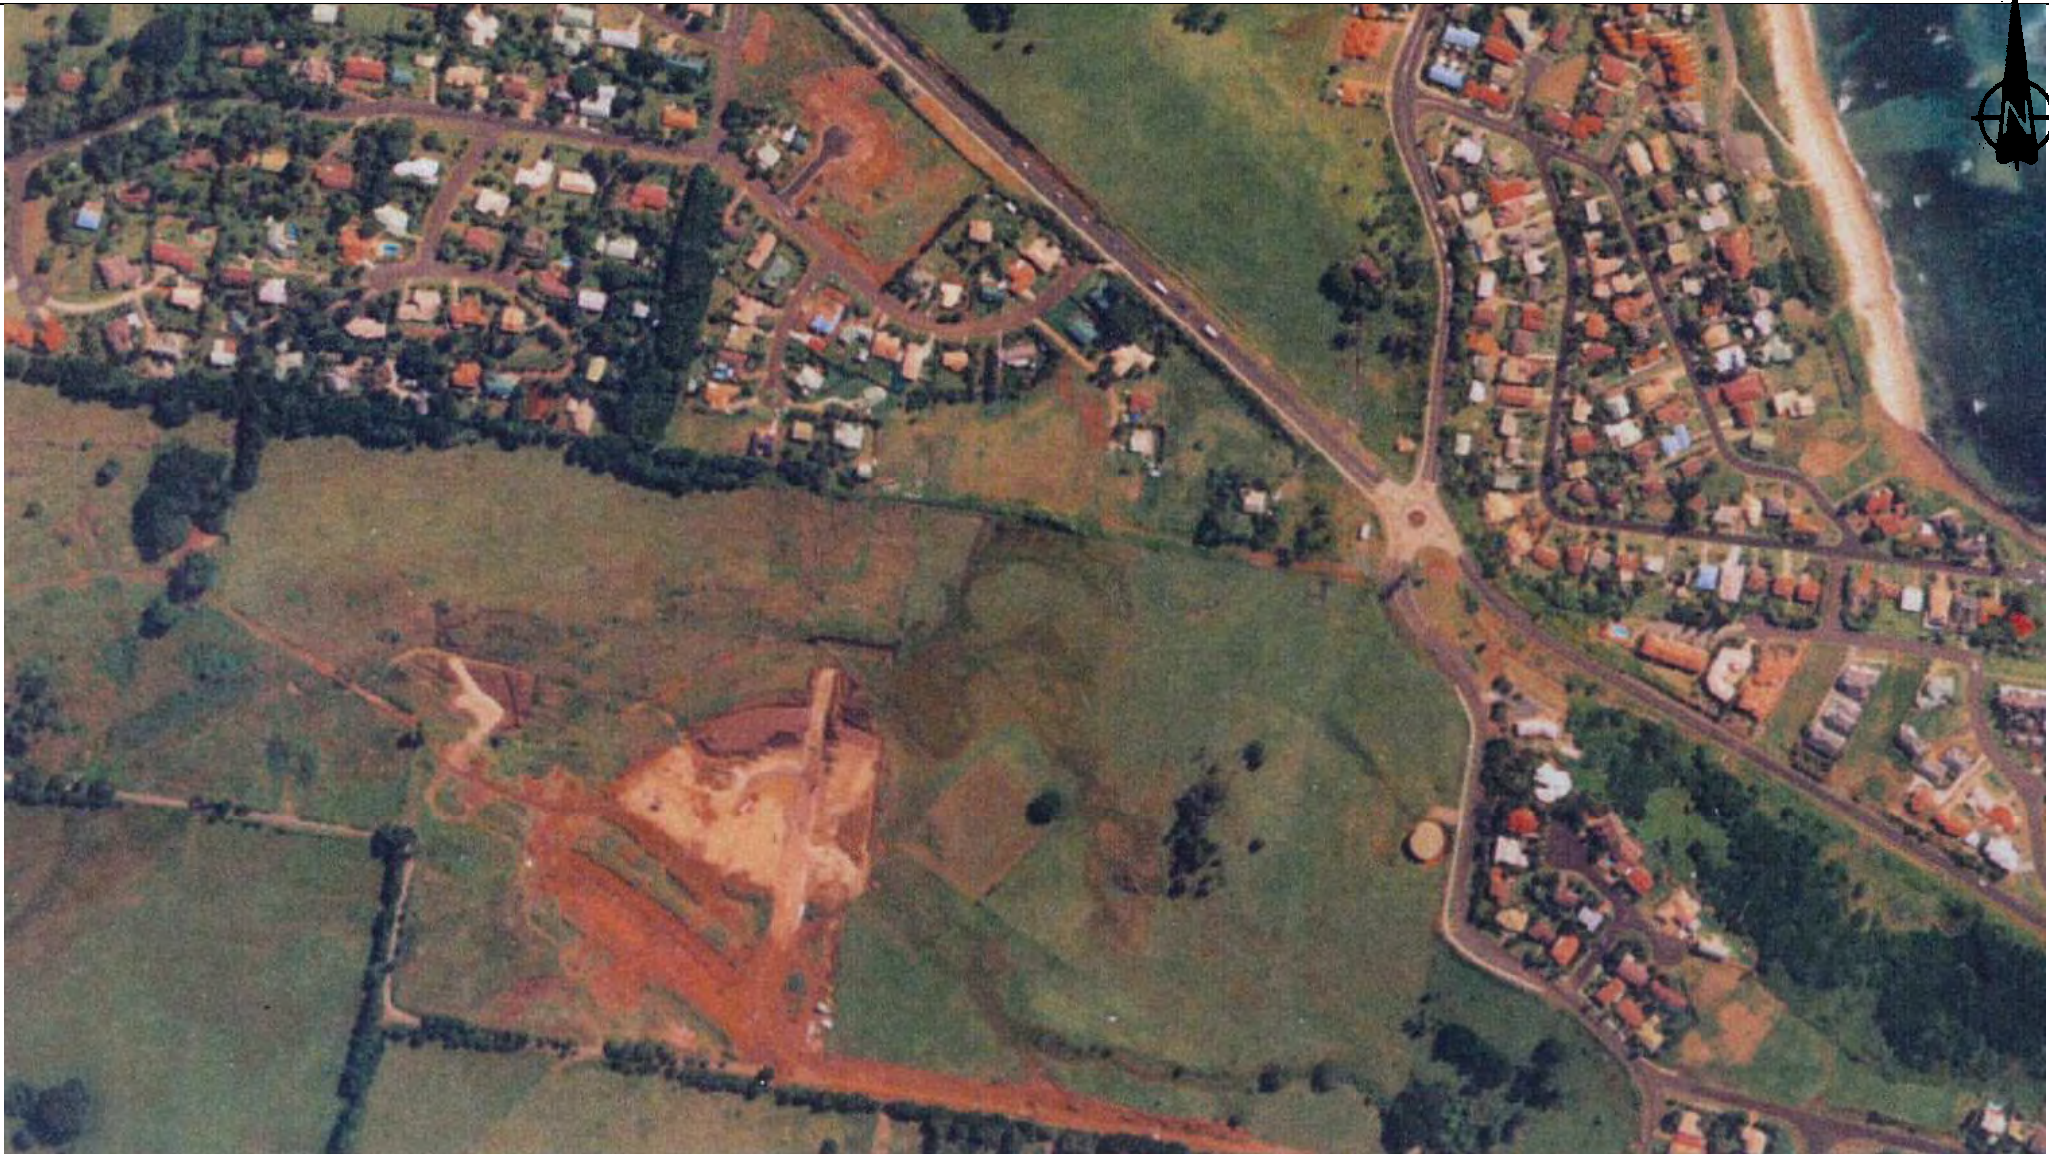
client:	Indigo (Lennox Head) Developer Pty Ltd	
project:	Phase 1 Site Contamination Assessment for Proposed Rezoning, Lennox Head NSW	
title:	Extract Aerial Photograph - 1997	
project no:	GEOTALST03192AA-AC	figure no: A6

Run: 8  
Photo: 4359 108  
Date: 22/4/97
