PLANNING PROPOSAL APPLICATION

PP2018/0001

176 - 184 George Street Concord West, NSW

Detailed Site Investigation

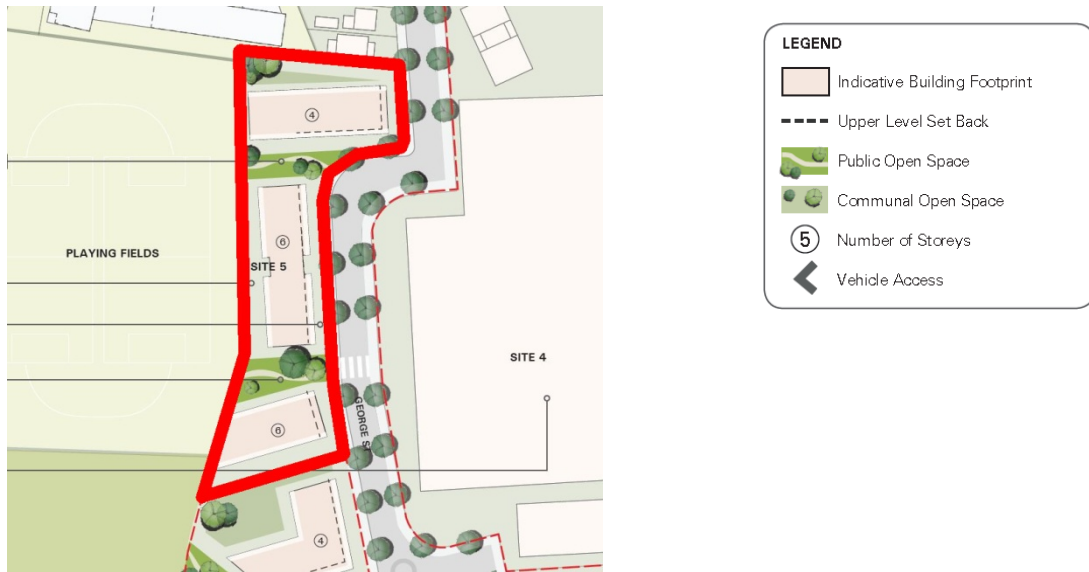
Figure 2 – Extract from Concord West Precinct Masterplan. (Site defined by red outline) (source JBA)

The Masterplan identifies seven (7) key sites with the subject site being nominated as Site 5. The Masterplan envisages that the built form on Site 5 will be six (6) storeys for the majority of the site, with a four (4) storey building at the northern end of the site. Extracts from the Concord West Precinct Masterplan are provided at **Figures 2 and 3**. The Masterplan also acknowledges that there are flooding/overland flow risks in the vicinity of the site. This issue is further discussed in Section 3.2.4.6.

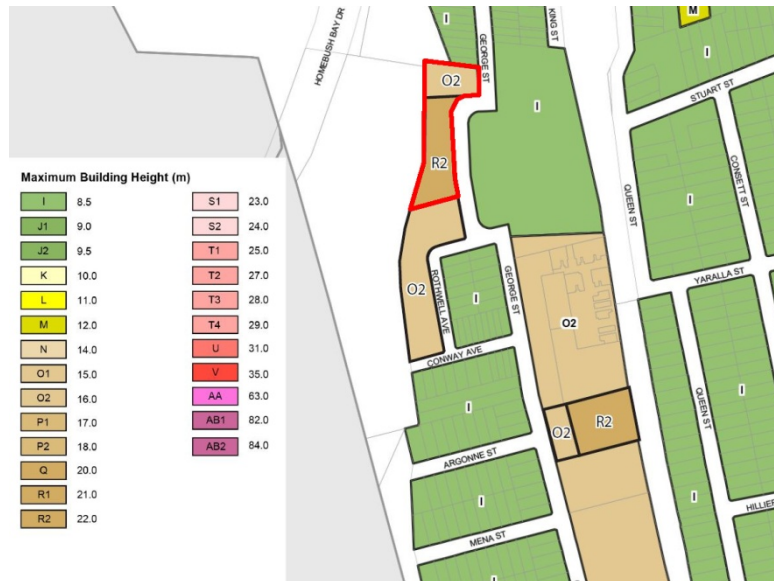
The Masterplan recommends a maximum building height of 16 metres at the northern end of the site and a maximum height of 22 metres over the remaining portion of the site. The Masterplan recommends a maximum FSR of 1.9:1. This is illustrated in **Figures 4 and 5**.

Figure 4 – Recommended maximum building height. (Site defined by red outline) (source Concord West Precinct Masterplan)

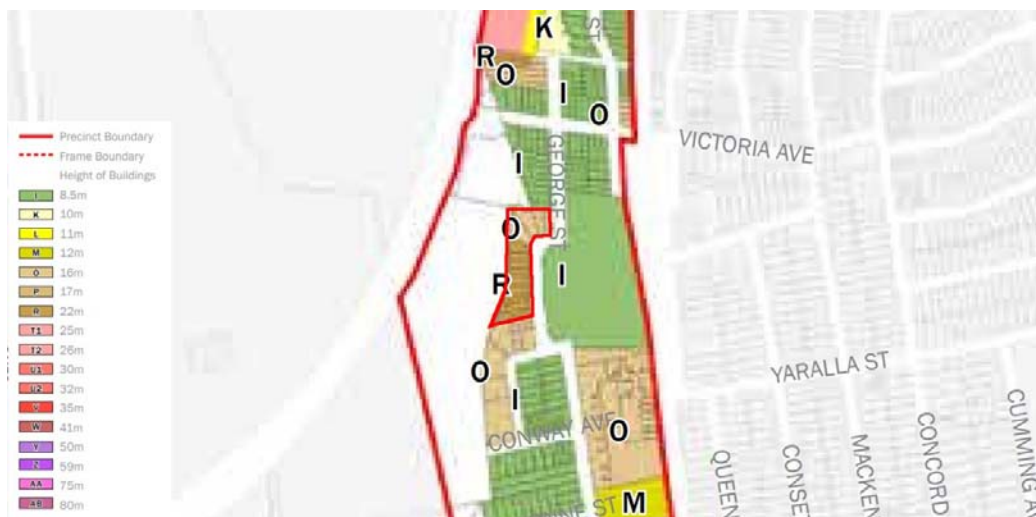
Figure 11 – Recommended maximum building height. (Site defined by red outline) (source Urban Growth)

The associated Parramatta Road Corridor Planning and Design Guidelines (2016) makes recommendations for land use zoning, building height and FSR for the subject site. These recommendations mirror those outlined within the Concord West Precinct Masterplan 2014 and are illustrated in Figures 10-12.

The PP will facilitate the medium to high density development of the subject site and will therefore contribute to increased housing provision in the Concord West locality. The recommended height and FSR as proposed by the PRUTS is aligned with the recommended outcomes of Council's Concord West Precinct Masterplan 2014. This PP is consistent with both the PRUTS and Masterplan.

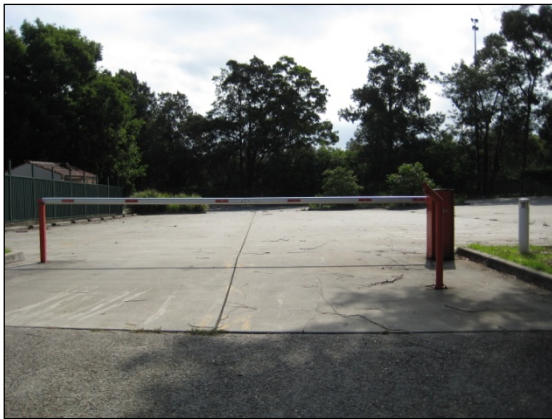
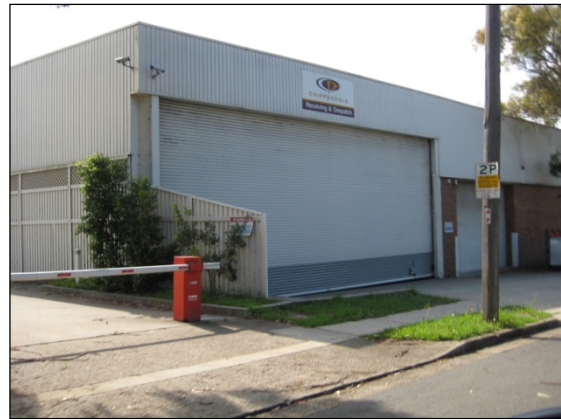
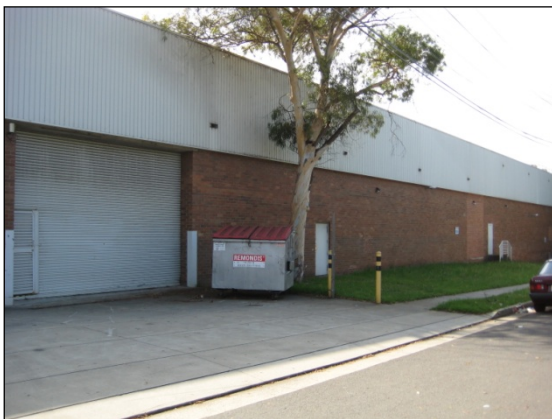
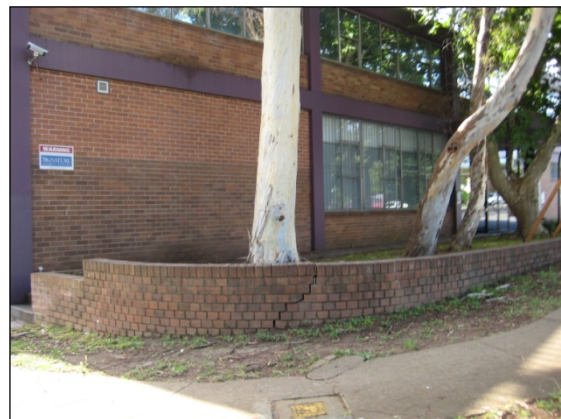
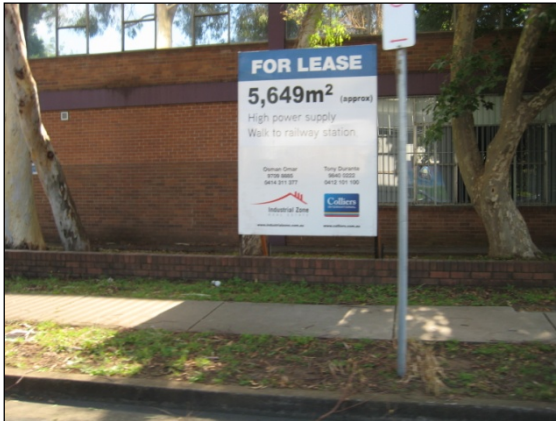
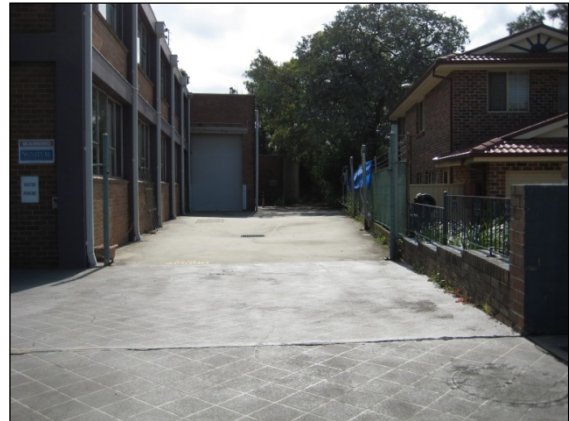
The subject site has been developed for a 5,649m² brick and metal clad warehouse building, with a number of loading docks and an at-grade car parking area.

The following photographs 1-6 demonstrate the existing site features:

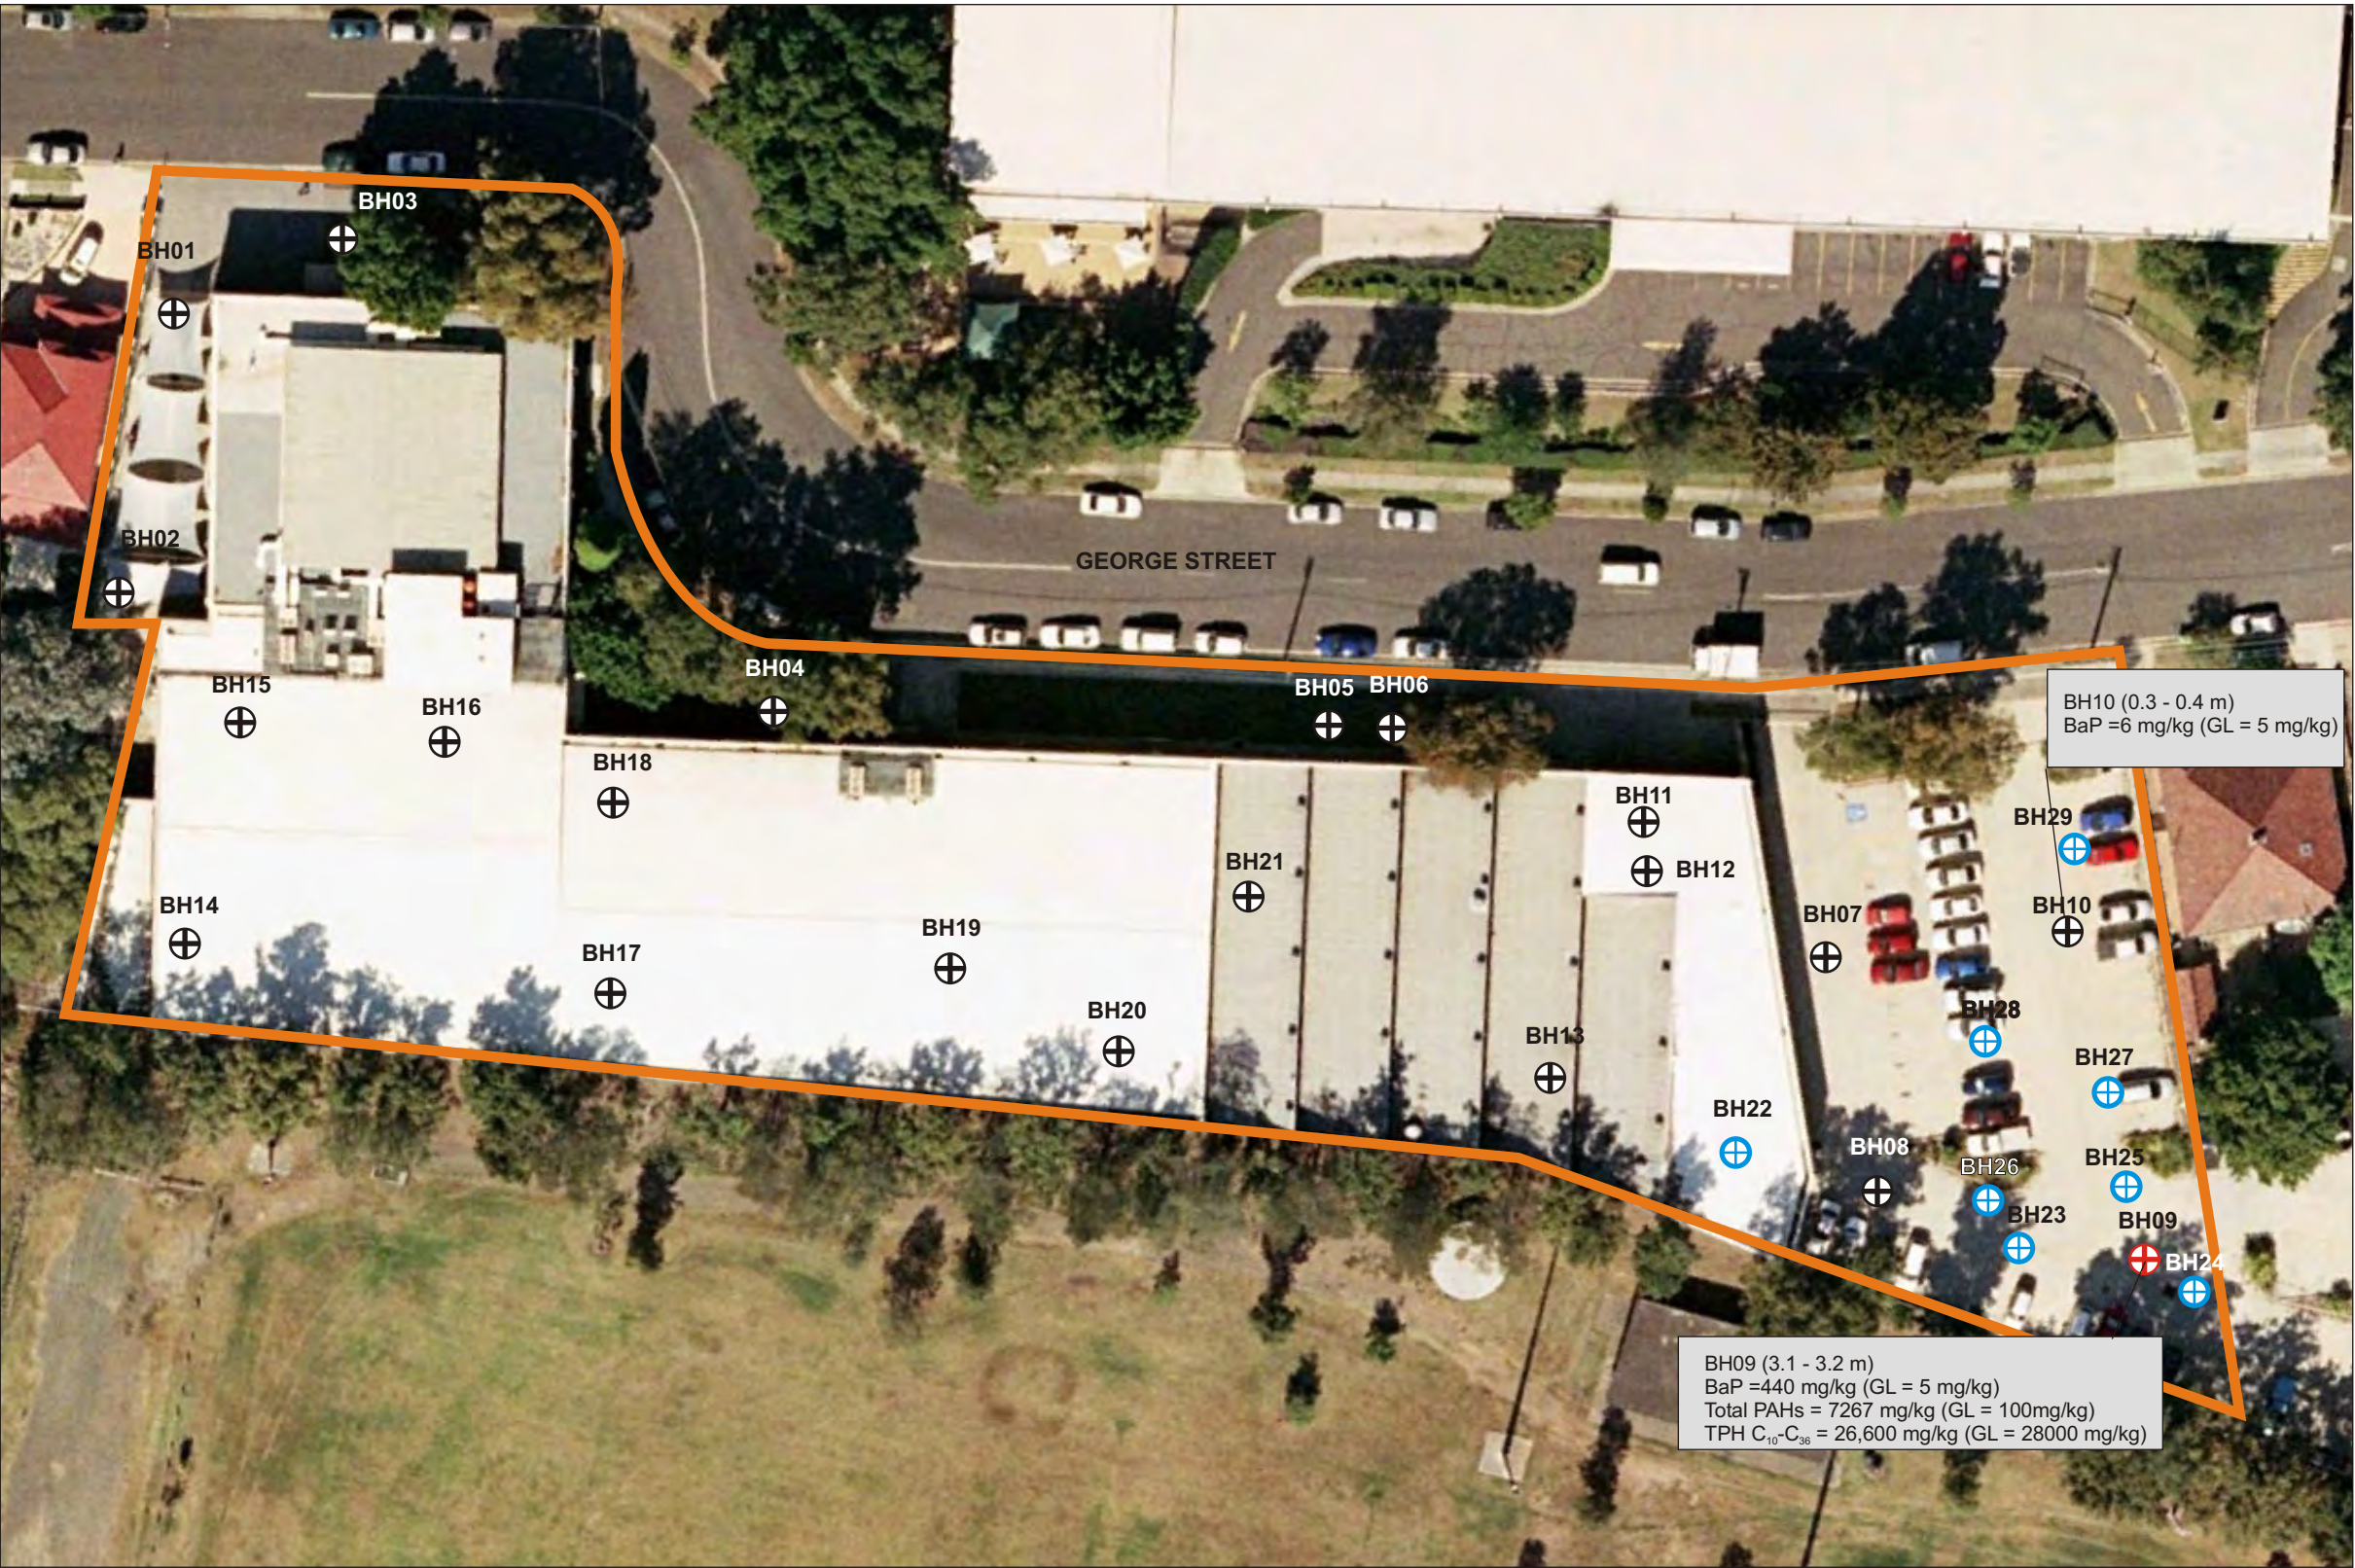
CLIENT TAYLOR WOODINGS				
PROJECT 176-184 George Street, Concord West, NSW				
TITLE Figure 3 - Sampling Locations				
SCALE NTS		DATE 20/10/10	DRAWING No. 91949_Fig3	ISSUE A
DRAWN A.L.	CHECKED N.K.	JOB No. 91949		
<div><div>

The justification for the sampling locations is presented in Table 4 and the position of the sampling locations is presented on Figure 3.

A summary of the exceedences of the industrial site criteria are shown on Figure 3.

- Approximate site boundary
- Sampling locations where exceedance reported 20-21/10/2010
- Sampling locations of 20-21/10/2010 field work
- Sampling locations of 12/10/10 field work

A summary of these exceedance is presented as Figure 3.

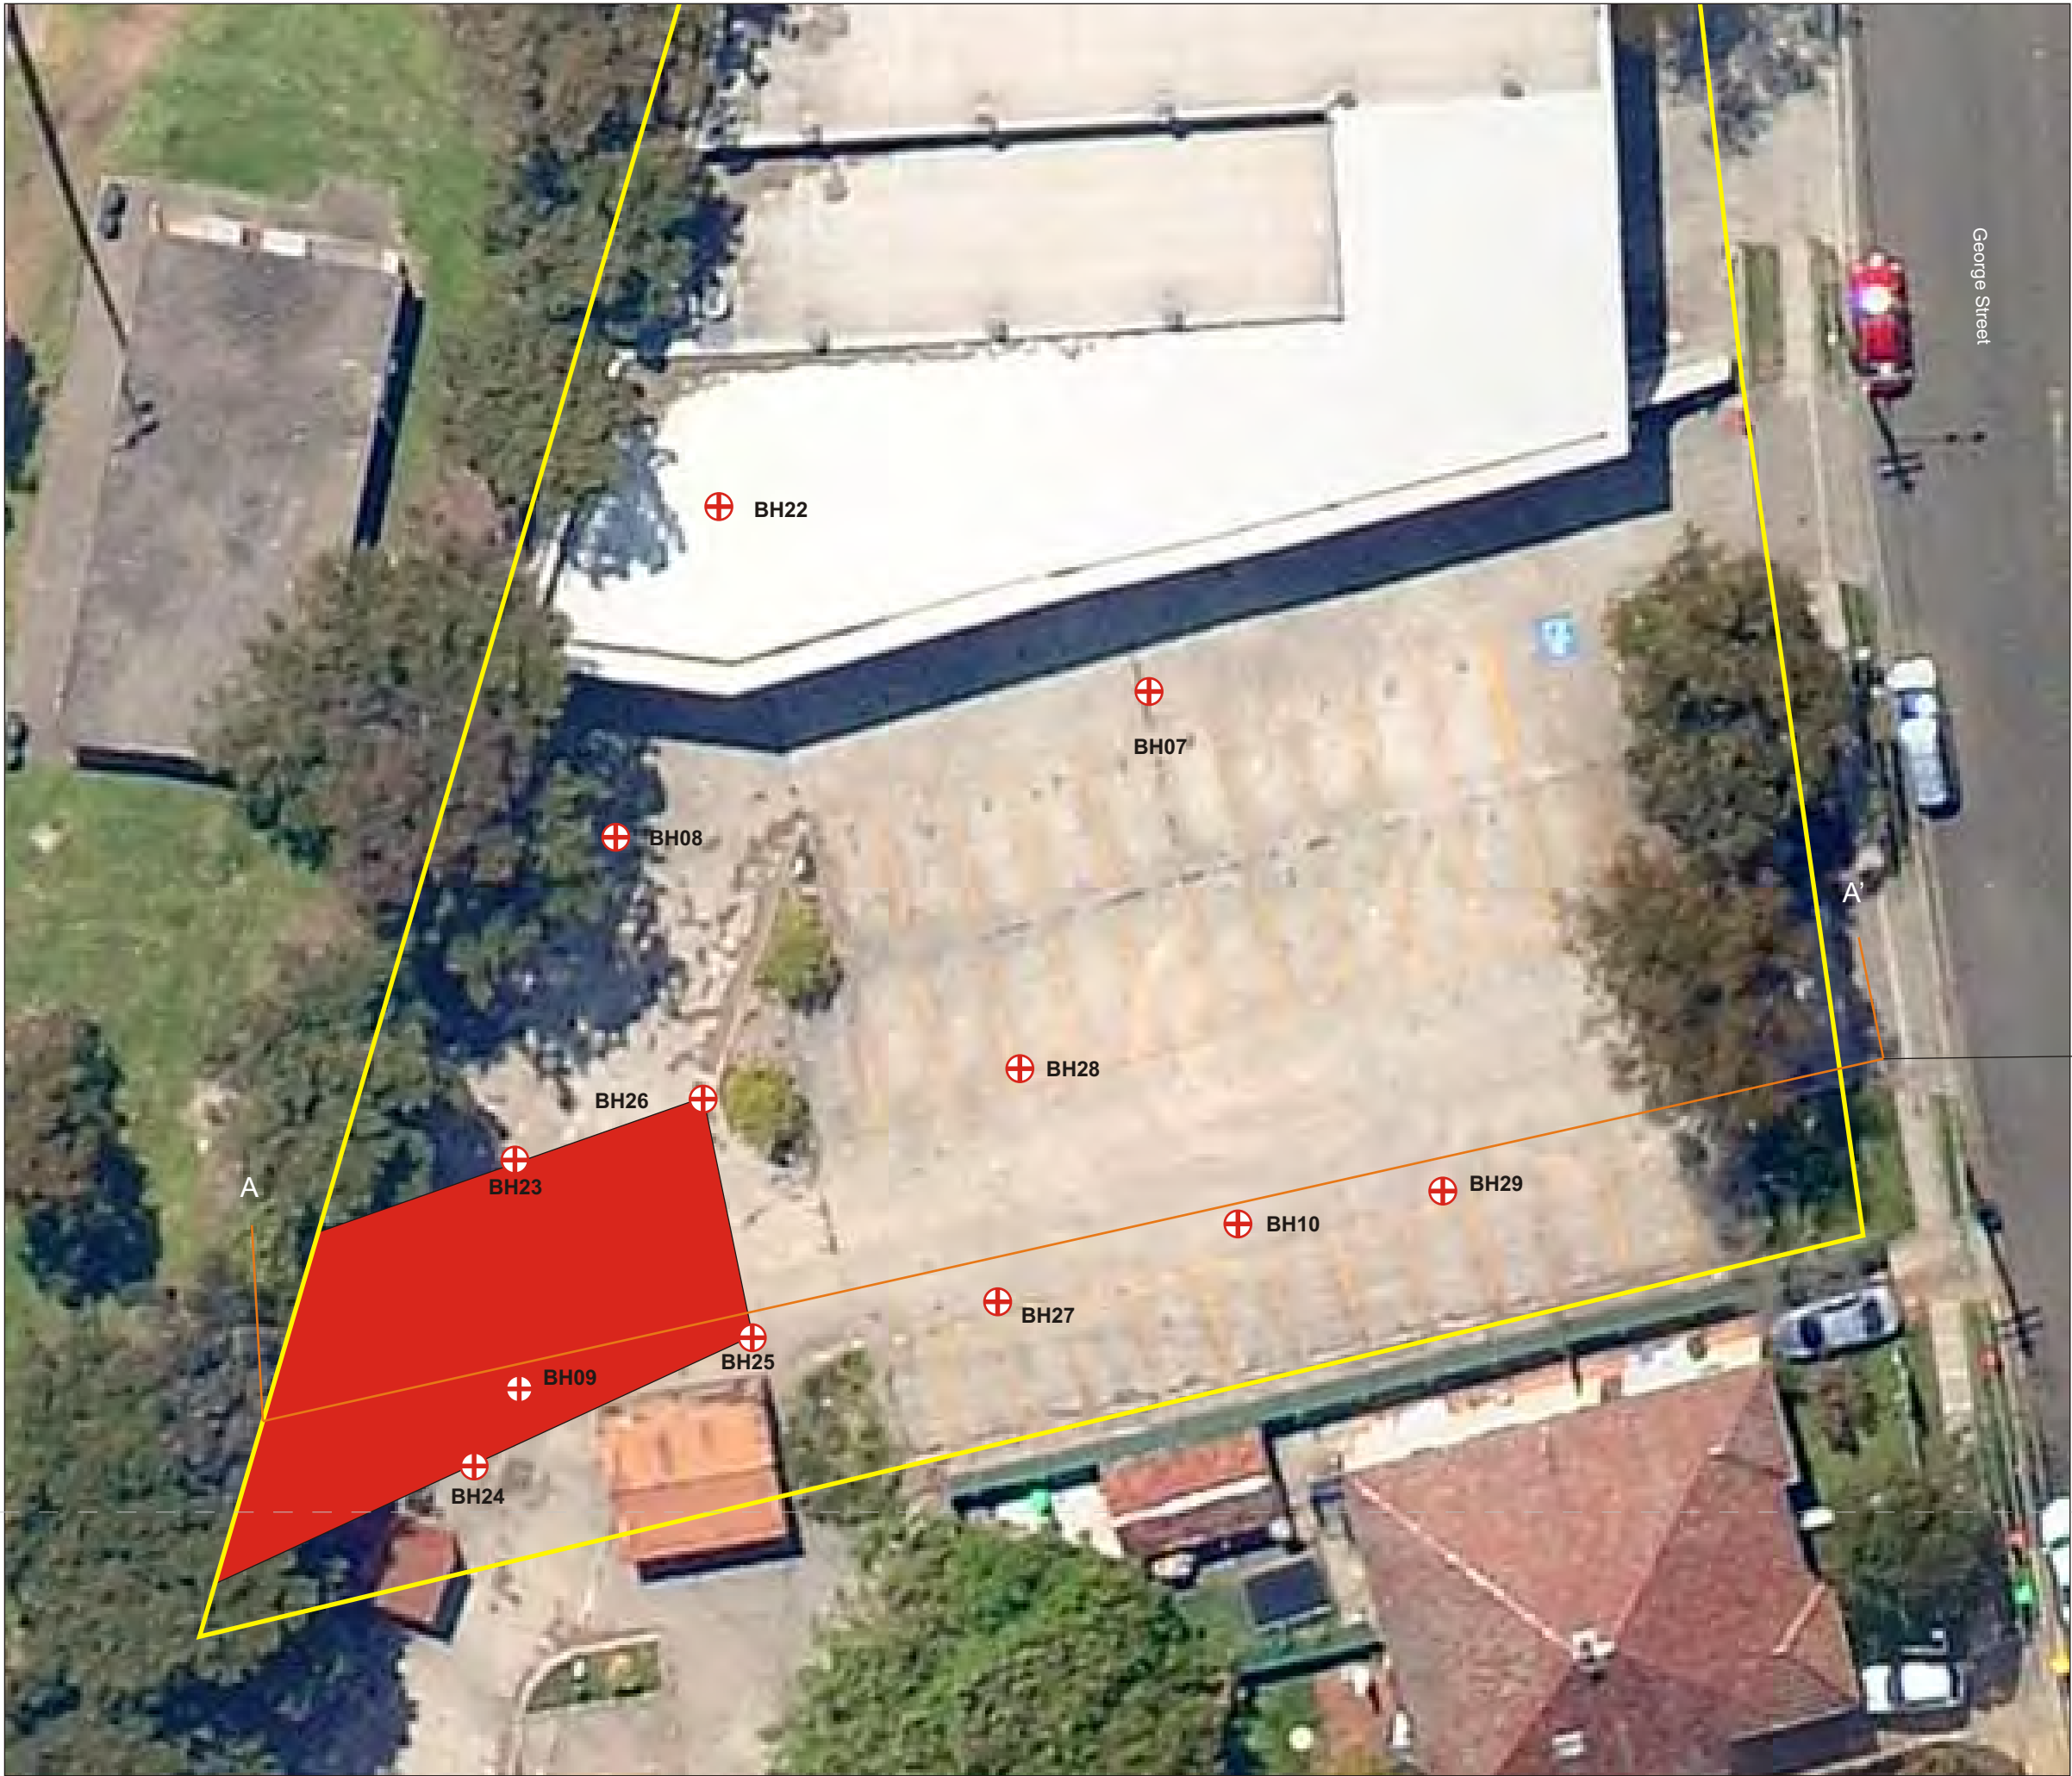
Approximate size of
contamination Hot Spot

CLIENT				
TAYLOR WOODINGS				
PROJECT				
176-184 George Street, Concord West, NSW				
TITLE				
Figure 4 - Area of Contamination Hot Spot				
SCALE	NTS	DATE	20/10/10	DRAWING No.
DRAWN	N.K.	CHECKED	D.S.	JOB No. 91949
				91949_Fig4
				A
SGA Environmental				
ASB 53 103 478 992				
Level 2				
120 Clarence Street				
Sydney				
NSW				
2000				
Offices in Sydney, Melbourne, Brisbane, Perth, New Zealand & Hong Kong				
		Phone	02 9299 2988	
		Fax	02 9299 5288	
		Email	enquiries@sgaproperty.com	
		Web	www.sgaproperty.com

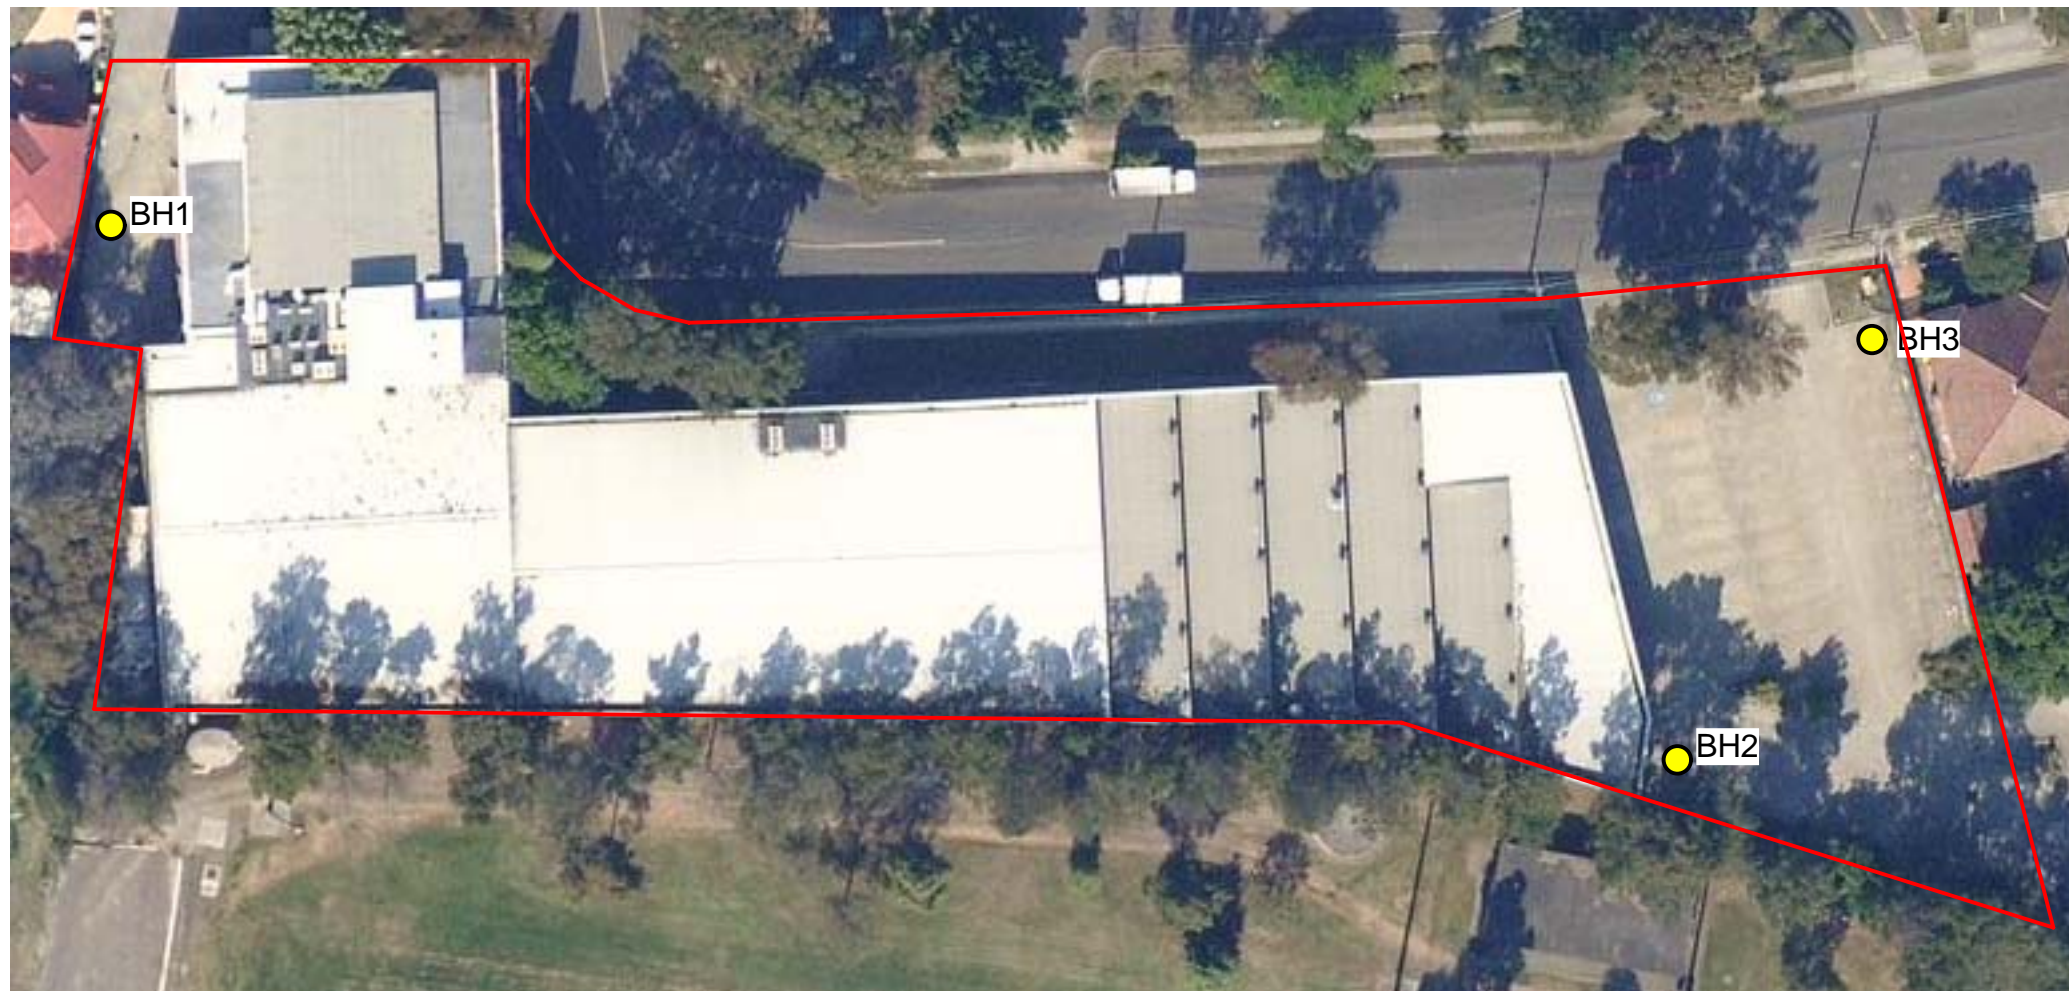
Title: 176-184 George St		Figure No: 2	Date: 10/2/12
Newcastle Office Phone (02) 4949 3800 Fax (02) 4949 3811	Sydney Office Phone (02) 9476 1765 Fax (02) 9476 1557	Scale As shown	Sheet 1 of 1
		Revision

- Borehole
- | Site Boundary

Site Layout with Sampling Locations

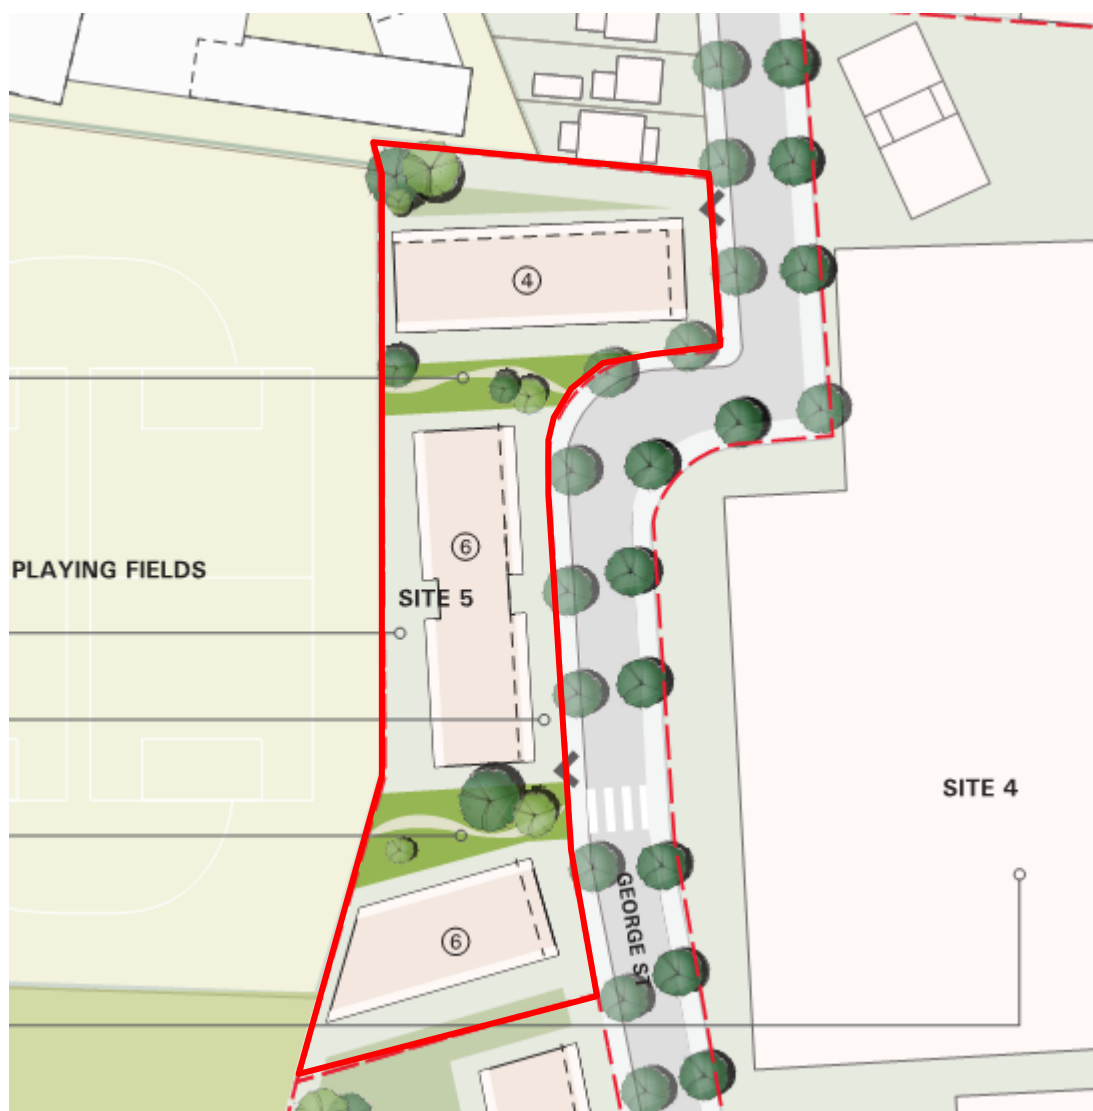
Figure 3 Site master plan (source: Concord West Precinct Master Plan, JBA, 2 May 2014)

Figure 1 shows an aerial photo of the existing site and surrounds. Figure 2 shows the site survey. Figure 3 gives the ground floor plans of the proposed development.

The existing buildings in the model were removed and replaced with the three buildings from masterplan.

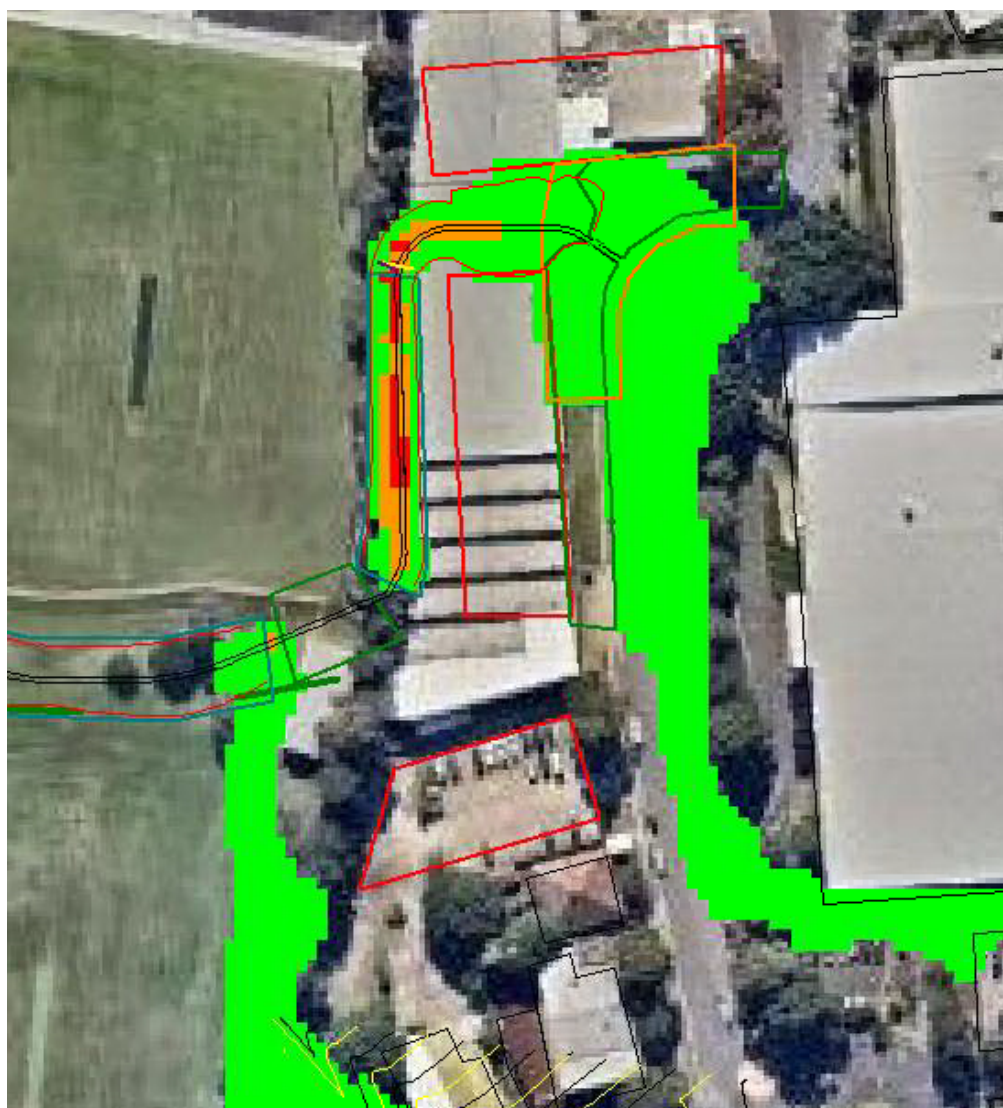
Figure 9 shows the flood hazard plan in accordance with the NSW government's "Floodplain Development Manual" April 2005 to enable Canada Bay Council assess the risk on their assets. High Hazard exists within the proposed open channel to the west of the proposed site. A safety protection treatment is recommended in the form of signage and/or fencing to eliminate or reduce the hazard. The appropriate safety protection treatment is subject to detailed design and coordination with landscaping works.

Figure 9: Flood Hazard Map
