## Preliminary contamination assessment

Lot 21 DP1077442, 1225 Eumungerie Road, Burroway NSW

Ref: R14261c

Date: 10 June 2014

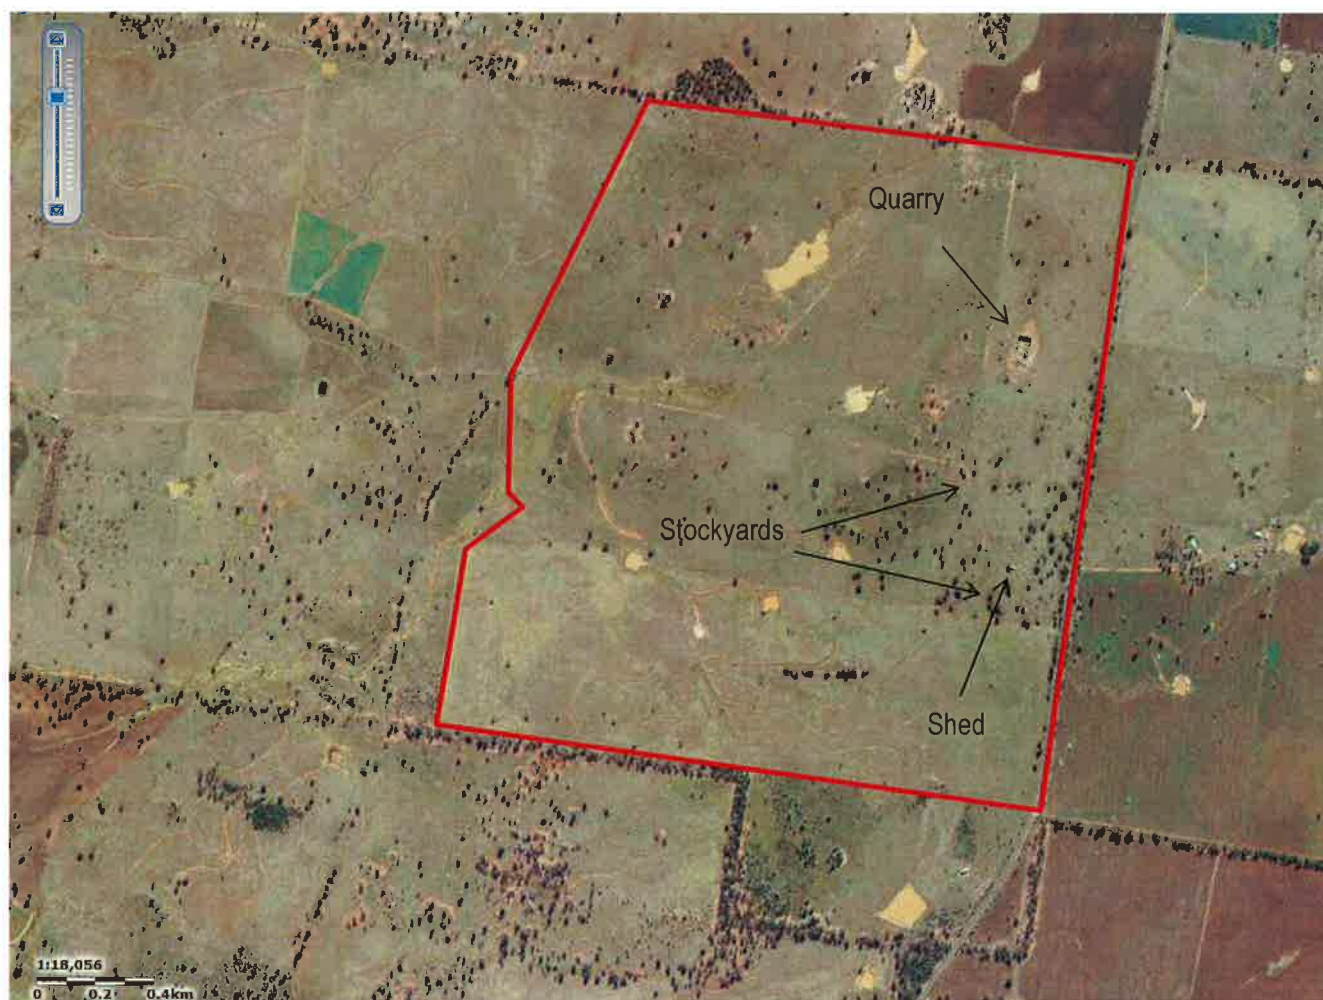
**Figure 2:** Aerial photograph of the site (2010)

New features identified in the 2010 aerial photograph were:

- The land-use of the investigation area appeared to have been grazing.
- Increase in dam numbers from 2 to 6.
- 10m x 30m galvanised shed built which is still in use.

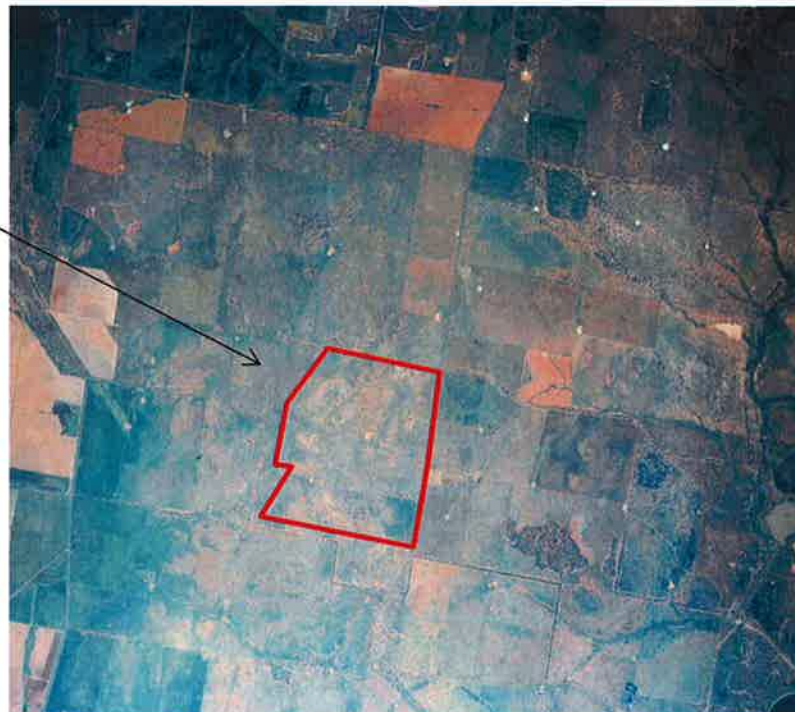
1996 site photo (site outlined in red)

New features identified in the 1996 aerial photograph were:

- The southern section of the investigation area appeared to have been contoured.
- Two dams created.

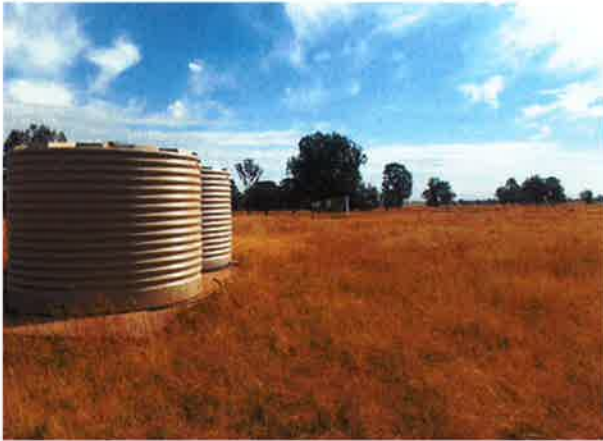
Looking south west over investigation area towards shed

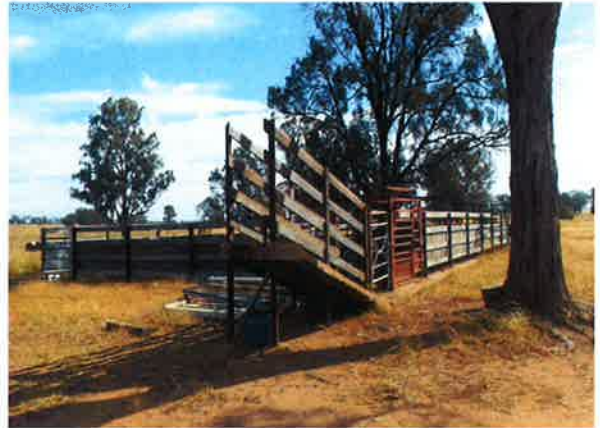
Two (2) medium sized (20m x 20m) stock yards with loading ramp are located in the central section of the site. A number of water troughs and natural water ways are located throughout the site servicing stock needs.

Two stockyards are located in the central section of the site. The yards are expected to have used for ease of loading and unloading stock. No potential contamination is associated with the holding pen.

One of two holding stock yards on site

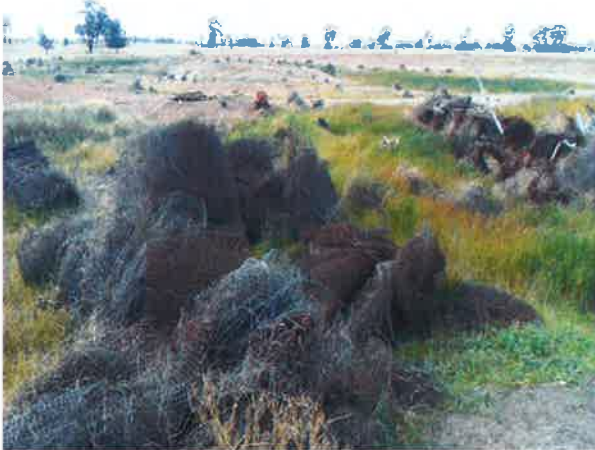
| Disposal locations, presence of drums, wastes and fill materials | Discarded fencing material located in the historic quarry |

The historic quarry has not been in use under the current owner (>10 years) and discarded fencing has been disposed in the area will require removal.

Looking north over quarry with discarded fencing material

The historic quarry has not been in use under the current owner (>10 years) and discarded fencing has been disposed in the area will require removal.

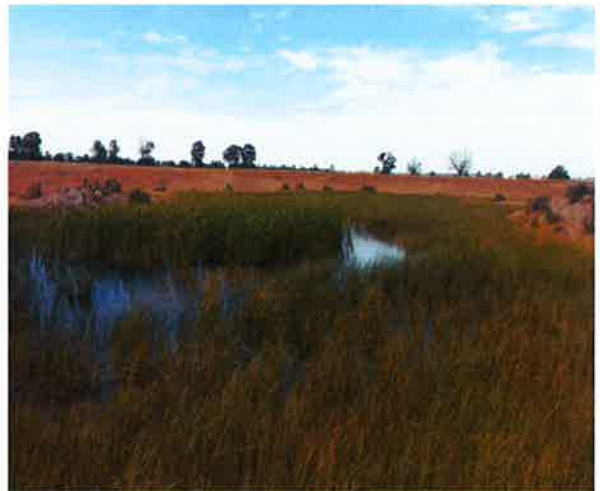
Northern extent of quarry which is inundated by standing water

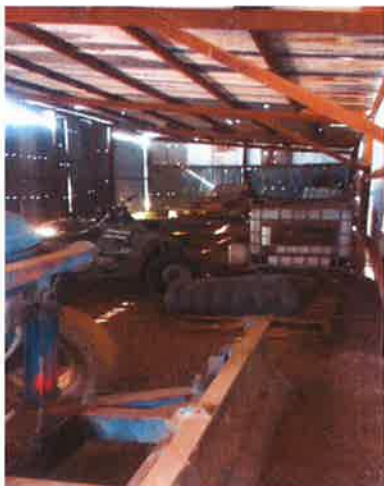
A medium sized (10m x 30m) galvanised shed is located proximal to one of the stock yards. The fully enclosed shed currently consists of dirt floor and small work bench. The shed is being used for machinery storage which includes tractors and motorbikes. No oil or surface staining was observed and 3 x 20L herbicide and wetting agent products were found in the shed.

A 10m x 30m fully enclosed galvanised shed is located on site with it primarily used for storage of machinery. No surface staining was observed.

Storage shed

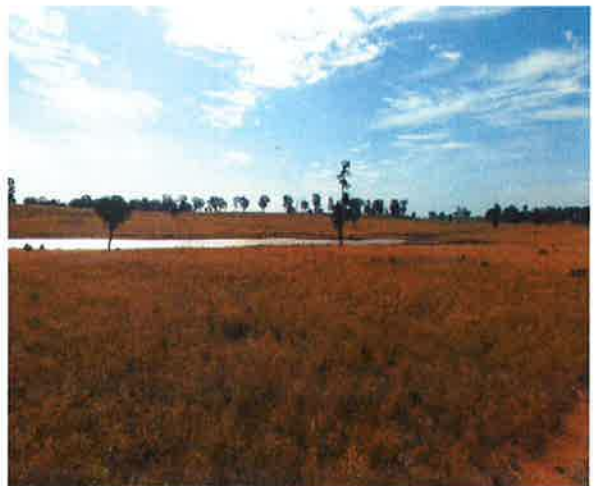
Five (5) 50m x 50m dams and one (1) 100m x 250m dam are located on site and are a part of a drainage system which flows to the south west of the property.

Looking west over largest of the six dams
