Remedial Works Action Plan

2102 & 2116 Camden Valley Way Edmondson Park NSW

Project Ref. P7503.1_R02

19th December 2016

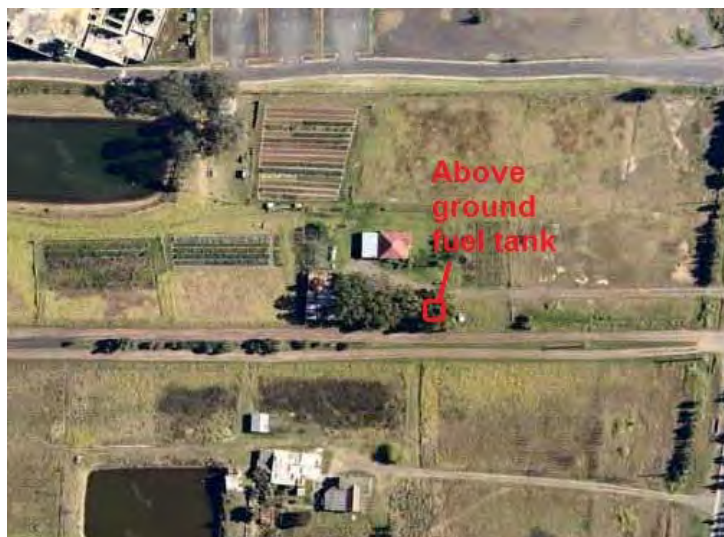
One empty (assumed diesel) AST, with a capacity estimated to be 500 L, was observed to the east of the dwelling at Site B. The previous contents were unknown and there were no observed odours or staining in the vicinity of the AST.

Approximately six, empty 100L oil drums were identified to the south of the dwelling at Site B. There were no observed odours or staining in the vicinity of the oil drums.

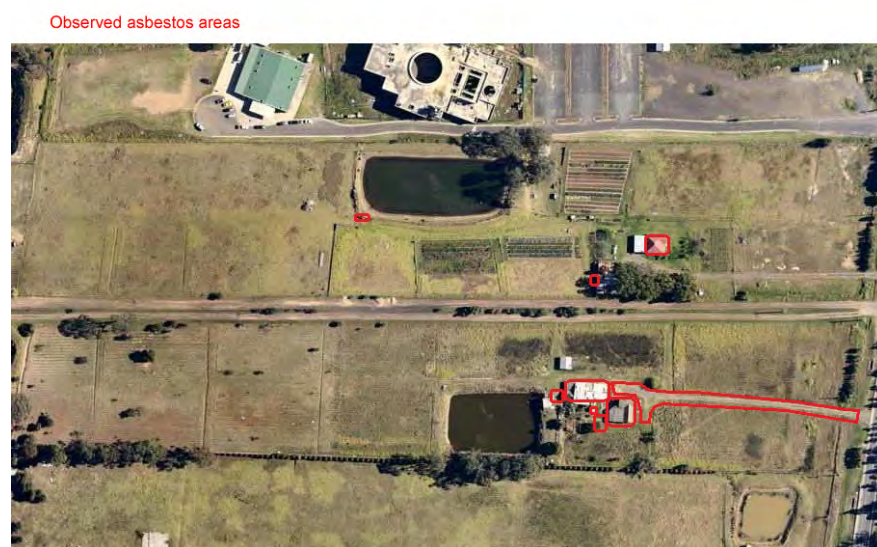
- A significant quantity of PACM roofing was stored immediately to the south of the sheds at Site A;
- Some PACM sheeting was observed to be used as small soil retainers to the south of the residential property at Site A;
- The driveway of Site A was an unsealed gravelly track with many ACM fragments observed on the surface;
- One potential asbestos containing material (PACM) pipe was observed in the area of debris storage to the south of the dam at Site B;
- Fragments of PACM were observed on the ground surface at the southern side of the tin sheds at Site B; and
- Two to three sheets of PACM were observed to the south of the dwelling at Site B.

Geotest did not make a comprehensive assessment of the buildings and sheds present at the site. ACM was observed to have been used in some building materials of most buildings at the site. During demolition and re-development of the site special attention should be given to these areas to prevent the un-necessary spread of contamination. Further, the presence for contamination in areas of long grass cannot be discounted. Please see figure below for locations:

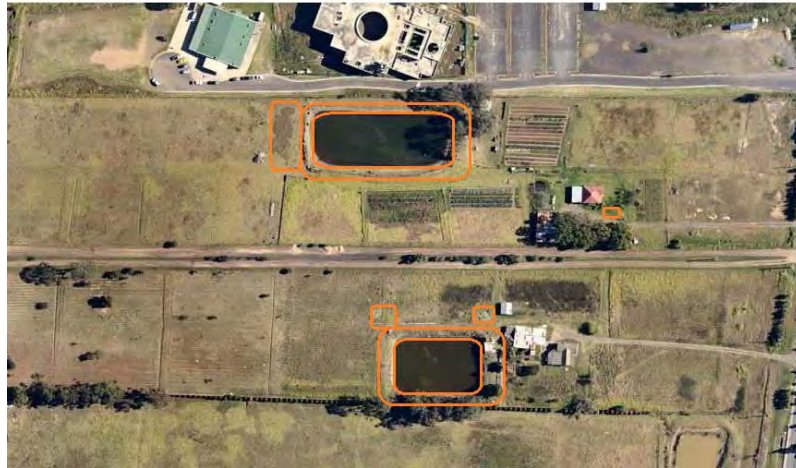
Fill areas

Fill material was observed in the following locations/stockpiles at Site A:

cannot be discounted. Geotest will target potential areas of fill during the intrusive investigation where possible however can never guarantee the presence of in-filled wastes.

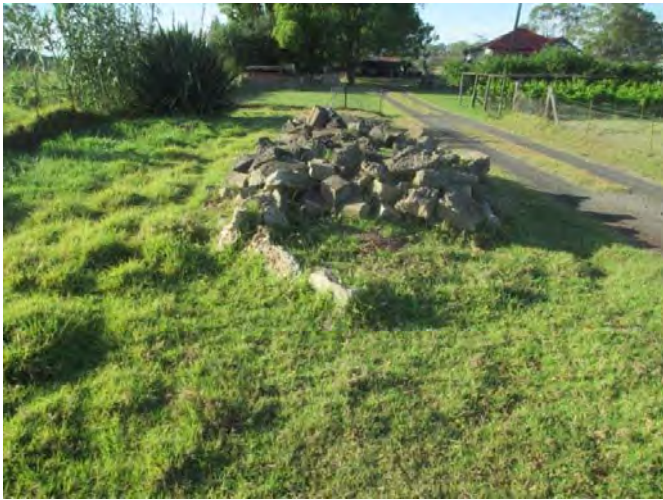
Rubble to the east of the driveway at Site B, looking south.

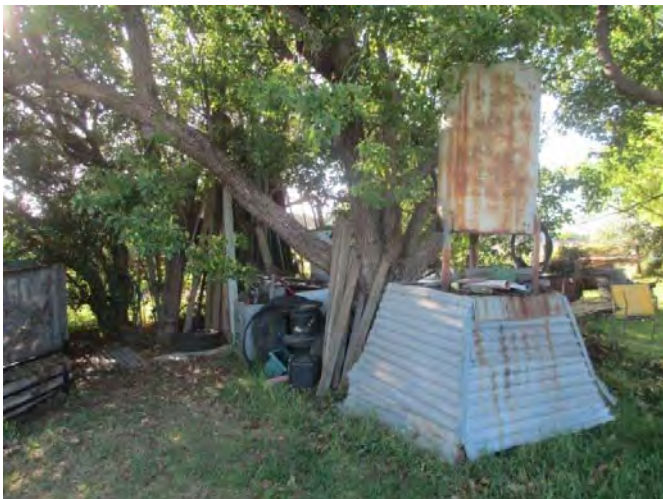
AST and other items in to the east of the dwelling at Site B.

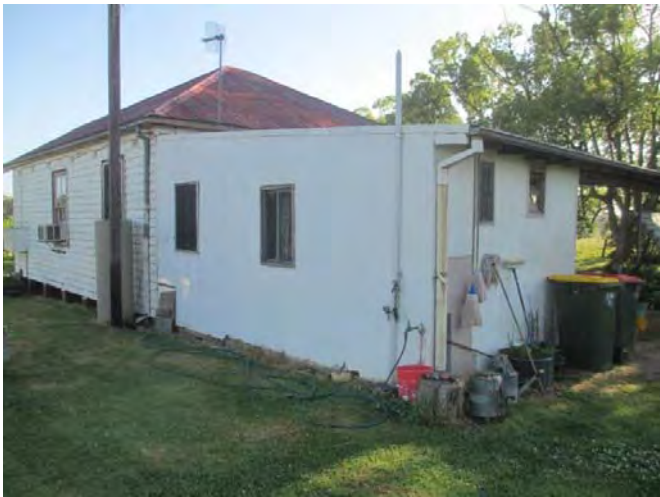
Dwelling at Site B with PACM walls.

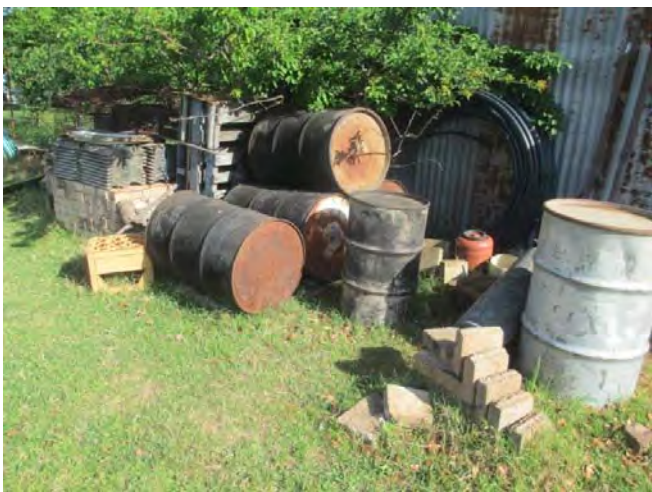
100 L oil drums to the south of the Site B dwelling.

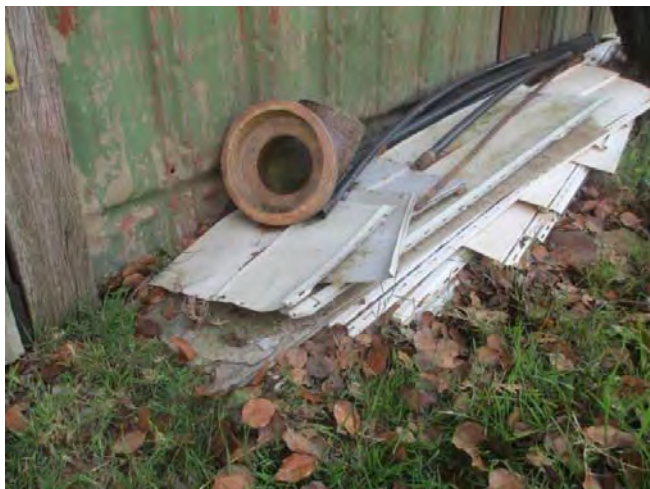
ACM on ground surface in the vicinity of site sheds

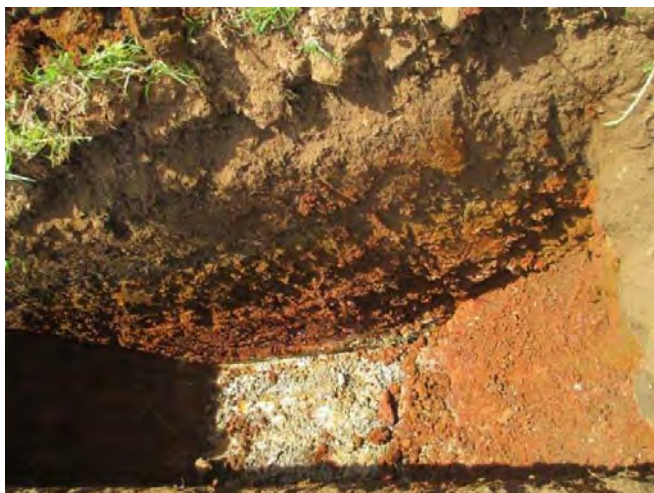
Residual clay soil profile characteristic of the site and broader area
