Final Report - Revision C

Remediation Action Plan

181 James Ruse Drive, Camellia, NSW

5 SEPTEMBER 2013

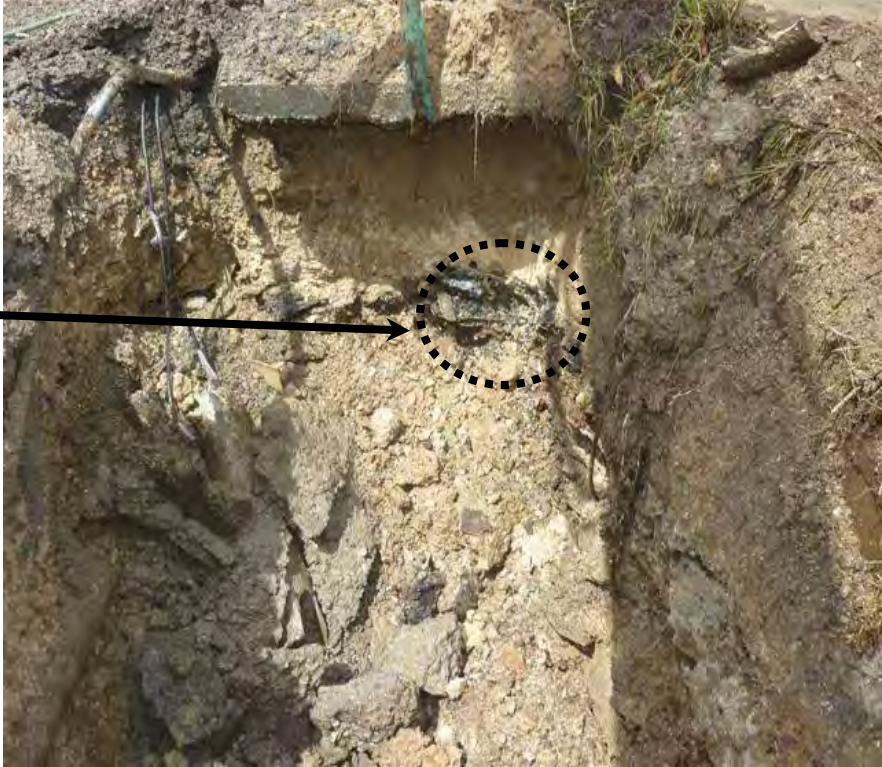
Client Name: Statewide Planning		Site Location: Camellia West	URS Project No.: 43218346
Date: 18/10/2012	Plate No: 1.

Description: Sample location TP1 – Observed clinker material – thin layer of black fill.			
Direction Photo Taken: Facing east

At test pit TP1, a bulk sample of the clinker was collected for TCLP and neutral (ASLP) leaching tests, and reported low leaching potential in both instances (URS, 2013). The chemical nature of the clinker material was assessed by comparing the soil bore locations where clinker was observed and the corresponding analytical PAH/TPH results, as presented in **Table 4-2**. The results show that the Clinker material comprises significant concentrations of TPH and PAH, but is relatively non-leaching when total concentrations are compared to the leachable concentrations.

Clinker materials were identified in the south east portion of the site at TP1 during the recent SSI, corresponding with previous descriptions of a black, vitreous material (and slag) found during the 2006 field works, at locations WSB43, WSB45 and WSB46. The following table (**Table 4-3**) presents an estimate of the quantity of clinker material (coexisting with ash) that could be present in this area of the site. The estimate is based on the total thickness of fill material recorded in the soil logs and compared to the thickness of clinker/ash material. For the purposes of this estimate, only material that was described as glassy/black was included as likely clinker material. Clinker and ash coexist in most instances; however it is the glassy/black description that makes this material distinguishable from other fill and ash.

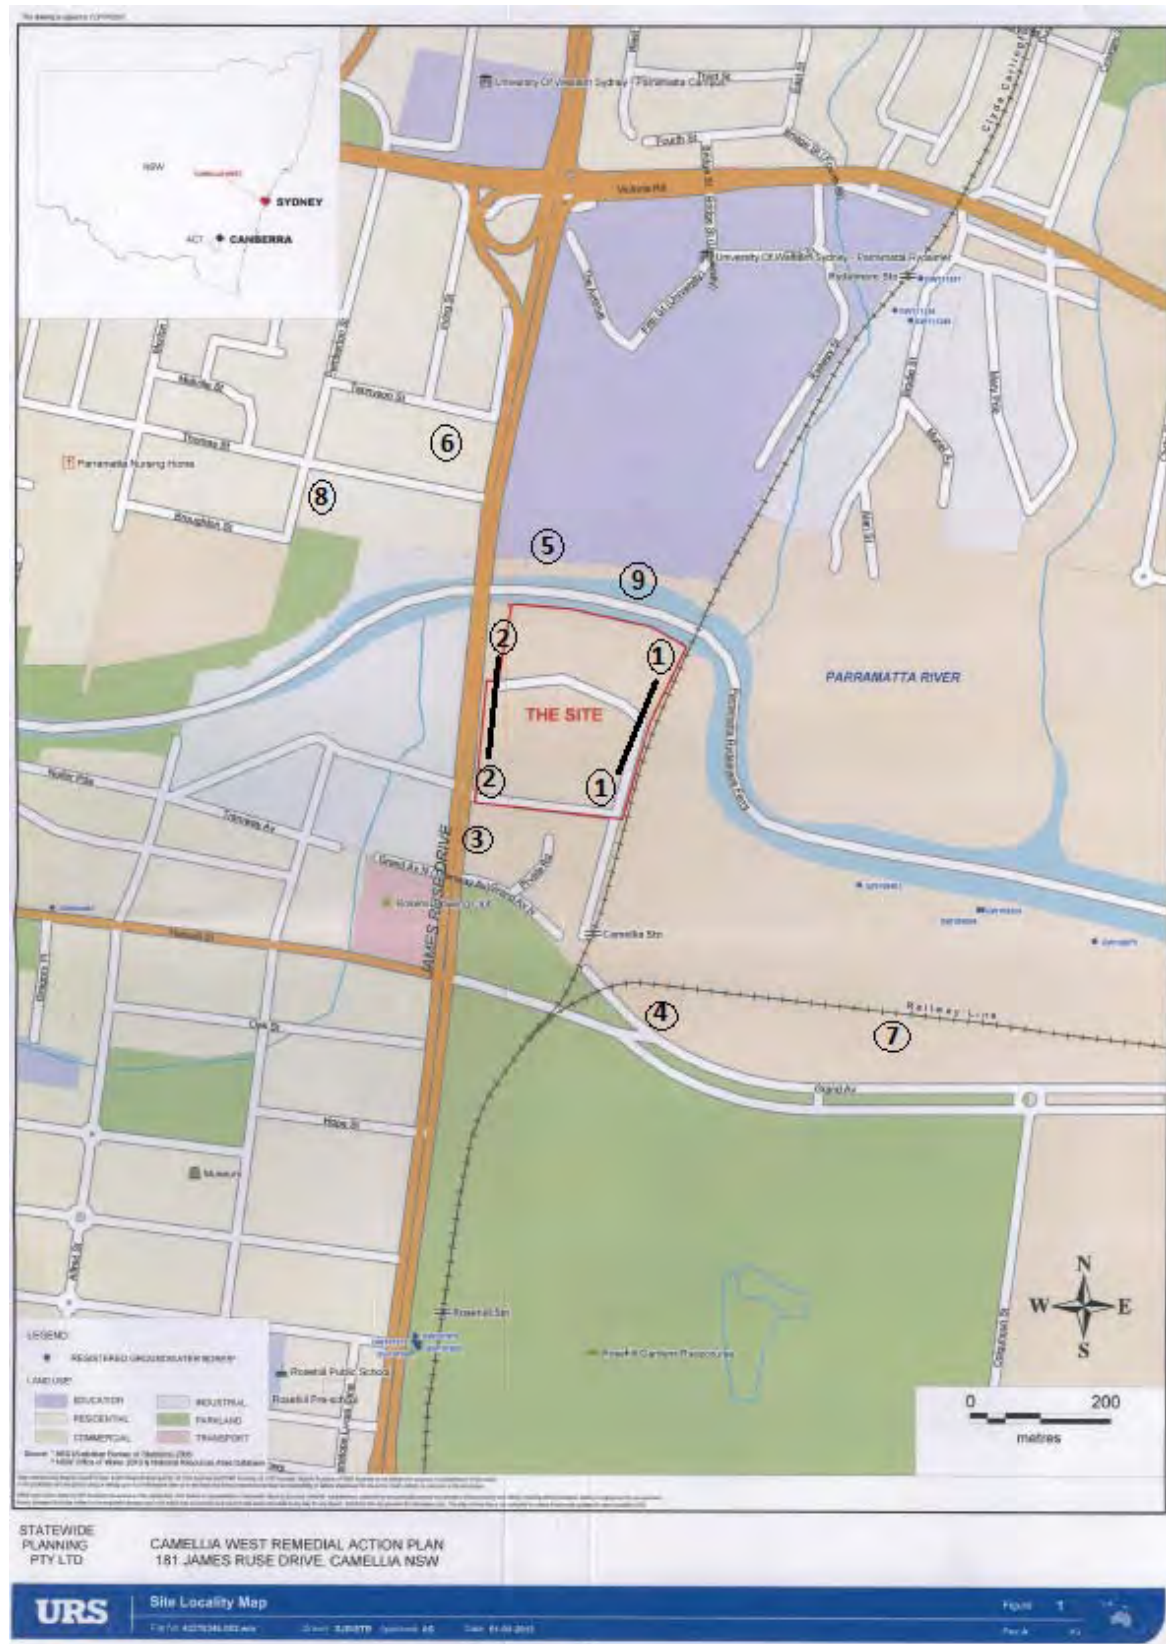
Figure 4-1: Site Location & Environmental Reference Locations

This is presented as Figure 4-1 and shows the location of the site. The site can be seen to be bordered by James Ruse Drive to the west, the Clyde Carlingford rail line to the east.

The two direct reading fibre counting instruments would be located along the ① - ① and ② - ② Reference locations. These two instruments may be located at other locations during the course of the Remediation Programme.

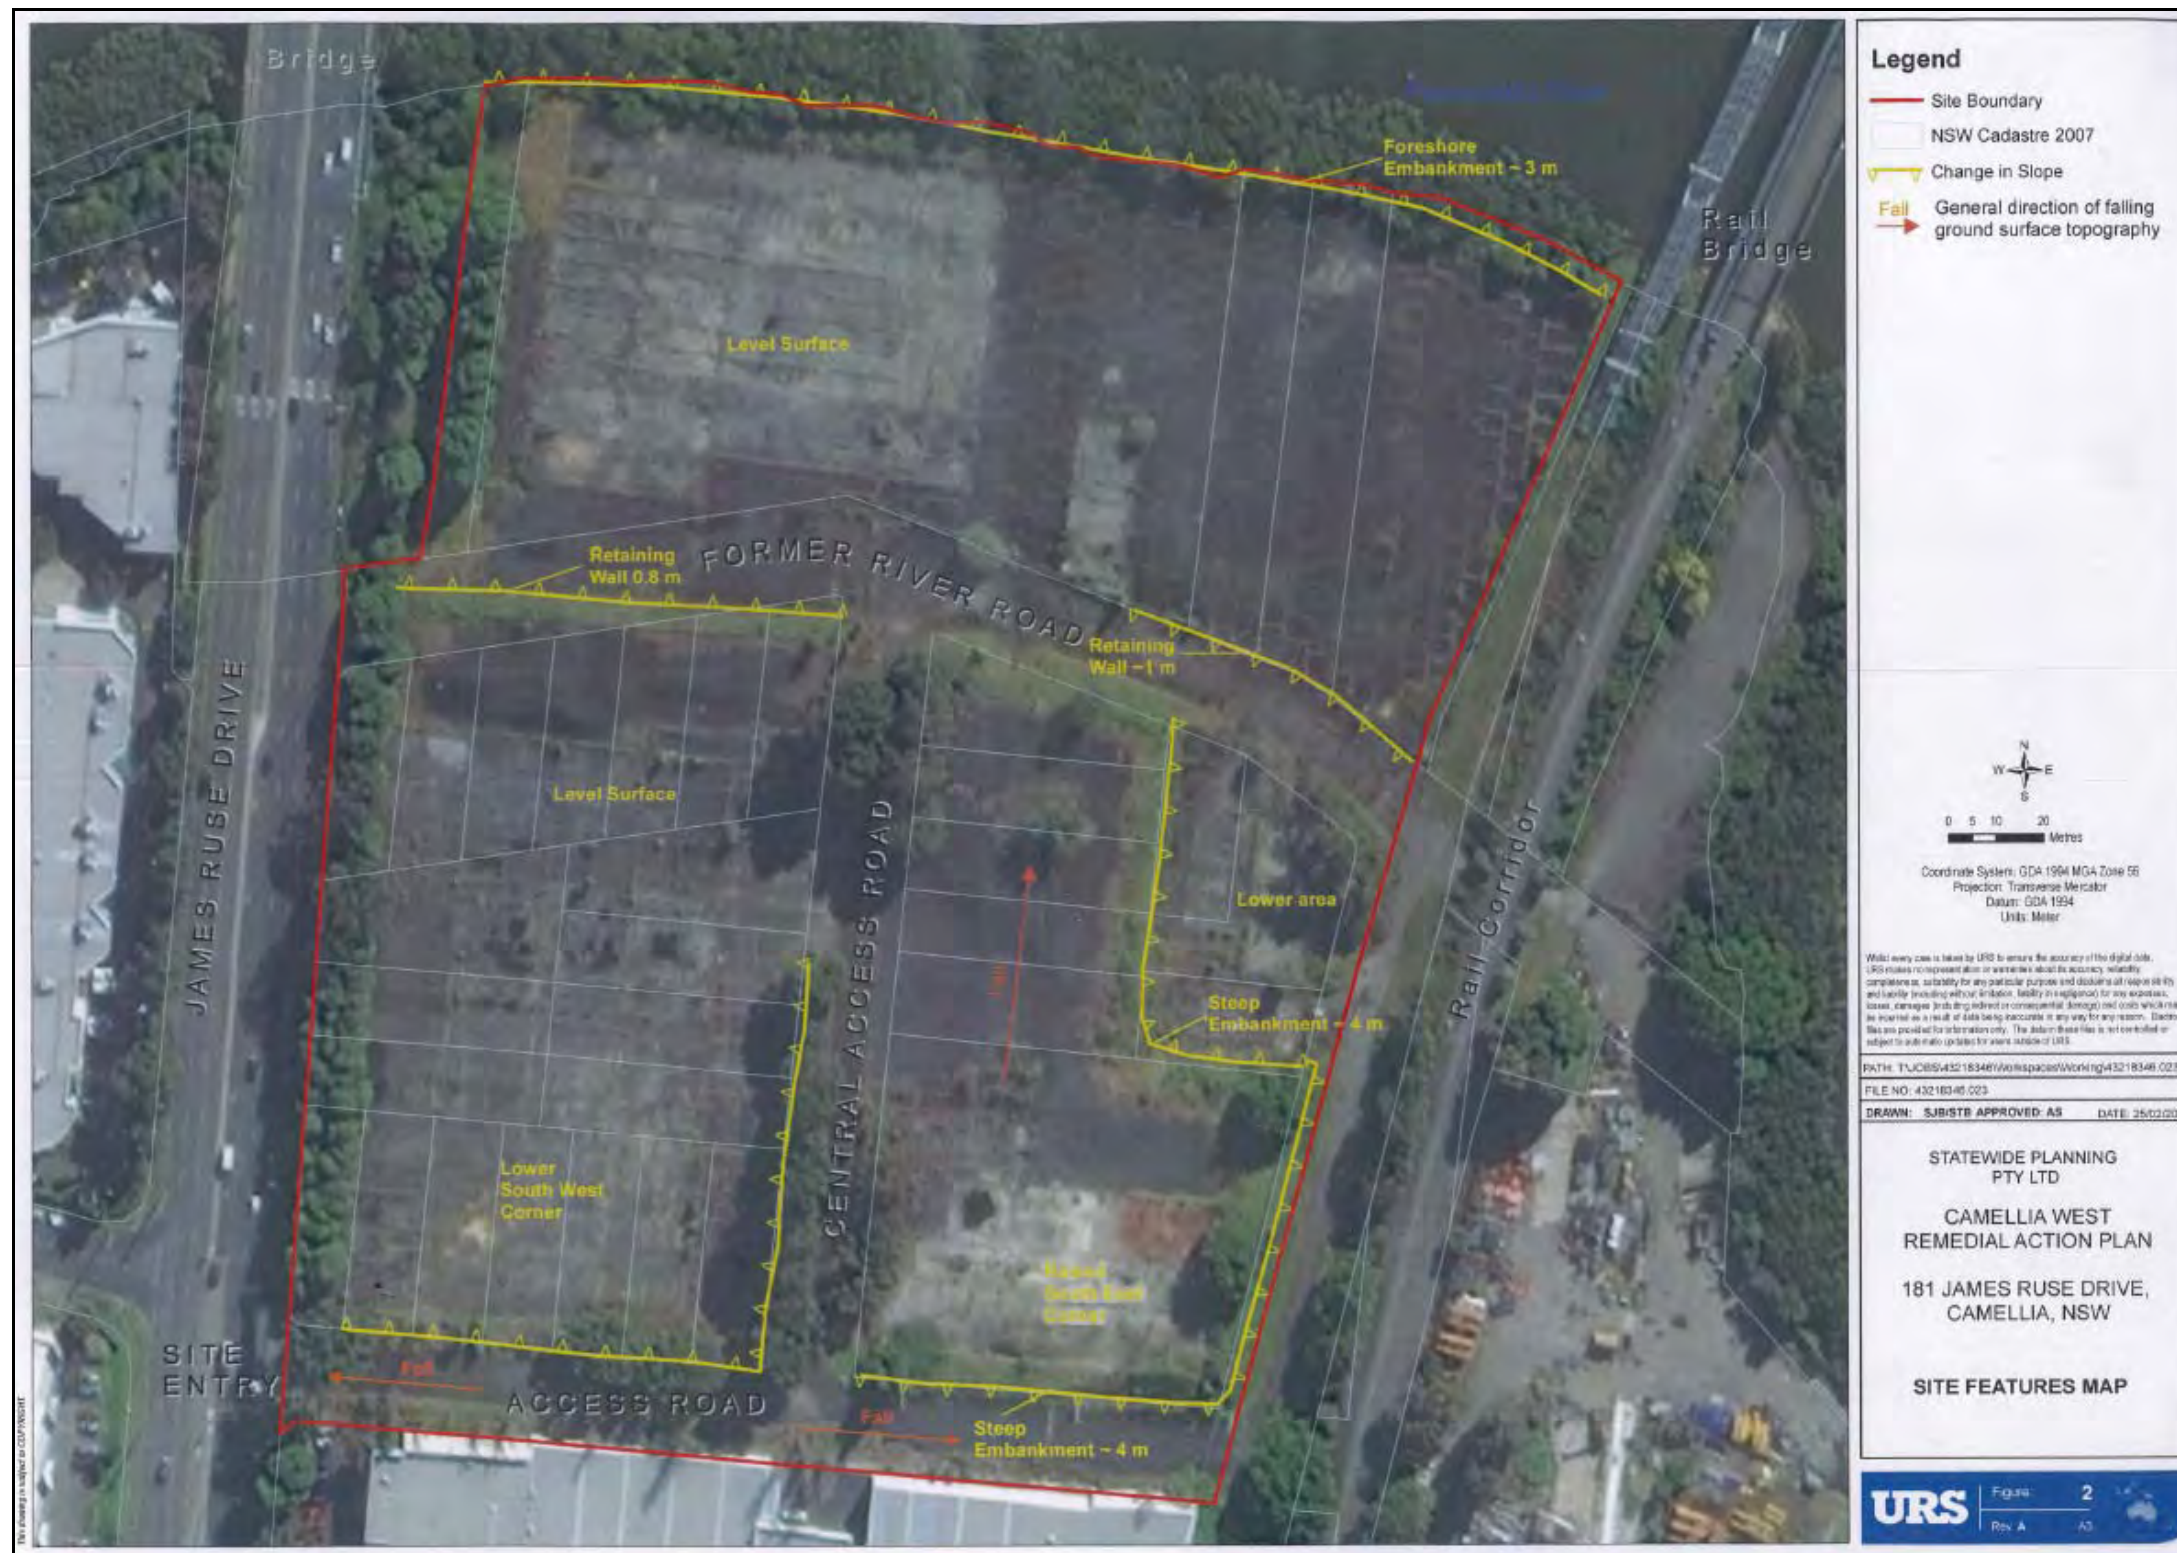
Figure 4-2: Site Features Map

The site features map is presented as Figure 4-2. This figure is an aerial photograph of the site and provides a description of the various surfaces of the site. Although shown on the figure these are discussed below.

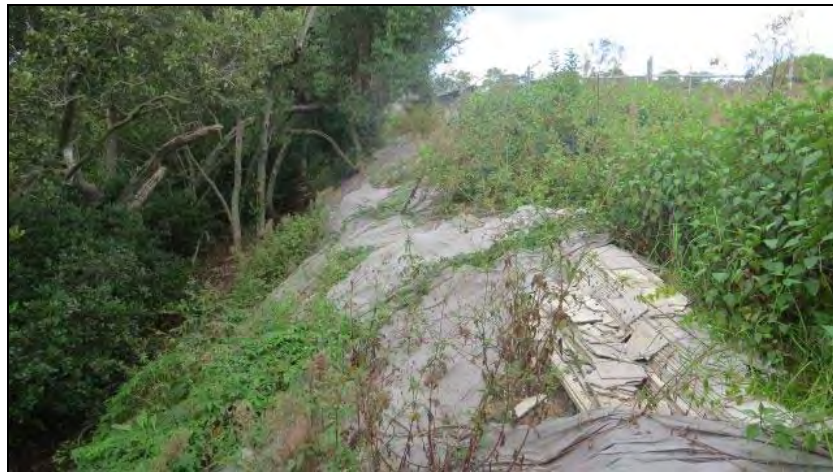
Photograph 1C: The Clyde Carlingford Rail line bridge across the Parramatta River is in the background of the photograph. There are numerous fragments of asbestos cement on the concreted areas. This is asbestos dust and debris and needs to be removed using safe work practices so that this material is not pulverised and able to become an uncontrolled source of airborne asbestos fibres and dust.

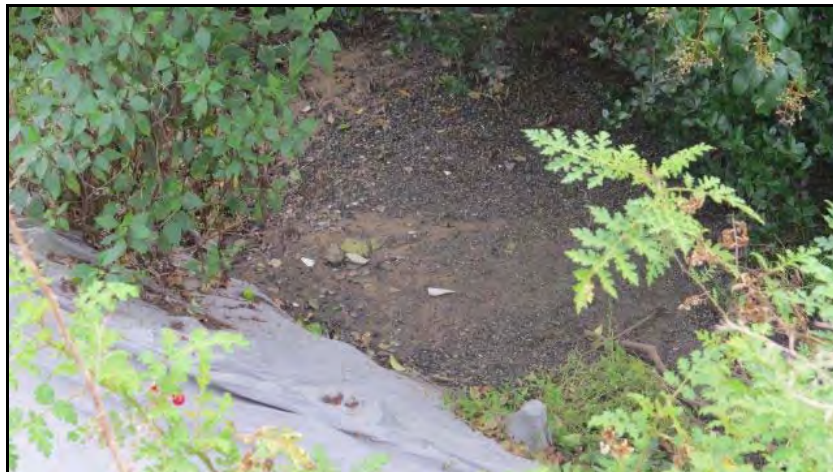
Photograph 2A: The edge of the River bank has the asbestos cement partially covered. Fragments of asbestos cement have been scattered through the mangroves and will require a depth of soil to be removed and the cleaned surfaces validated to the standards discussed in the URS Remedial Action Plan.

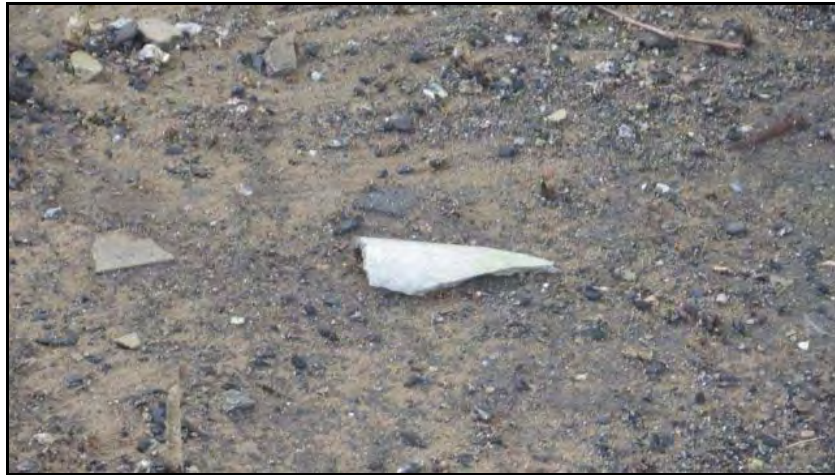
Photograph 2B: Fragments of asbestos cement on the foreshore.

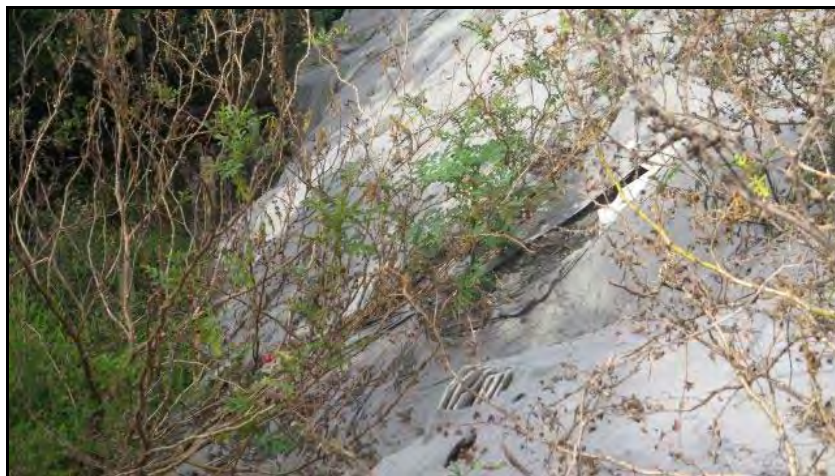
Photograph 2E: The sheets of asbestos cement are visible through portions of this fabric.

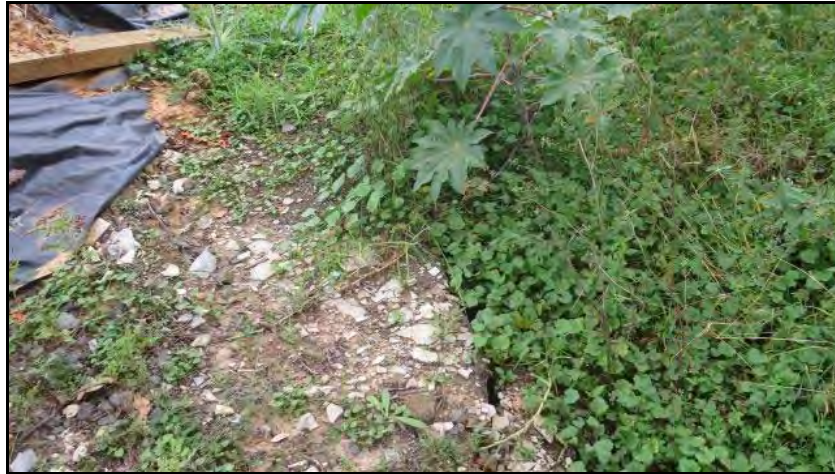
Photograph 4: A view along the western edge of the site where asbestos cement fragments are also on the surface. The remediation of the site would remove the potential for these fragments to be disturbed and release asbestos fibres.

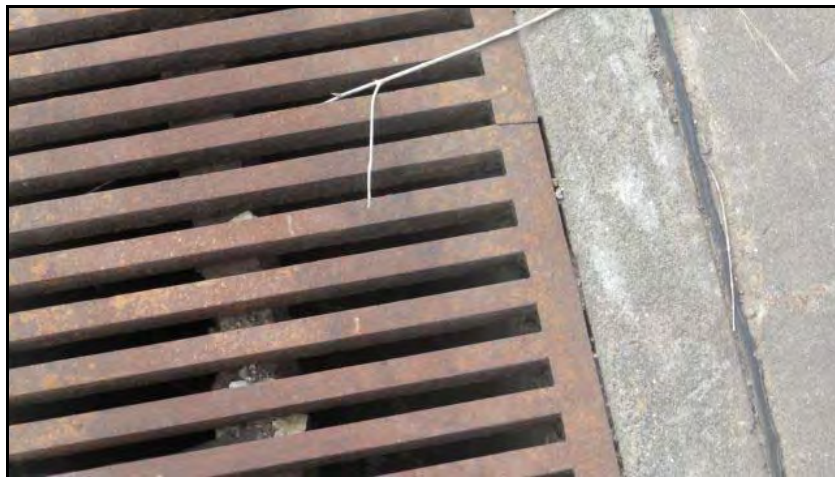
Photograph 5A: Contamination of stormwater pits and pipelines has occurred from past uses of the site. This pit is in the northern area of the site.

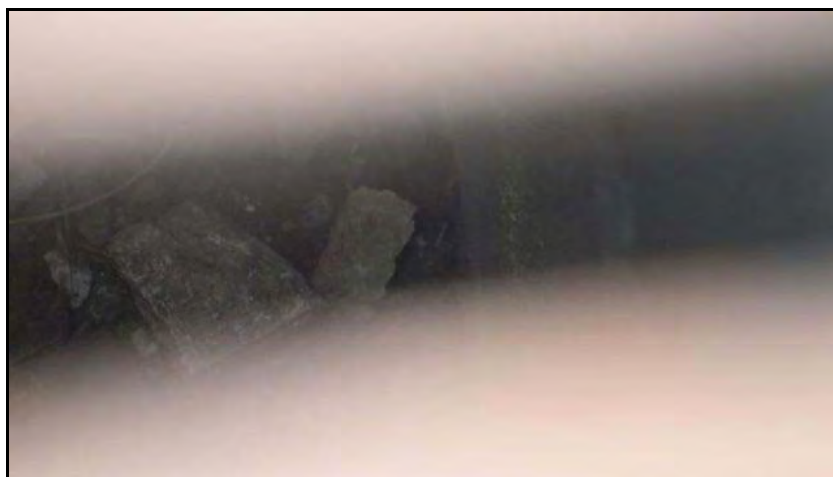
Photograph 5B: Fragments are in the floor of the pit.

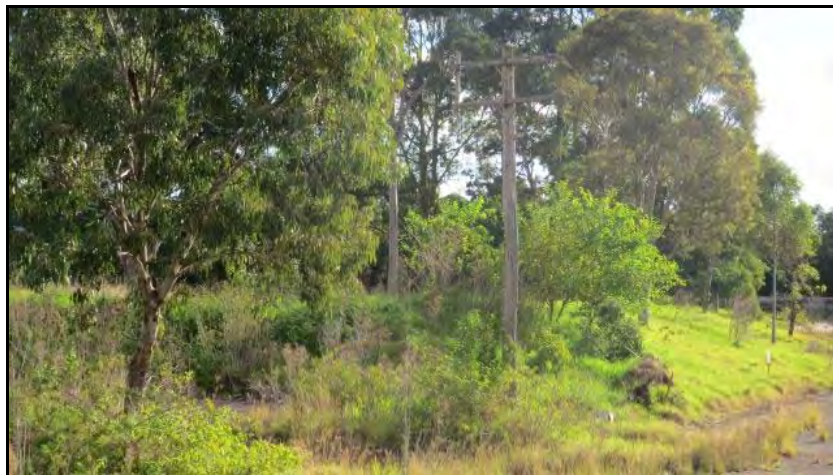
Photograph 8A: The embankment from the level surface shown in Figure 4-1 down to the former River Road. This roadway would have been the original ground surface of the site if as expected the power pole shown is original.

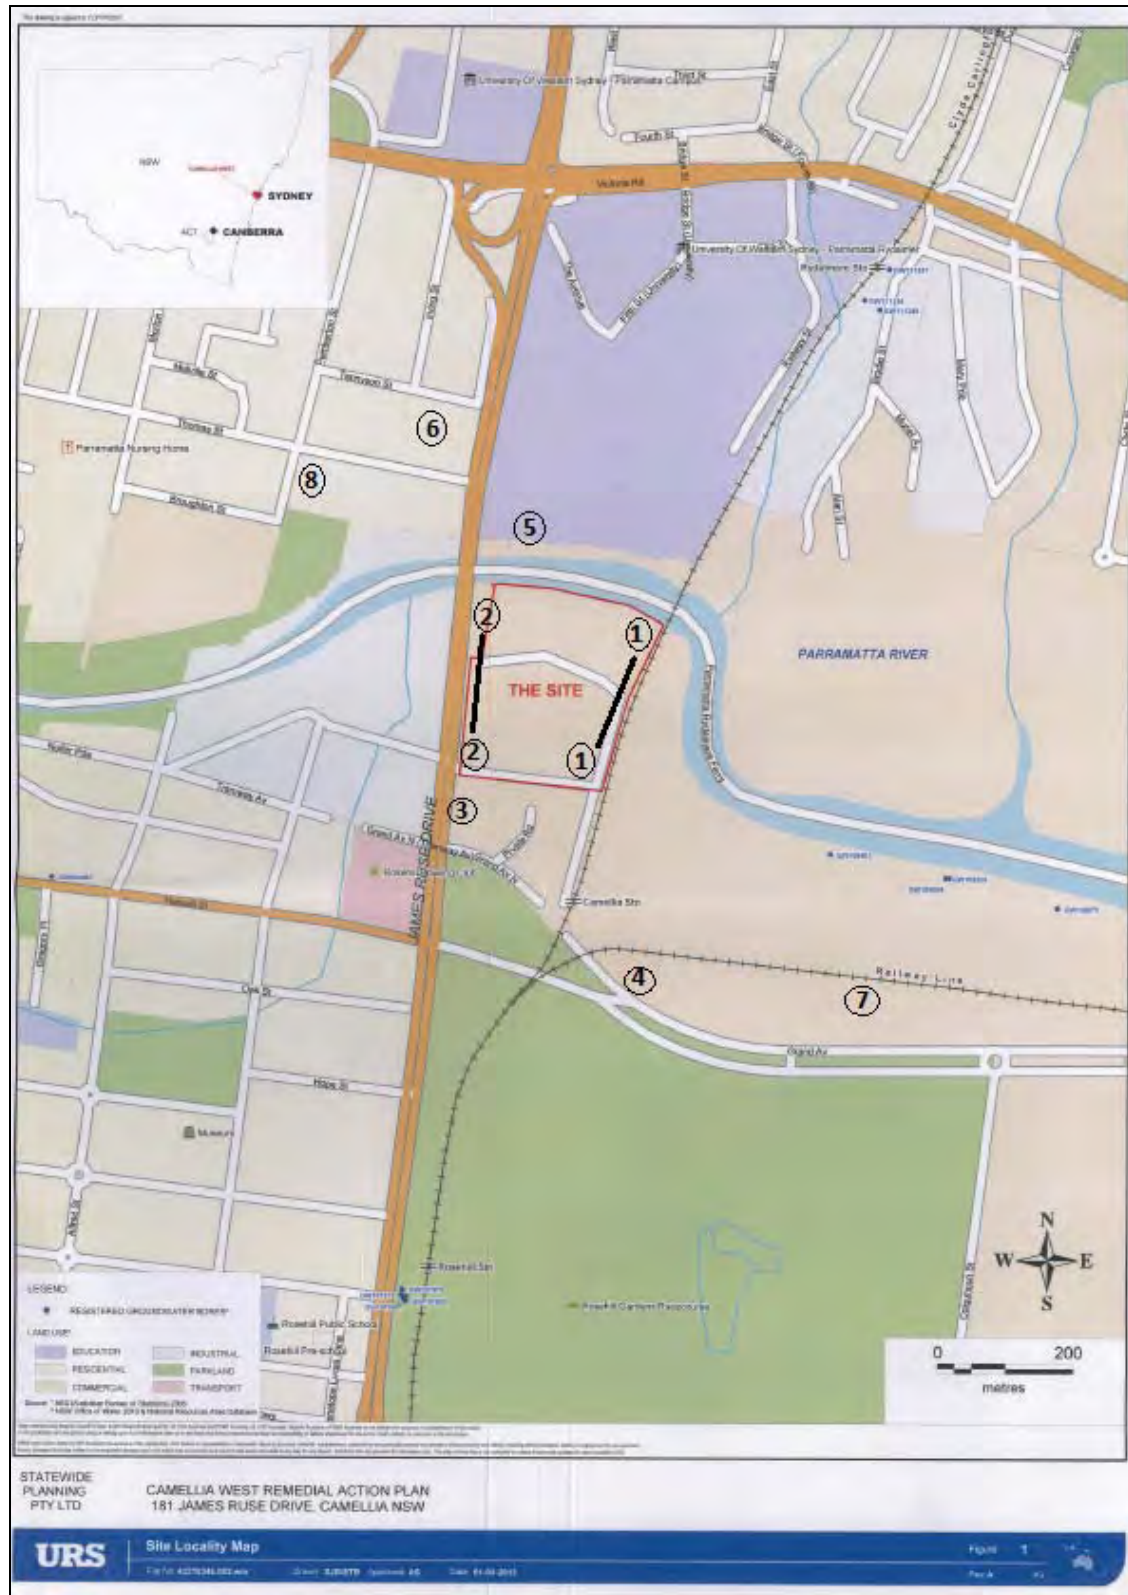
Figure 11-1: Environmental Reference Locations

The TEM method would be used during the pilot trial including excavation at the work area exclusion zone and also on site and at the reference locations shown on Figure 11-1.

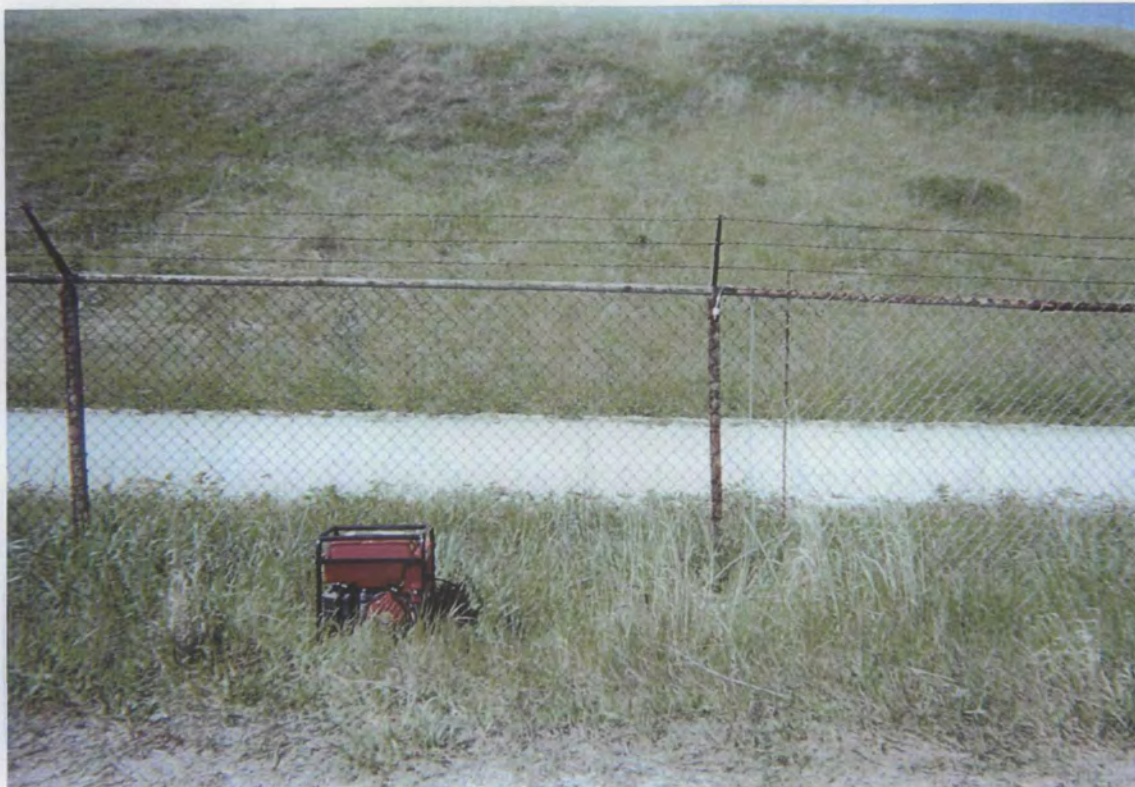
Photograph No.: 2
TDD Number: S05-0203-007
Location: Johns Manville Site 2
Subject: North air monitoring station

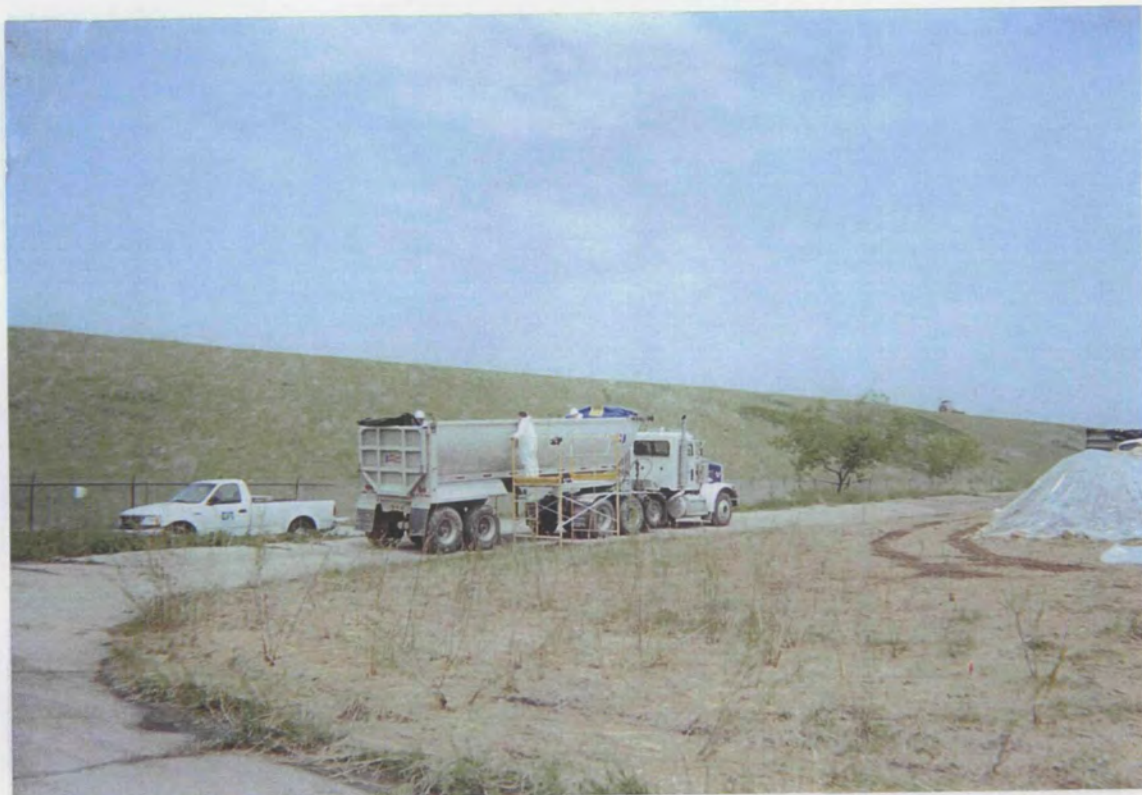
Photograph No.: 3
TDD Number: S05-0203-007
Location: Johns Manville Site 2
Subject: Lining of trucks

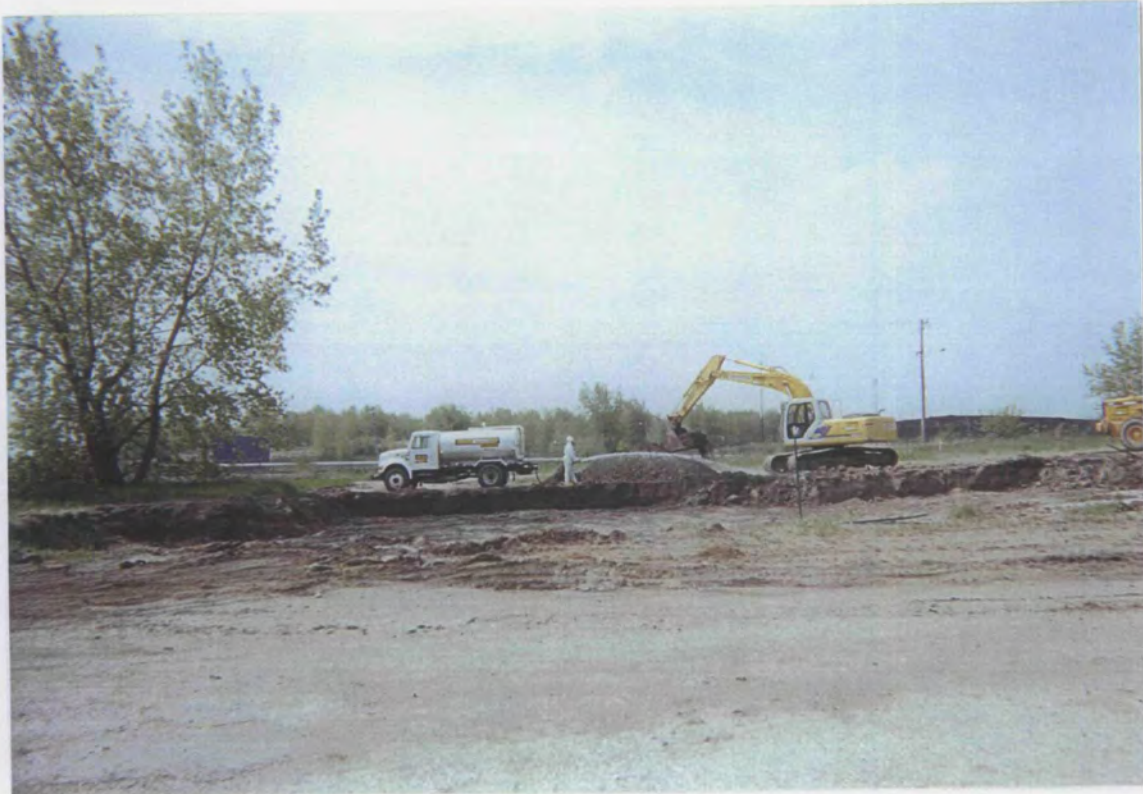
Photograph No.: 4
TDD Number: S05-0203-007
Location: Johns Manville Site 2
Subject: Watering soil during excavation

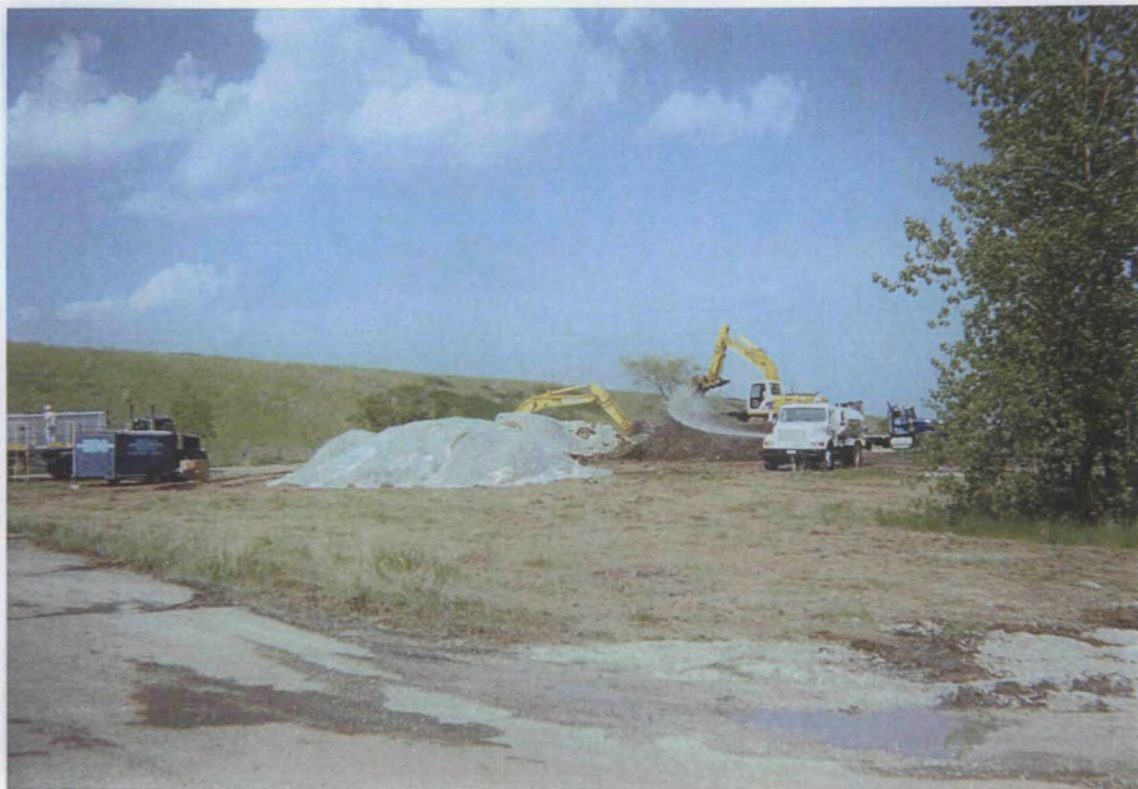
Photograph No.: 5
TDD Number: S05-0203-007
Location: Johns Manville Site 2
Subject: Load-out of ACM-containing soil

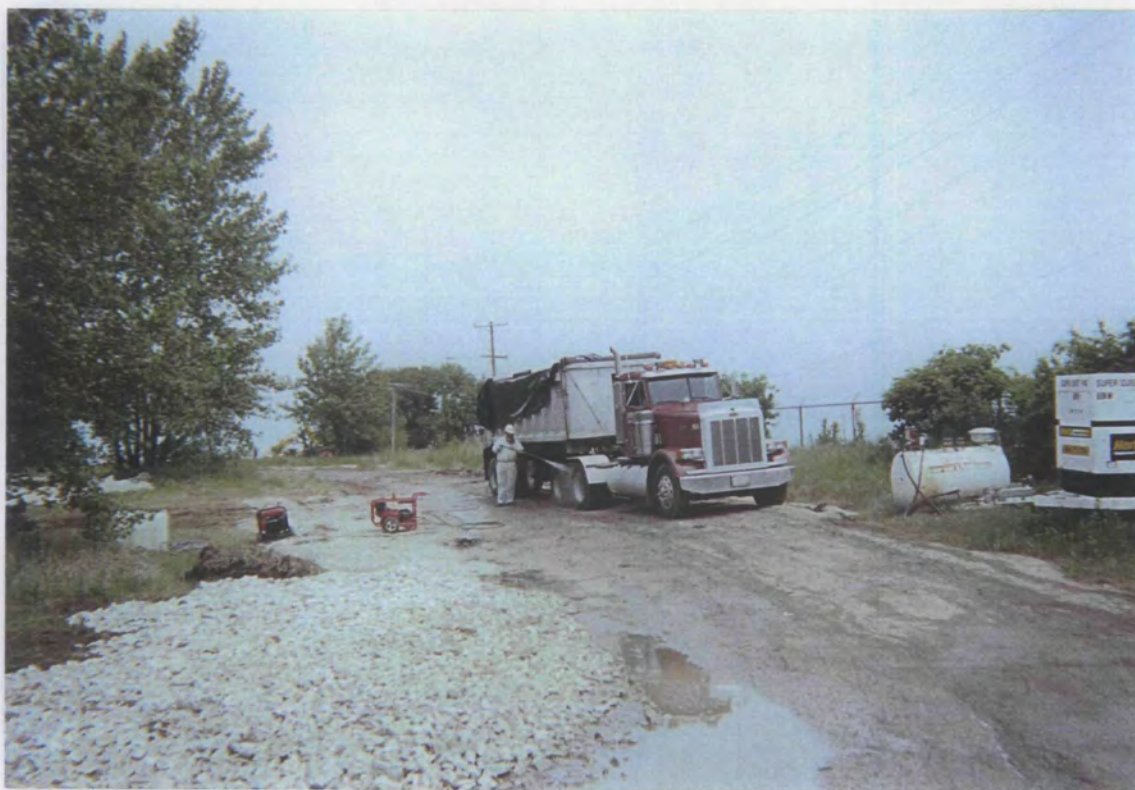
Photograph No.: 6
TDD Number: S05-0203-007
Location: Johns Manville Site 2
Subject: Power washing of truck tires before truck leaves

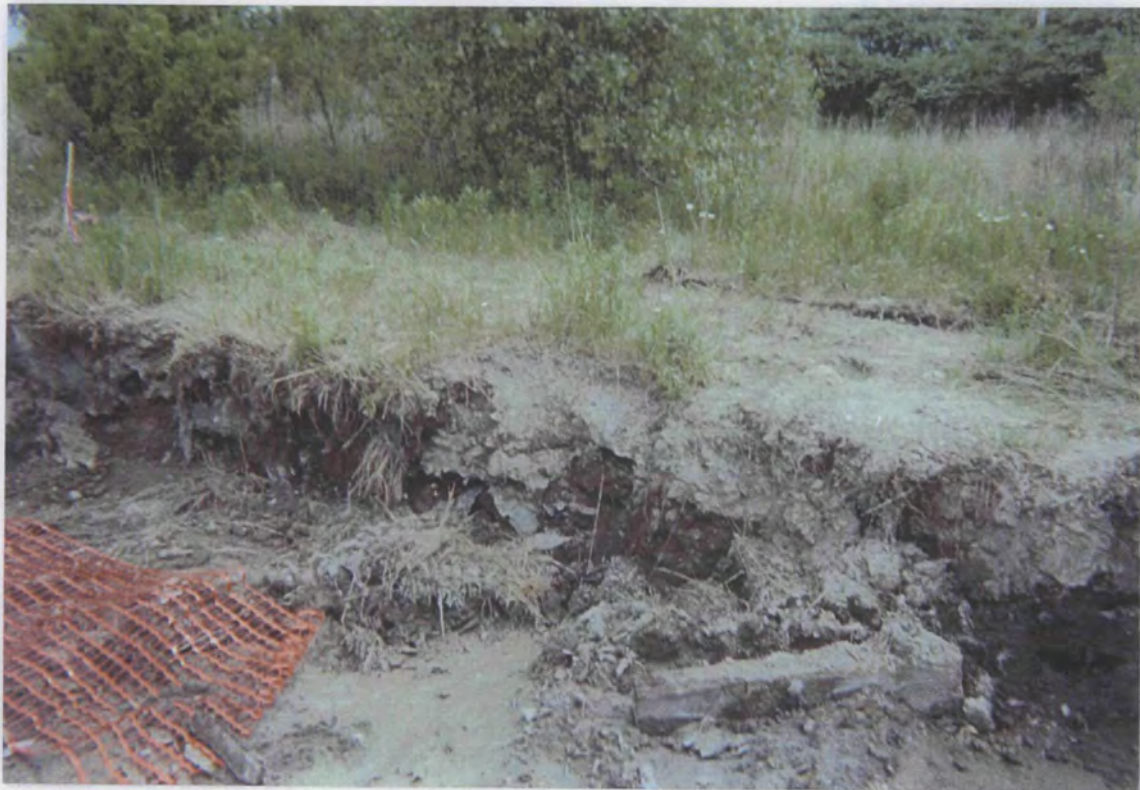
Photograph No.: 7
TDD Number: S05-0203-007
Location: Johns Manville Site 2
Subject: ACM in south wall of grid B7

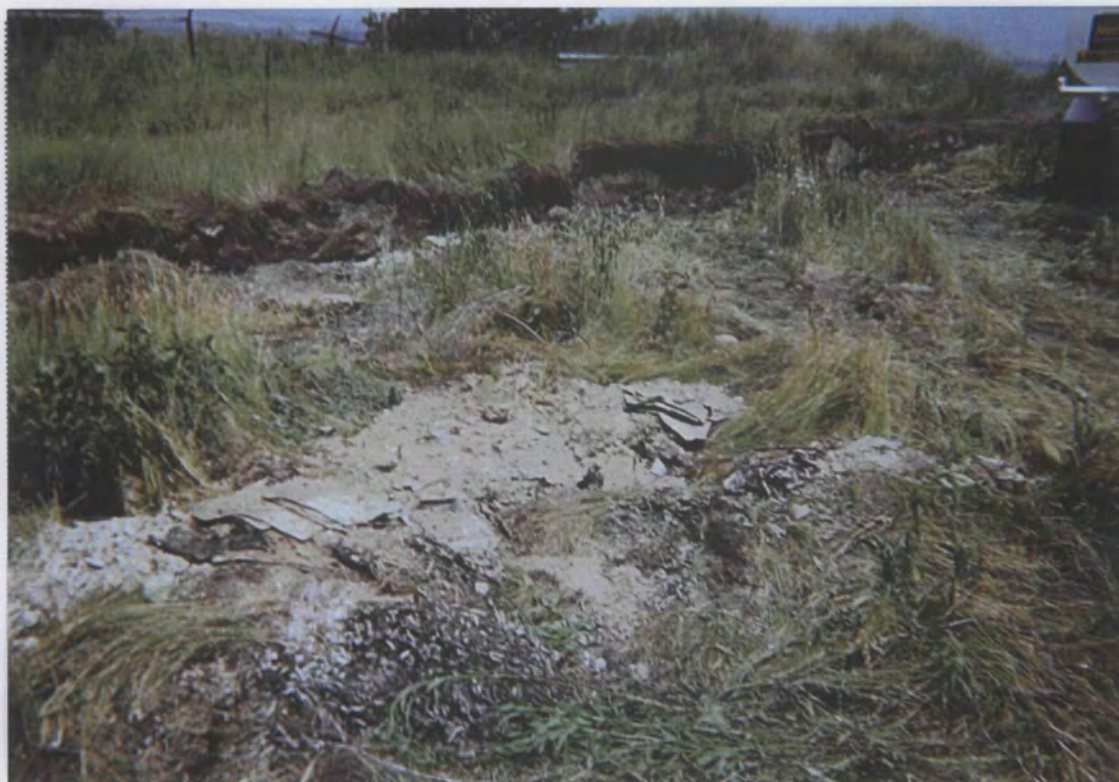
Photograph No.: 8
TDD Number: S05-0203-007
Location: Johns Manville Site 2
Subject: ACM from grid A15

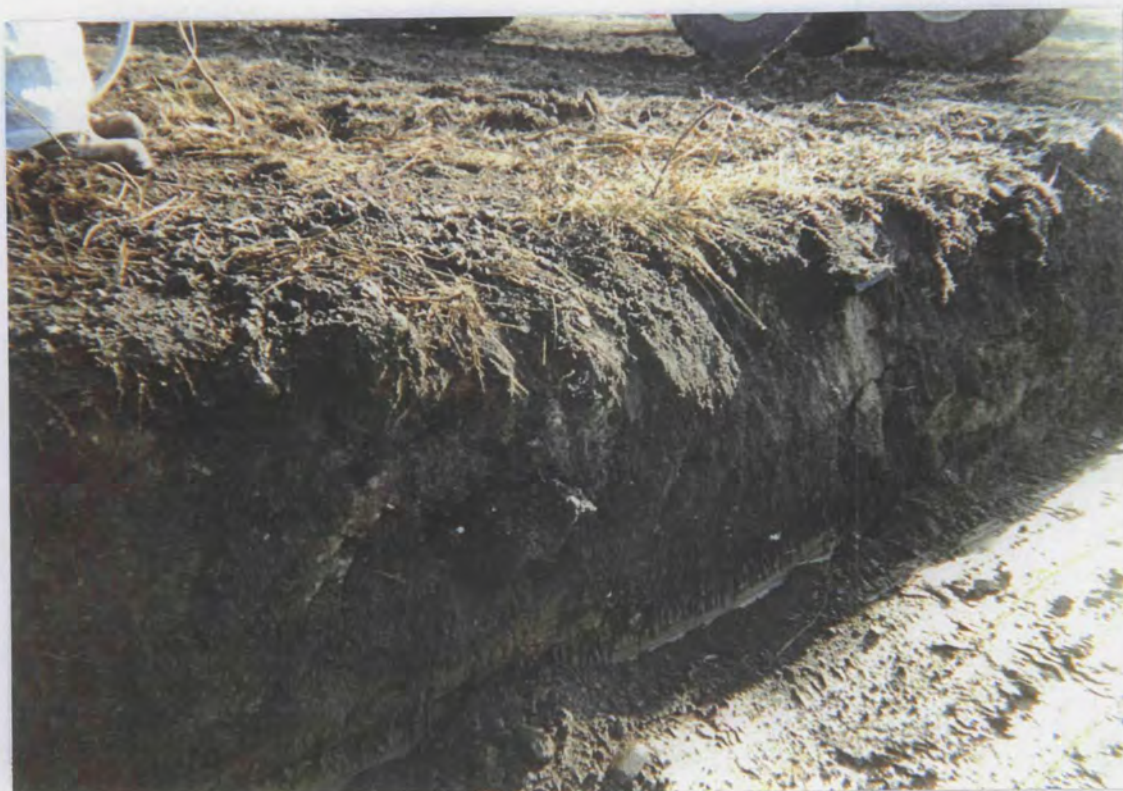
Photograph No.: 9
TDD Number: S05-0203-007
Location: Johns Manville Site 2
Subject: ACM in north wall of grid C13

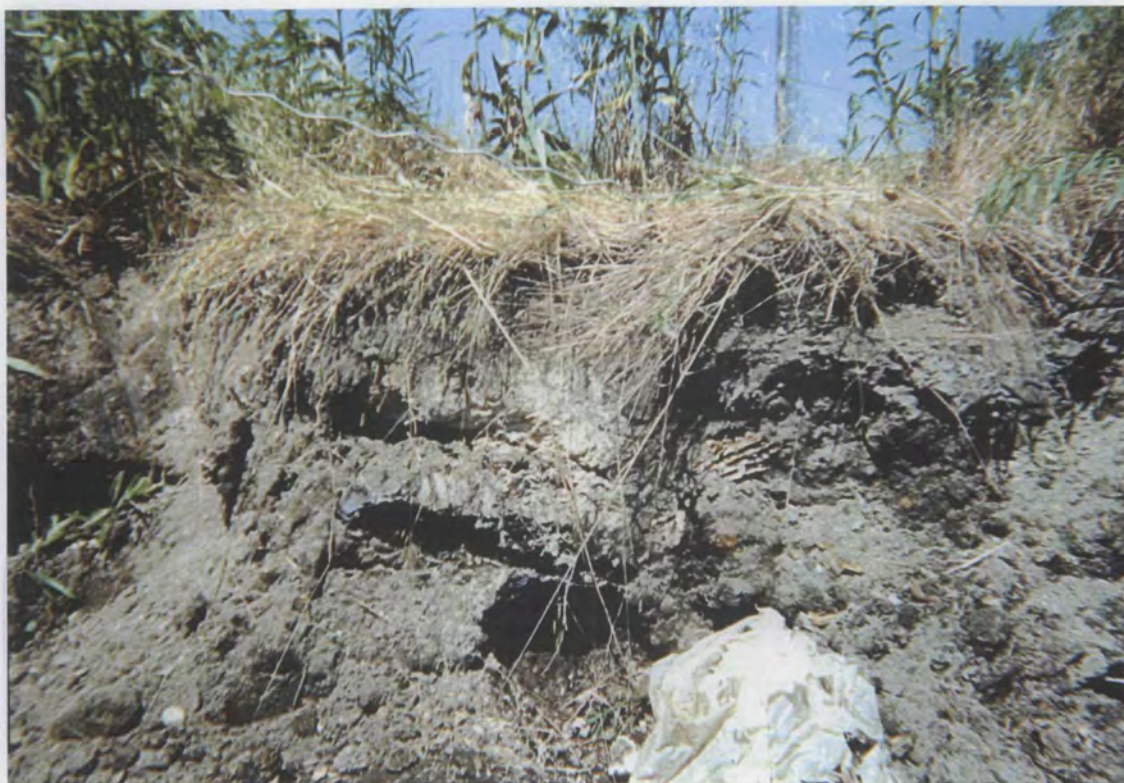
Photograph No.: 10
TDD Number: S05-0203-007
Location: Johns Manville Site 2
Subject: ACM in west wall of grid B13

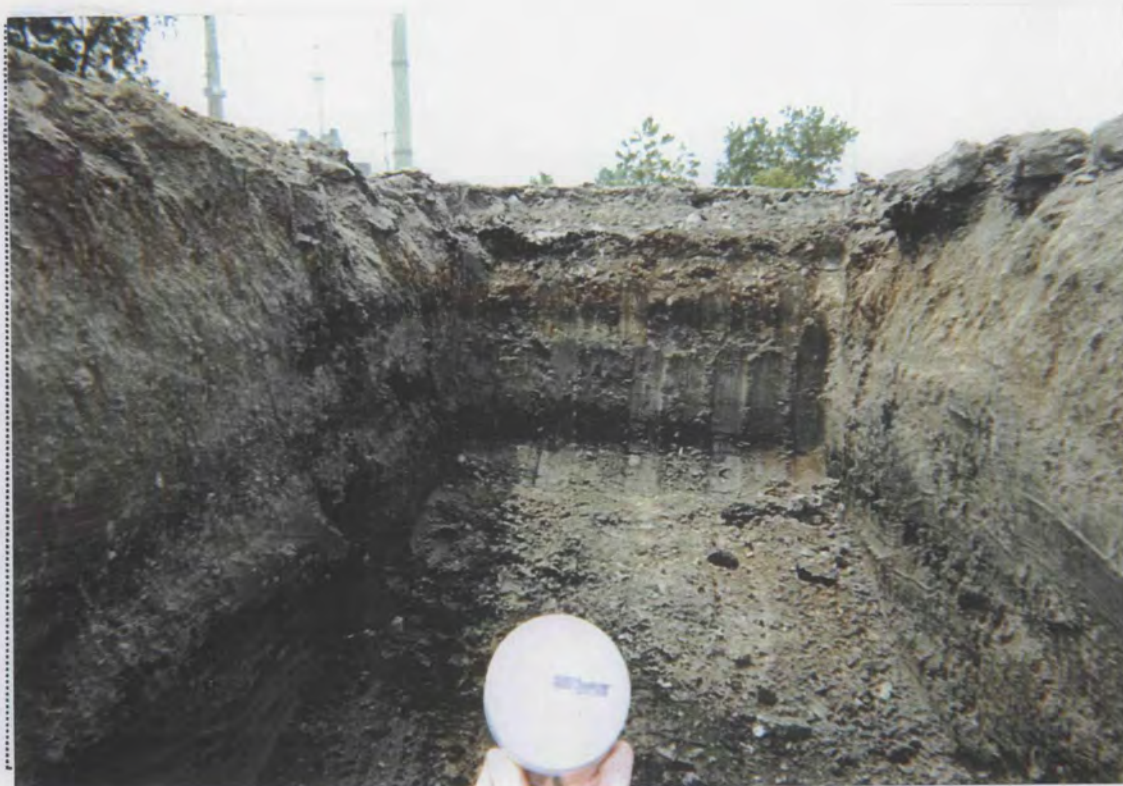
Photograph No.: 11
TDD Number: S05-0203-007
Location: Johns Manville Site 2
Subject: Test trench C10-northwest

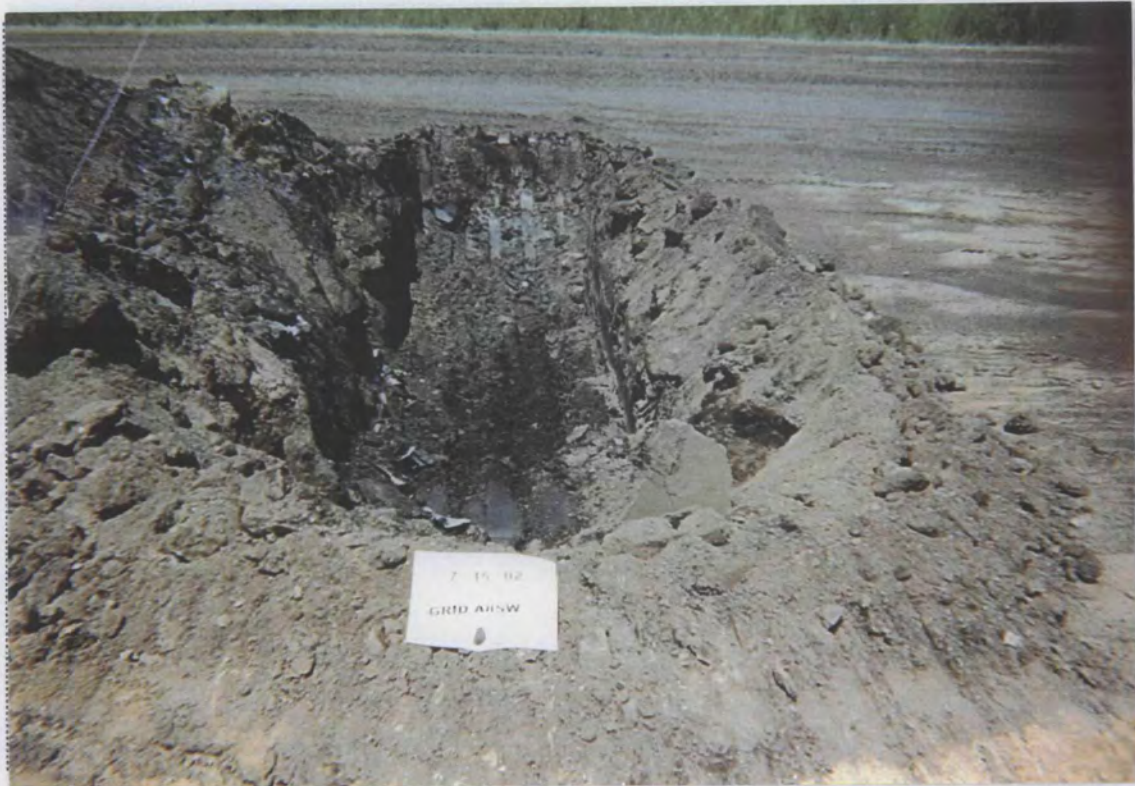
Photograph No.: 12
TDD Number: S05-0203-007
Location: Johns Manville Site 2
Subject: Test trench B2-southeast

Orientation: North
Date: July 10, 2002

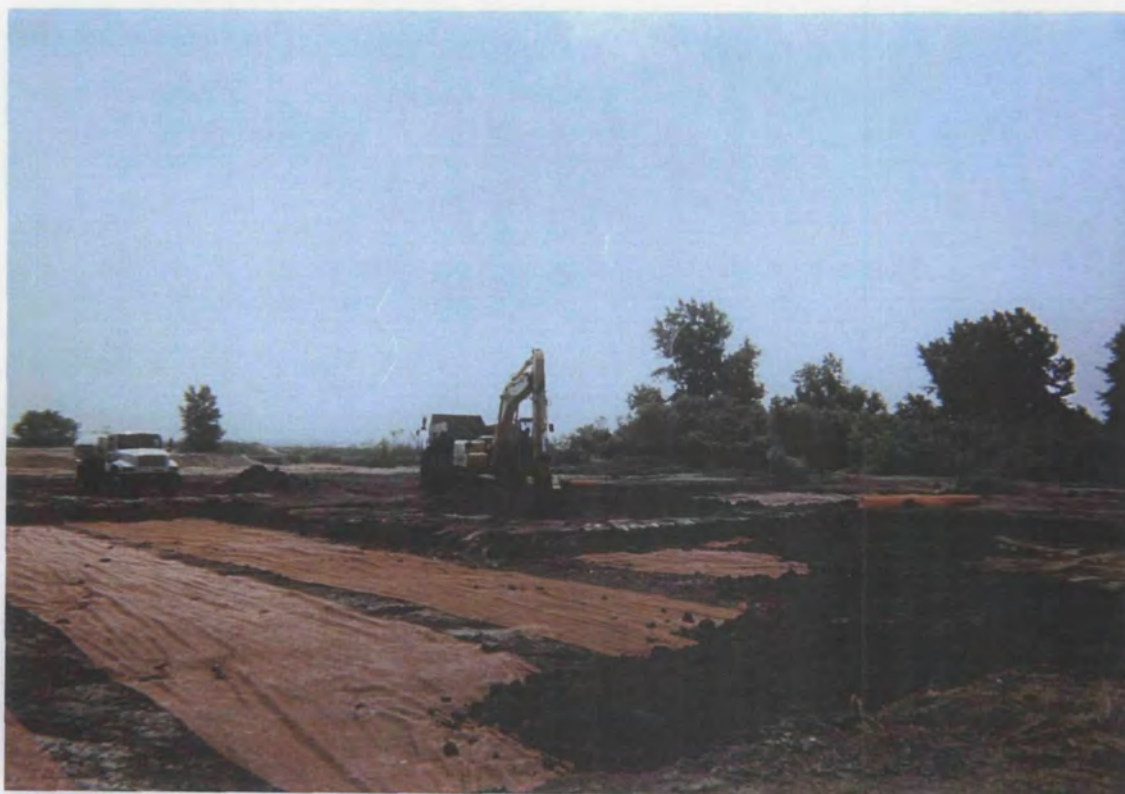
Photograph No.: 13
TDD Number: S05-0203-007
Location: Johns Manville Site 2
Subject: Test trench A8-southwest

Orientation: North
Date: July 15, 2002
