Final Report - Revision C

Remediation Action Plan

181 James Ruse Drive, Camellia, NSW

5 SEPTEMBER 2013

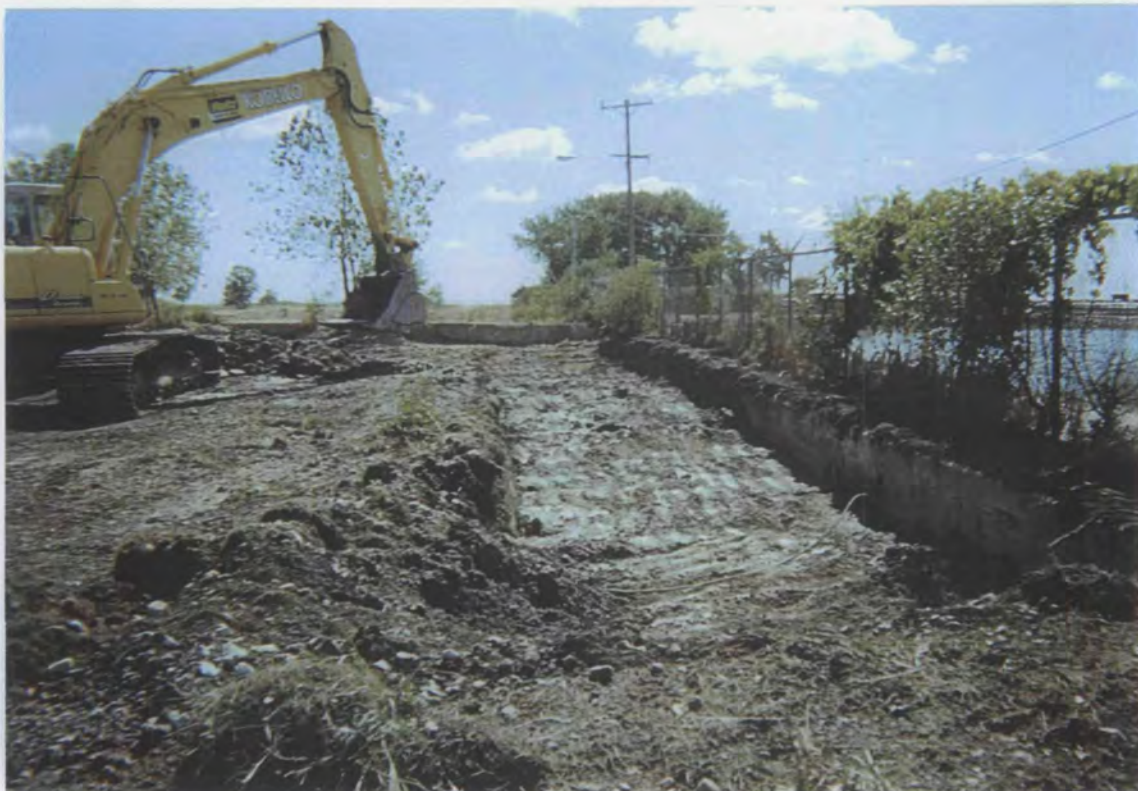
Photograph No.: 14
TDD Number: S05-0203-007
Location: Johns Manville Site 2
Subject: Scraping surface of grids

Orientation: Southeast
Date: July 17, 2002

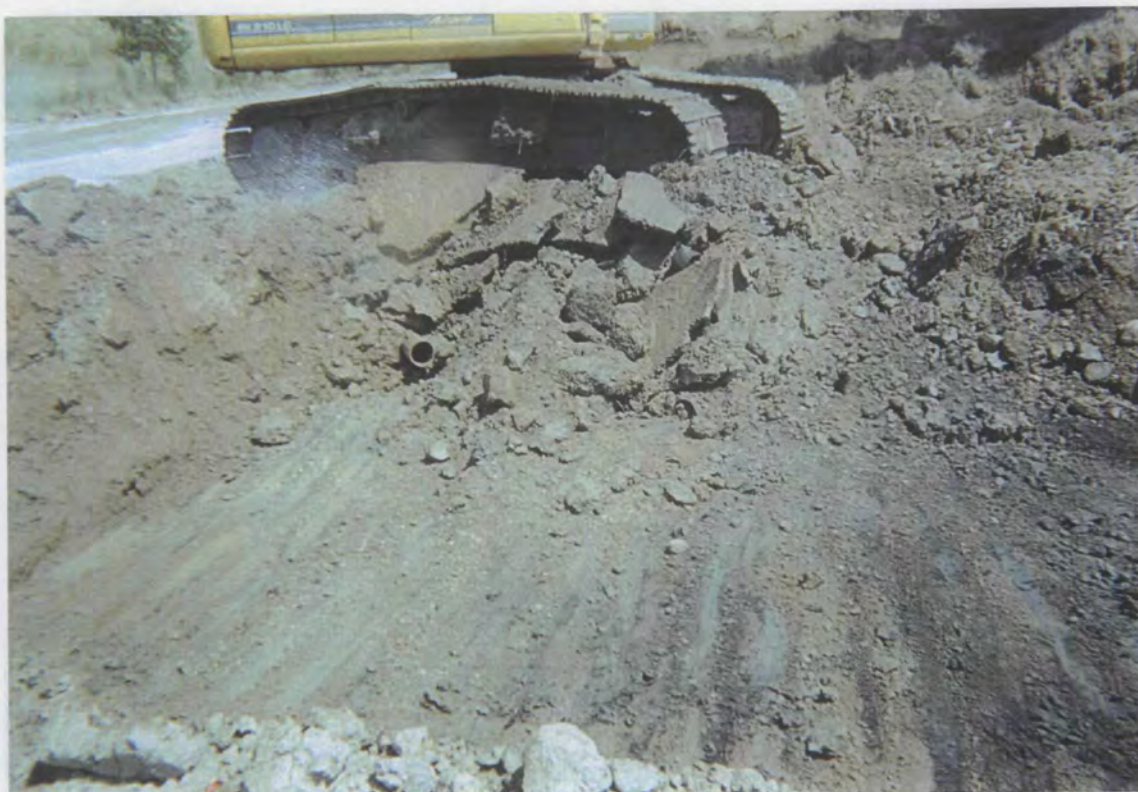
Photograph No.: 15
TDD Number: S05-0203-007
Location: Johns Manville Site 2
Subject: Excavation of grids C2 and C3

Orientation: East
Date: August 6, 2002

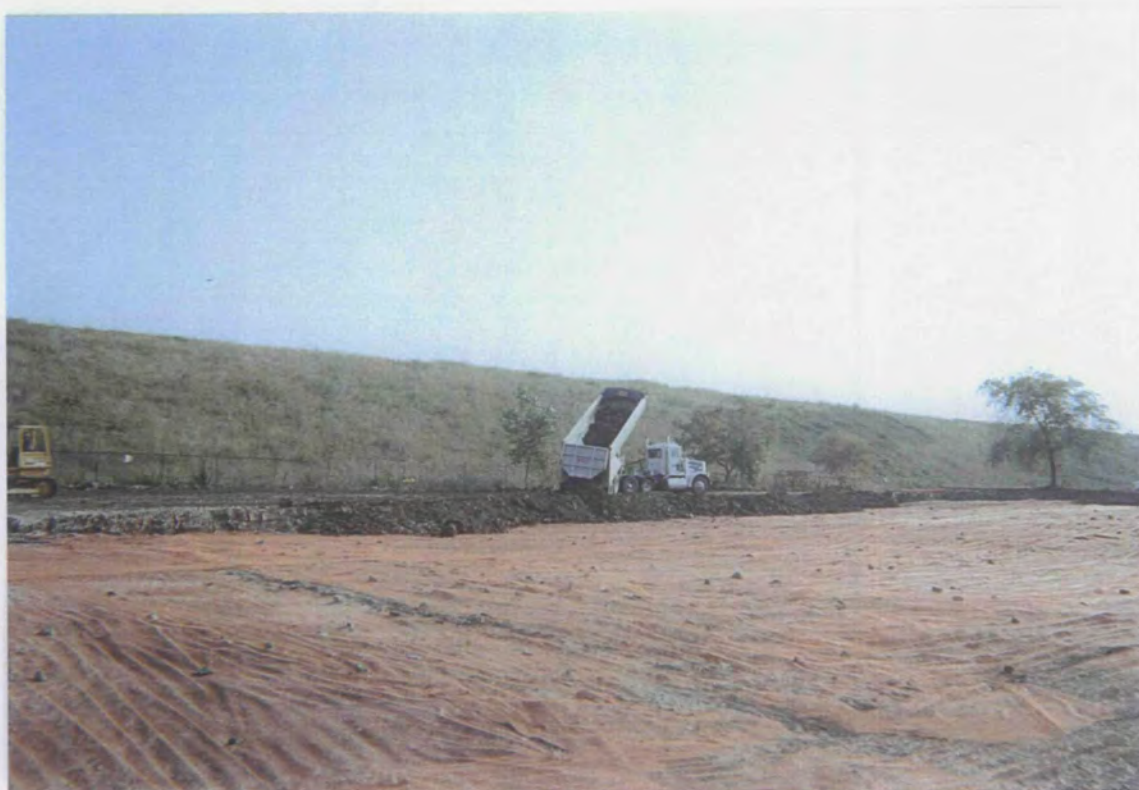
Photograph No.: 17
TDD Number: S05-0203-007
Location: Johns Manville Site 2
Subject: Load-out of remaining soil

Orientation: Northeast
Date: August 27, 2002

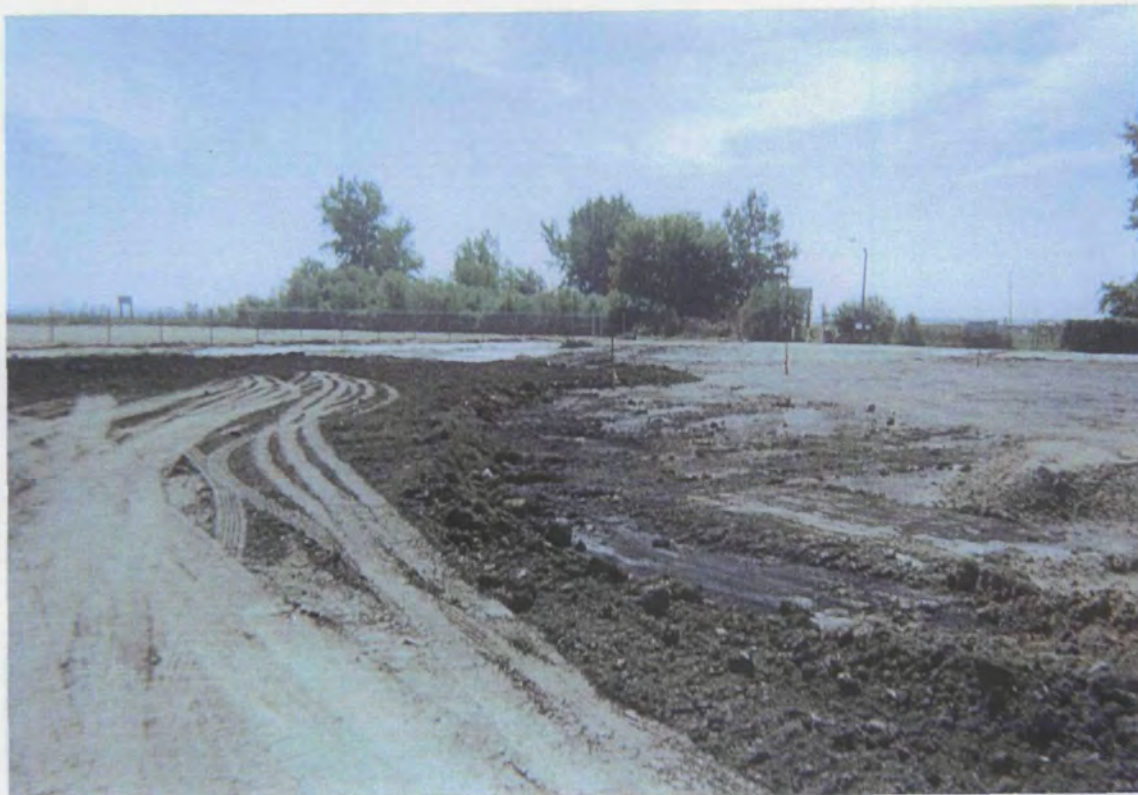
Photograph No.:	19	Orientation:	West
TDD Number:	S05-0203-007	Date:	August 30, 2002
Location:	Johns Manville Site 2		
Subject:	Grids after backfilling with 2 feet of clay and additional 1 foot of sand

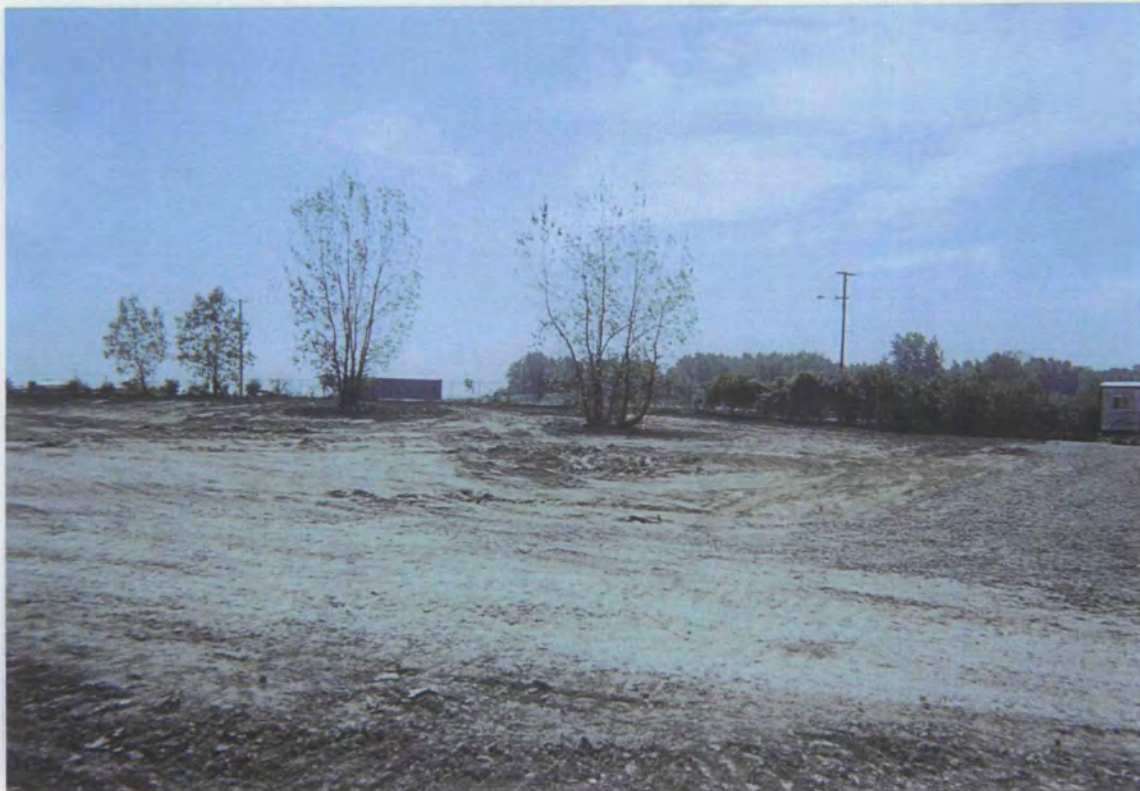
Photograph No.: 20
TDD Number: S05-0203-007
Location: Johns Manville Site 2
Subject: Access road and parking lot re-establishment

Orientation: Southeast
Date: September 6, 2002

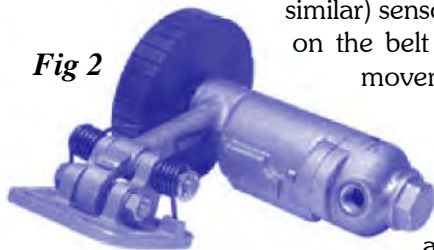
Fig 2 shows a spray control valve capable of controlling the flow of any fluid by mechanically

sensing belt movement without the need for an independent

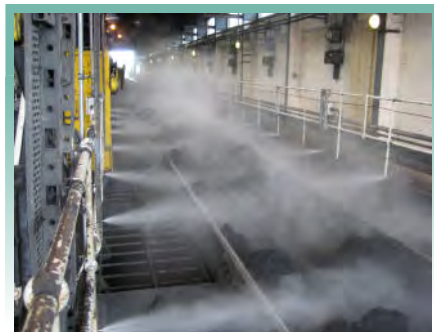
Fig 3

Dust Suppression over open rail track hoppers

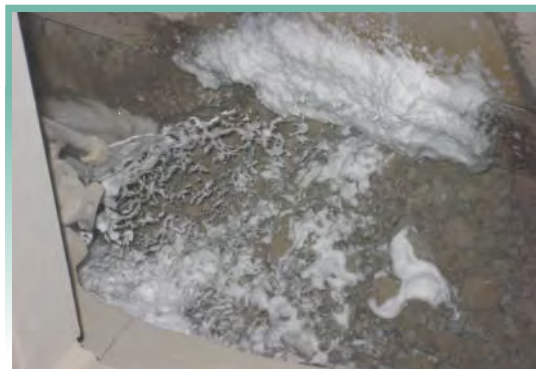
**Foam spray added to limestone
at a crusher inlet**

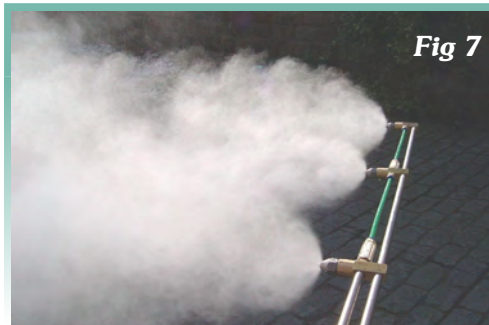
Fig 7

bypassing the resonator carries the atomised droplets downstream in a soft plume shaped spray. In **Fig 7** the droplets have low mass and low forward velocity with low impingement

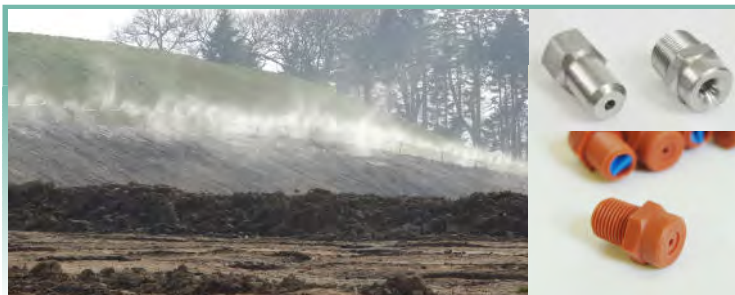
Water Spray Nozzle Systems: Such systems provide immediate dampening of general material handling processes and site boundaries. The nozzle design ensures a cone spray pattern is achieved at pressures from 1 to 8 Bar.

These types of nozzle systems are a low cost option for material handling processes/site boundaries where wetting is not a problem. Nozzles are available in various materials including plastic, stainless steel and brass with flow volumes ranging from 0.3 lts/min up to 90 lts/min per nozzle.

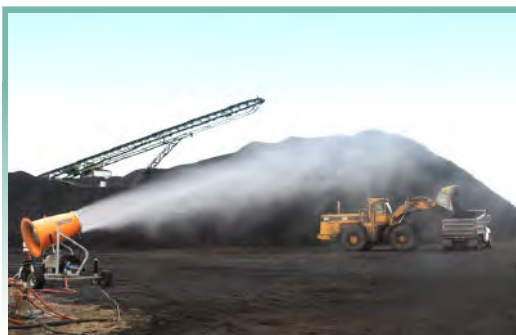
Fog Cannon:

When vast open spaces require dust suppression and a semi permanent system is not a practical option, the solution may lie with the introduction of a fog cannon to the site.

These huge mobile and expensive units can utilise up to 60 hydraulic spray nozzles mounted circumferentially around the outlet head of a large fan assisted barrel. The concentration of nozzle spray together with the high flow of air from the fan, throws the droplets many metres towards the source of the dust activity. The droplets scatter in a plume of relatively soft spray and can capture fugitive dust before it becomes airborne and a major problem.
