181 JAMES RUSE DRIVE

Riverbank Management Plan

Report No. 14047RP2

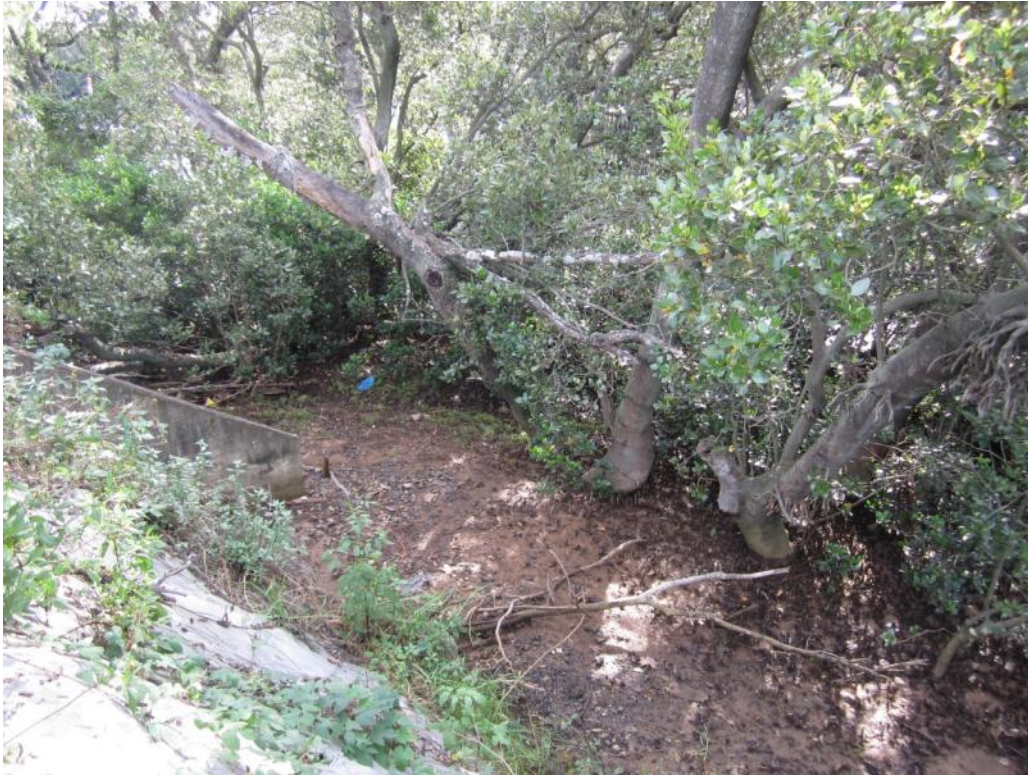
Photograph 1.1 Interface of exotic weed covered, geotextile matted slope and mature mangroves

pilosa), Morning Glory (*Ipomoea indica*), and Asthma Weed (*Parietaria judaica*). At the bottom of the slope there is an interface of one to several metres of bare soil (in places covered with asbestos containing material) at the high tide zone before the mangroves occur northwards to the edge of the river. The mangrove area consists predominately of the Grey Mangrove (*Avicenna marina*) species, with scattered occurrences of River Mangrove (*Aegiceras corniculatum*).

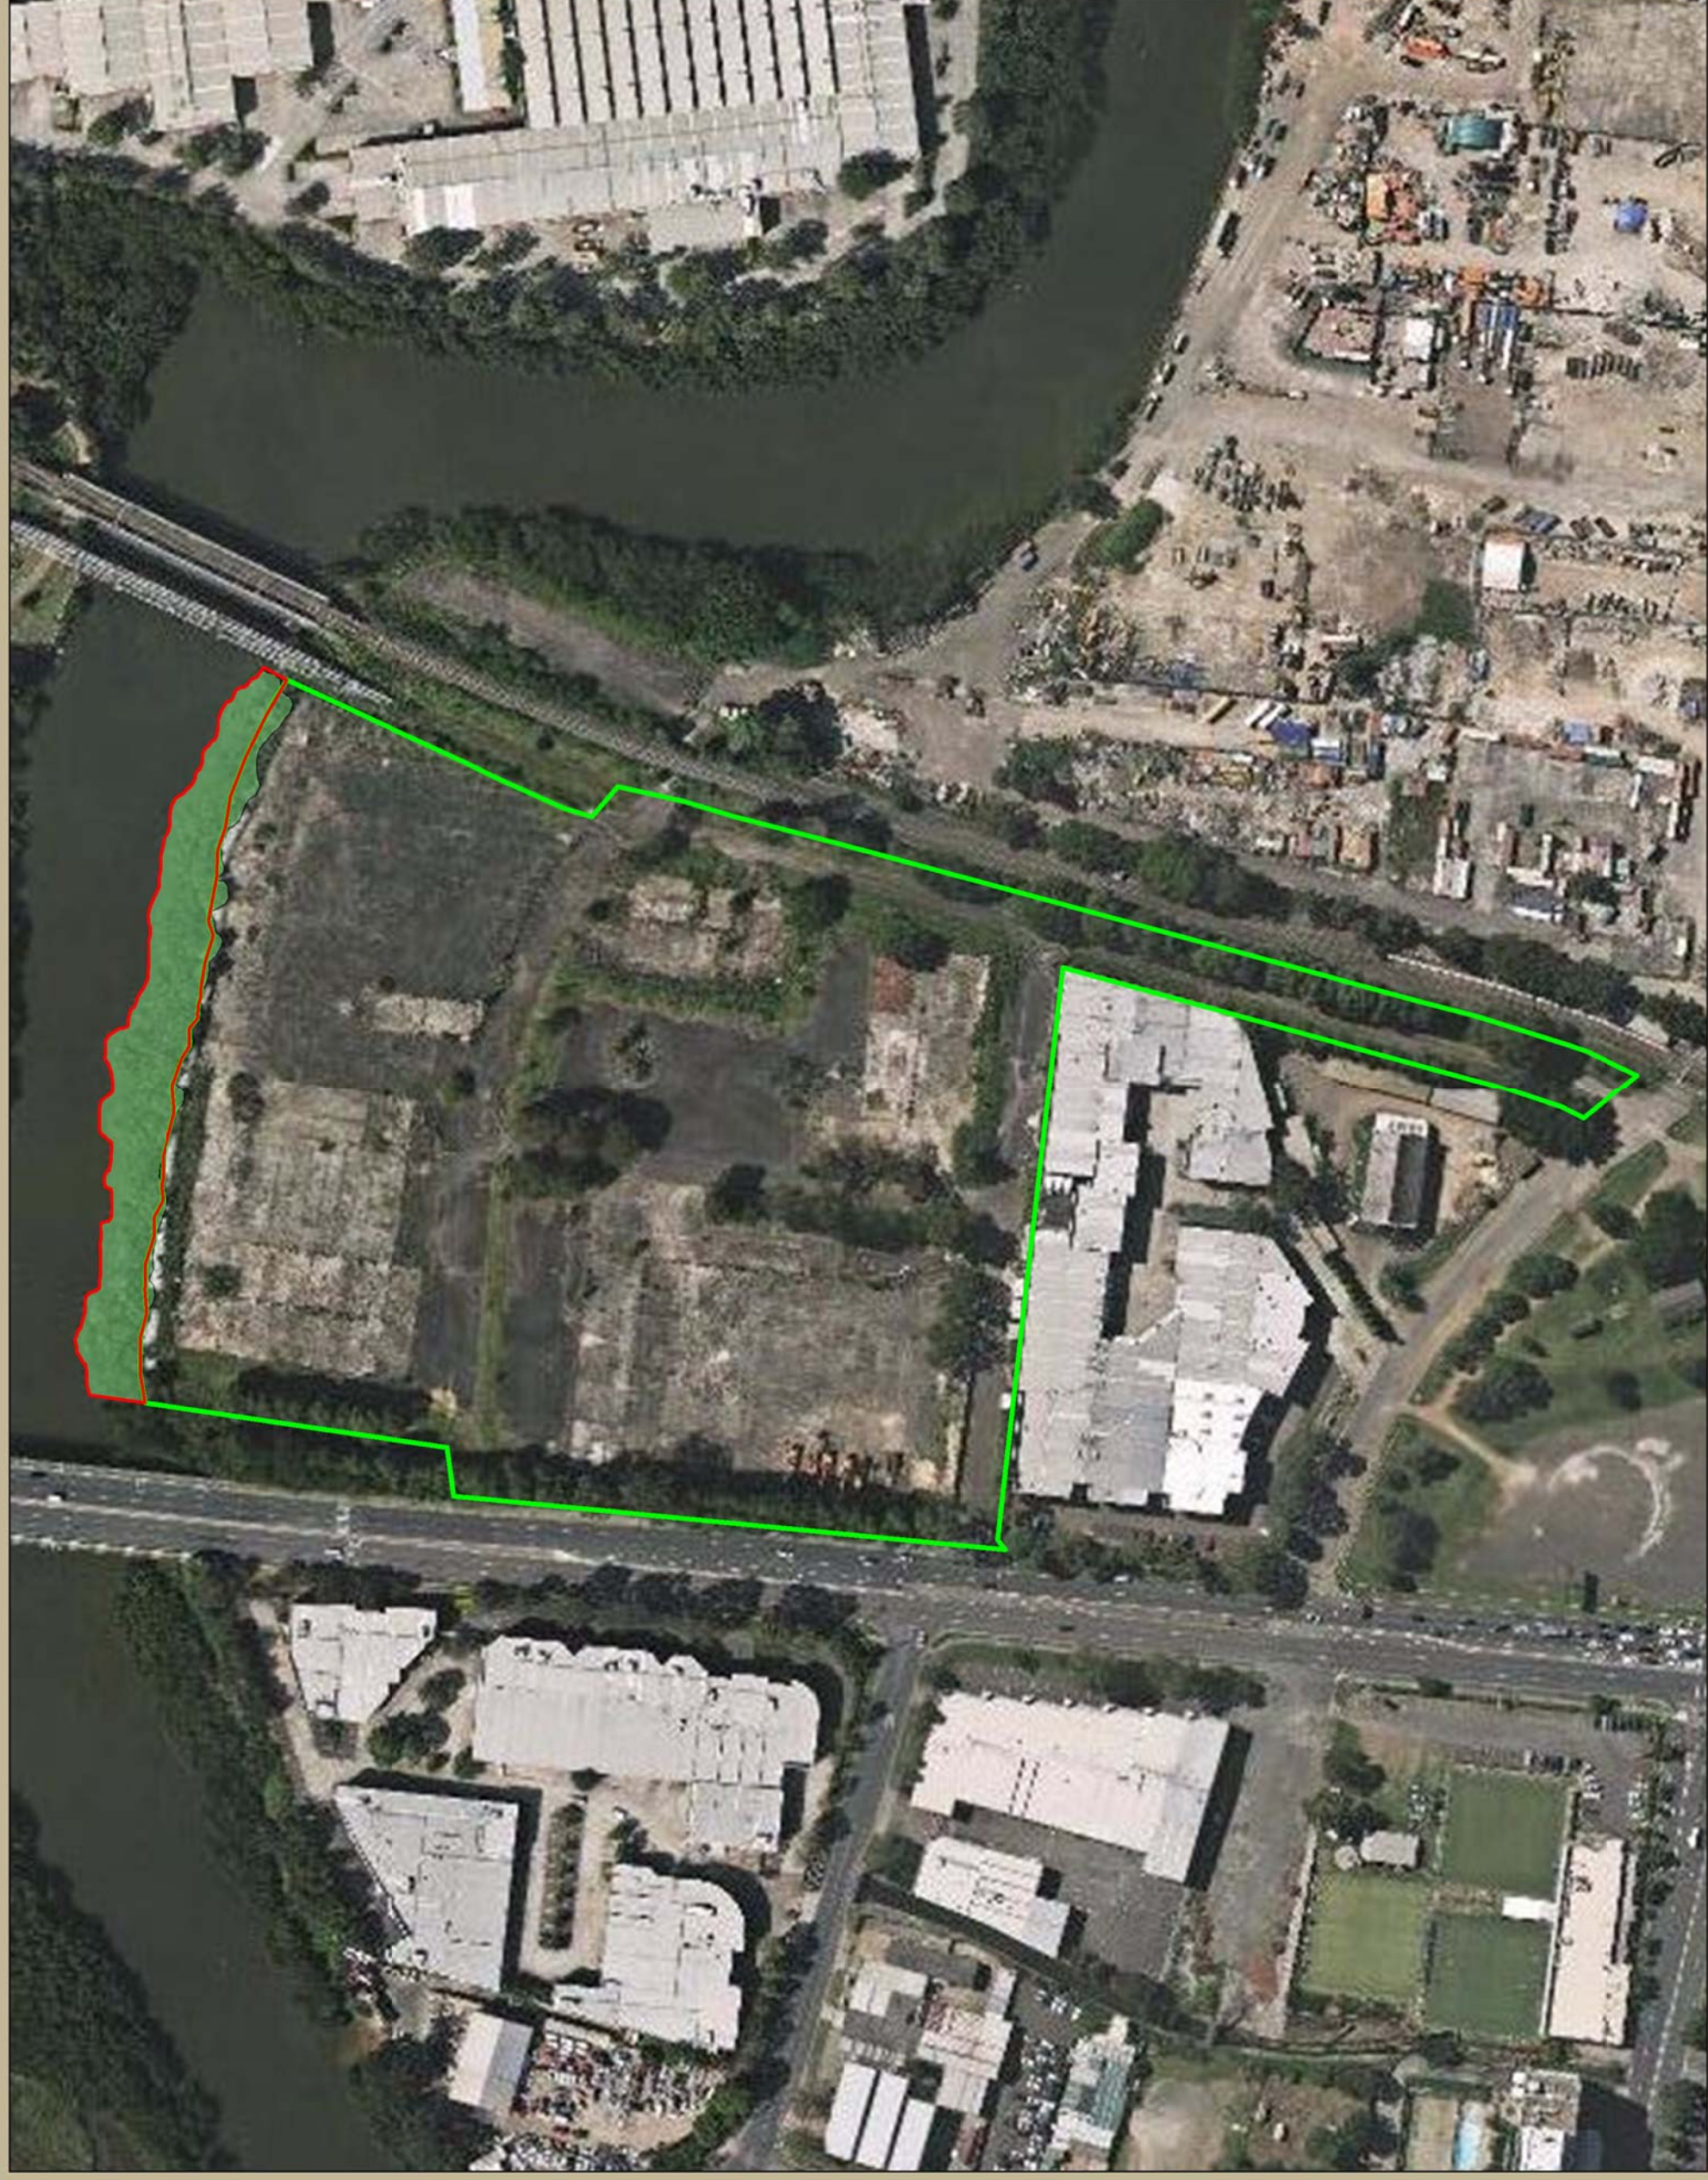
Figure 1.1 Area Subject to RMP and Extent of Mangroves

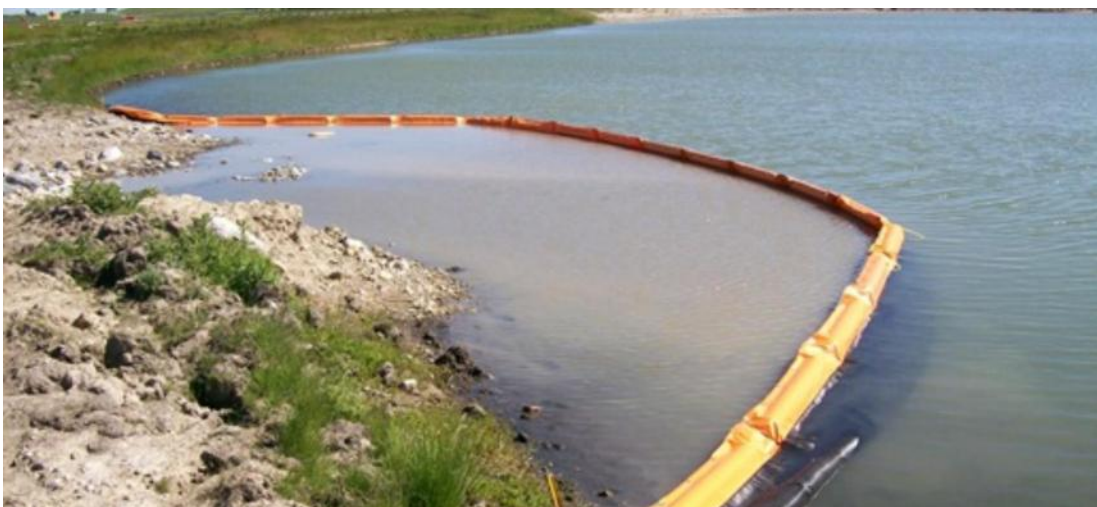
Photograph 2.1 Sediment curtain creating a worksite

Prior to commencing soil removal from site and clearing of mangroves, a temporary sediment curtain should be installed beyond the Mean Low Water Mark (MLWM) to create a worksite area. The sediment curtain consists of a floating boom with a mesh attached below. The mesh is weighted at the base with the weights resting on the benthic sediments. An example of an installed sediment curtain is provided in **Photograph 1**.

The mesh size of the sediment curtain should be at an appropriate scale to prevent any asbestos material and soils disturbed during works washing into the river during tidal action. In particular, it is important that ACMs are contained within the work site to prevent them being washed up on riverbank areas outside the subject site.

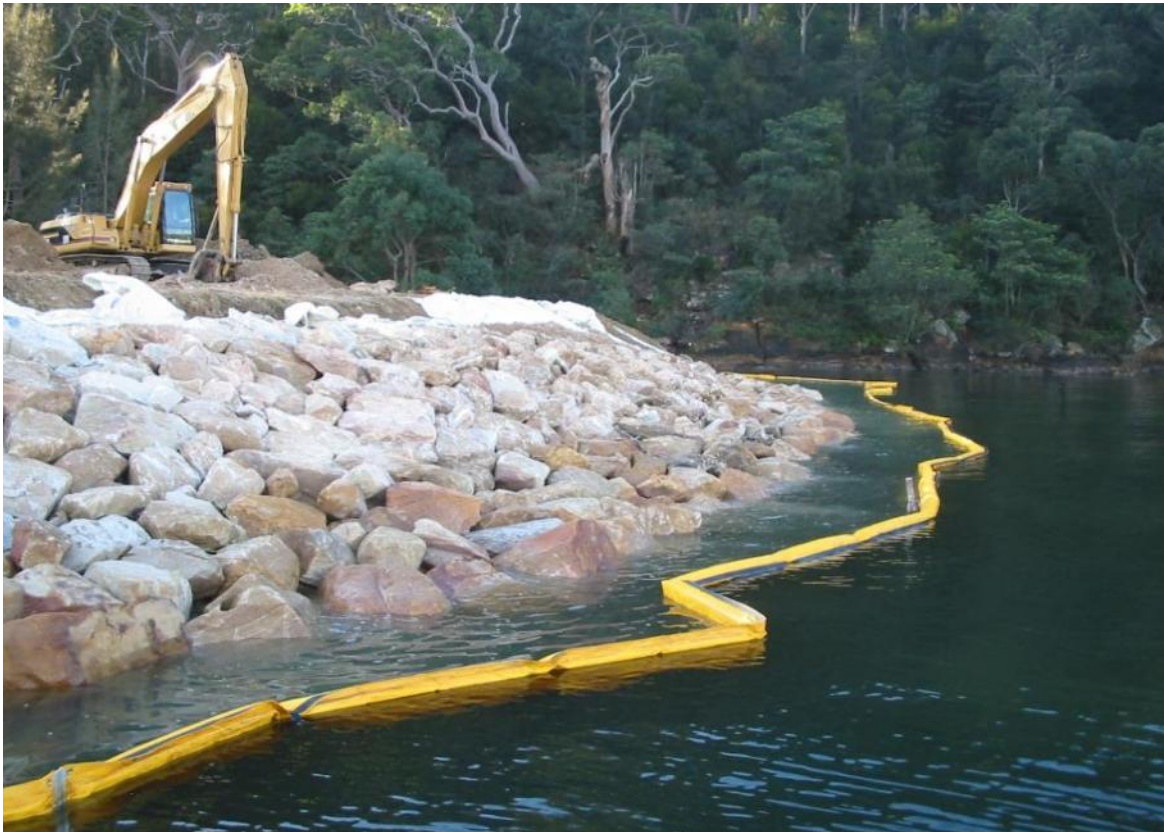
Photograph 3.1 Rock fillet on landward side of sediment curtain

A barrier of rock fillets should be established at the MLWM concurrent with refilling the subject site with soil and prior to removal of the sediment curtain. An example of a rock fillet barrier prior to removal of a sediment curtain is shown in **Photograph 2**.

The rock type used should be sandstone which will allow large gaps for fish movement and provide aesthetic value to the foreshore area. The height of the rock fillets should correspond with the average height of a high tide at the site.

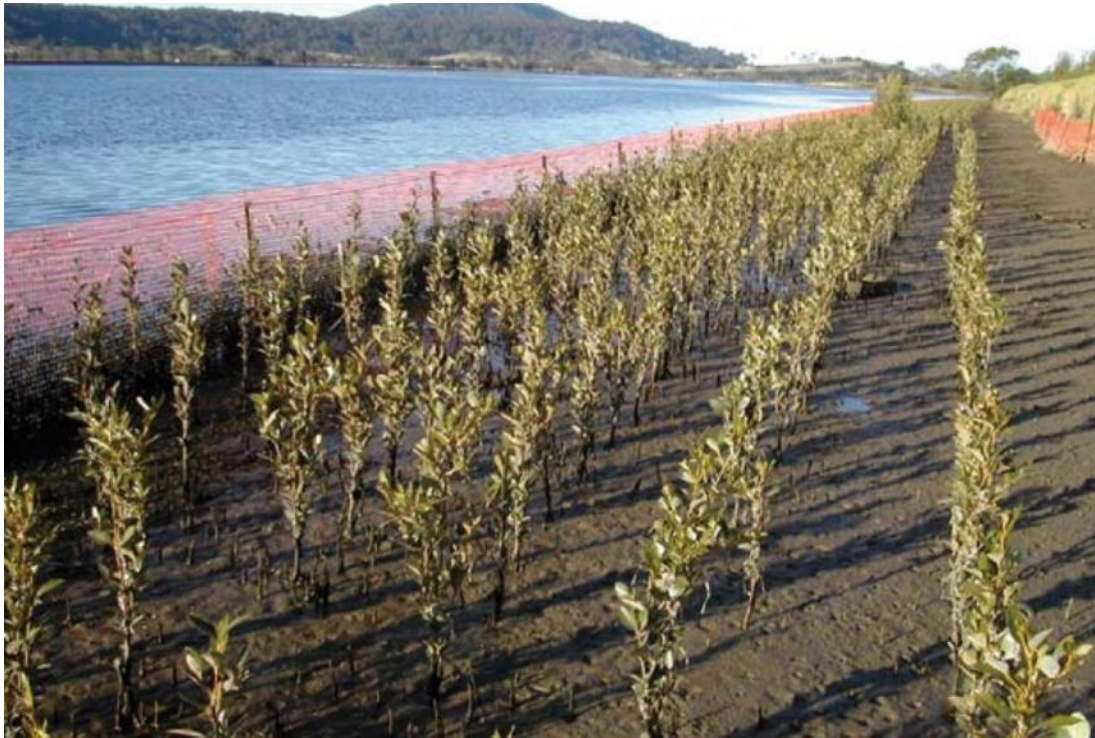
Photograph 4.1 Example of Mangrove Restoration Plantings along the Shoalhaven River (DPI 2008)

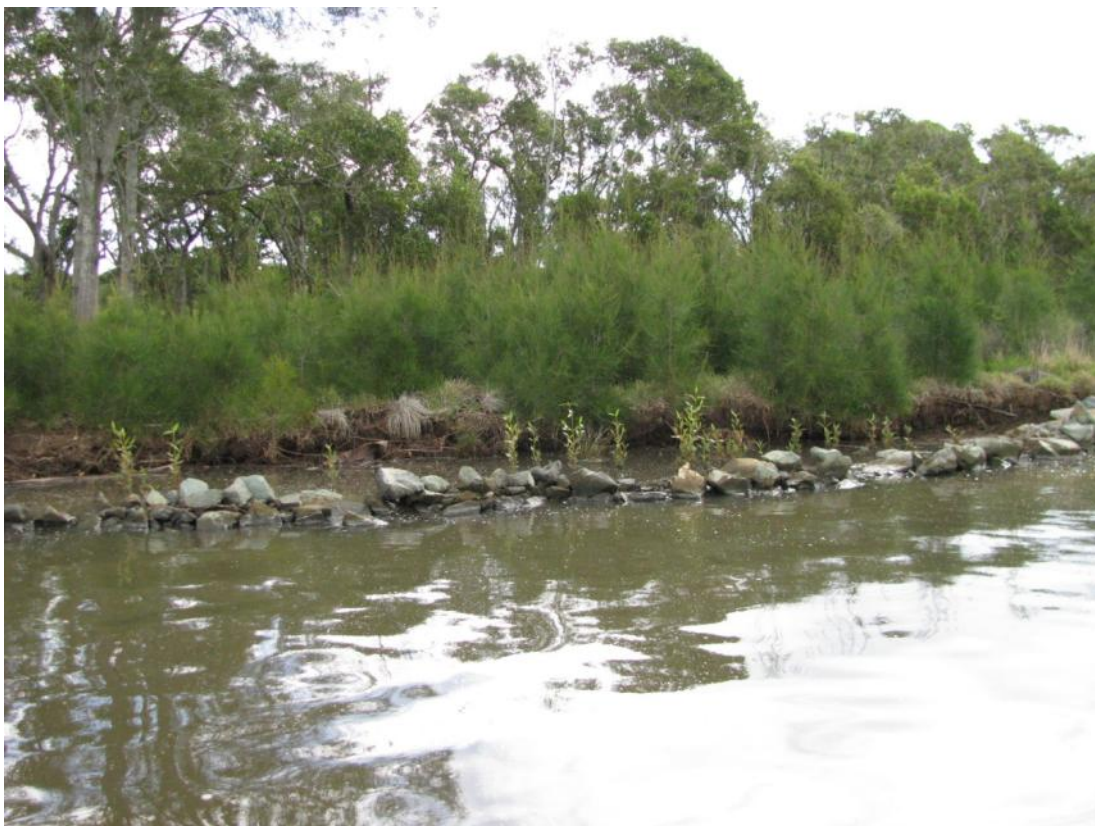
Photograph 4.2 Example of Rock Fillets used to Protect Mangrove Plantings

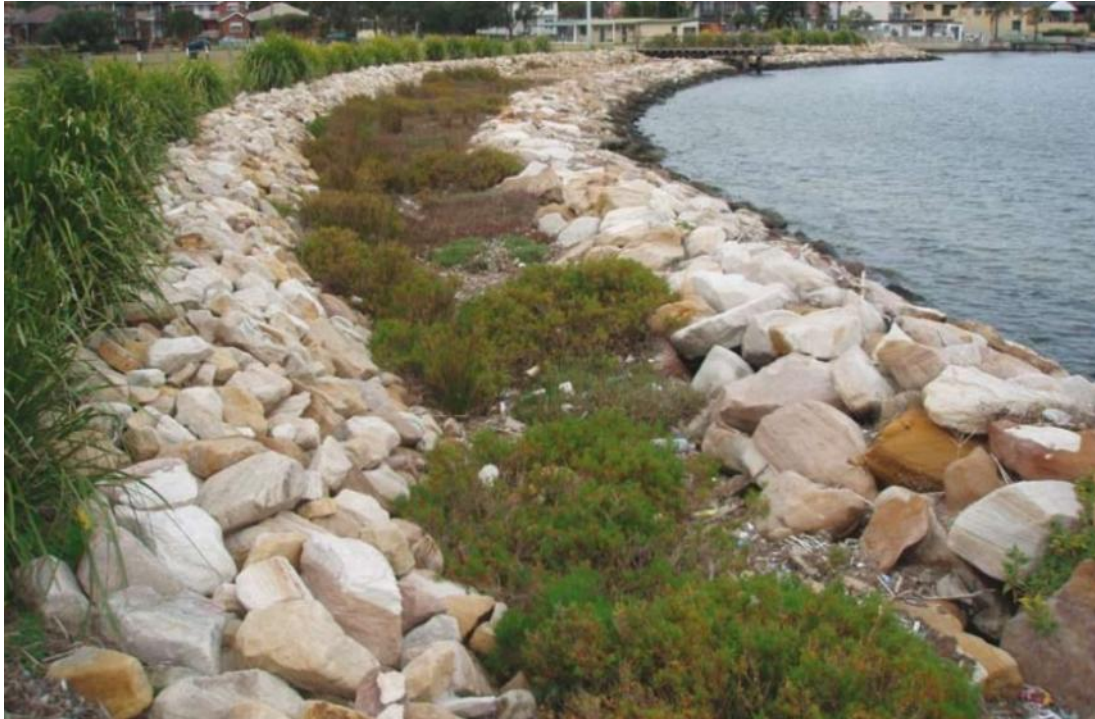
Photograph 4.3 Example of Planted Saltmarsh along the Georges River (CMA 2009)

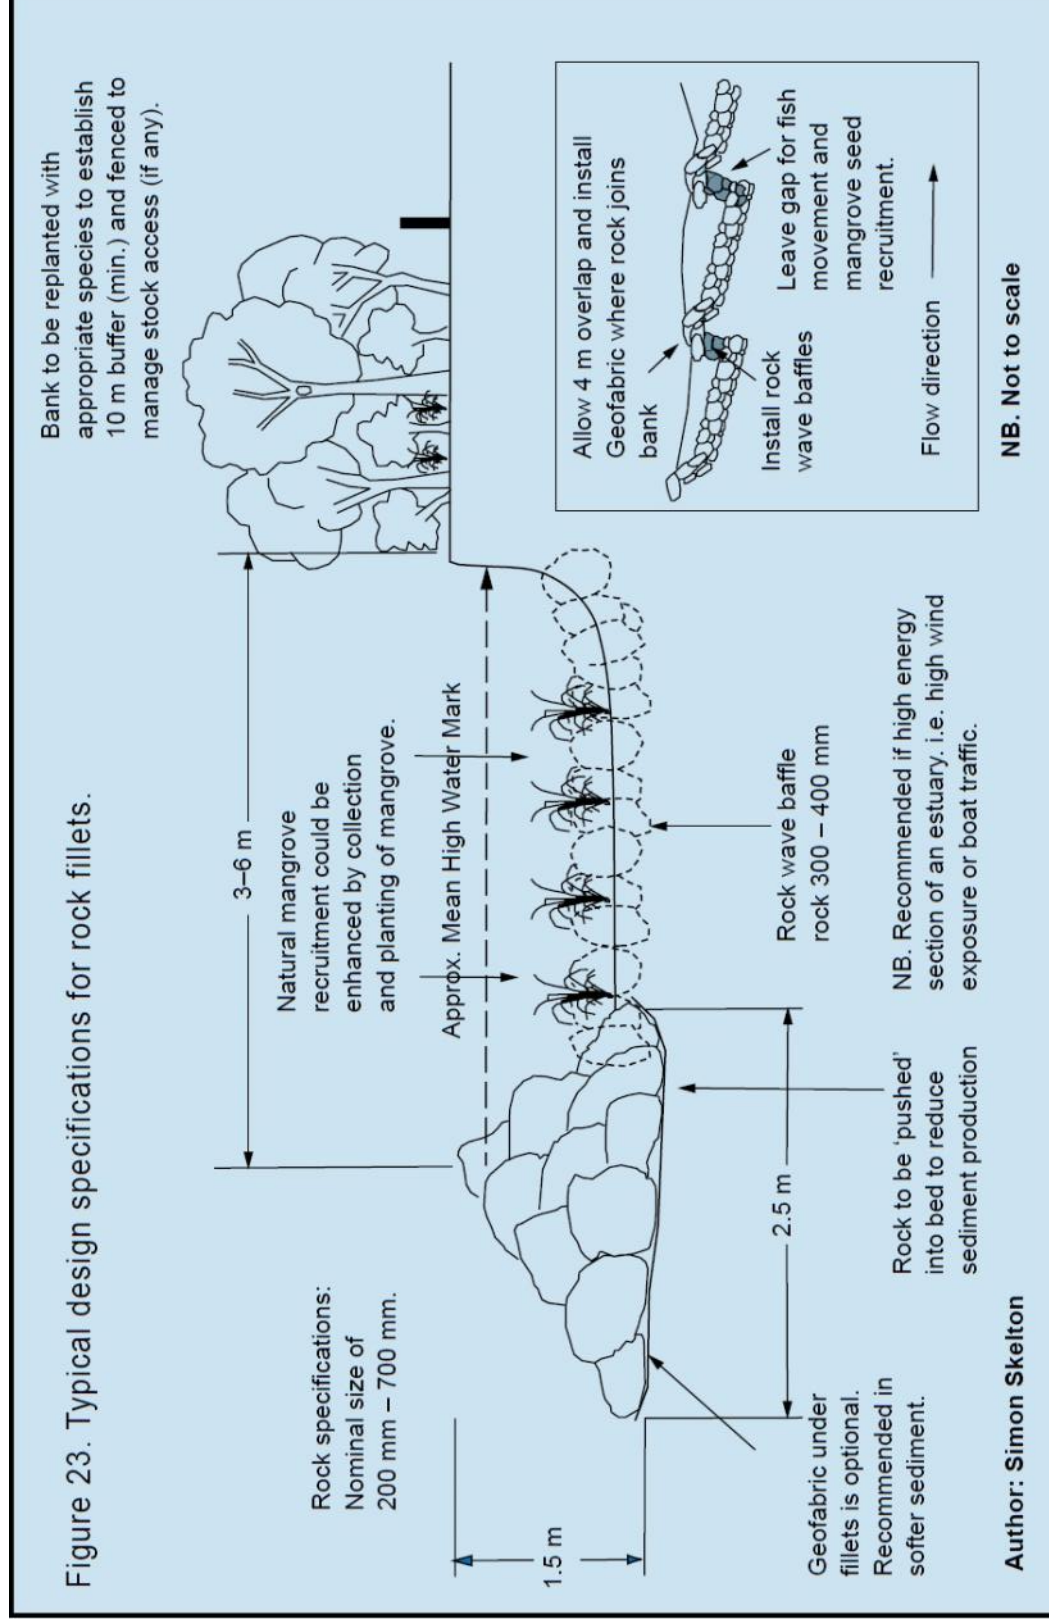
Figure C.1 Standard Rock Fillet Design (DPI 2008)

At a minimum, the rock fillets should cover at least half of the tidal shoreline to create protected areas for establishment of mangroves. The placement of the rock fillets can be staggered to match the natural contours of the shoreline. **Appendix C** contains design examples of rock fillets.

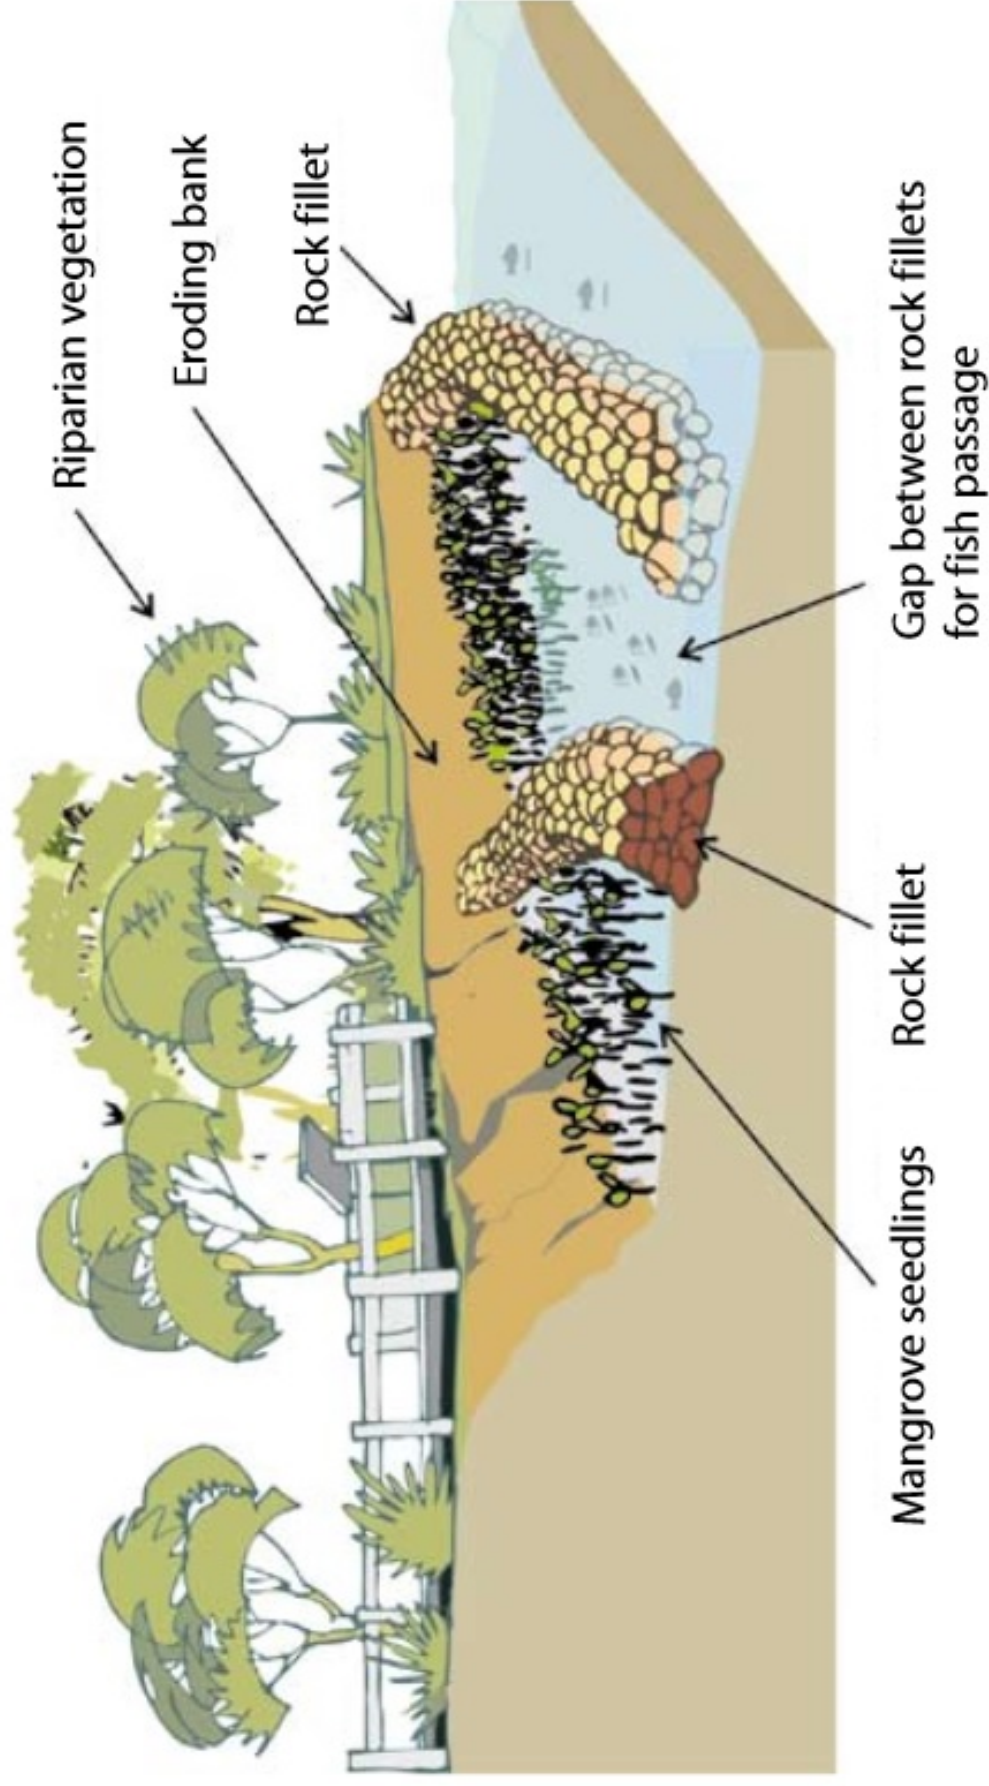
Figure C.2 Multiple Rock Fillet Design (CMA 2009)

As the width of the area of mangroves existing on the site is currently up to 40m in some areas, several rock fillet walls should be staggered southwards at intervals to reduce tidal action across the site and allow for multiple discrete areas to establish mangrove plantings. Further rock fillet walls should be established around the Mean High Water Mark (MHW), where the interface currently exists between the geotextile covered slope and the mangroves, to allow for the establishment of an area of saltmarsh that will only undergo inundation during higher than average tides.
