**REPORT  
on  
DETAILED CONTAMINATION ASSESSMENT**

**CUMBERLAND NEWSPAPERS REDEVELOPMENT –  
SITE A  
142 – 154 MACQUARIE STREET  
PARRAMATTA**

***Prepared for  
NEWS LIMITED***

***Project 71682  
July 2010***

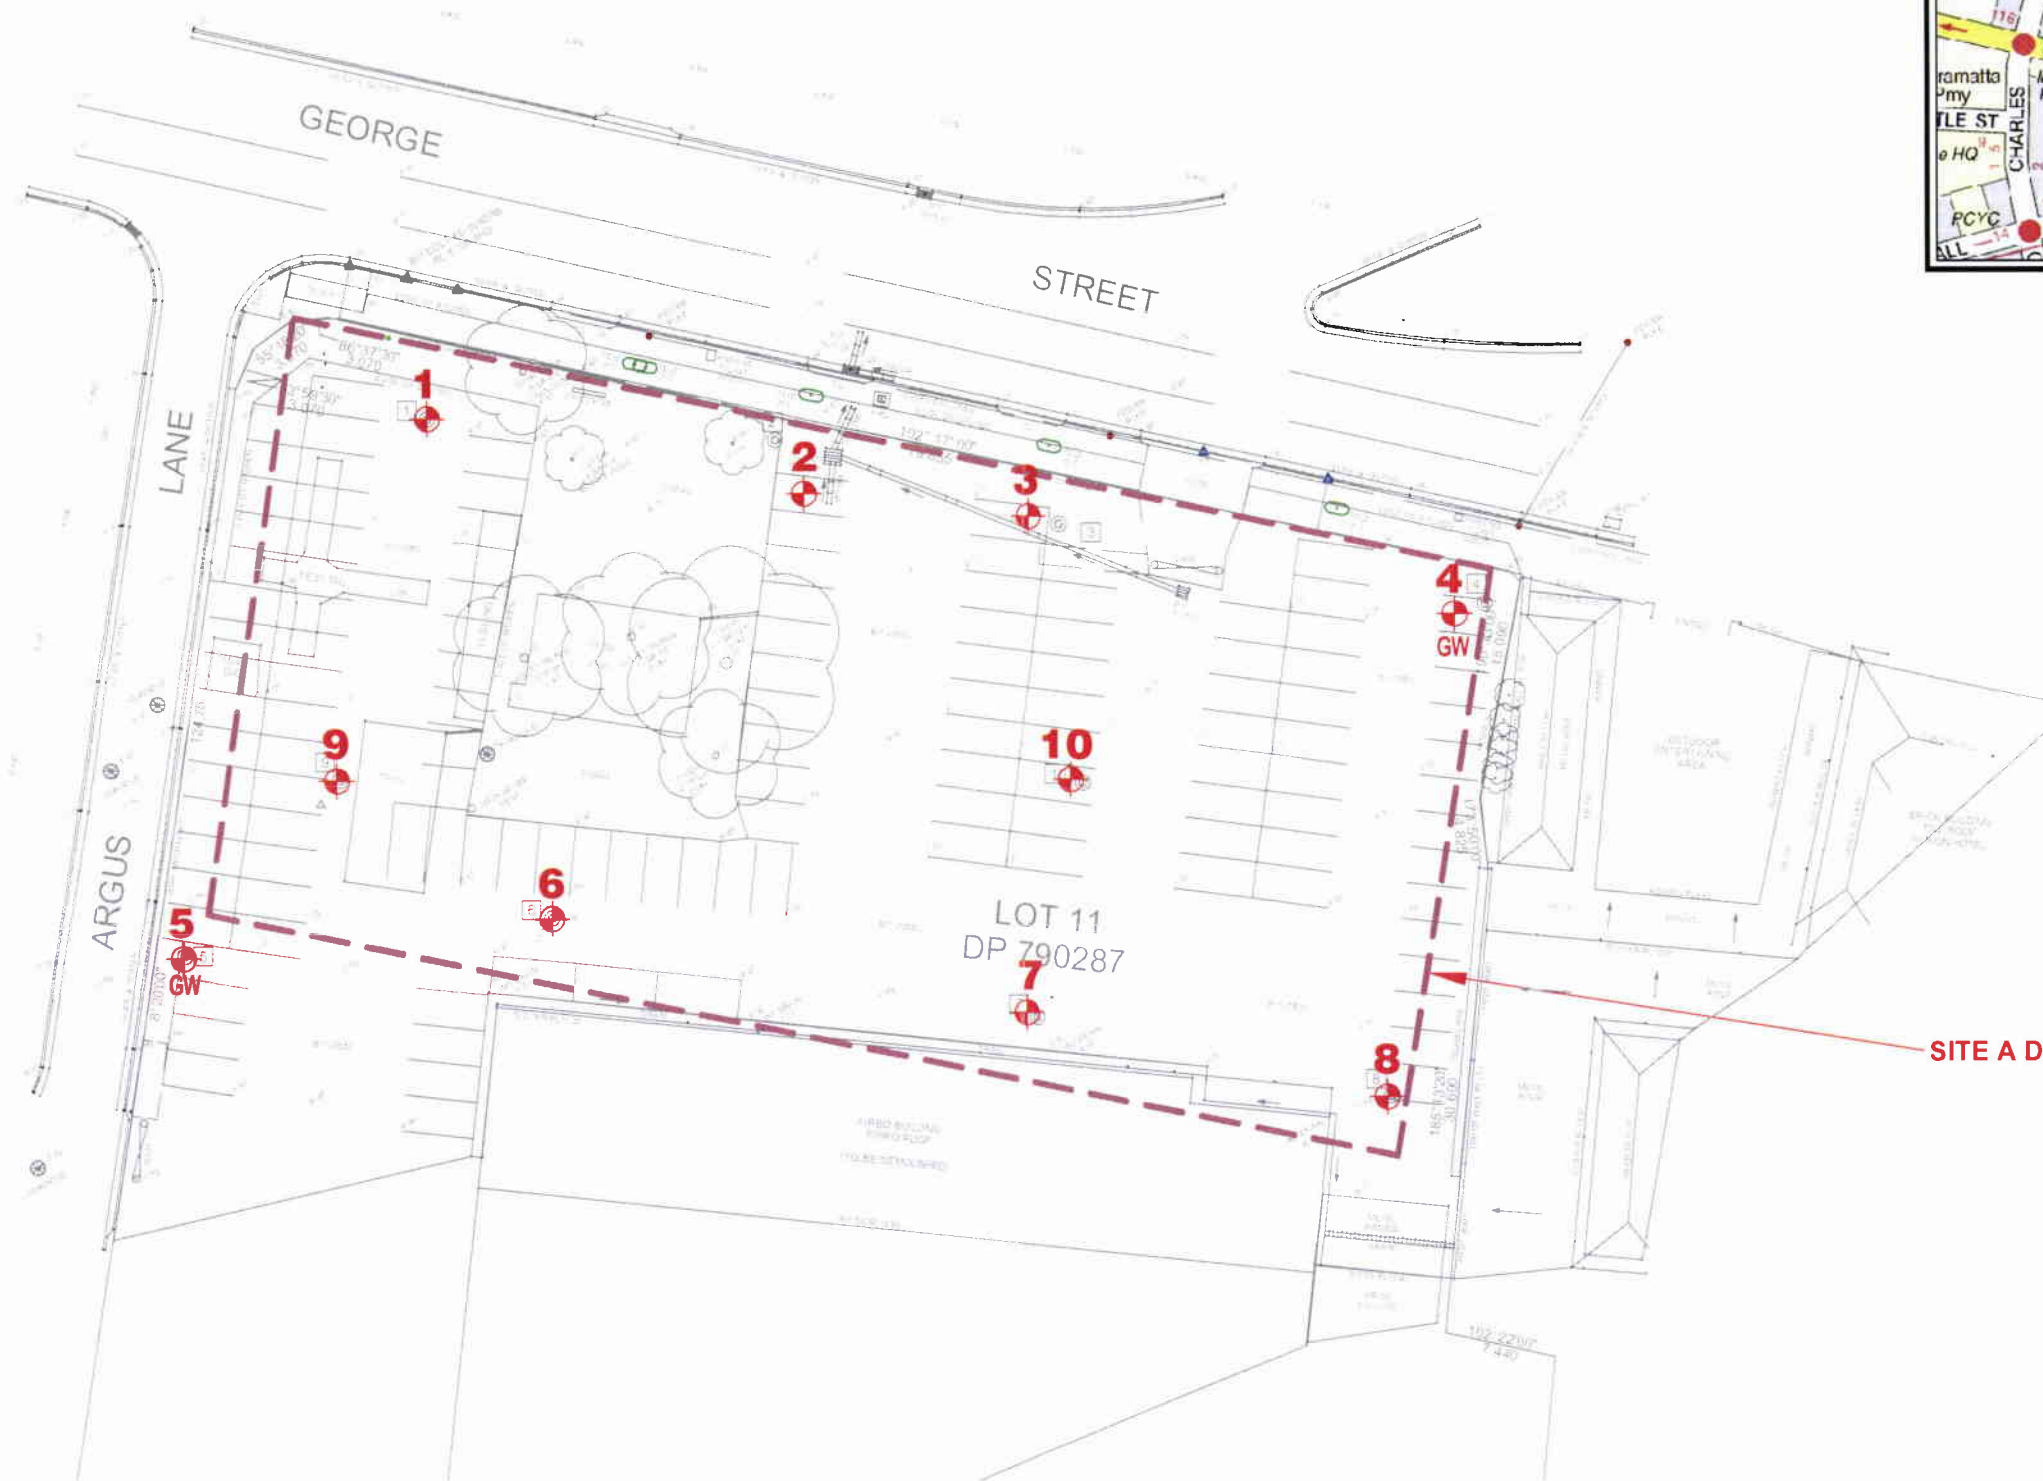
| DRAWING No: | E1 |

LOCALITY PLAN

SITE A DEVELOPMENT AREA

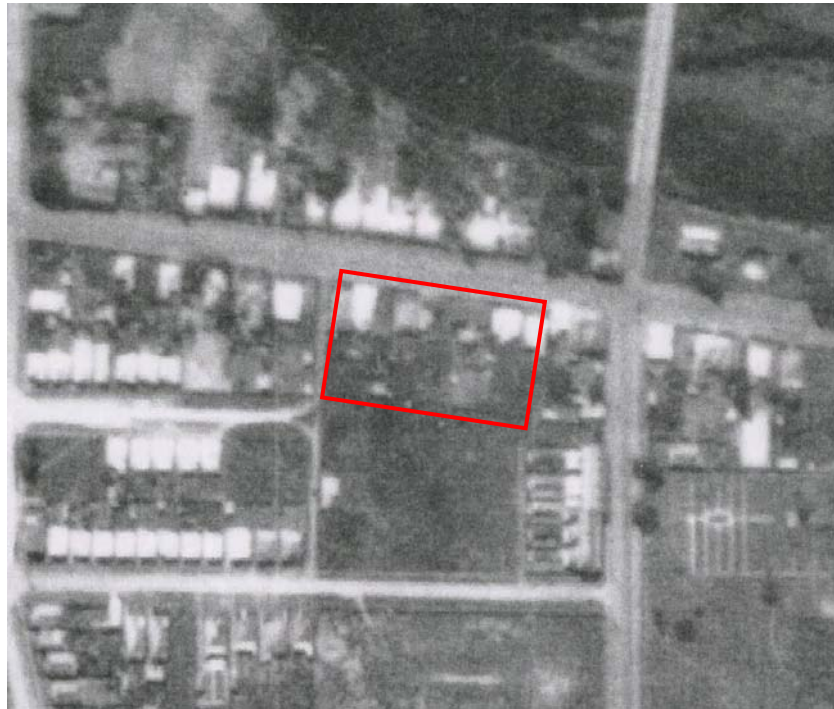
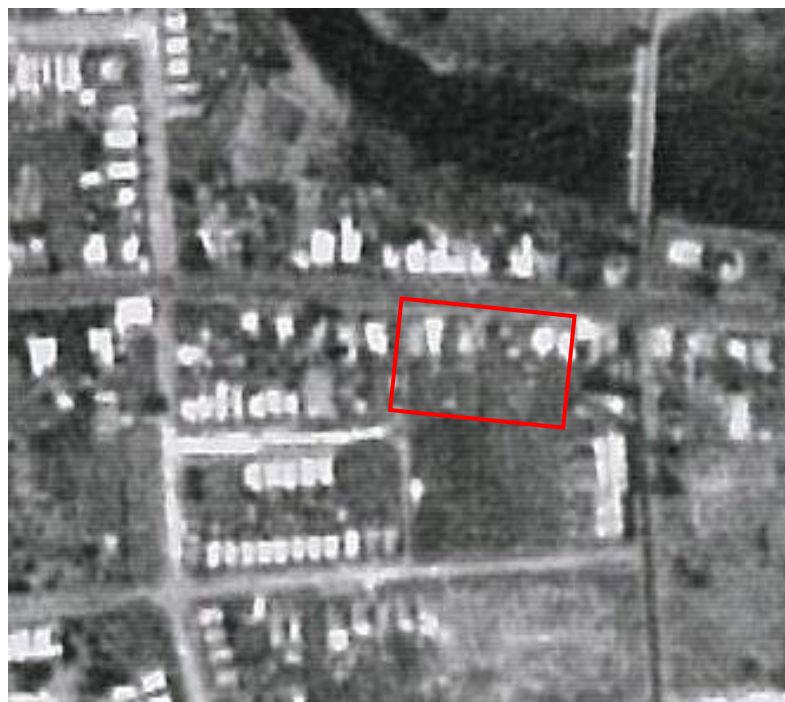
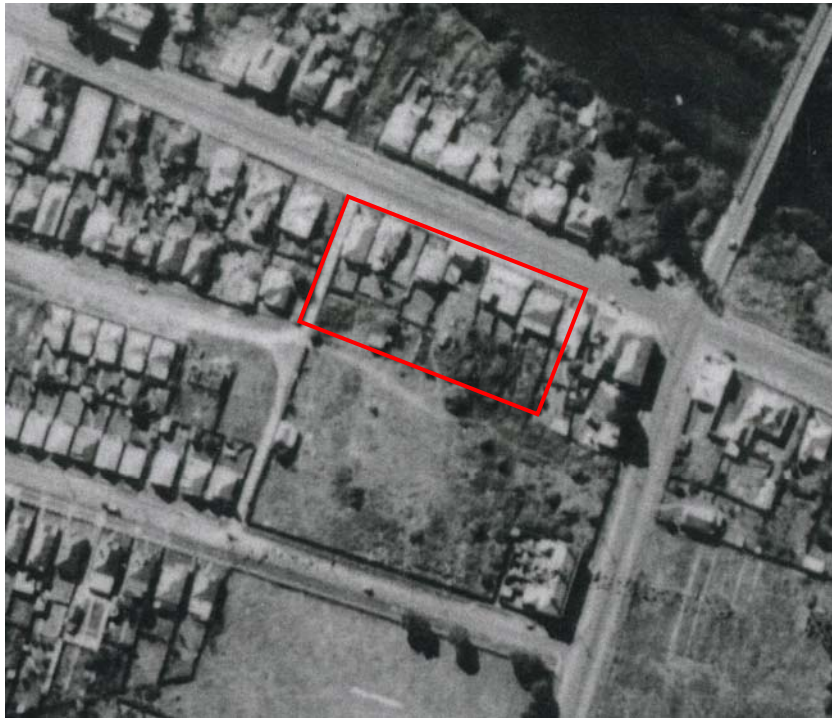
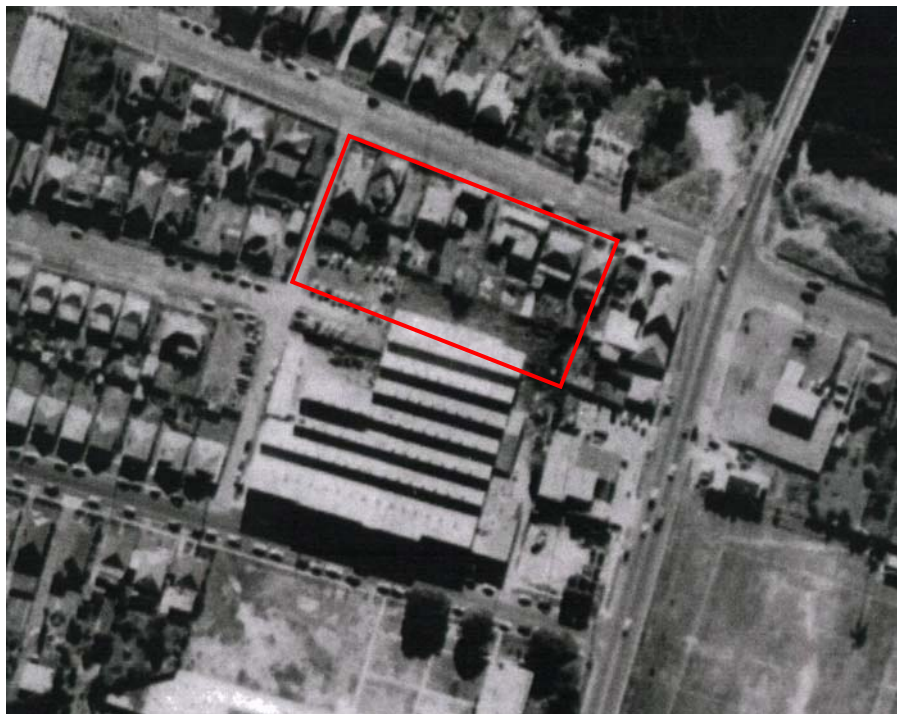
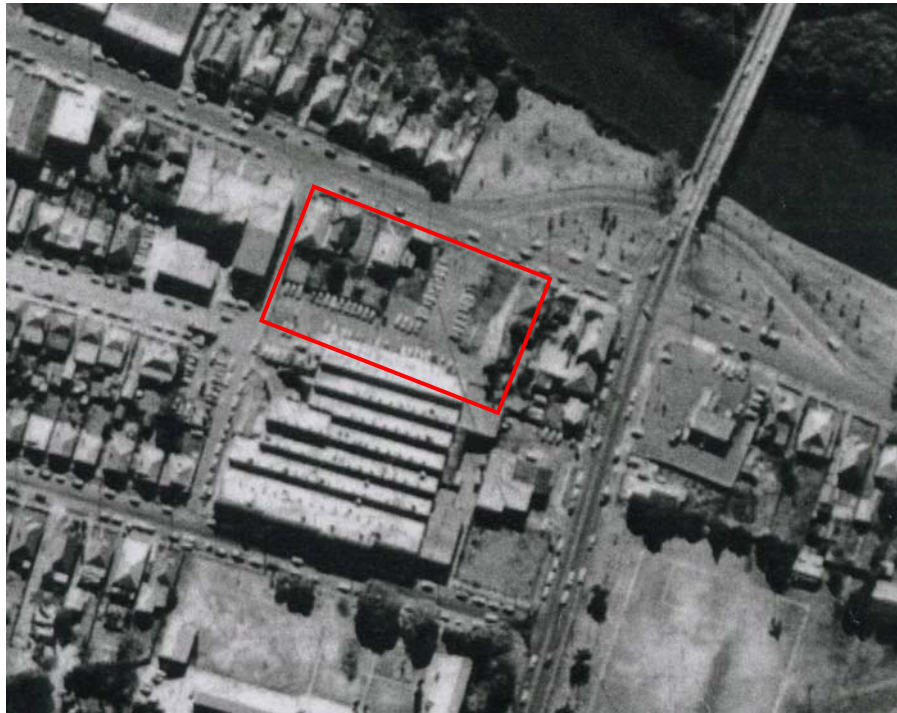
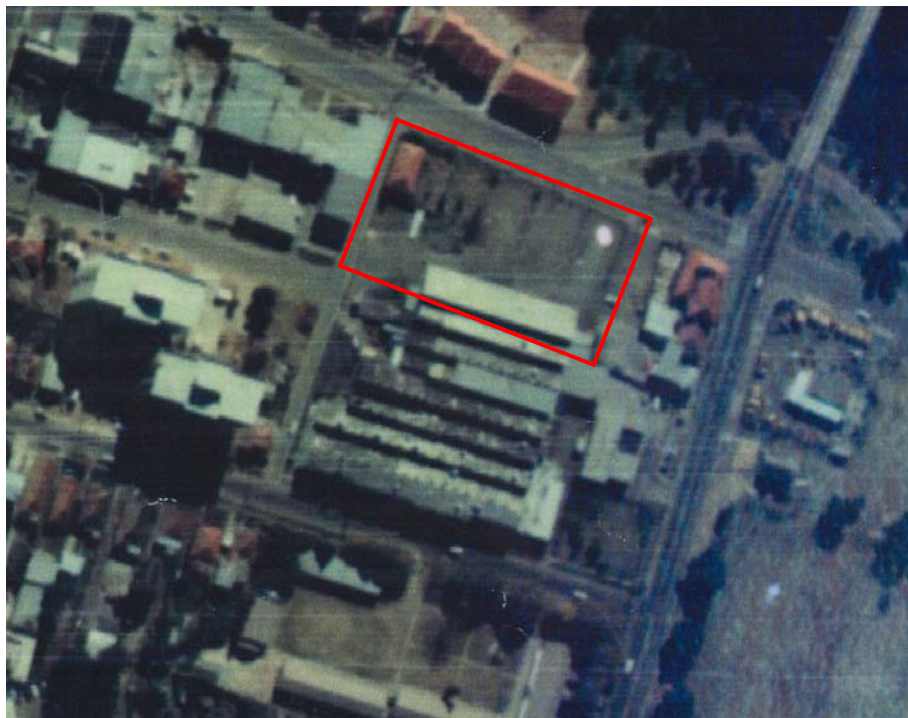
A review of available aerial photographs from 1928, 1930, 1951, 1961, 1970, 1982, 1986, 1991, 2002 and 2008 was undertaken to evaluate the land-use patterns on the site. Site details observed in the aerial photographs are provided in Table 1.

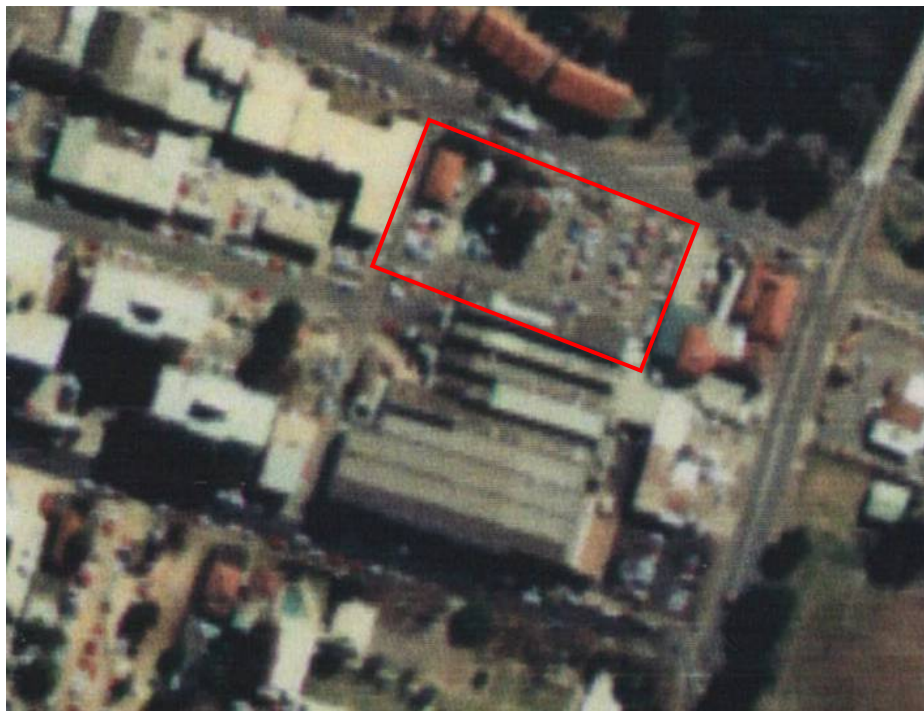
PHOTO 8: Aerial photograph from 1991

| Year | Details |
|---|---|
| 1991 | No change to the buildings on the site. The roof of the large commercial building fronting Macquarie Street appears to have been replaced since the previous photo. |
