Harness Racing NSW
Proposed Tamworth Harness Racing Facility
Phase 1 Contamination Site Assessment

28 January 2014

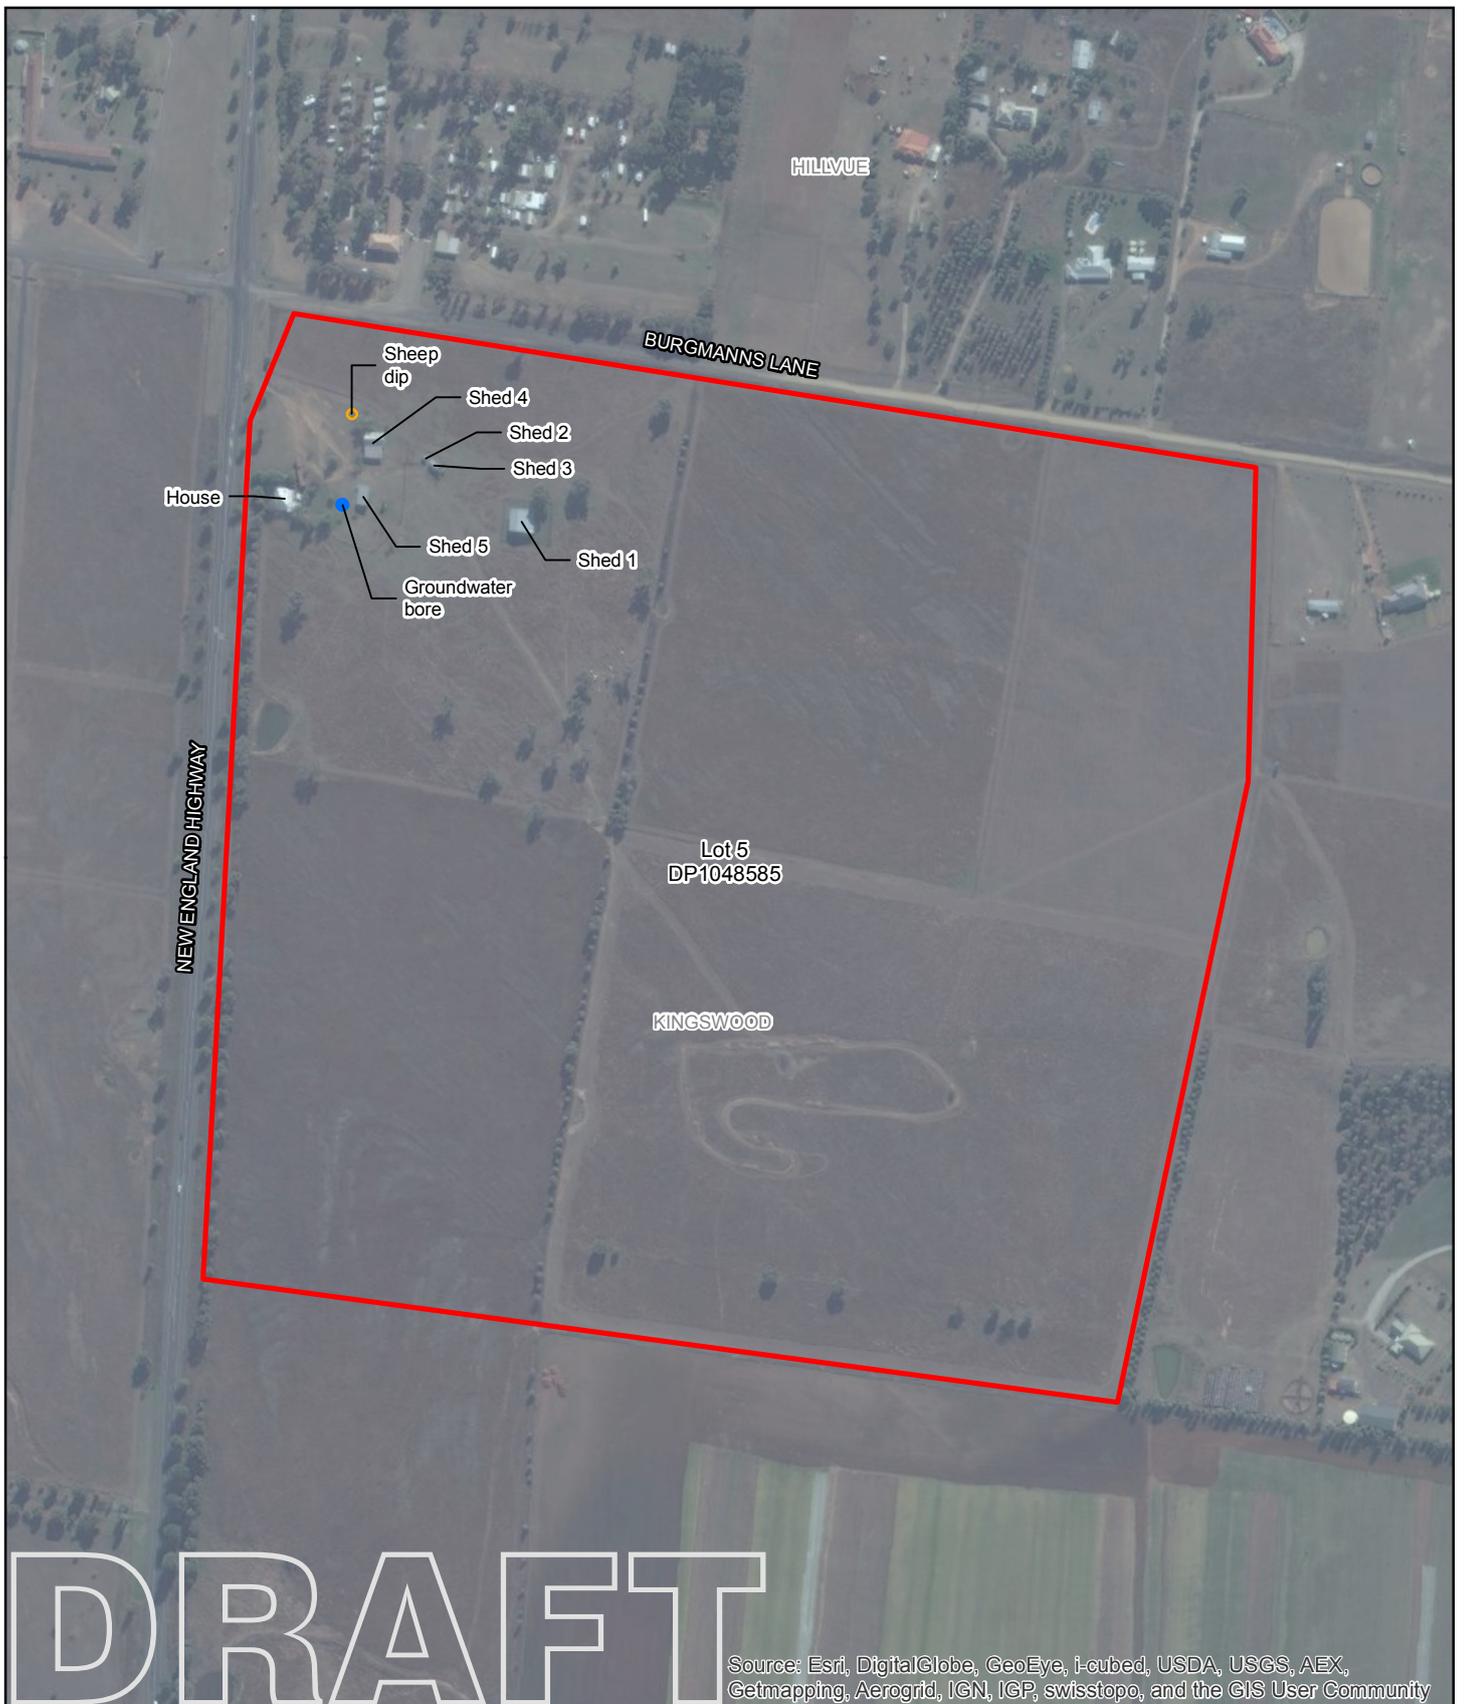
Figure 2

- Site Boundary
- Sheep dip
- Groundwater bore

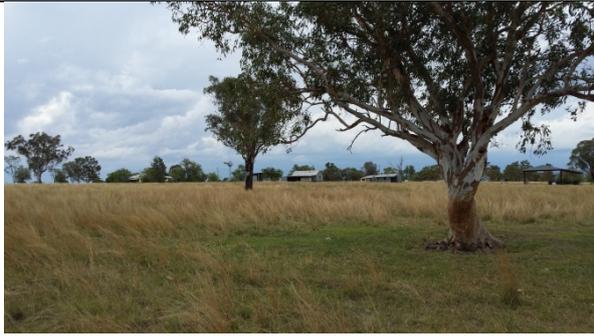
- The Site was generally cleared of vegetation, consisting of pasture, mown grass and scattered trees and shrubs.
- The northwest portion of the Site contained five sheds and an abandoned farm house (Photos 1-9).

Photo 1. NW portion of site containing house and sheds, looking NW from central portion of the Site.

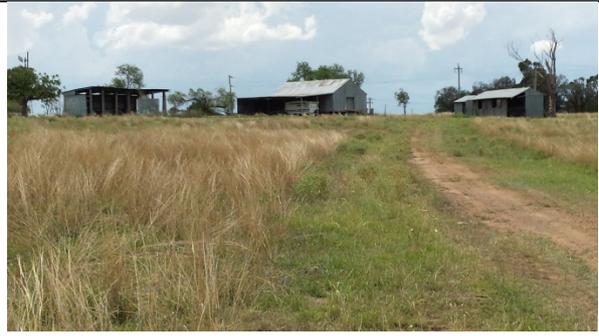
Photo 2. Sheds 5,4,3 and 2, from left to right, looking NW.

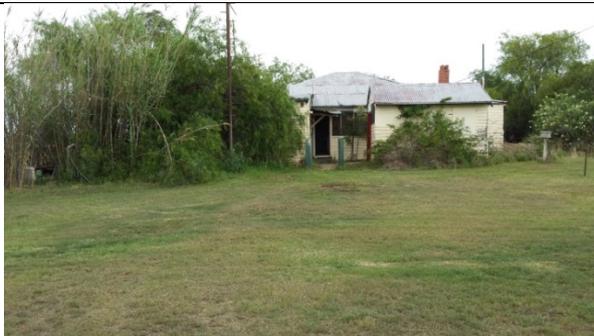
- A summary of the sheds and an abandoned farm house are as follows:
 - The abandoned farm house contained possible asbestos containing material (ACM), lead based paint and polychlorinated biphenyls (PCBs) in the form of old fluorescent lights (Photo 3).

Photo 3. The abandoned house, looking W.

- Undertake a hazardous buildings and material survey of the structures on the site if they may be demolished as part of the redevelopment, and detailed inspection (with limited soil sampling) of former building locations.
- Removal of herbicide drums and drum of unknown blue liquid. It is noted that TRC holds a chemical collection program twice yearly to enable safe disposal of chemicals. The program focuses on agricultural and veterinary chemicals.
- Undertake soil sampling within the areas of the herbicide drum and associated soil staining, drum of unknown liquid and in the area of the sheep dip. Assessment of past fertiliser use could be conducted in conjunction with this sampling.
- Undertake soil sampling within the vicinity of the residence to identify the presence of ACM fragments and potential for contamination.

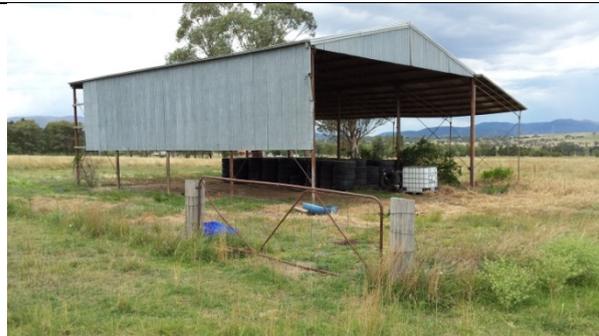
- Shed 1 (Photos 4 and 5) was used for tyre, chemical and possibly machinery storage. It contained approximately 300 used truck tires, a lawn mower and an empty 1000 L Glyphos (glyphosate) herbicide drum that was open at the bottom and dated 10/6/10. The base of the shed was dirt and free from vegetation. Possible staining on soil was noted in the vicinity of the herbicide drum.

Photo 4. Shed 1, looking NE.

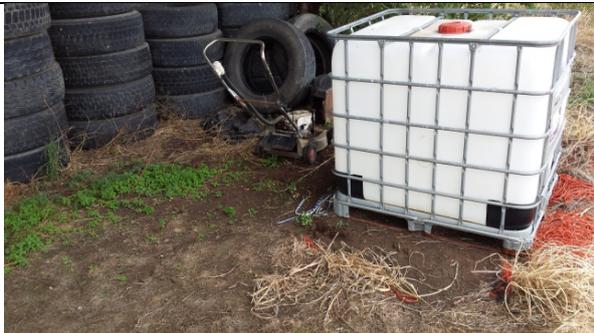
Shed 1 contained used truck tyres and an empty glyphosate herbicide drum. Possible staining was noted in soil around this drum. Shed 3 contained a 20-30 L un-labelled drum of an unidentified, blue, viscous liquid.

Photo 5. Tires, empty glyphosate herbicide drum and possible staining in Shed 1, looking E.

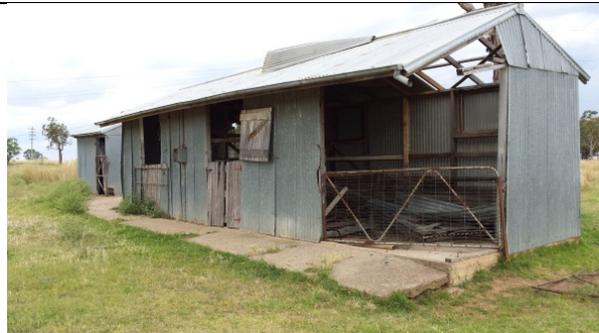
- Shed 2 (Photo 6) was derelict and possibly used as a stable or for livestock/dairy. The shed had a concrete floor and presented no obvious signs of contamination.

- Shed 3 (Photos 6 and 7) was derelict and possibly used for storage. It had a concrete floor and contained a 20-30 L un-labelled drum of an unidentified, blue, viscous liquid and several drums containing wood and metal waste.

Photo 6. Shed 2 and 3, looking NW.

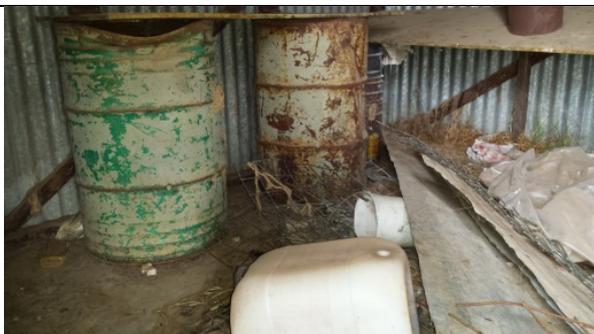
Photo 7. Chemical drum and waste storage drums in Shed 3, looking NW.

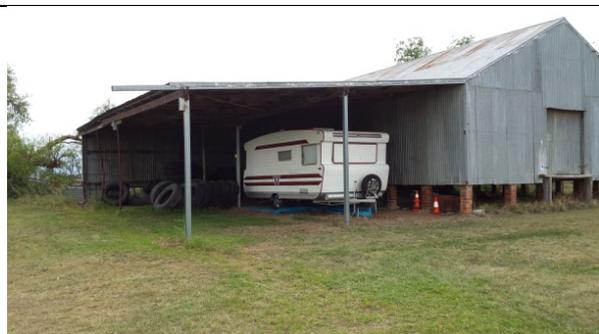
- Shed 4 (Photo 8) was possibly used as a shearing shed. No access inside shed 4 was available. The outside of the shed contained a caravan, approximately 50 used truck tyres and some metal/wood waste. No obvious signs of contamination were noted.

Photo 8. Shed 4, looking NW.

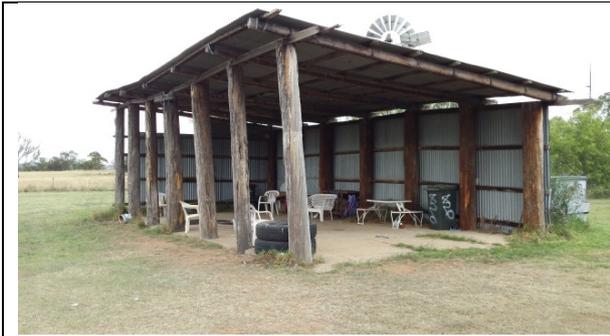
- Shed 5 (Photo 9) was a shelter with a concrete floor that was possibly used for machinery storage. No obvious signs of contamination were noted. A bore water tank and dumpster containing standard, household waste were also noted in this vicinity.

Photo 9. Shed 5, looking SW.

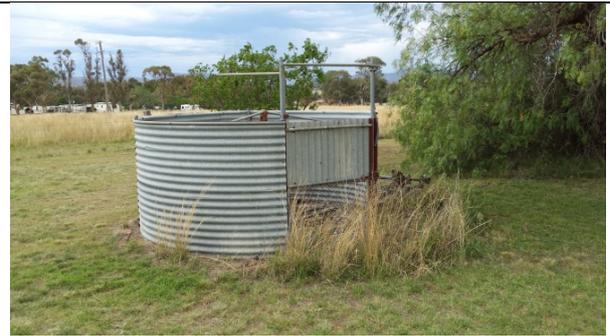
- A derelict sheep dip/spray (Photos 11 and 12) was located to the north west of shed 4. It consisted of a concrete floor with 50 mm bund, metal sides, overhead spray unit, sump and pump. It is possible that the chemicals used may have overflowed the bund however no evidence of impacted vegetation was noted.

A former sheep dip was located to the north west of shed 4. It was noted that the chemicals used may have overflowed the bund however no evidence of impacted vegetation was noted.

Photo 10. Sheep dip/spray, looking NE.

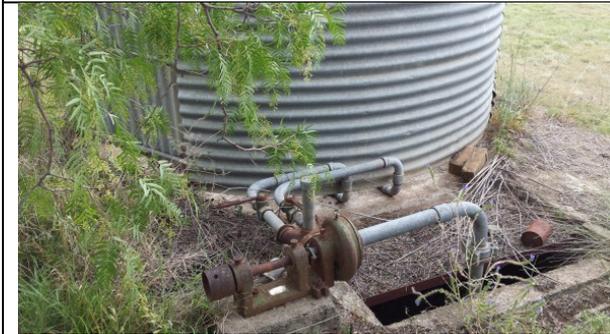
Photo 11. Sheep dip/spray, looking NW, showing sump, pump and bund.
