REPORT
TO
DARCSOL PTY LTD
ON
GEOTECHNICAL INVESTIGATION
FOR
PROPOSED MIXED-USE DEVELOPMENT
AT
2-12 TENNYSON ROAD, GLADESVILLE, NSW

29 October 2012
Ref: 26029SPrpt

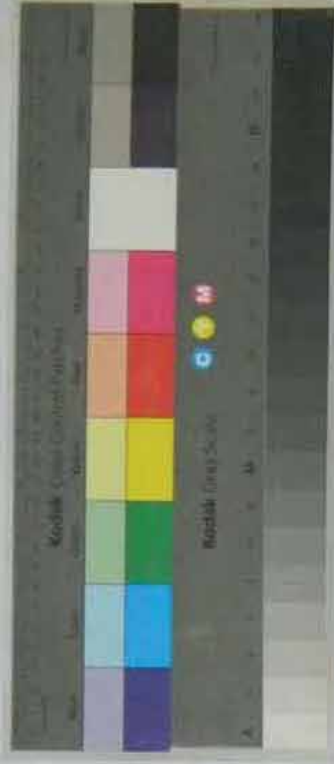
26029SP BH2 START CORING AT 0.73m

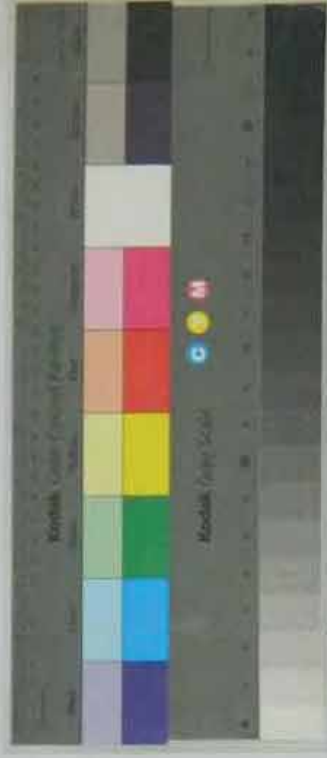
26029SP BH7 START CORING AT 4.24m

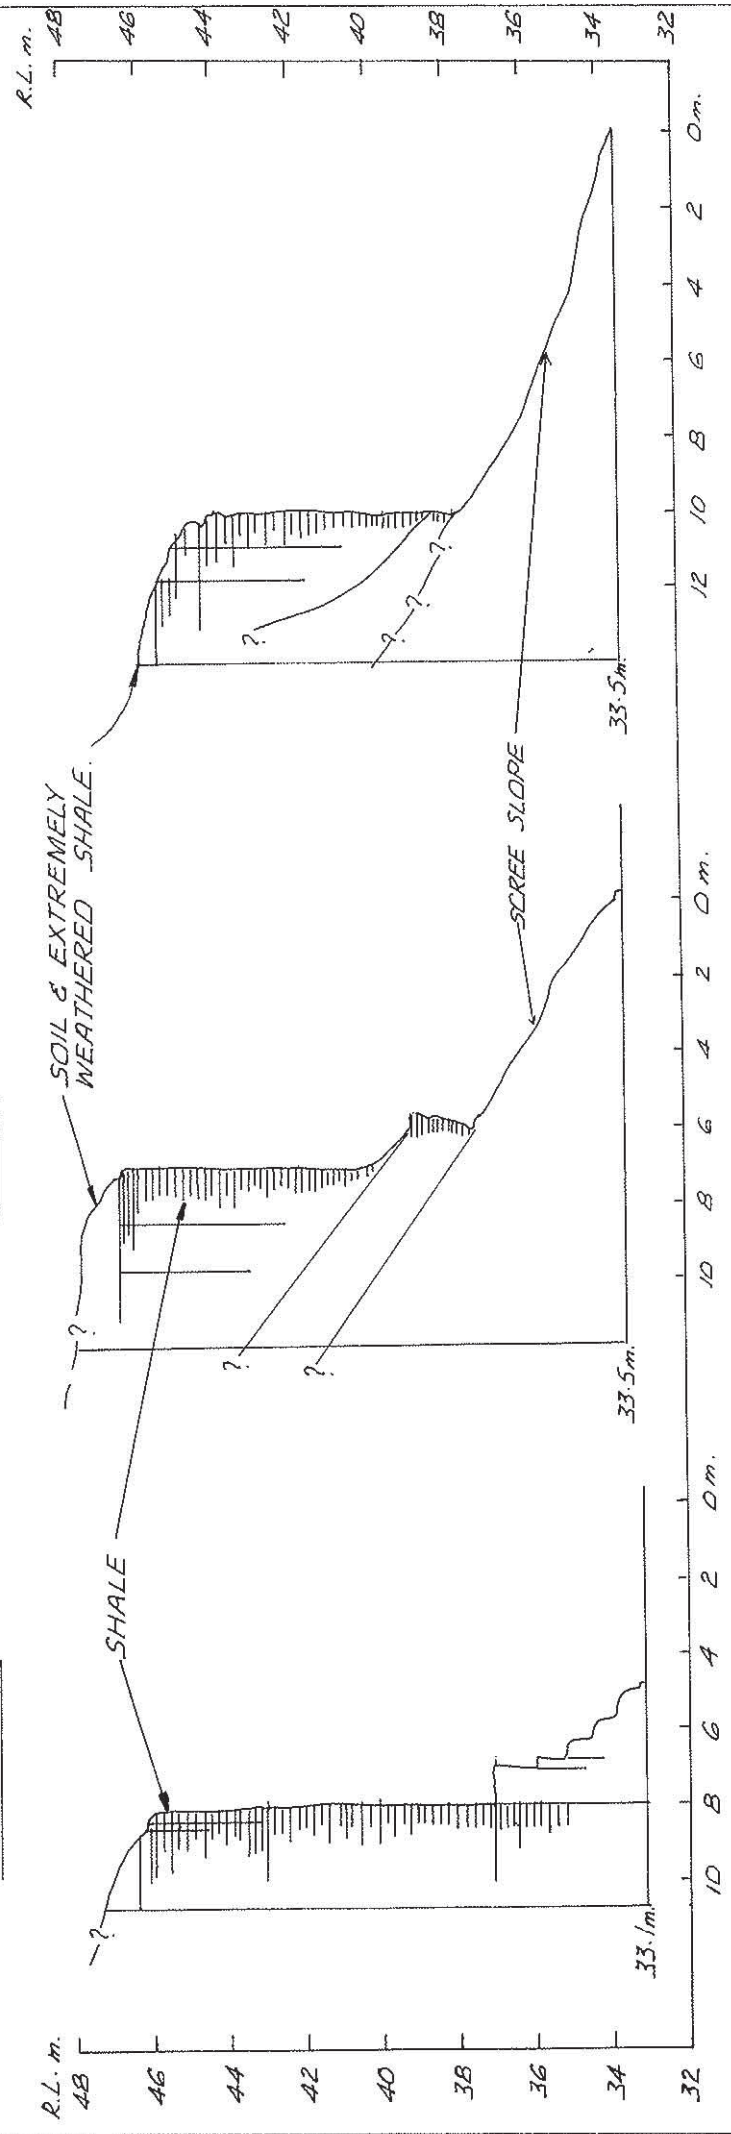
Report No. 7676XS Figure No. 2

SECTION 2

SECTION 3

SECTION 5

SECTION 6

SECTION 7

SECTION 8

SECTION 9
