## **Appendix 15 - Preliminary Site Investigation - Auto Alley Precinct**

Parramatta City Council  
Preliminary Site Investigation

Auto Alley Precinct  
Parramatta LGA, NSW, 2150

26 February 2016  
43375-57854 (Rev 3e)  
JBS&G

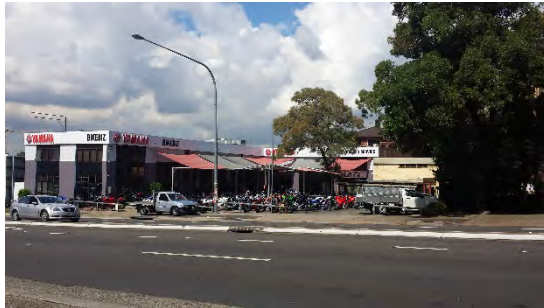
Fronting the Great Western Highway, these allotments comprised the Yamaha BikeBiz dealership. The majority of the property was concrete paved and was noted to be in poor condition. An older style two storey brick showroom and service centre occupied land within the eastern and south eastern property extent. A single storey workshop and repair centre of brick construction occupied land within the south western property extent.

**Photo 1** – BikeBiz fronting the Great Western Highway facing south

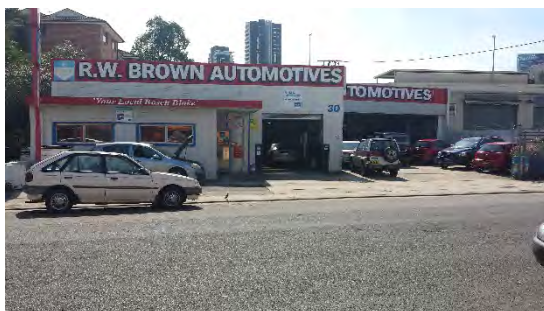
Fronting Landsdowne Street, this allotment comprised a single storey brick commercial building tenanted by R.W Brown Automotives. The building occupied the majority of the property. Land surrounding structures comprised concrete hardstands, the ground surface of which appeared to have been altered in areas. Surface staining was observed in areas of hardstands.

**Photo 2** – R.W Brown Automotives fronting Landsdowne Road facing north

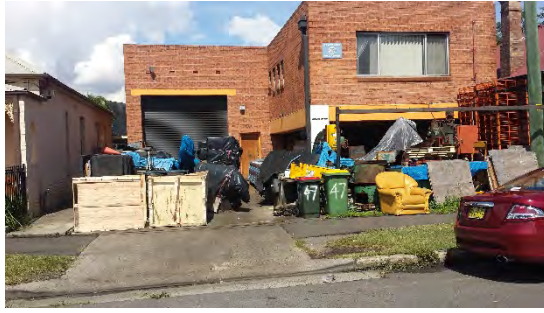
Fronting Rosehill Street, these allotments comprised a commercial style building of brick construction. The building occupied the majority of the property. Surrounding areas comprised bituminous and concrete hardstands. Scrap metal, timber, furniture and various manufacturing equipment were stored at the front of the property on hardstands.

**Photo 3** – Commercial style building fronting Landsdowne Road facing south

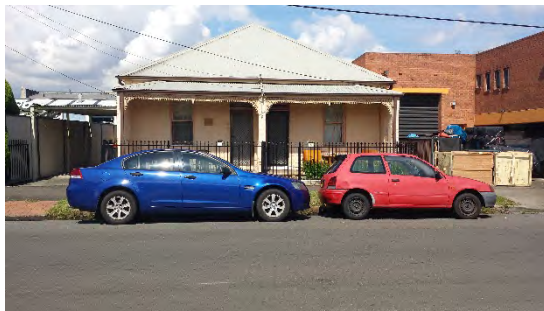
Fronting Landsdowne Road, this allotment comprised a residential duplex of brick construction with corrugated iron roofing. Land surrounding the residences comprised concrete hardstands. The building was noted to be in moderate condition with minor areas of flaking paint.

**Photo 4** – View of the property facing south from Lansdowne Road

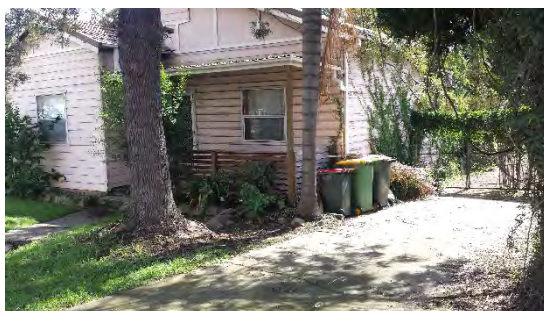
Fronting Dixon Street, these allotments comprised several single storey older style residences of wooden panelling and fibre cement (ACM) sheet construction with ceramic tile roofing. The residences were noted to be in poor to moderate condition with flaking paint and fragments of ACM observed in areas. Land surrounding the residences generally comprised landscaped areas and lawn.

**Photo 5** – Residence fronting Dixon Street facing north

It is also recommended that Hazardous Building Material Surveys (HBMS) be undertaken prior to any demolition and redevelopment works on individual land parcels within the site.

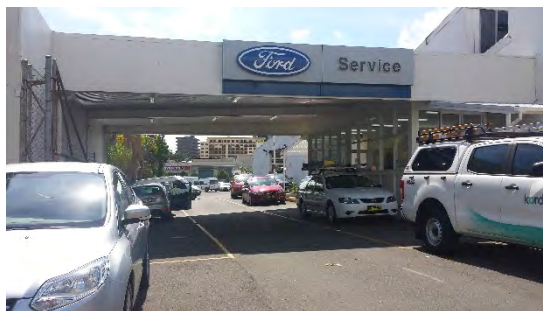
Several modern and older style car dealerships, including Thomson Suzuki, Fiat and Alfa Romeo fronted Church Street. Suzuki, Alfa Romeo and Ford service centres were located within the south eastern property extent, fronting Dixon Street. The buildings were noted to be of various construction materials suggesting the buildings were progressively constructed over time. A riser, potentially associated with a UST, and bowser were observed within the north eastern extent of Lot 1 in DP 180199 (**Figure 4**). An above ground storage tank (AST) was observed in proximity to Lot Y in DP 401259 and Lot 8 in DP 12623 (**Figure 4**).

**Photo 6** – The Ford service workshop fronting Dixon Street facing north with potential UST and bowser to the north of canopy area

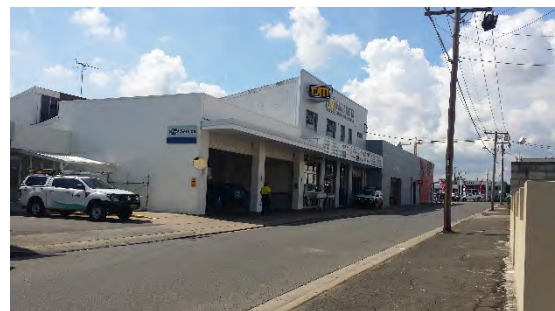
**Photo 7** – The auto service workshops fronting Dixon Street facing north east

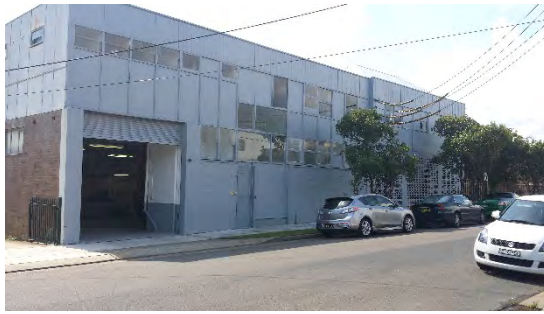
Fronting Rosehill Street, these allotments comprised an older two storey warehouse style structure of brick and fibre cement sheet (ACM) construction. The warehouse style structure appeared to occupy the southern and central property extent, with yard areas to the north.

**Photo 10** – Warehouse style building fronting Rosehill Street facing north

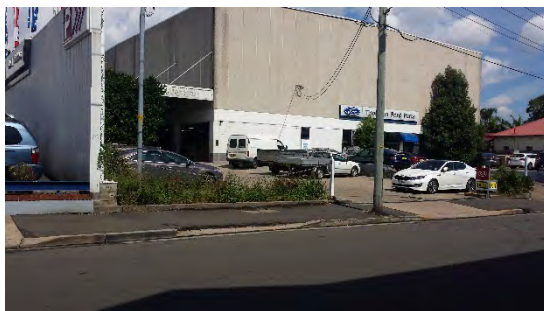
A large older style multi storey warehouse, Thomas Ford Parts, occupied the majority of Lot 1 in DP 778374. Lot 1 in DP 129414 and Lot 4 in DP 12623 contained the Thompson Ford car dealership which comprised caryard areas and an older style sales building in the western extent of Lot 4 in DP 12623.

**Photo 11** –Thomas Ford parts warehouse facing south

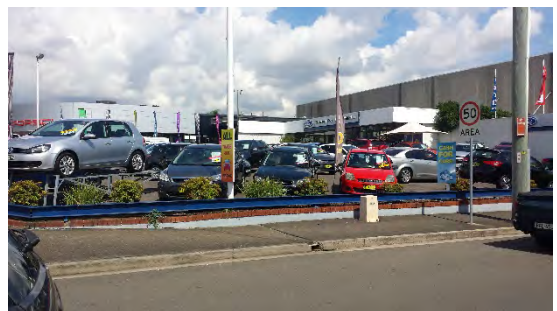
Fronting Church, Dixon and Rosehill Streets, these allotments comprised the car dealership of Thompson Ford. The majority of the property comprised concrete and bituminous hardstands, the ground surface appeared to have been altered when compared to surrounding allotments. Potential exists for the placement of fill beneath raised roads and loading docks in areas. Surface staining was observed in areas.

**Photo 12** –Thomas Ford car dealership facing south from Dixon Street

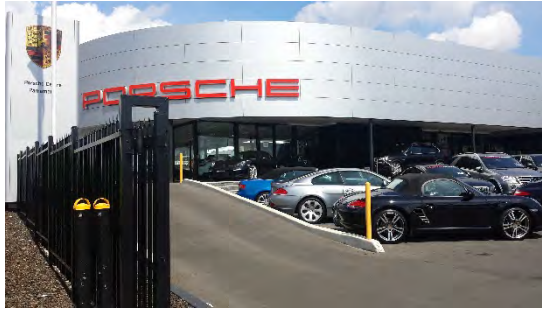
Situated on the corner of Church and Rosehill Streets, this allotment comprised a Porsche car dealership. A modern showroom and sales building was located within the southern property extent. A small workshop area occupied land within the western property extent. The ground surface surrounding the properties structures comprised bituminous pavements and appeared to be have been subject to cut and fill activities.

**Photo 13** – The Porsche car dealership fronting Church and Rosehill Streets

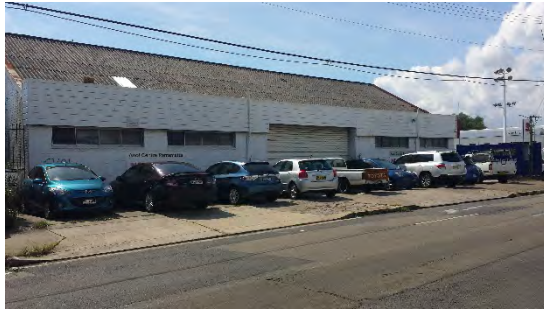
A large warehouse style structure occupied the entire footprint of Lot 7 in DP 71134, Lot 1 in DP 962456 and the western extent of Lot 1 in DP 78099. The warehouse was noted to be of brick and metal with Super Six roofing (ACM). Two risers and bowlers, potentially associated with two USTs were observed along the southern façade of the warehouse style structure (**Figure 4**).

**Photo 16** – Warehouse building with Super Six roofing fronting Boundary Street

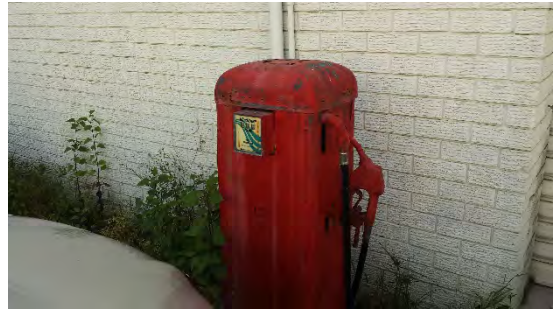
A large warehouse style structure of concrete and sheet metal construction occupied the majority of Lot 39 in DP 597587. A riser, potentially associated with a UST, was observed along the eastern façade of the warehouse style structure (**Figure 4**). A modern electrical substation was observed within the north eastern extent of Lot 2 in DP 203854.

**Photo 17** – One of two red bowsers observed fronting Boundary Street

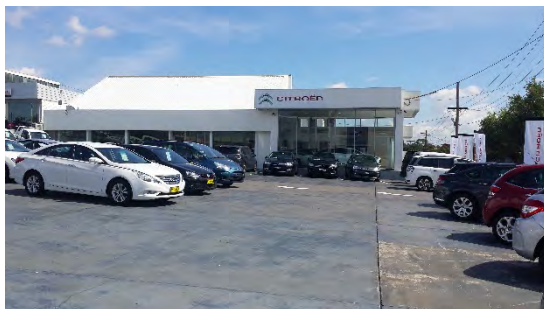
Situated on the corner of Church and Rosehill Streets, these allotments comprise the car dealership of Citroen. The majority of the site comprised concrete and bituminous hardstands, the ground surface of which appeared to have been altered in areas. A small older style sales office was situated within the western property extent.

**Photo 18** – The Citroen car dealership facing west from Church Street

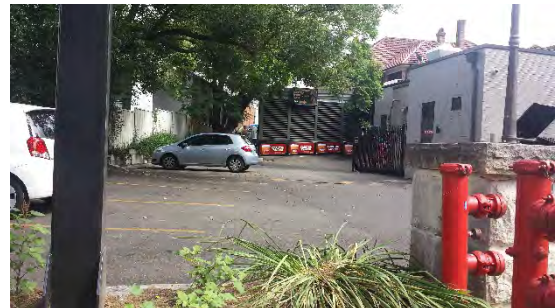
**Photo 21** – The car park at the rear of the pub facing west from Anderson Street

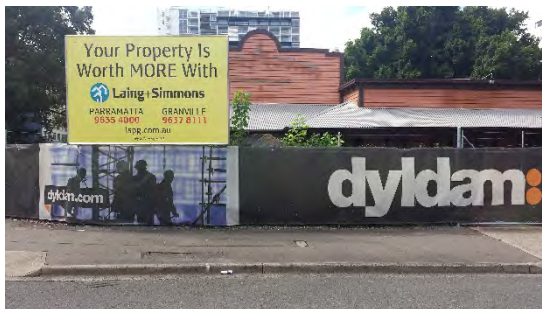
Situated on the corner of Anderson and Parkes Streets, this allotment comprised a vacant single storey building previously tenanted by Lonestar Steakhouse restaurant. The building was of timber and brick construction and appeared to be in moderate condition with no visible signs of flaking paint. The ground surface surrounding the property structures generally comprised landscape areas and bituminous hardstands. It is noted at the time of inspection shade cloth with signage was present around the site indicating potential future redevelopment.

**Photo 25** – The western side of the building facing east from Anderson Street

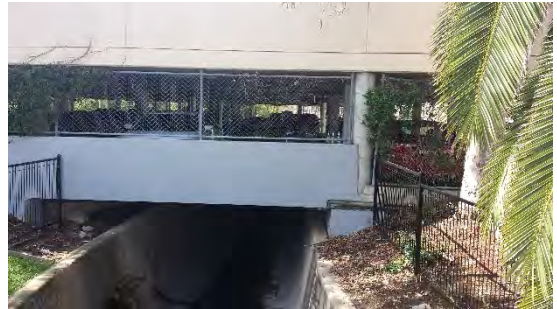
Fronting Anderson Street, this allotment comprised a multi storey commercial building (Holiday Inn) occupying the majority of the property. A large multilevel car park was present in the southern extent of the property. Surrounding the buildings of concrete construction were landscaped areas and bituminous hardstands. A stormwater easement (Clay Cliff Creek), with a west east alignment, ran below the multistorey car park within the southern property extent.

**Photo 28** – Clay Cliff Creek easement below the multilevel car park within the south property extent

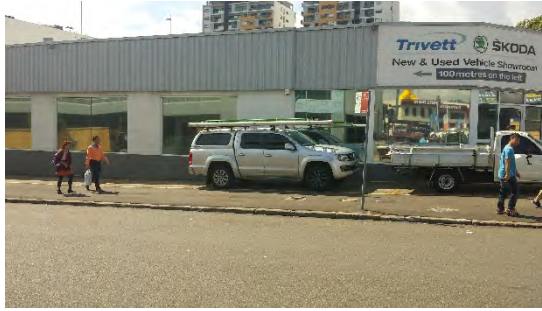
Situated on the corner of Anderson and Marion Streets, this allotment comprised a single story commercial style building of concrete and brick construction with sheet metal roofing. The building occupied the entire property footprint. At the time of the site inspection the building appeared vacant with no signage apparent. Based on the building's configuration it appeared the property may have potentially been used as a mechanics/automotive repair centre or car dealership with automotive repair centre facilities.

**Photo 30** – Commercial style building facing east from Anderson Street

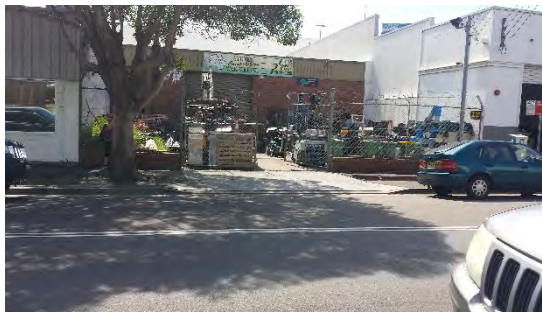
Fronting Marion Street, this allotment comprised a single story brick warehouse style structure within the north property extent tenanted by Sydney Competition Warehouse. The remainder of the property comprised concrete and bituminous hardstands. Scrap metal, timber and construction goods were stored on hardstands within the southern lot extent.

**Photo 31** – Street view of the warehouse building fronting Marion Street

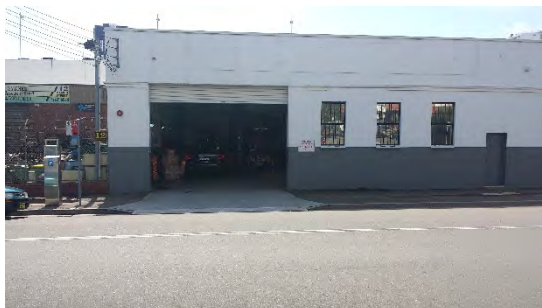
Fronting Marion and Andersons Streets and Jubilee Lane, these allotments comprised a warehouse style building (Trivett Tyres) of concrete and brick construction. The warehouse style structure occupied the entirety of Lot 3 in DP 71096. The remainder of the property comprised concrete hardstands. Heavy surface staining was observed along the Marion Street and Jubilee Lane road frontages. The rear of this property, fronting Jubilee Lane, was a car wash facility, with staining from the vehicle entry, into the lane.

A suspected riser and bowser, potentially associated with a UST was identified within the north eastern property extent (**Figure 4**).

**Photo 32** – The southern portion of the warehouse building fronting Marion Street facing north

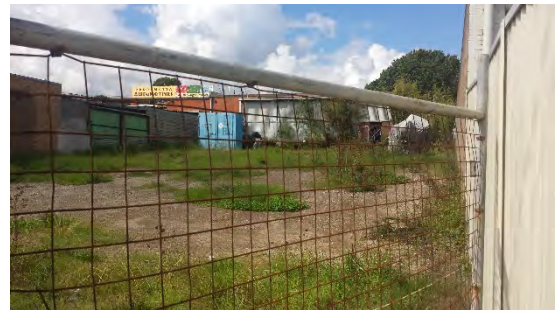
The balance of the property (Lots 1 and 2 in DP 996565) comprised cleared vacant land parcels, the ground surface of which was surfaced with grass cover. Land within the southern extent of Lots 1 and 2 in DP 996565 appeared disturbed, the subject of filling. A dangerous goods storage cabinet was observed within the south eastern extent of the vacant land parcels.

**Photo 34** – The vacant land parcel facing south

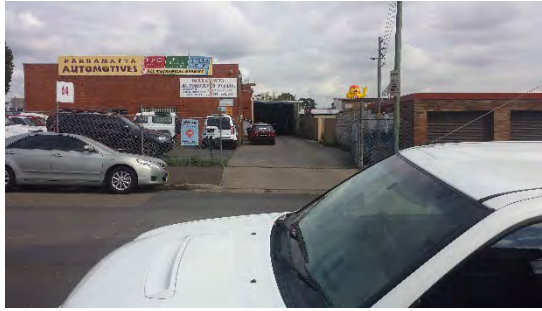
Parramatta Automotive occupied Lot 1 in DP 706520 situated to the south of Neil Baileys Auto Electrical and café Oasis. A single storey commercial style building of brick construction was observed within the south western lot extent. The surrounding areas comprised largely of concrete and bituminous hardstands. A riser, potentially associated with a UST was observed along the southern lot boundary (**Figure 4**).

**Photo 35** – Parramatta Automotive fronting High Street, facing west

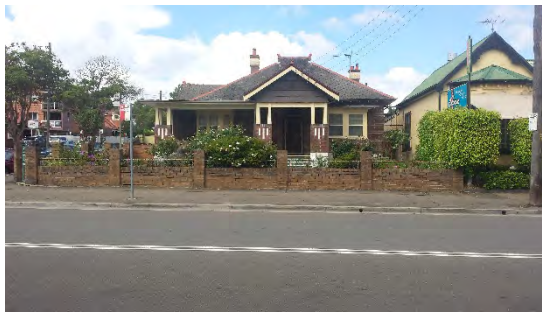
Situated on the corner of Marion and High Streets, this allotment comprised a residence of brick construction with a slate tile roof. Within the rear yard were extensions to the residence, several sheds, potentially of ACM construction (**Figure 4**) and a double car brick garage. The residence and site structure were in moderate conditions with minor areas of flaking paint.

**Photo 37** – The residence fronting Marion Street facing south

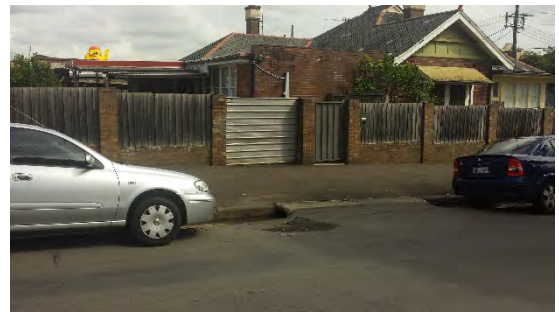
**Photo 38** – The eastern side of the residence facing west

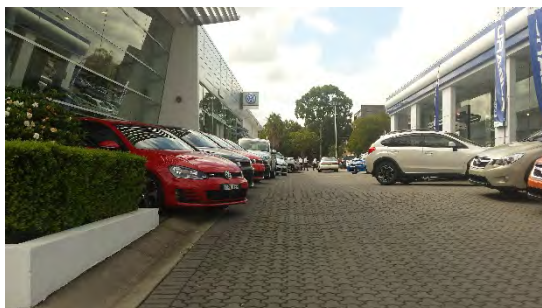
Fronting Church Street and extending through to High Street, this allotment comprised the car dealerships of Denlo Subaru and Volkswagen. Two modern showrooms fronted Church Street. Several older style structures were observed within the central property extent comprising workshops and offices associated with the used car dealership occupying the eastern property extent. Within workshop areas several 205 L (44 gallon) drums were observed within unbunded areas.

The property's topography appears to have been filed in areas when compared to surrounding allotments. The ground surface surrounding structures largely comprised hardstands and pavements. A small area of exposed soils was observed within the north eastern property extent. A modern electrical substation was observed within the south eastern property extent.

**Photo 42** – View of the car dealerships fronting Church Street

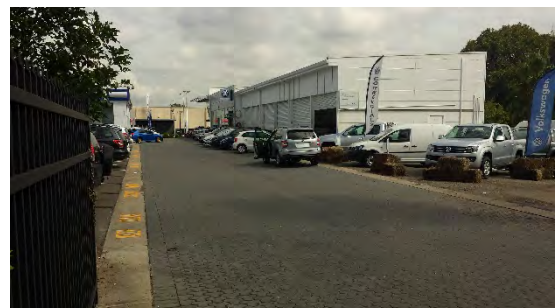
**Photo 43** – View of the workshop buildings facing east

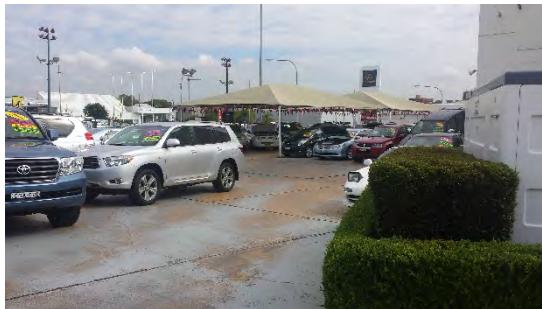
Situated on the north-eastern corner of Raymond and Church Streets and extending east to High Street, these allotments comprise the car dealerships of Terry Shields Toyota and Lexus. The majority of the property comprises paved concrete hardstands, the ground surface of which appear to have been altered in areas from the regional north east trending topography. A showroom occupied the majority of Lot 1 in DP 318189. An older style two storey split level warehouse conversion comprising offices; showroom and workshop areas occupied the majority of Lot 3 in DP 234313. A riser associated with an underground storage tank (UST), and bowser were observed along the south, western façade of the warehouse style structure (**Figure 4**). A small electrical substation was observed within the south eastern extent of Lot 2 DP 500595. Lot 2 in DP 318189 fronting High Street appeared to be used for parking and comprised a level parcel of land, surfaced with road base gravels.

**Photo 44** – View of the car dealership yard looking north west towards Church Street with substation in the foreground

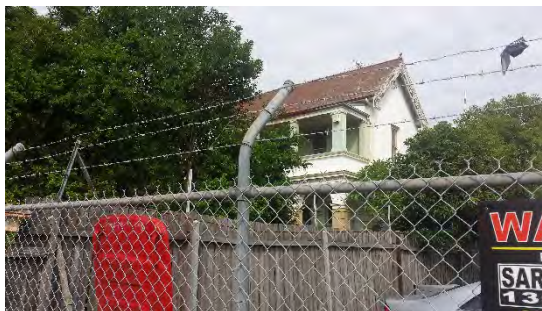
Fronting High Street, these allotments comprised an old two storey residential style structure of brick construction with cement tile roofing. The residence was noted to be in generally good condition with minor areas of flaking paint. Two smaller structures, a garage and shed, potentially of fibre cement sheeting (asbestos containing material (ACM)), were observed along the northern property boundaries (**Figure 4**). Yard areas surrounding the residence and property structures were surfaced with grass cover.

**Photo 46** – Side view of parcel AF from the neighbouring property to the north west

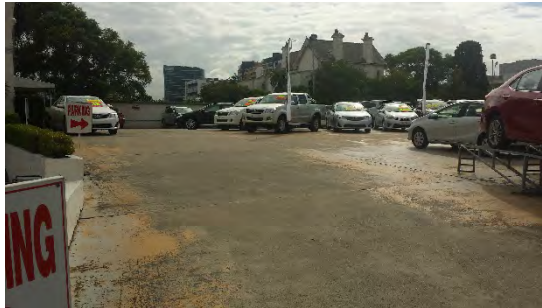
Fronting High Street, this allotment comprised a vacant land parcel, the ground surface of which comprised concrete hardstands, part of the Terry Shields Toyota dealership as discussed above in **Section 2.2.31**. The ground surface appeared to have been altered (potentially filled) sloping south towards Raymond Street and east in areas towards High Street.

**Photo 48** – View of the caryard facing north

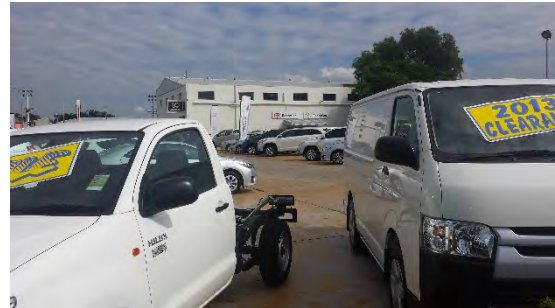
**Photo 49** – View of the caryard facing west along the eastern property boundary
