# **HERITAGE IMPACT STATEMENT**

**PROPOSED DEMOLITION  
MANANGLE PUBLIC SCHOOL**

**Station Street, Menangle NSW**

**October 2007**

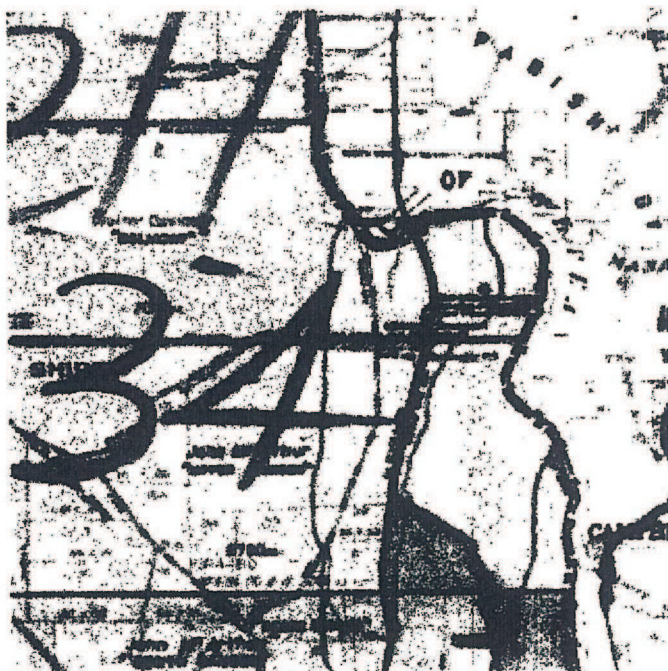
**Figure 1 : Parish Map 1922 Indicating General Land Use (LPI)**

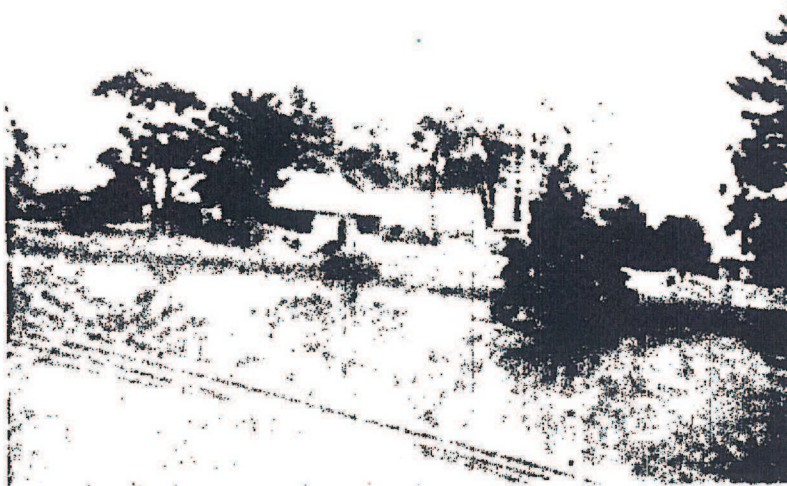
**Figure 4 : Menangle Public School 1930 (Note Original School / Residence behind)  
(Campelltown City Council)**
