## **JACARANDA PONDS**

### **STREAM CLASSIFICATION**

21<sup>st</sup> August 2009

#### Project: 301015-01761 JACARANDA PONDS STREAM CLASSIFICATION

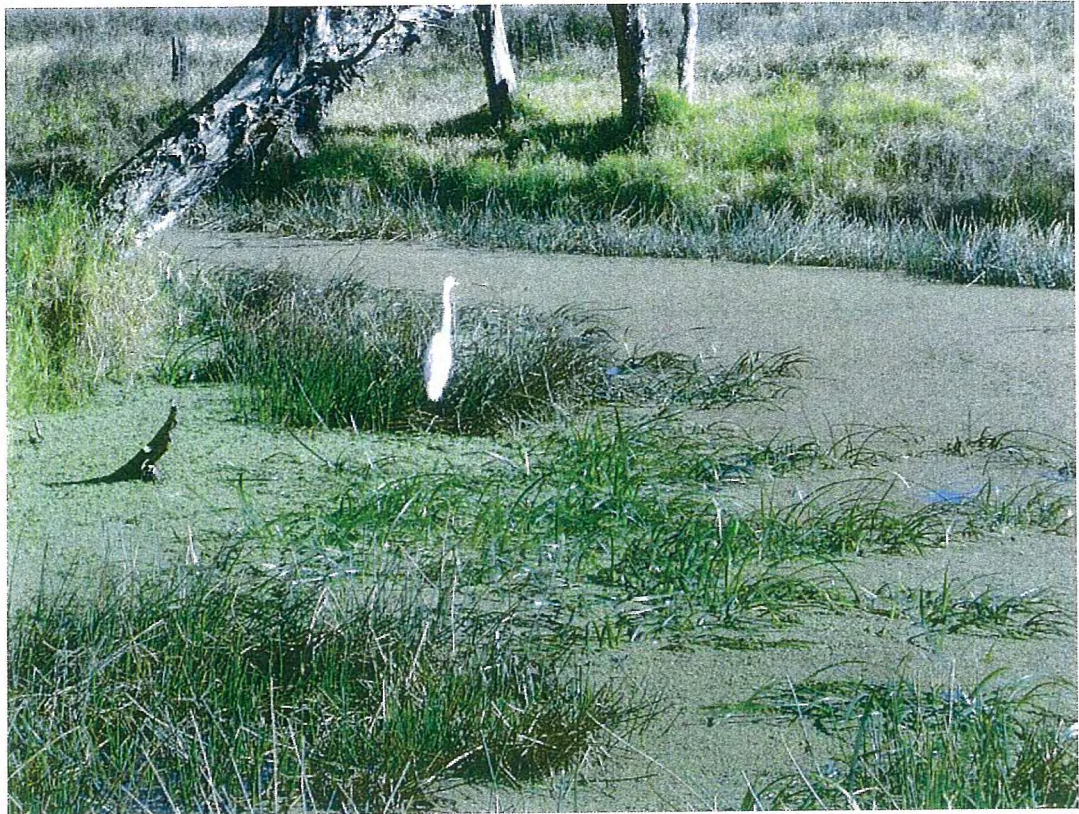
- the watercourse has significant environmental value;
- main creek channel is continuously flowing (*refer Plate 1*);
- it provides habitat for riparian fauna (*refer Plate 2*);
- it provides a riparian corridor;
- the creek holds (*limited*) aquatic fauna.

Plate 2: View looking upstream along Currency Creek towards western site boundary

The alignment of Watercourse 1 (*W1*) and the existing classification by DWE is shown in **Figure 2**. It is recommended that the Category 1 classification be retained for the length of the watercourse that passes along the southern boundary of the site.

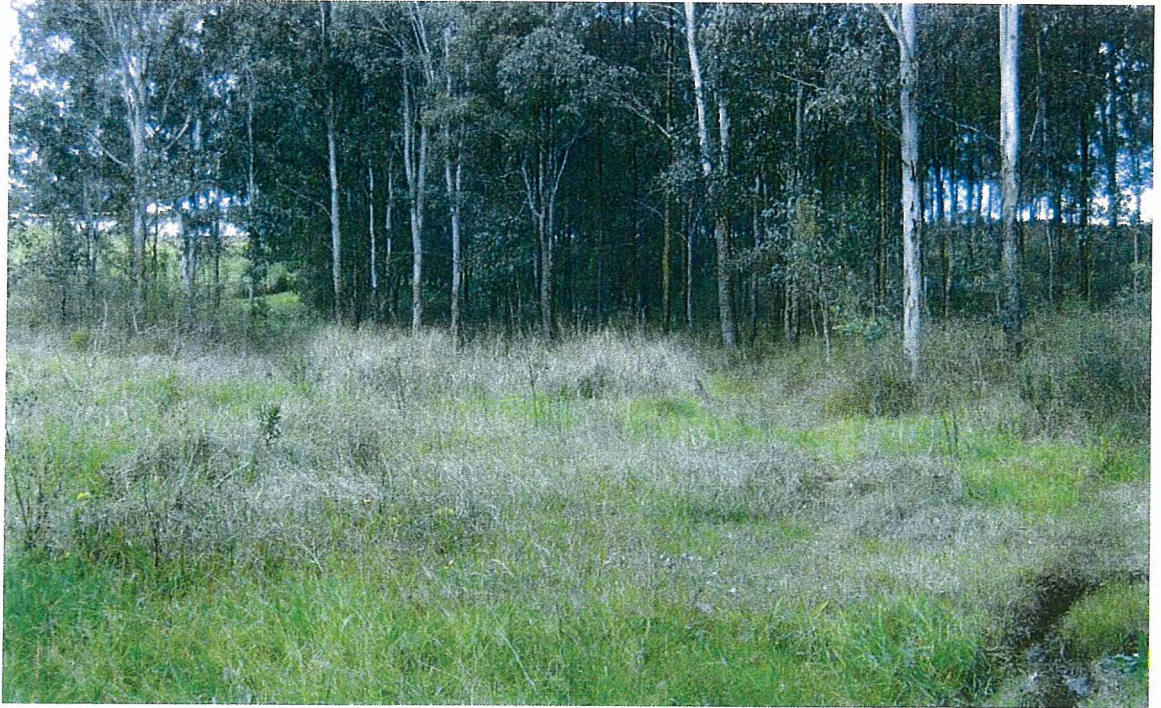
- no defined channel (*refer Plate 3*);
- no overland flow, dry gully (*refer Plate 4*);
- no significant riparian vegetation;
- no vegetation connectivity upstream from gully (*refer Figure 3*);

Plate 3: View looking upstream along Watercourse 2 from western site boundary

The alignment of Watercourse 2 (W2) and the existing classification by DWE is shown in **Figure 3**. It is recommended that the Category 1 classification be removed for the 120 metre length of the watercourse identified within the site boundary. In other words, it is recommended that this section of W2 be removed from the existing mapping of classified watercourses.

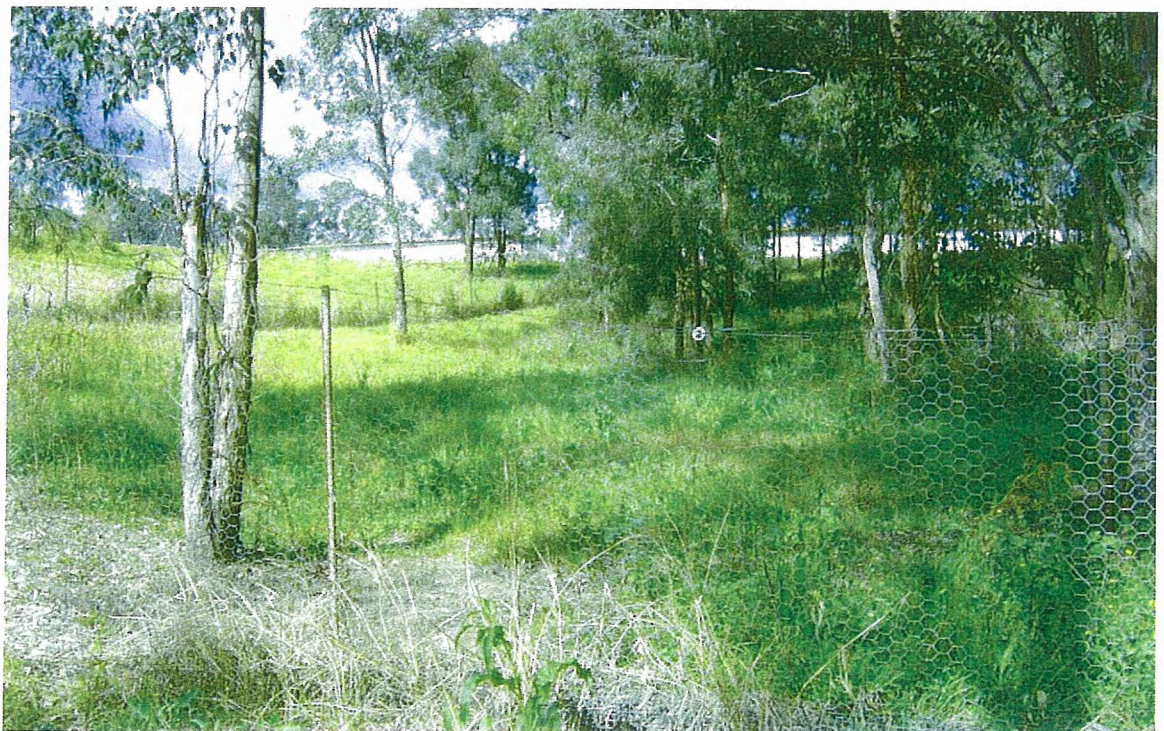
Plate 4: View looking upstream along Watercourse 2 towards farm sheds

It should be noted that this recommendation applies only to the length of Watercourse 2 that lies within the Jacaranda Ponds site (*refer Figure 3*). It is also noted that a designated flow path will need to be retained along the gully to allow drainage of stormwater collected within this section of the site.

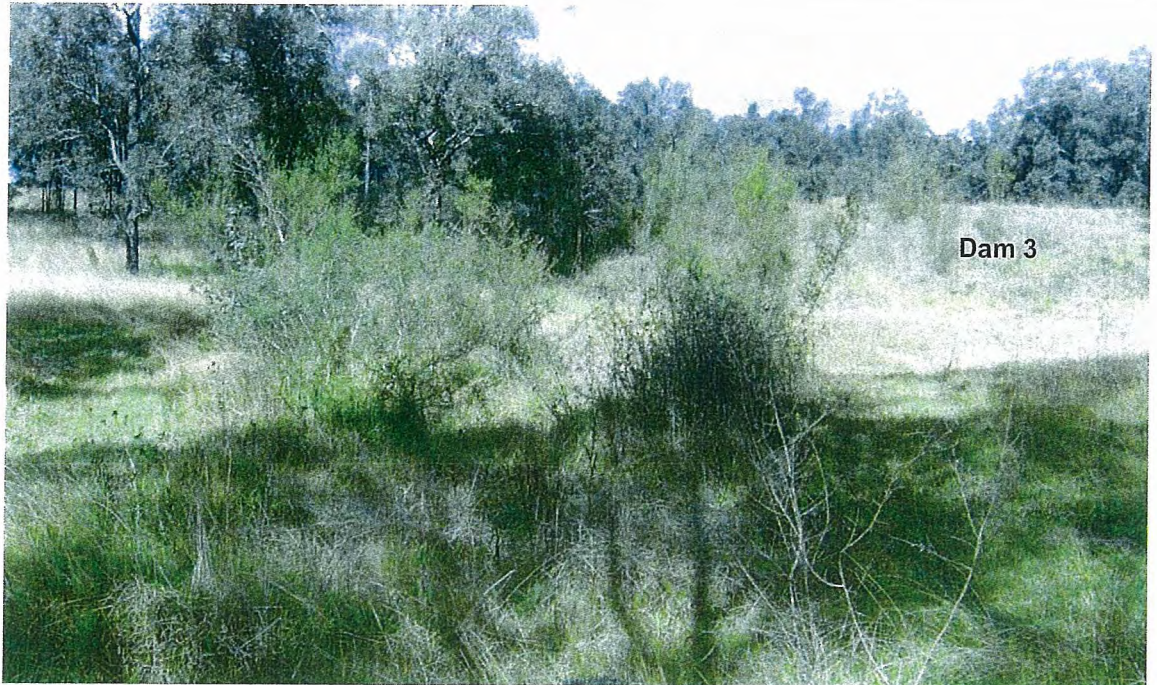
- there is no defined channel for the first 20 metres north of Dam 3 (*refer Plate 5*). There is no significant vegetation other than pasture grass at this location;
- there is no defined channel upstream from Dam 3 (*refer Plate 6*);
- no overland flow, dry gully (*refer Plate 6*); and,
- lack of vegetation connectivity downstream from Dam 3 or upstream from gully (*refer Figure 3*).

- the dam itself provides limited habitat for birds and amphibians (*refer Plate 7*), however;
- there is no defined channel upstream or downstream from the dam (*refer Plates 5 and 6*) and therefore, the dam does not lie on a watercourse; and,
- there is no vegetation connectivity downstream from the dam.

**Plate 5: View looking upstream along Watercourse 3 from northern site boundary**

It is recommended that the Category 1 classification be removed for the entire length of W3 within the site boundary. In other words, it is recommended that these sections of W3 be removed from the existing mapping of classified watercourses.

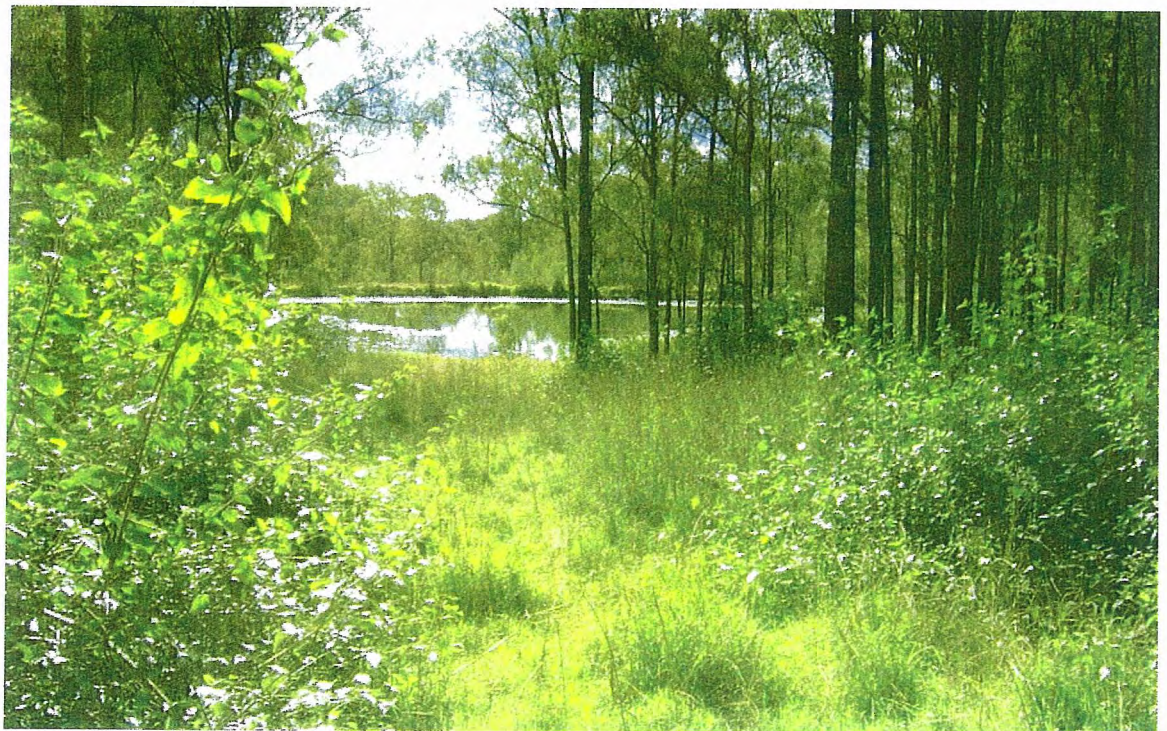
**Plate 6: View looking downstream along Watercourse 3 towards Dam 3**

Similar to the gully at W2, a designated flow path will need to be retained along the gully to allow drainage of stormwater collected within this section of the site.

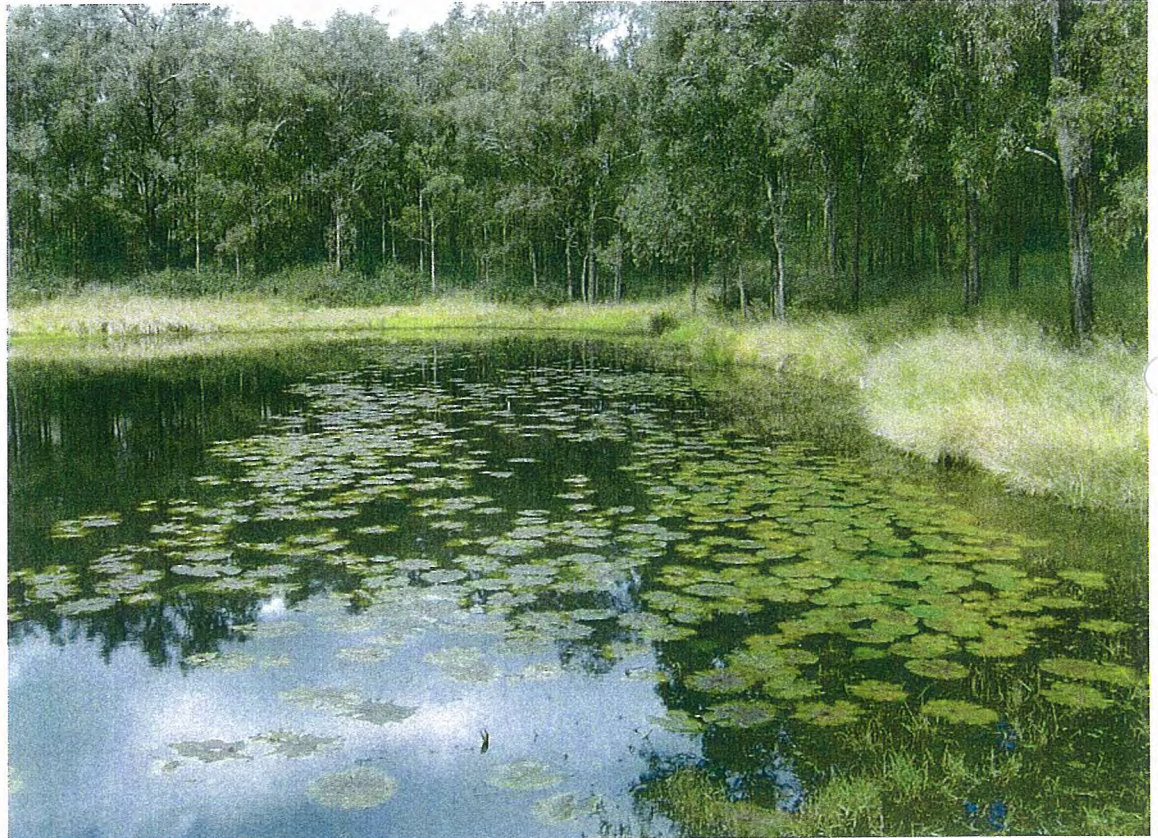
Plate 7: View looking south from northern side of Dam 3

It is recommended that the Category 1 classification for Dam 3 be changed to a Category 3, based on the following observations:

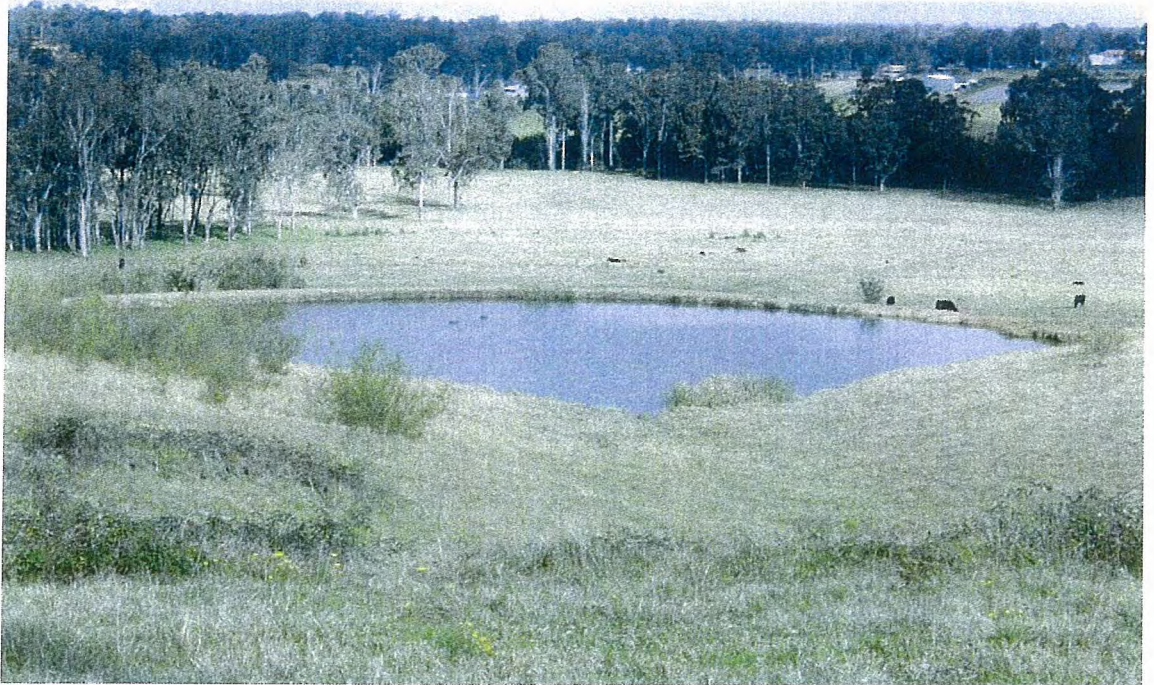
Furthermore, it is evident that all of the dams are man-made and have been constructed as part of past farming activities at the site (*refer Plate 8 for an example*). Accordingly, it is recommended that the dams could be removed as part of any future development of the site, if required.

Plate 8: View looking at Dam 5 from the north-west

The location of Dams 1, 2 and 4 to 8 and their existing classifications by DWE are shown in **Figure 1**. It is recommended that the Category 3 classification be retained for each dam.

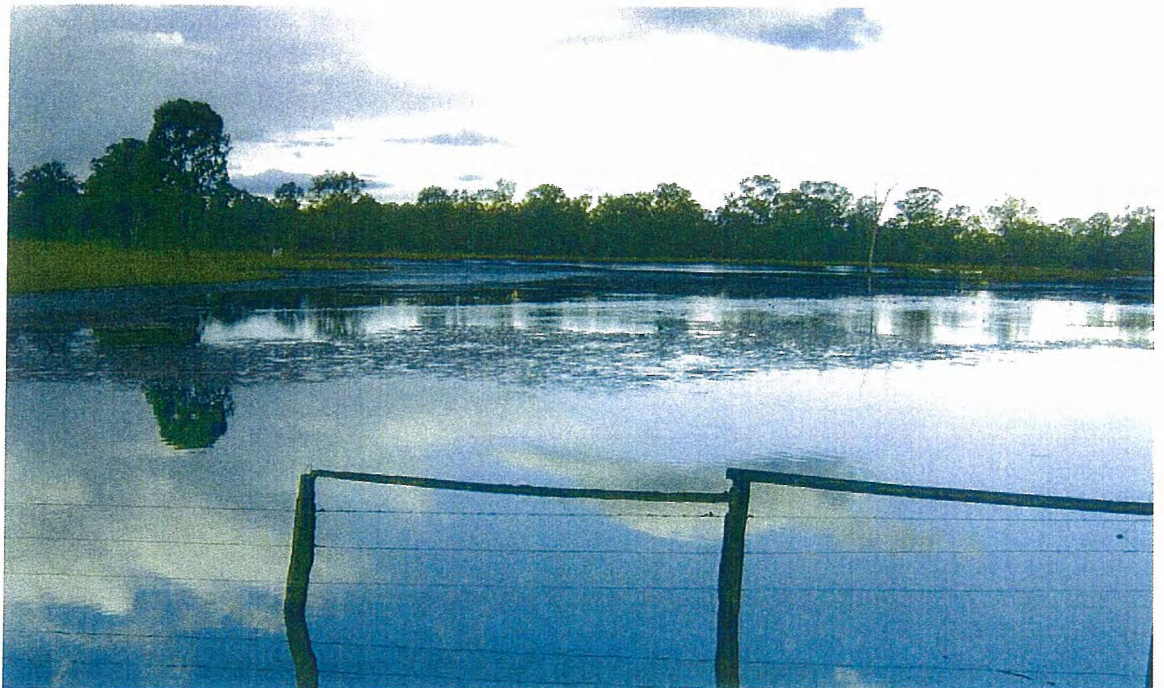
Plate 9: View looking east across Dam 8

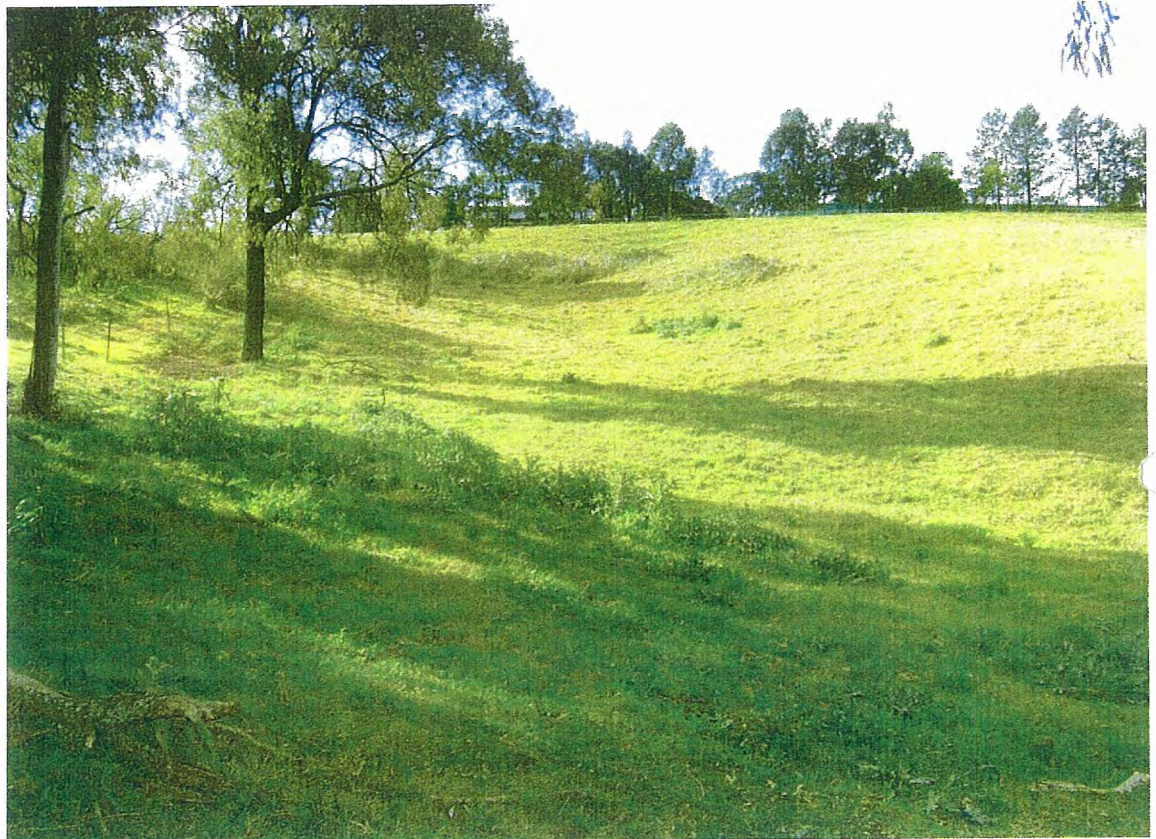
The alignments of these “potential” watercourses are shown as the orange line-work in **Figure 4**. These locations were inspected as part of site investigations and it was determined that all could be effectively defined as dry gullies with no riparian vegetation. **Plates 10** through **13** confirm that a majority of the site is pasture land and therefore, has little environmental value.

Plate 10: View looking north-west upstream along gully above Dam 6

Accordingly, it is not recommended that any of the additional sites that were inspected be incorporated into the stream classification mapping for the site.

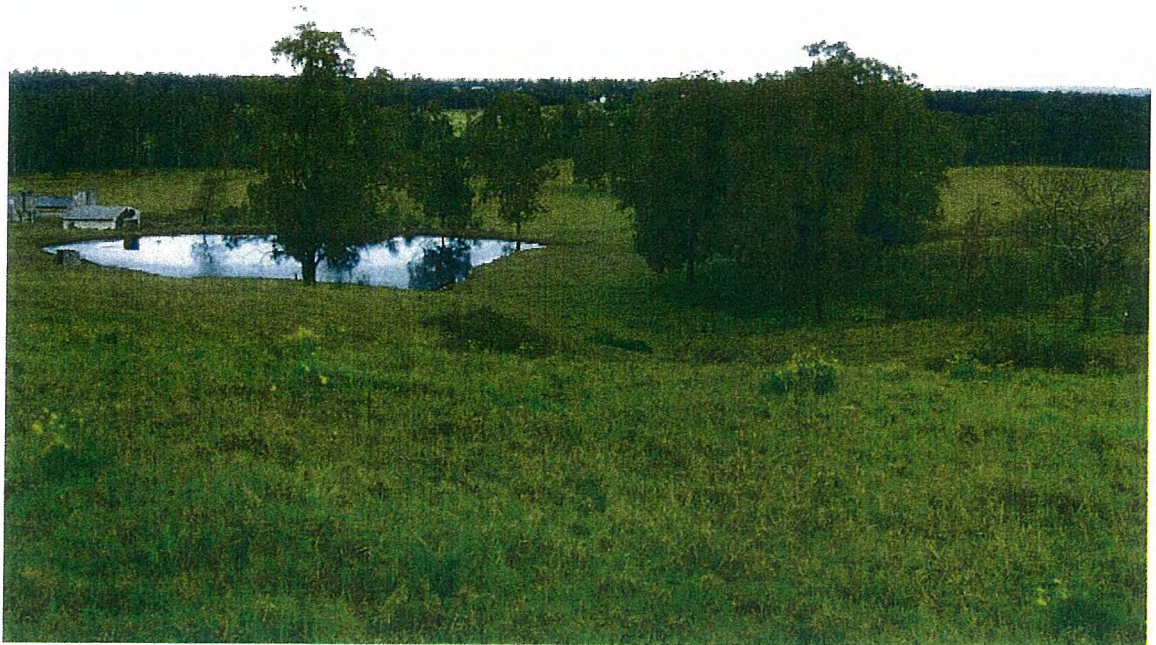
Plate 11: View looking south-east downstream along gully towards Dam 6

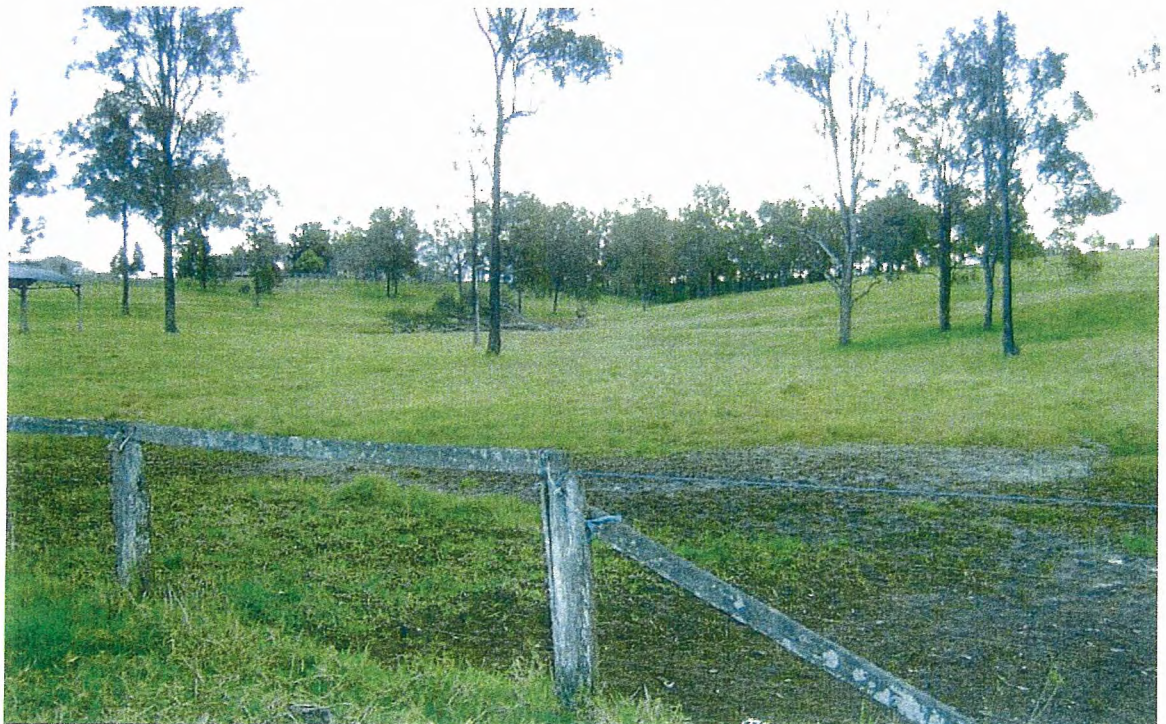
Plate 12: View looking south-west from western edge of Dam 8

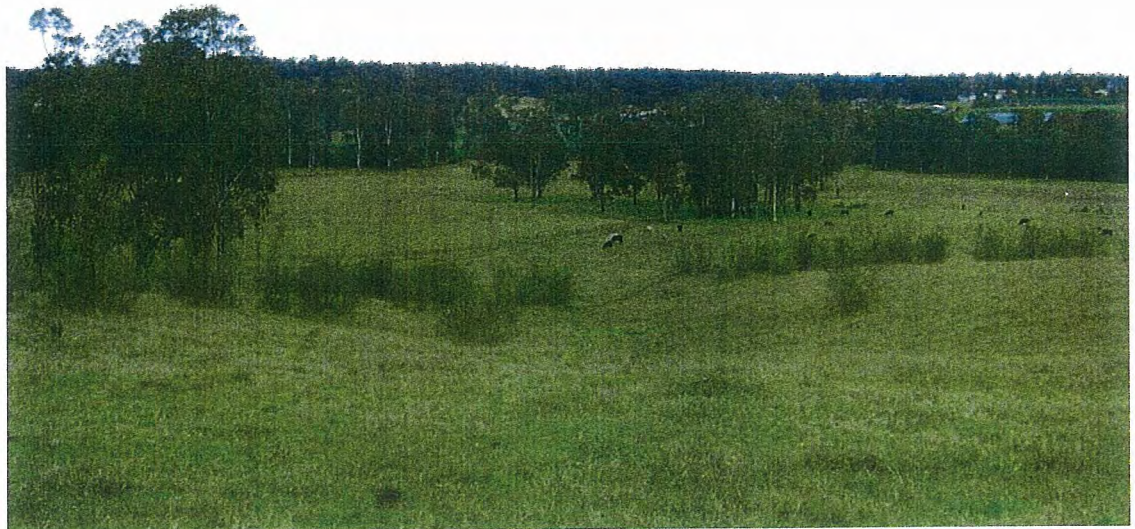
Plate 13: View looking south from ridge line north of Dams 5 and 6

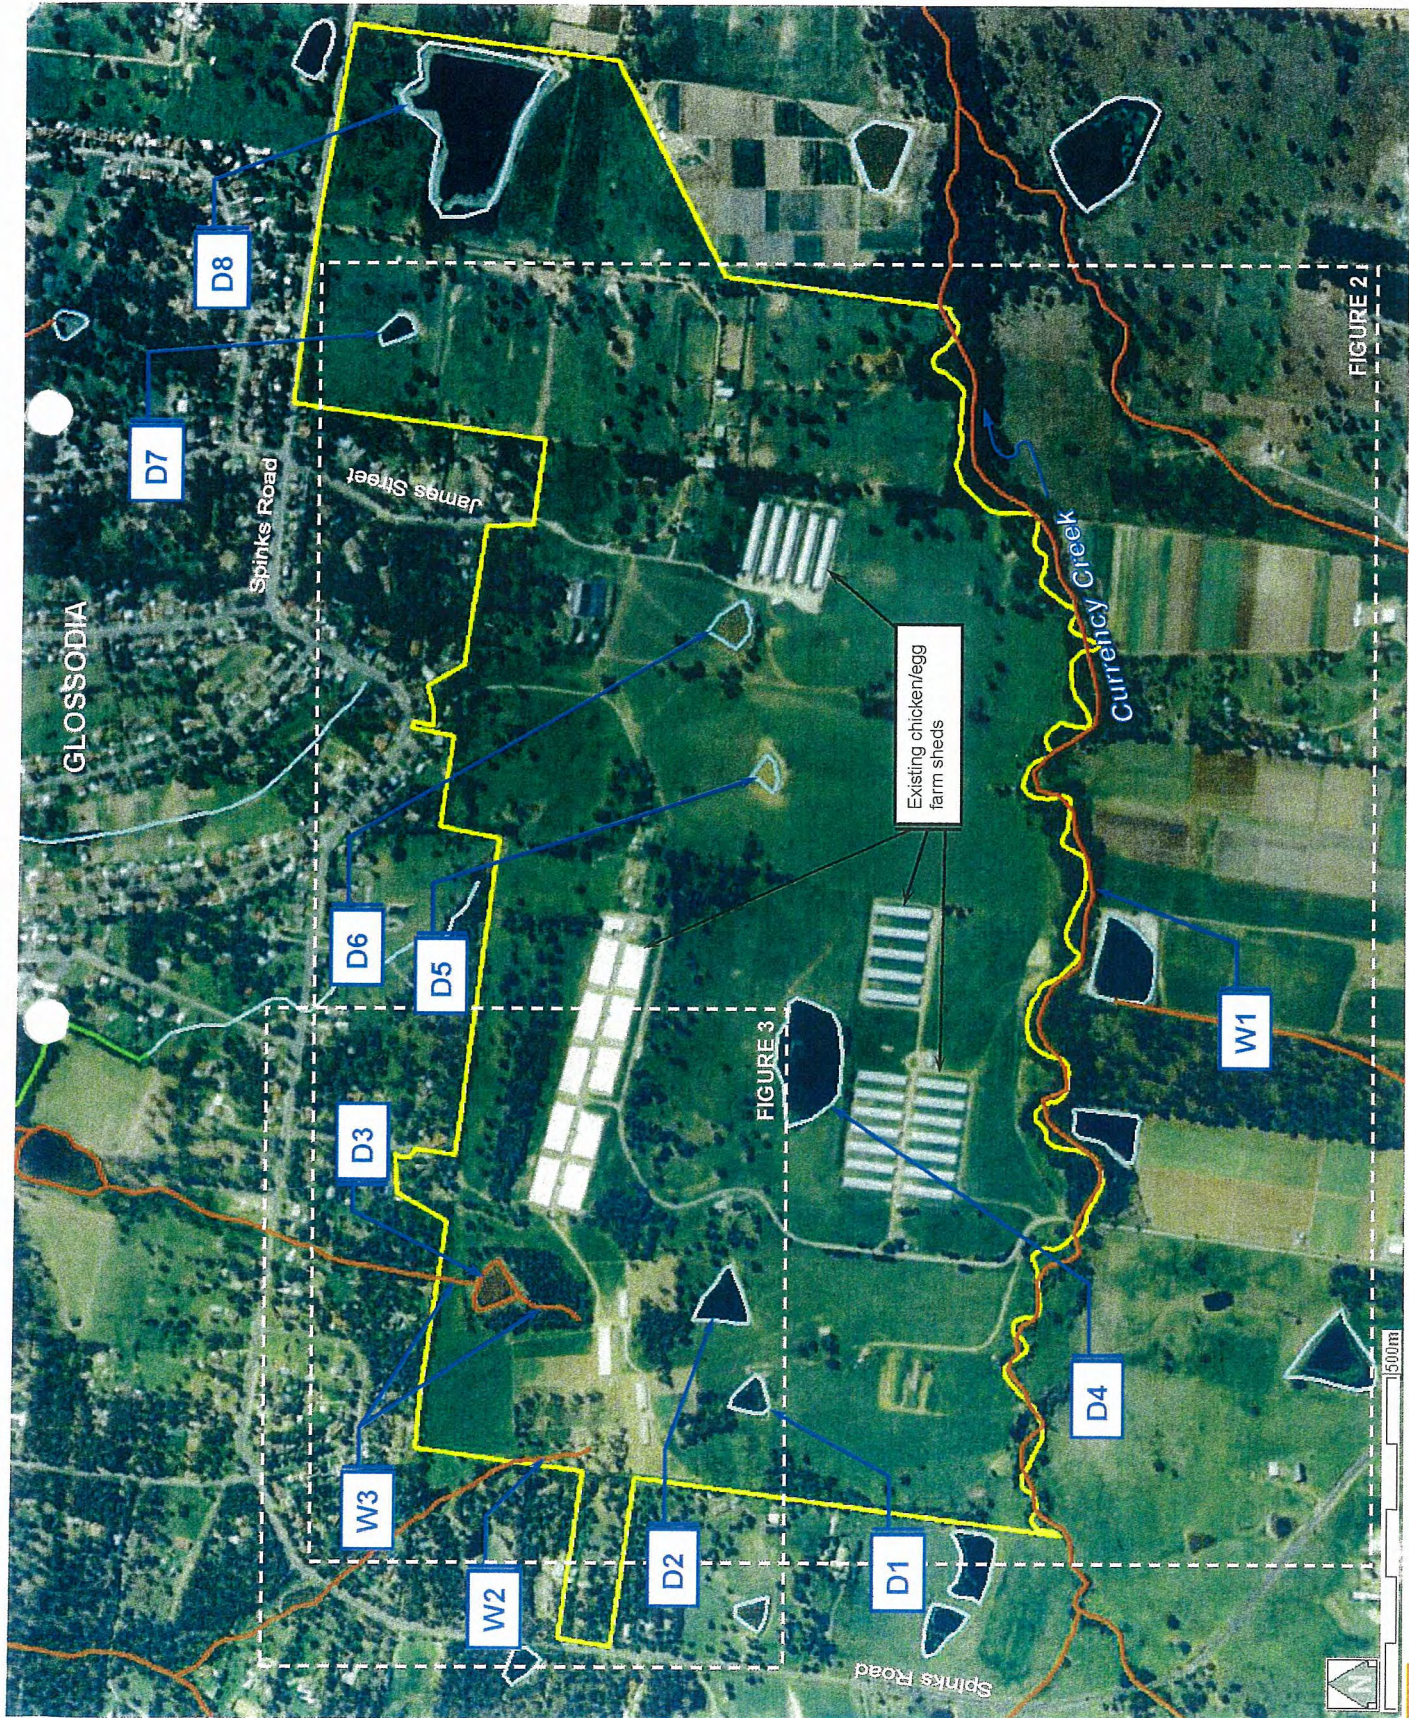
FIGURE 1

The Department of Water & Energy (DWE) has identified three main watercourses within the site. These are numbered and shown in **Figure 1**, as per the GIS mapping colour scheme adopted by DWE.

Currency Creek has been labelled for this investigation as Watercourse 1 (W1), which flows along the southern boundary of the site in an easterly direction (*refer Figure 1*). Watercourse 2 (W2) refers to the streamline in the north-western corner of the site that is shown to flow in a north-westerly direction. Watercourse 3 (W3) refers to the streamline and associated Dam 3 (D3) located to the east of W2. All three waterways have been classified as Category 1 watercourses according to the existing DWE mapping.

In addition to these watercourses, several farm dams have been identified at the site and are currently classified as Category 3 watercourses (*refer Figure 1*).
