It is proposed to redevelop the BaptistCare retirement village at 264-268 Pennant Hills Road, Carlingford, NSW. The village currently serves as a self-contained community housing and aged care facility providing a range of services and amenities. The site is being redeveloped into high quality residential flat building and multi-dwelling housing development.

Calibre Consulting has been commissioned to participate in creating an integrated and effective stormwater management concept for the site to complement the overall objectives of the development. The following report outlines the principles to be applied to the proposed development in relation to stormwater management, including rainwater harvesting and reuse, detention, treatment drainage.

# Tree Risk Assessment

## **Appendix 7 – Ecological Assessment**

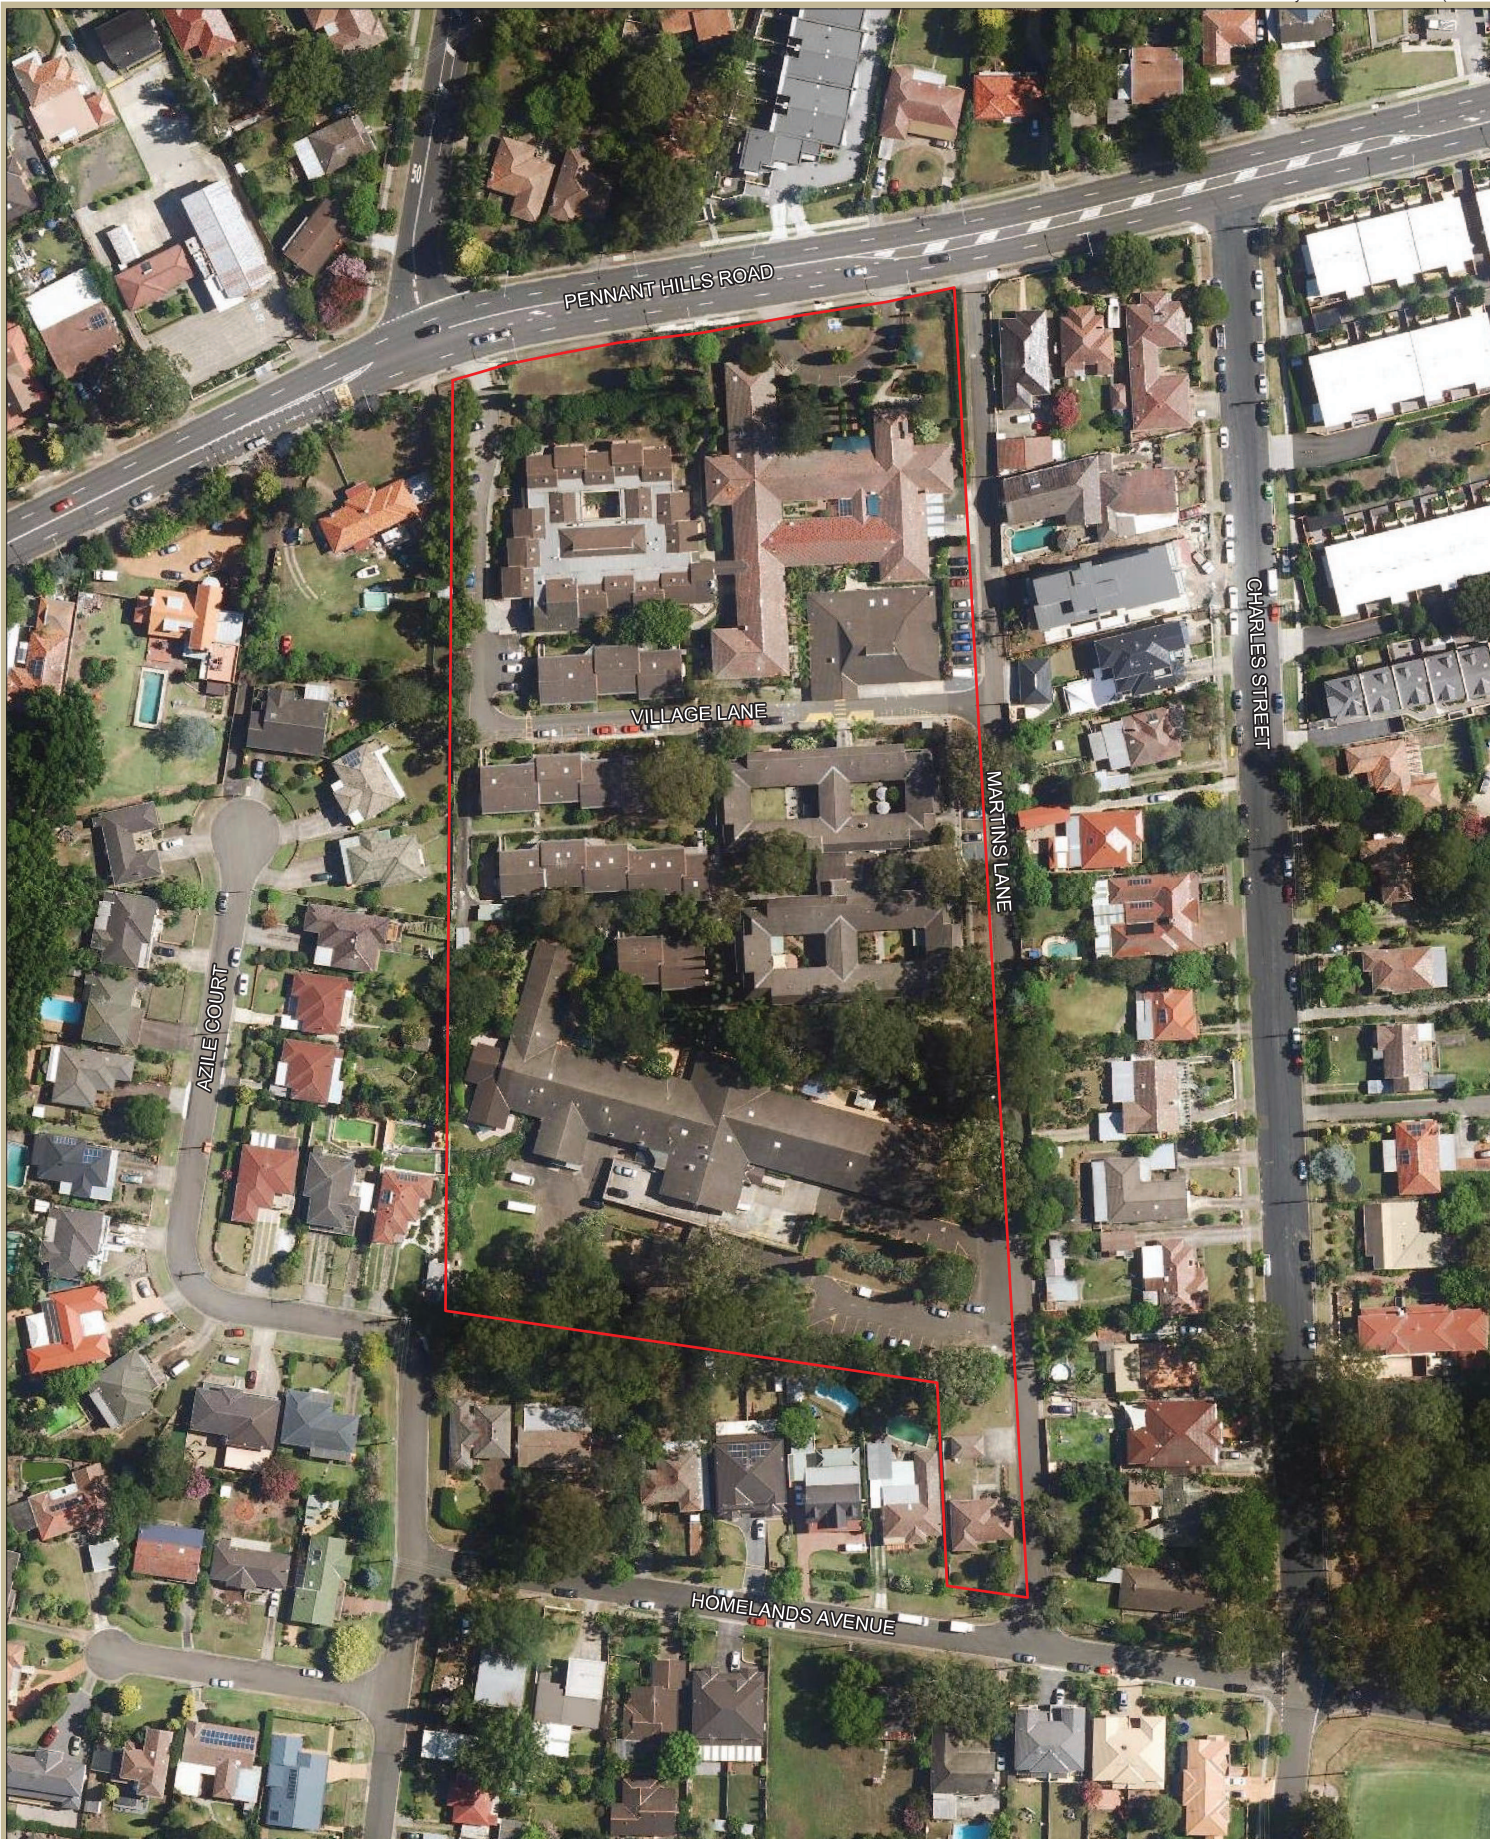
A concept master plan developed by Allen Jack and Cottier Architects (AJ+C) has proposed future redevelopment of the site, post rezoning, to include 350 apartments within nine residential flat buildings and three multi dwelling housing buildings (Allen Jack + Cottier Architects, 2015). The preliminary concept scheme is shown in **Figure 1.3**.

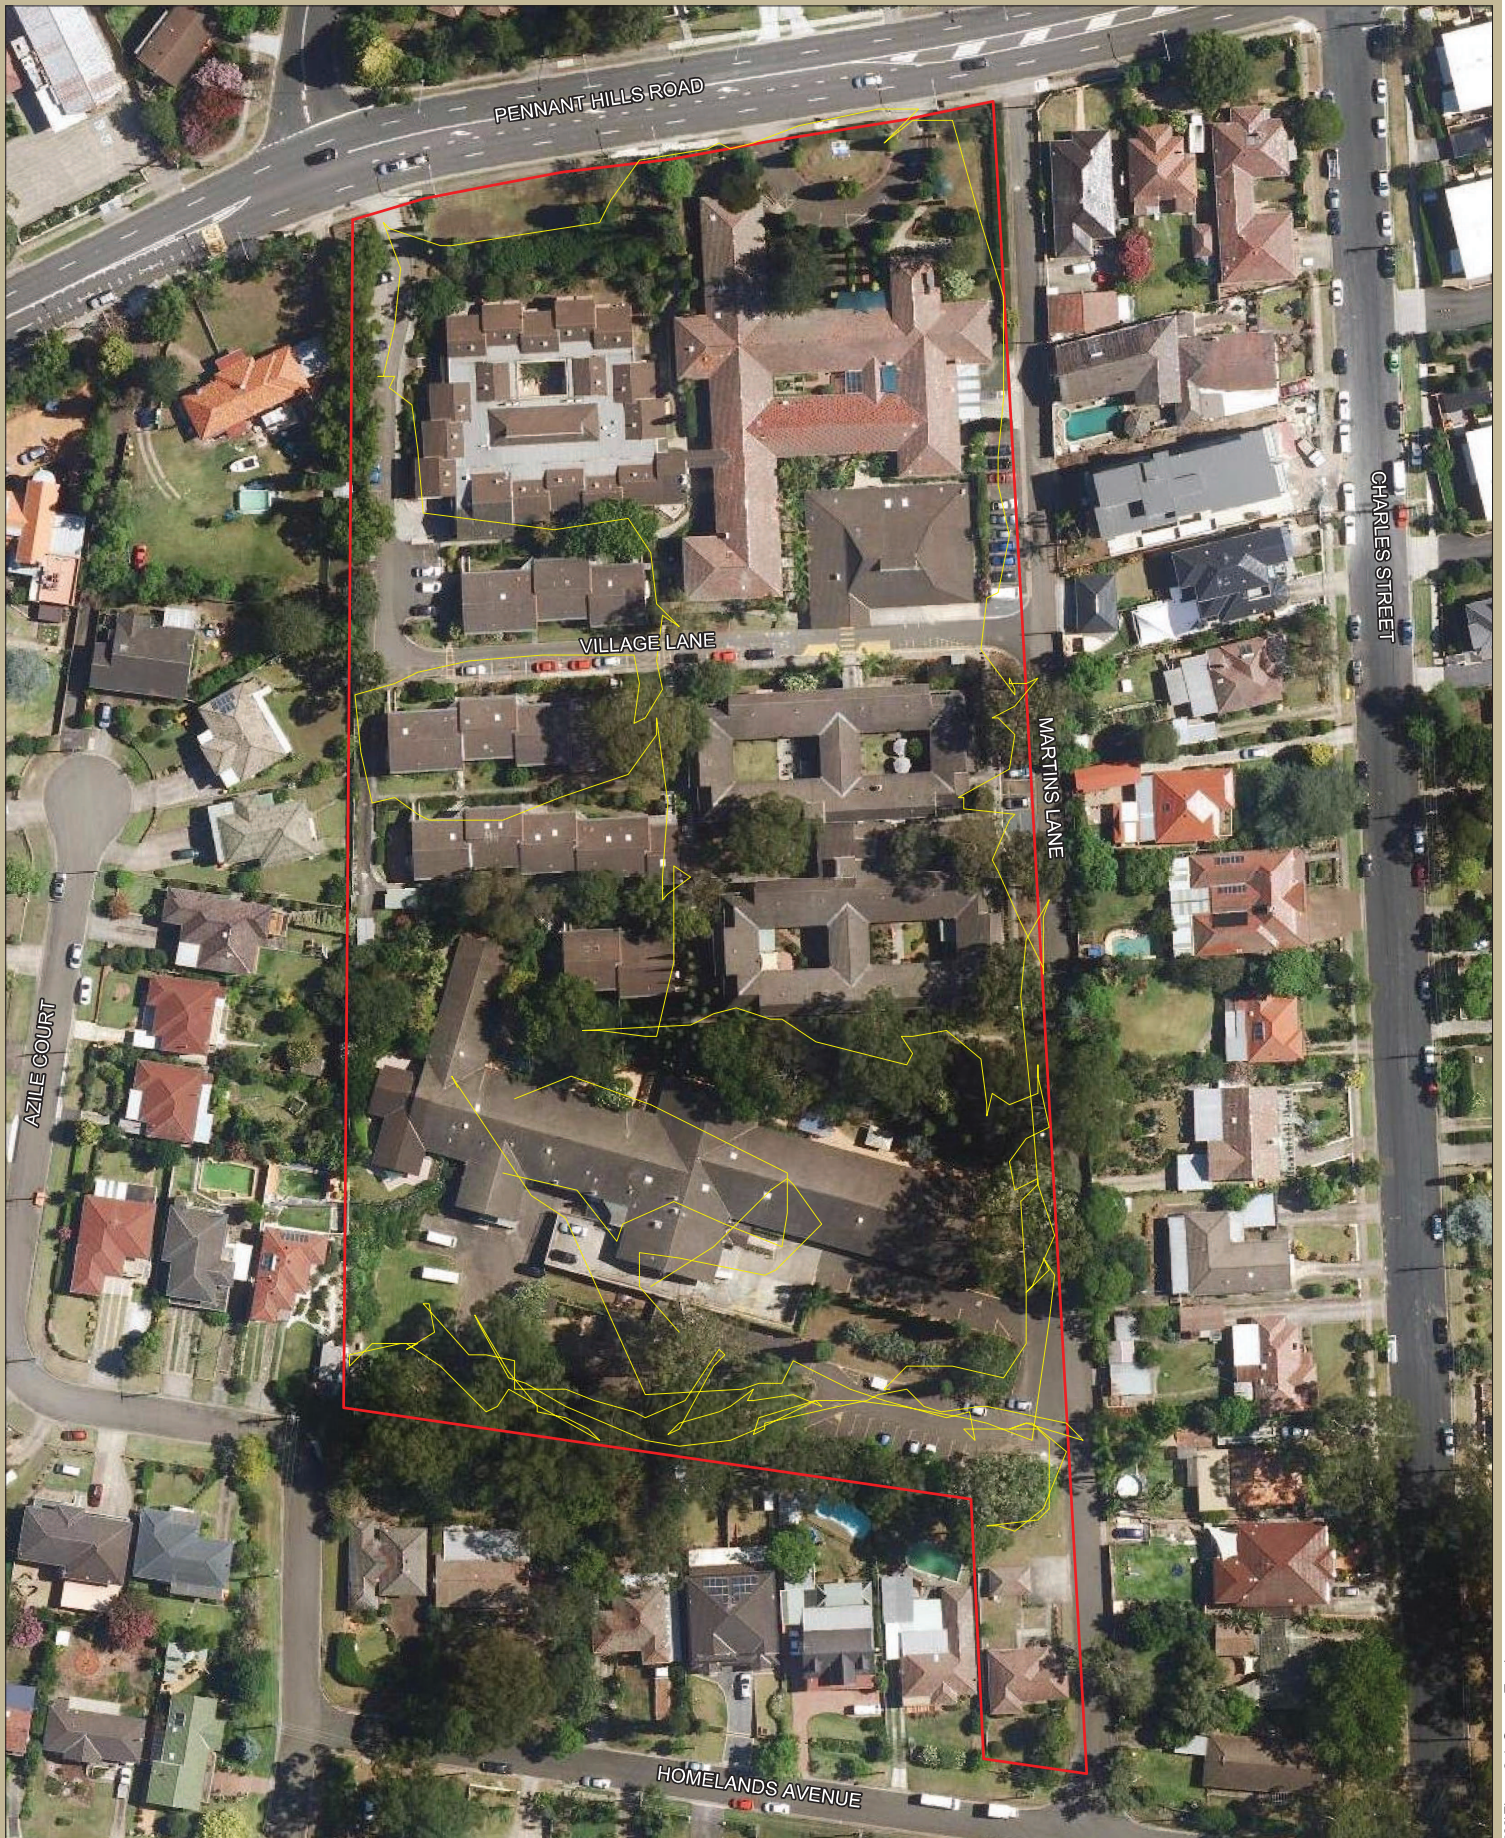
- Legend**
- Subject Site
  - Survey Tracks

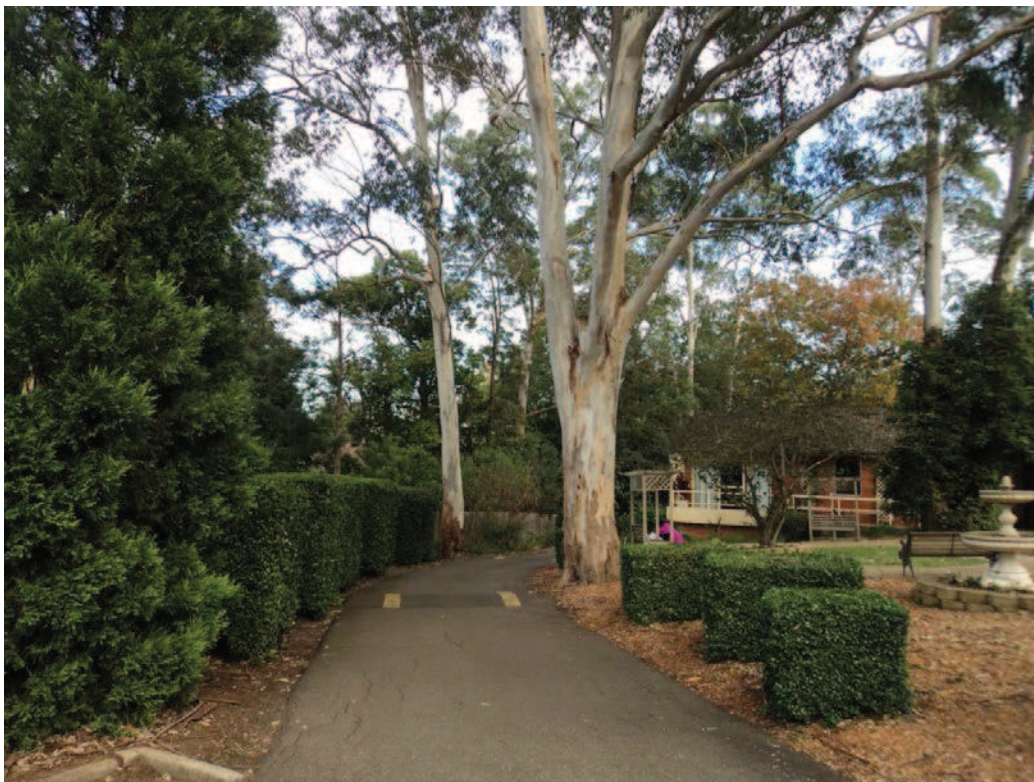
**Photograph 3.1 Mature remnant trees amongst planted vegetation in Area 1 (photo point 1 in Figure 3.1)**

The small patch of Area 1 located in the south central section of the subject site contains one *Eucalyptus saligna* (Sydney Blue Gum) with a mown lawn understorey (see **Figure 3.1** and **photograph 3.2**).

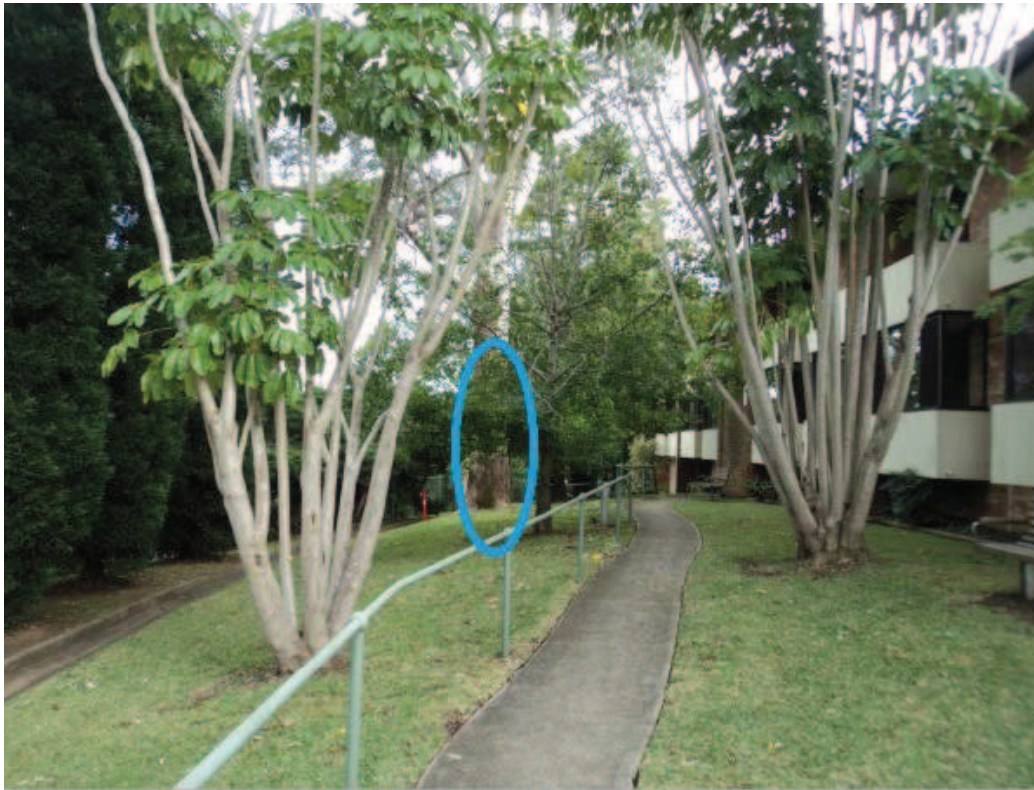
**Photograph 3.2** *Eucalyptus saligna* (circled in blue) isolated from other Area 1 vegetation with mown lawn understorey (photo point 2 in Figure 3.1),

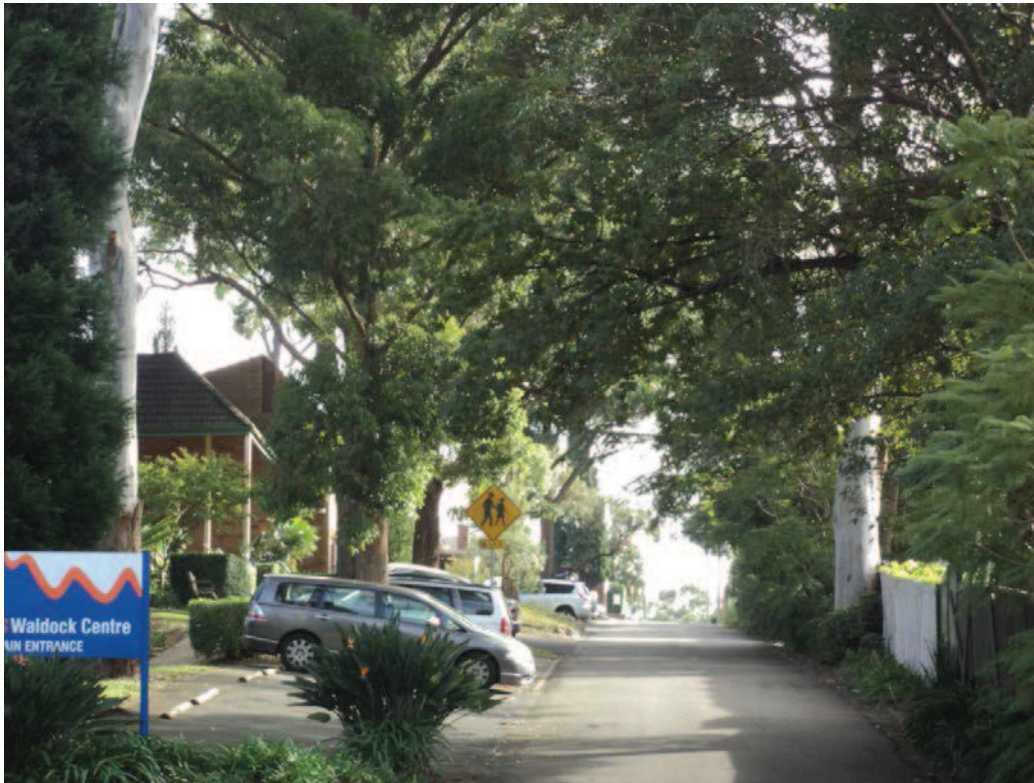
**Photograph 3.3 Planted and remnant vegetation along Martins Lane within Area 2 (photo point 3 in Figure 3.1)**

A mixture of native and exotic shrubs has been planted in the garden beds and along the eastern fence line. Native planted shrubs are *Banksia serrata* (Old-man Banksia), *Banksia integrifolia* (Coast Banksia) and *Melaleuca quinquenervia* (Broad-leaved Paperbark). *Agapanthus* sp. (African Lily), *Strelitzia reginae* (Bird of Paradise) and *Trachelospermum jasminoides* (Star Jasmine) are the only planted exotic shrubs found in this area.

The understorey beneath the remnant trees in this area appears to be from original topsoil as it contains native species such as *Rytidosperma* sp. and *Aristida ramosa* (Three-awned grass). Other native species found throughout the original topsoil were *Dichondra repens* (Kidney Weed), *Carex inversa*, *Cyperus gracilis* (Slender Flat-sedge) and *Glycine tabacina*. Exotic grass species such as *Cynodon dactylon* (Couch Grass), *Paspalum dilatatum* (Paspalum) and *Pennisetum clandestinum* (Kikuyu) also occurred within the area.

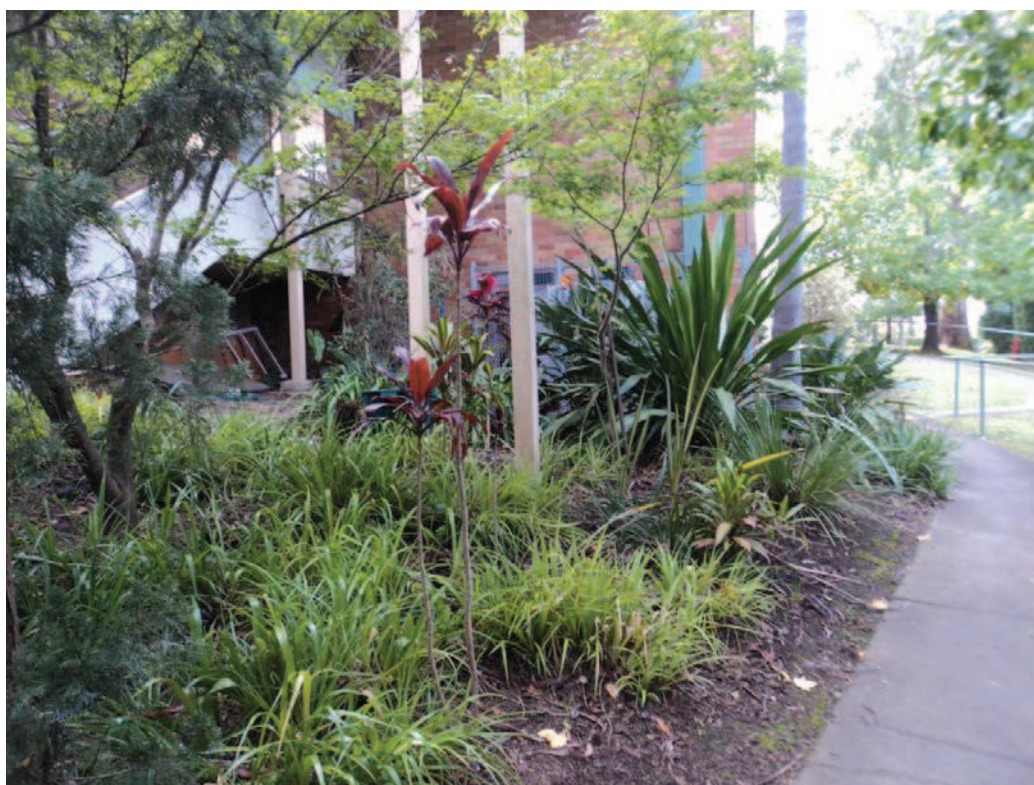
**Photograph 3.4** Planted vegetation within garden beds of Area 3 (photo point 4 in Figure 3.1)

The understorey vegetation of this community exists in a mixture of landscaped areas including lawns, mulched areas and garden beds. Areas of lawn are present along walkways and carparks (see **Photograph 3.6**). Common exotic grasses comprising these lawn areas include *Aristida ramosa* (Three-awned Grass), *Axonopus fissifolius* (Narrow-leaved Carpet Grass), *Cynodon dactylon* (Couch Grass), *Paspalum dilatatum* (Paspalum), *Pennisetum clandestinum* (Kikuyu), and *Stenotaphrum secundatum* (Buffalo Grass). Garden beds containing planted ornamental exotic species occur in all areas of the subject site with commonly planted exotic shrubs being *Olea europaea* subsp. *cuspidata* (African Olive), *Ligustrum lucidum* (Large-leaved Privet), *Ligustrum sinense* (Small-leaved Privet), *Hibiscus* sp. (Pink Hibiscus), *Cotoneaster glaucophyllus* (Cotoneaster) and *Trachelospermum jasminoides* (Star Jasmine). Planted native ornamentals include *Lomandra longifolia* (Spiny-headed Mat-rush), *Banksia serrata* (Old-man Banksia), *Banksia integrifolia* (Coast Banksia), *Pittosporum revolutum* (Wild Yellow Jasmine) and *Melaleuca quinquenervia* (Broad-leaved Paperbark). Most garden beds contain little to no remnant ground cover species and are dominated by variety of exotic herbs, grasses and vines including: *Pennisetum clandestinum* (Kikuyu), *Modiola caroliniana* (Red-flowered Mallow), *Sida rhombifolia* (Paddy's Lucerne), *Oxalis corniculata*, and *Araujia sericifera* (Moth Vine).

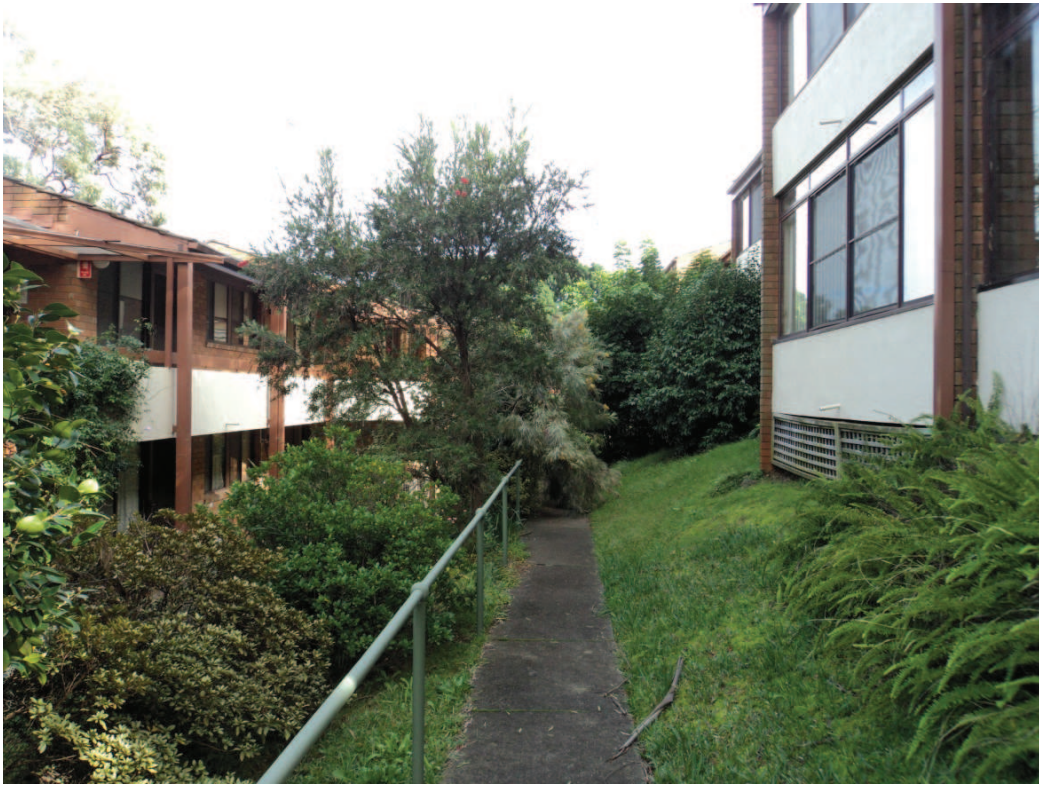
**Photograph 3.5 Planted vegetation along walkway of Area 3 (photo point 5 in Figure 3.1)**

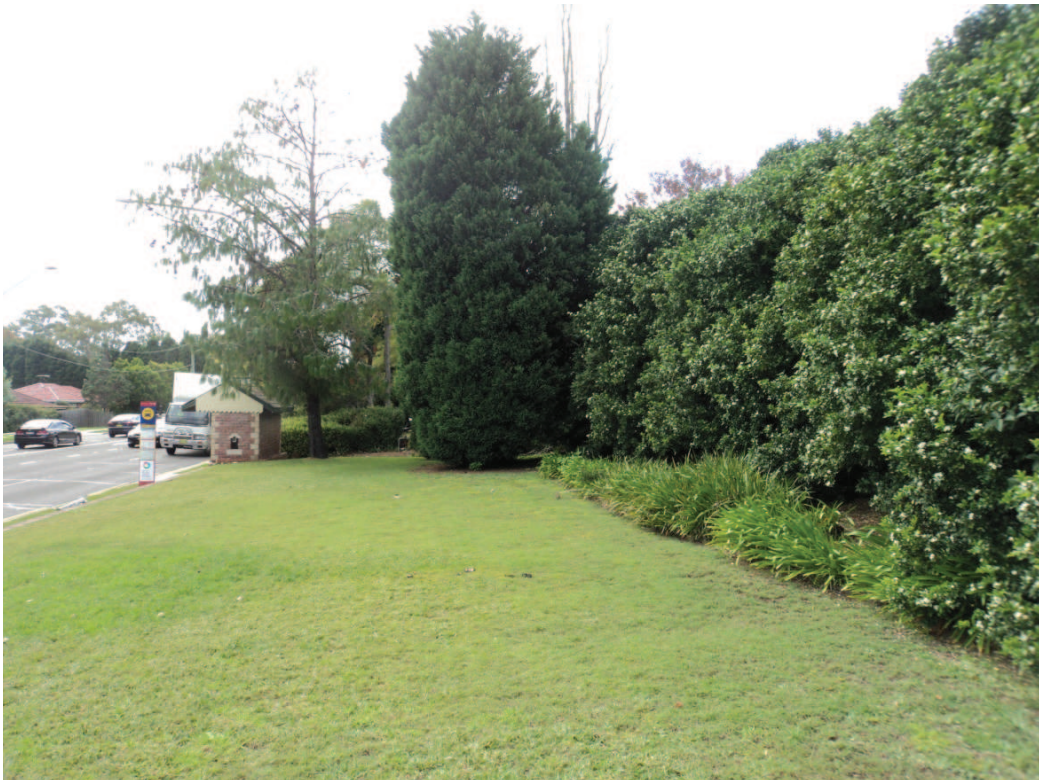
**Photograph 3.6 Planted vegetation in northern portion of Area 3 (photo point 6 in Figure 3.1)**

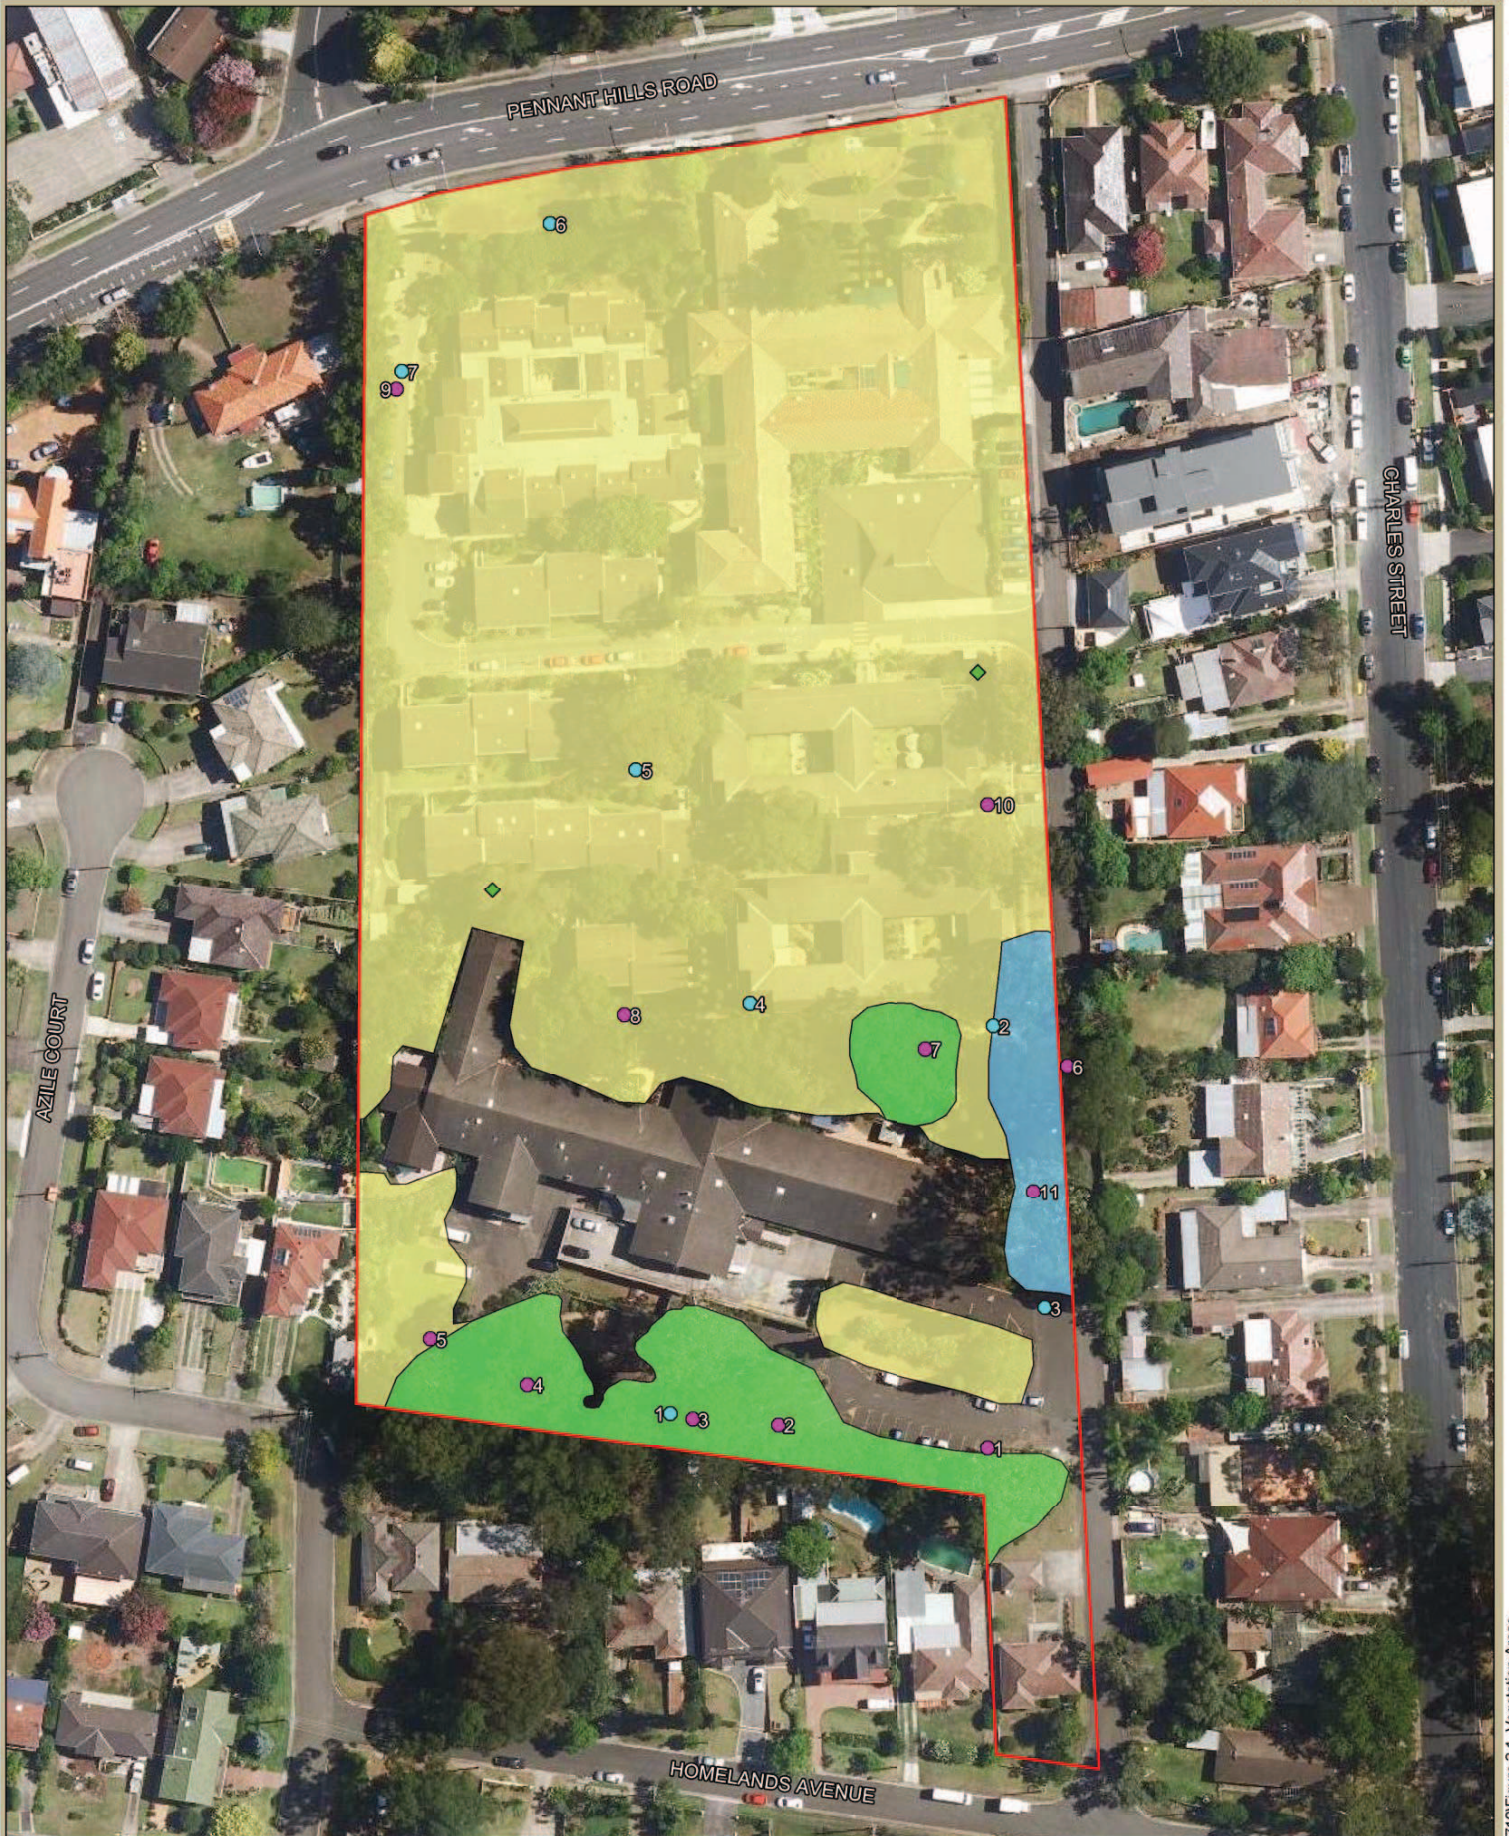
- Legend**
- Subject Site
  - Blue Gum High Forest - Area 1
  - Blue Gum High Forest - Area 2
  - Planted Native and Exotic Vegetation
  - Habitat Items
  - Photo Point Locatic
  - Threatened Species**
  - Eucalyptus nicholii*

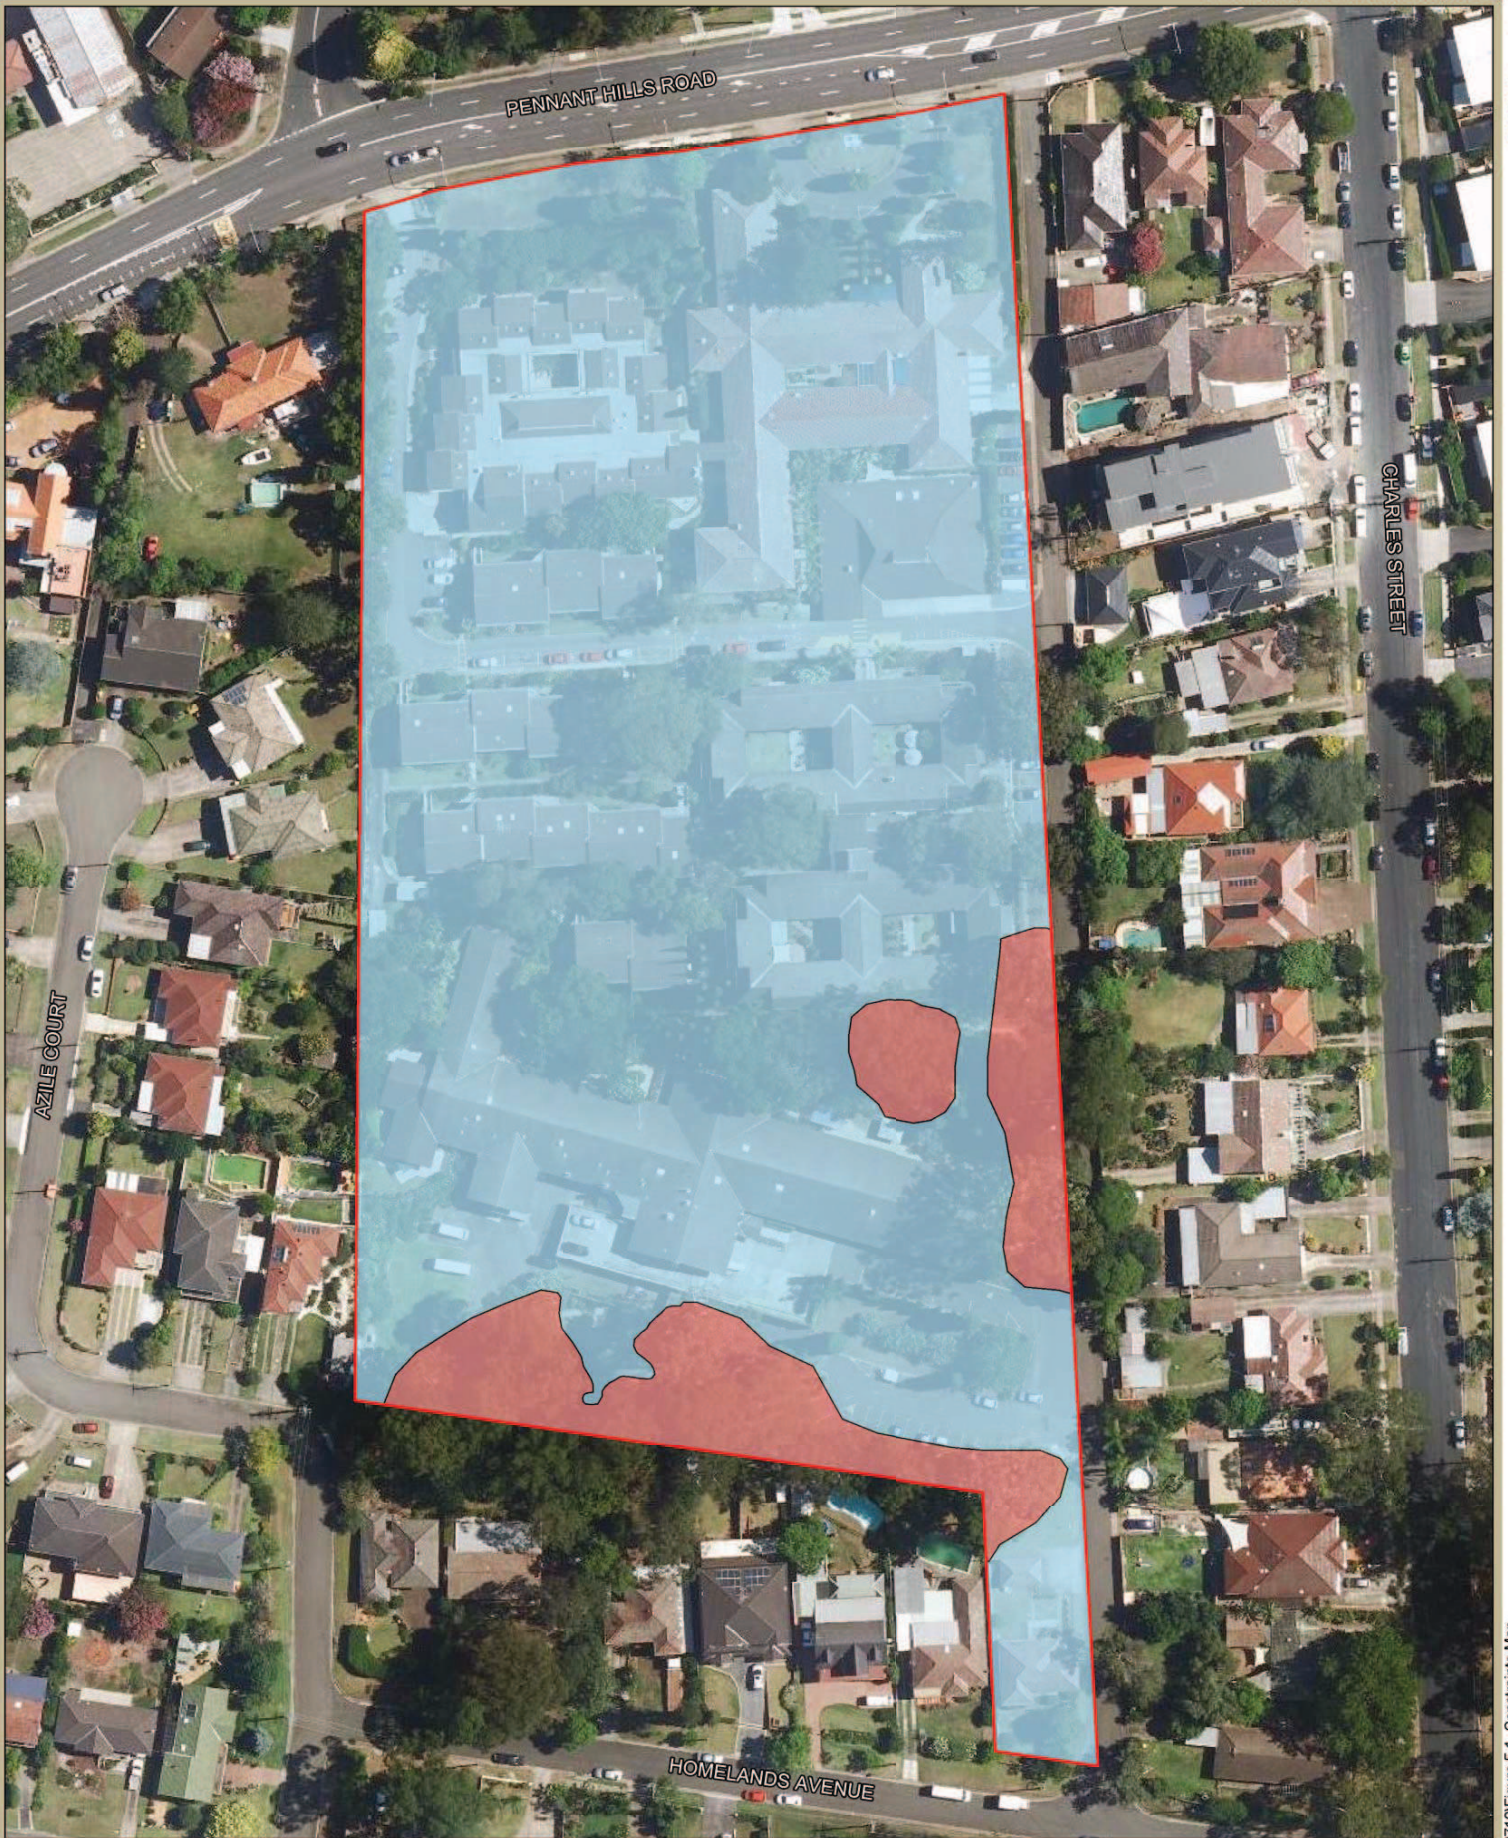
- Legend**
- Subject Site
  - Constraint**
    - High
    - Low
