**Soil Contamination Report (SEPP 55)  
Rezoning for Residential Subdivision  
Moama NSW**

**“Pinterry”  
312 Perricoota Road, Moama NSW  
(A & L Pitman)**

**October 2016**

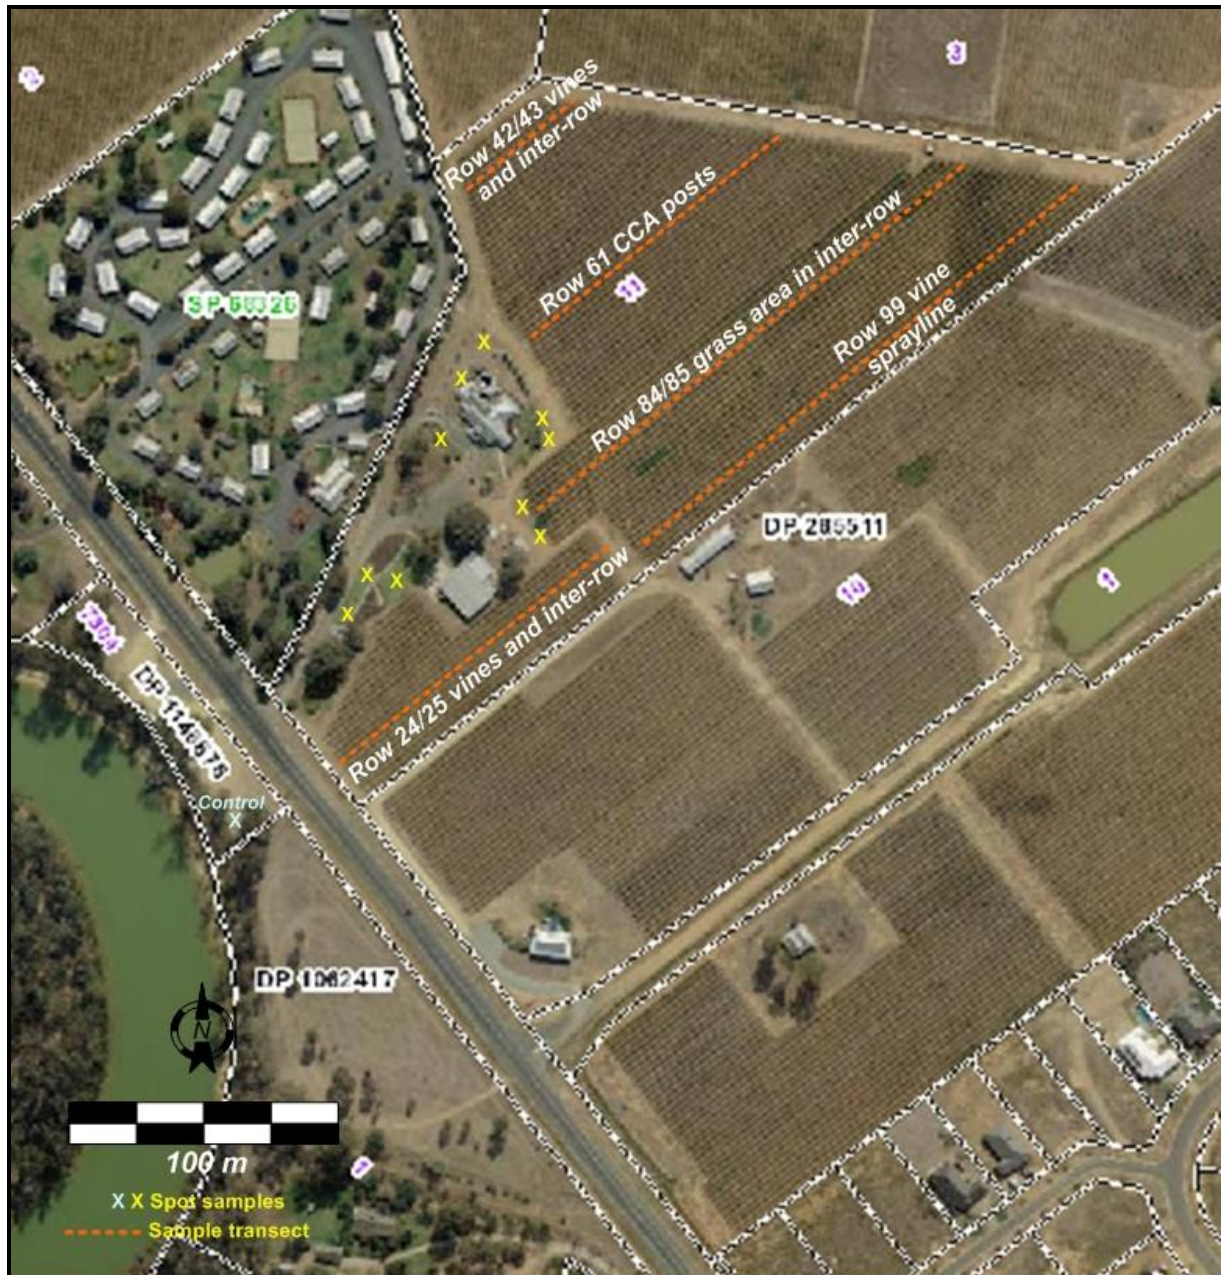
Figure 3. SEPP 55 Investigation study area and sample sites

Soil sampling was conducted within the 7.45 ha of the subject land on 22<sup>nd</sup> September 2016. Sampling was generally conducted as indicated by the National Environmental Protection Measure (2013), Schedule B (5a) Guideline on Data Collection. Materials and despatch procedures are outlined in Appendix 3. Within Lot 11 sixty soil samples were collected from the surface horizon (0-100 mm) and bulked to make up six samples for full contaminant screening and analysis. Sampling was randomly distributed in the garden area and transects established in the vineyard to ascertain the impact of past and current agricultural activities (Figure 3). Treatment areas considered included:

- Home garden area;
- Mixed sampling within vine rows (Rows 24/25 and 42/43);
- Spot sampling within the herbicide spray line (Row 99);
- Spot sampling in the grassed inter-row area (Row 84/85);
- Sampling immediately adjacent to CCA treated pine posts (Row 61 – Metals only).

Other potential contaminants, including hydrocarbons, were well below the Limit of Reporting (LOR) and were recorded as a "less than" (<) value (Appendix 1) indicating that there is no cause for concern in relation to these parameters in the area delineated Lot 11 (Figure 3).

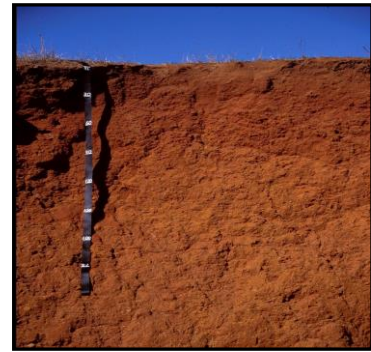
**Figure 5. Hypocalcic red sodosol**

In more recent classifications (McKenzie *et. al.* 2004) the soils are classified as Hypocalcic Red Sodosols (Figure 4), previously known as a Red Brown Earth. This is a common soil type on the prior stream levees of the flat Riverine Plain of New South Wales with clay loam topsoils and mottled brown clay subsoils. The soil is characterised by a brown clay-loam topsoil (0-10 cm) of massive structure. The subsoil (10 cm+) is red-brown angular blocky medium clay.

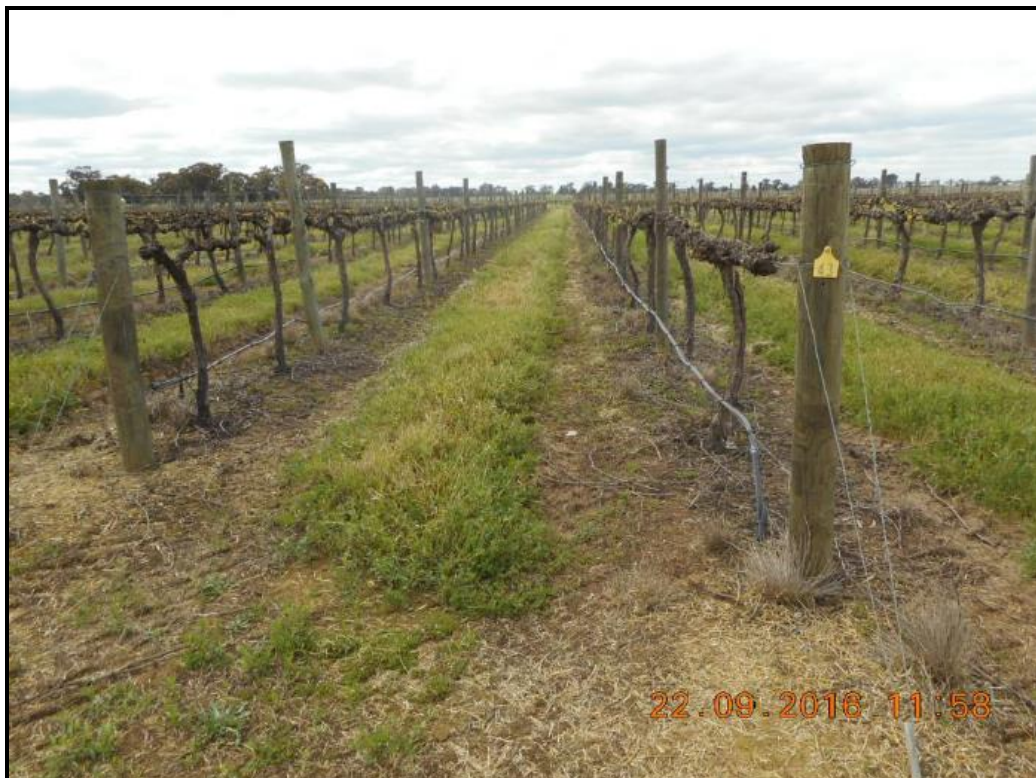
**Figure 6. Site overview, Lot 11**

The soil contamination assessment is principally based on concerns relating to contaminants from past and current agricultural practices, in particular herbicide and pesticide usage. In conducting the assessment, the risk of contamination from other hazardous site activities and associated substances is considered (e.g. Oil leakage from power transformers, asbestos in buildings). In this instance the greatest potential hazards are from past fertiliser use (DDT and Dieldrin) and residue of heavy metals, such as copper ,chrome, arsenate (CCA) derived from treated pine posts in the vine lines (Figure 5).

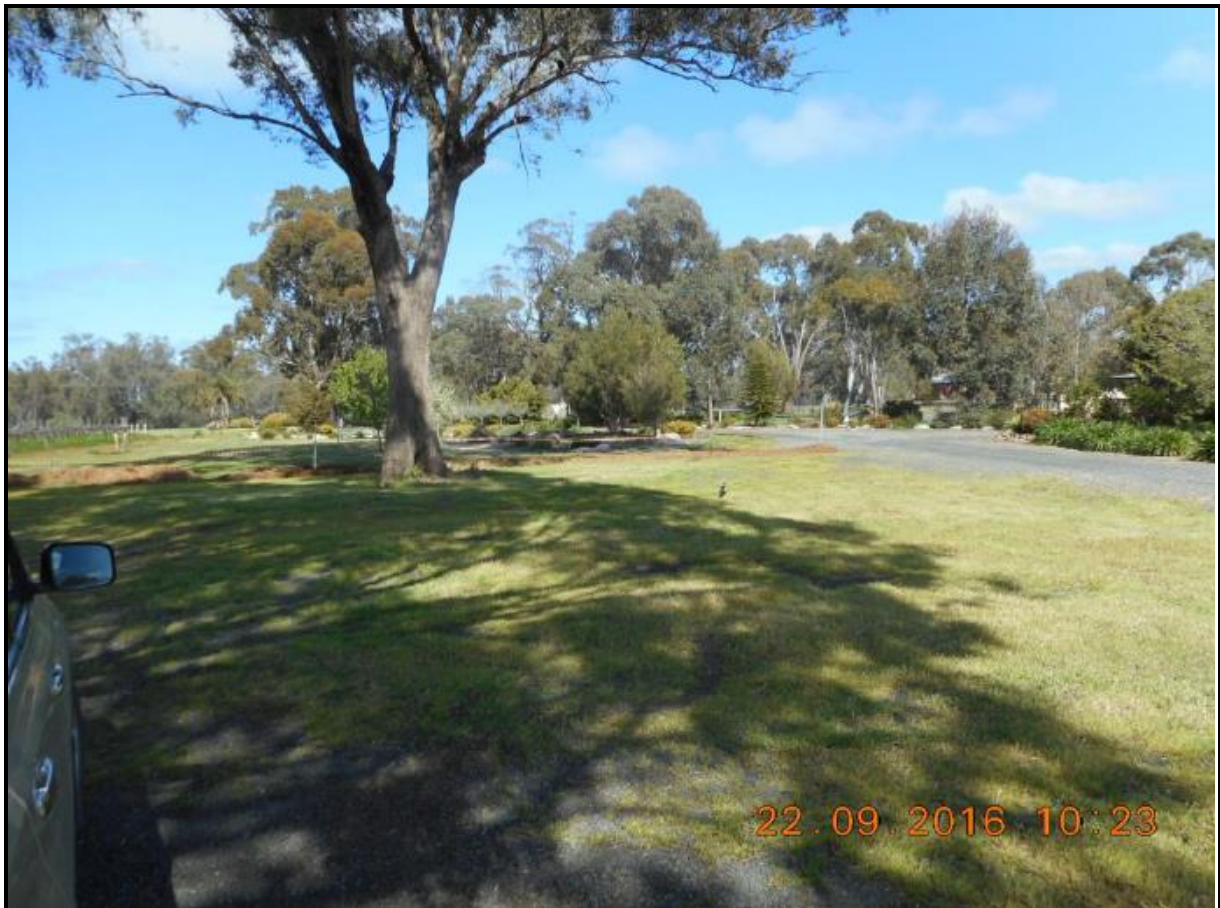
*Garden area on southern end of Lot 11*

Degradation of vegetation and loss of canopy cover has been observed in some local tree species in the area over the past 10 years. Weeds and grasses previously covered most of the ground on the site with 90 per cent coverage during winter and 65 per cent coverage during summer thus minimising the risk of erosion and reducing the potential for runoff.
