Soil Contamination Assessment (SEPP 55)

Kooyong Park Sustainable Development - Stage 2 Local Environment Plan Rezoning (LEP amendment under the "gateway system" of DoP)

Holmes Street,
Moama
NSW

Prepared for
Perpetual Green Developments Pty Ltd
November 2011

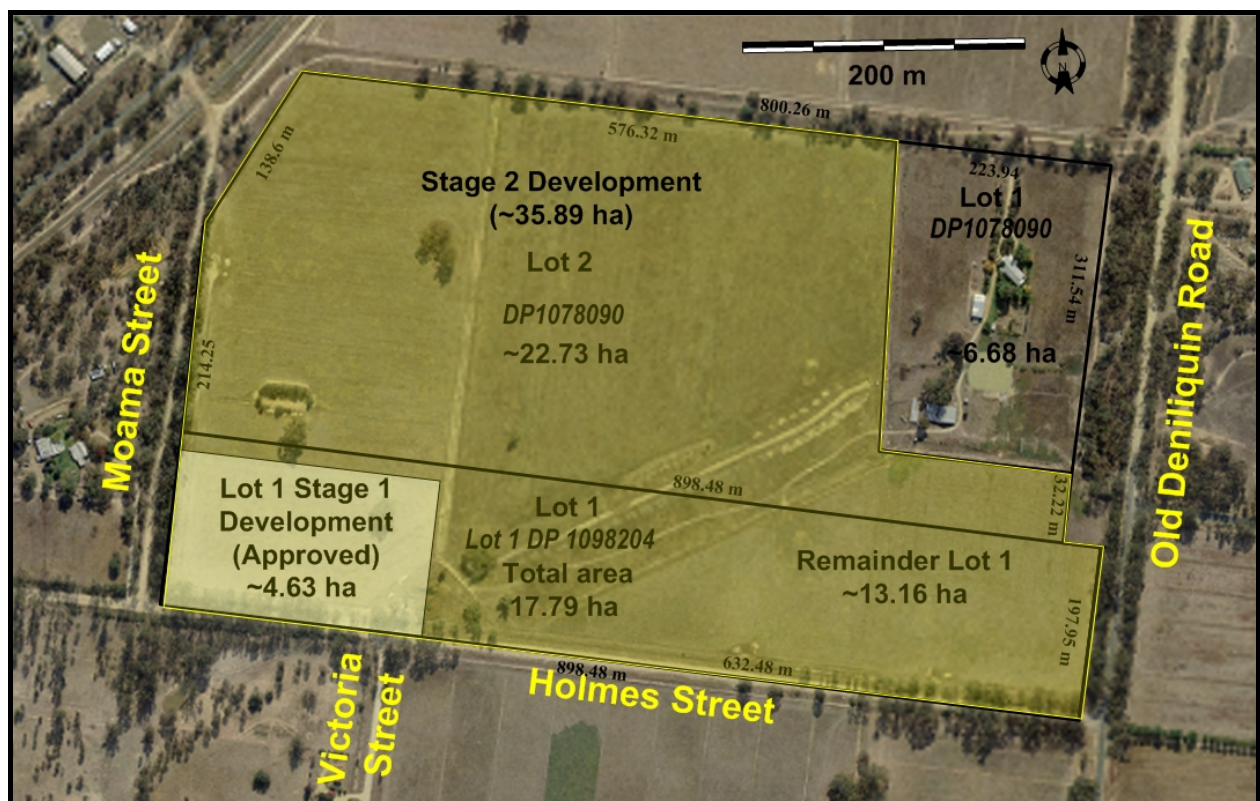
Figure 2. Development site

Advanced Environmental Systems were requested to undertake site assessment, soil testing and screening for potential chemical contamination near Moama township NSW. The area is defined as Lot 1 (~6.68 ha) and Lot 2 (~22.73 ha) DP1078090 and Lot 1 DP1098204; surrounded by Moama Street, Holmes Street and Old Denilquin Road Moama, NSW. Specifically, this report provides an assessment of the results of an investigation in relation to any potential land contamination from past and present practices and activities on Lot 1 DP1078090 and the Stage 2 development area marked in yellow (Figure 2).

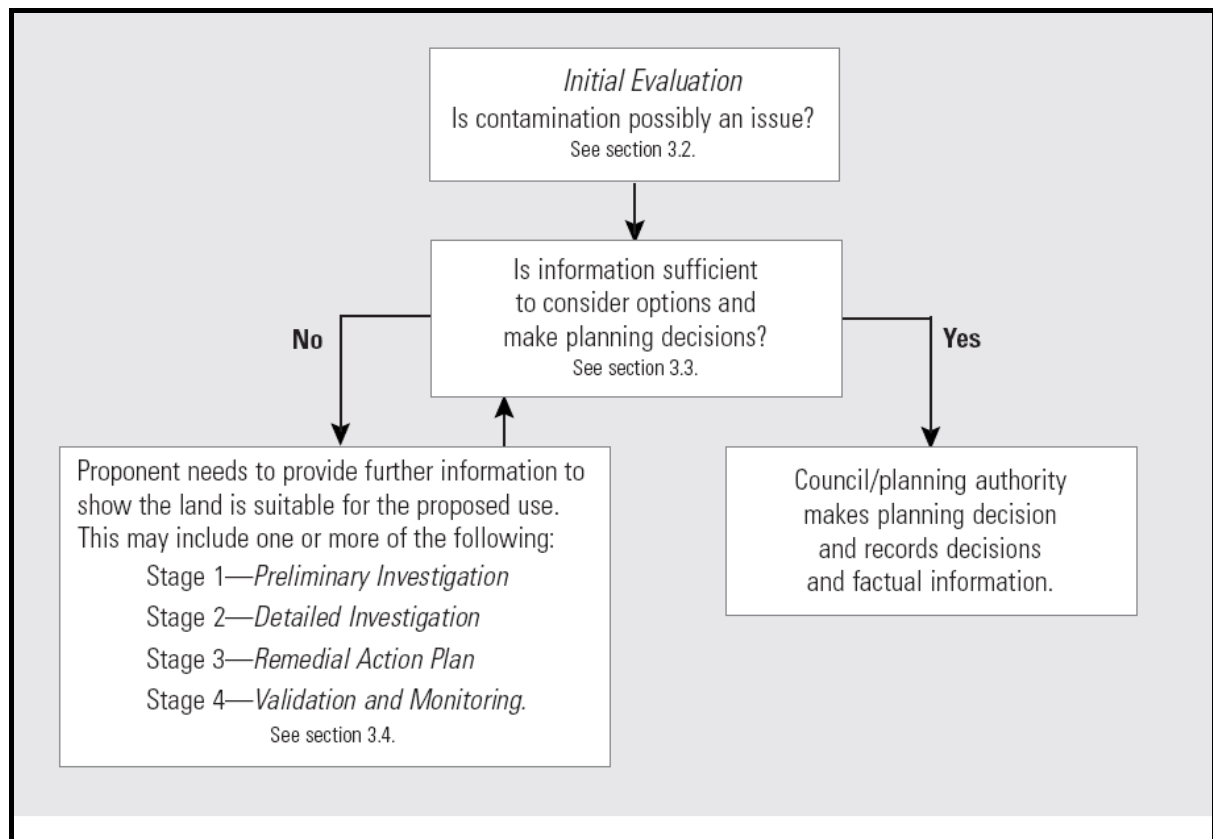
Figure 3. Decision process for changes in land use

The preliminary site assessment provides information in relation to soil sampling and analysis conducted at the Kooyong Park site. Depending on the results of the site assessment, Council decides if a detailed contaminated site investigation is required (Figure 2).

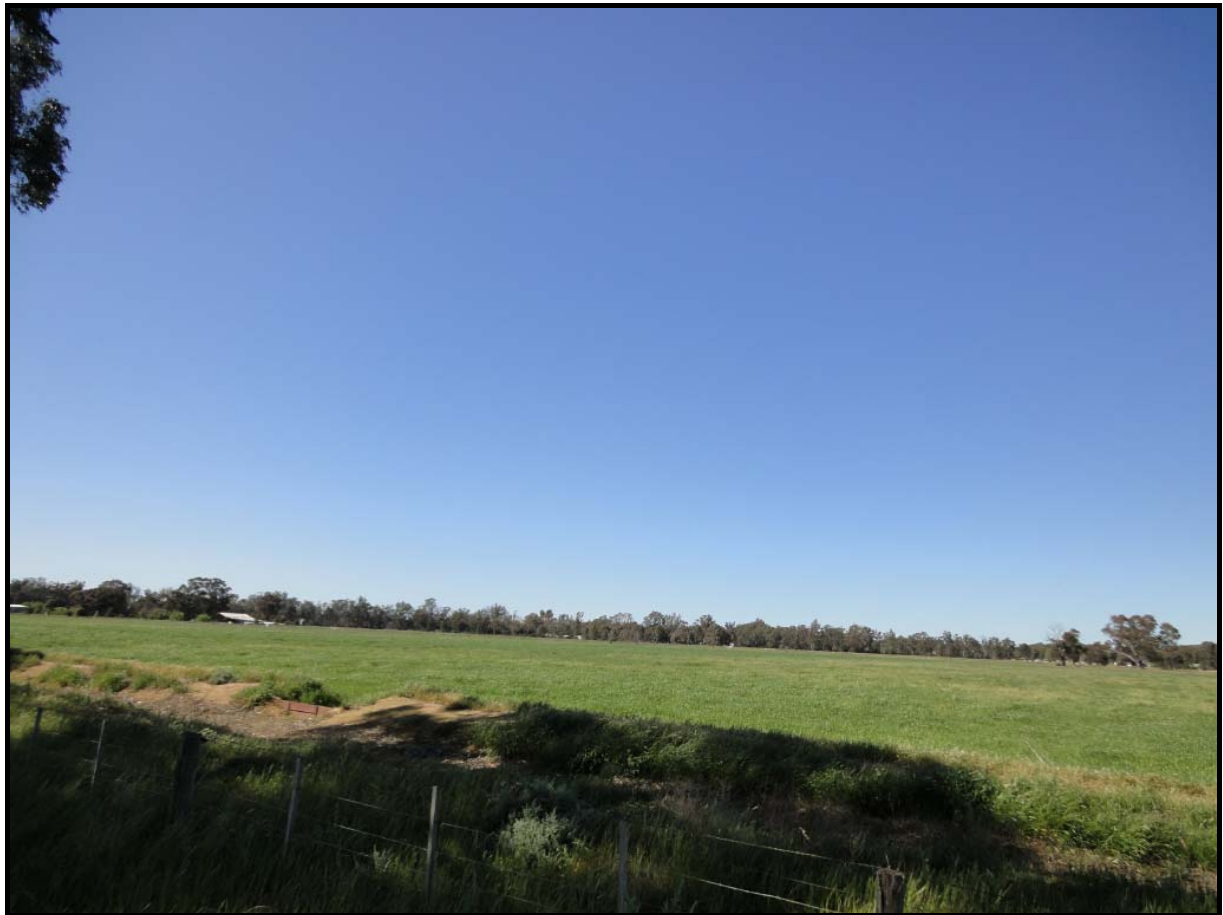
Figure 4. Development and sampling area (view to south east)

The property is predominantly cleared land with a few old remnant and younger regenerating eucalypts (Figure 4). There are also a few dams on the property, which were dry during the drought years and have recently filled with runoff.

Degradation of vegetation and loss of canopy cover has been observed in some tree species in the area over the past 10 years. Indigenous ground cover, crops and grasses cover most of the ground on the site with 90 per cent coverage during winter and 65 per cent coverage during summer thus minimising the risk of erosion and reducing the potential for runoff. There are no areas that appear to have been used for refuse, oil or waste disposal.

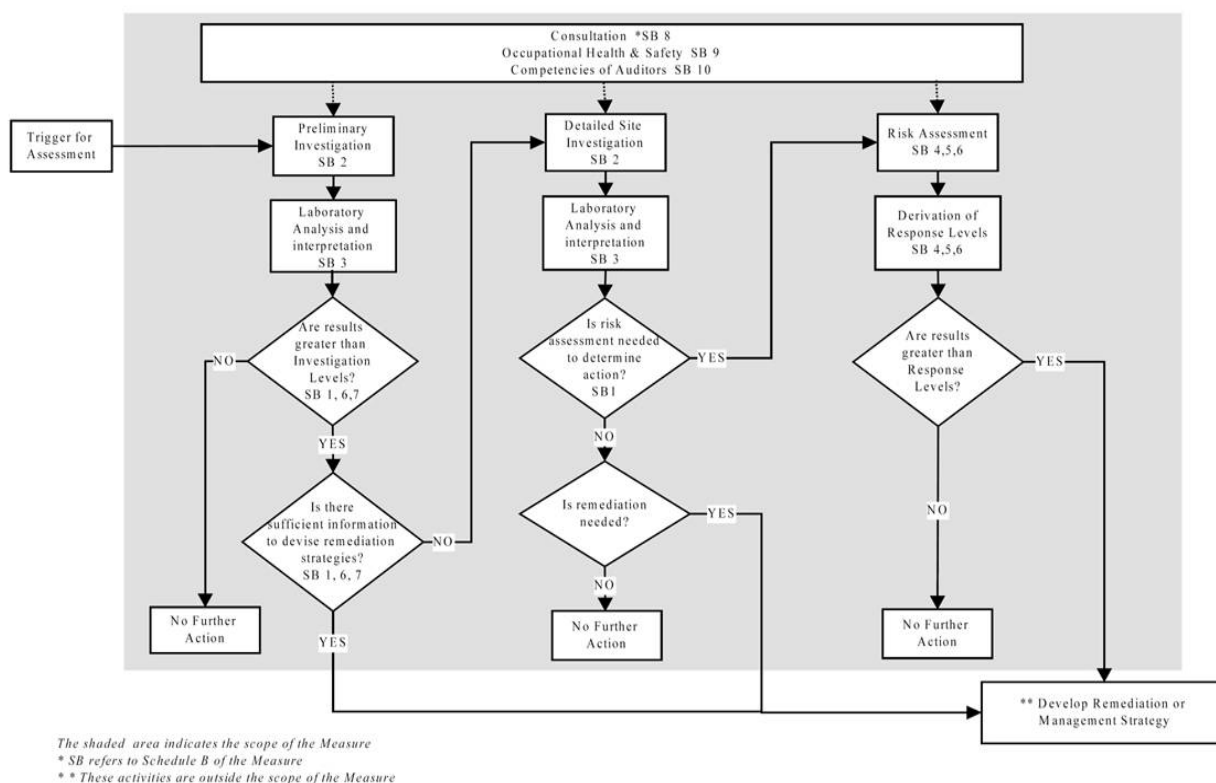
Appendix 3. General process for assessment of contamination

(NEPC Guidelines)
