CAMDEN COUNCIL PLANNING PROPOSAL

Amendment to Camden LEP 2010

Lot 102 DP 1193881

182 Raby Road, Gledswood Hills

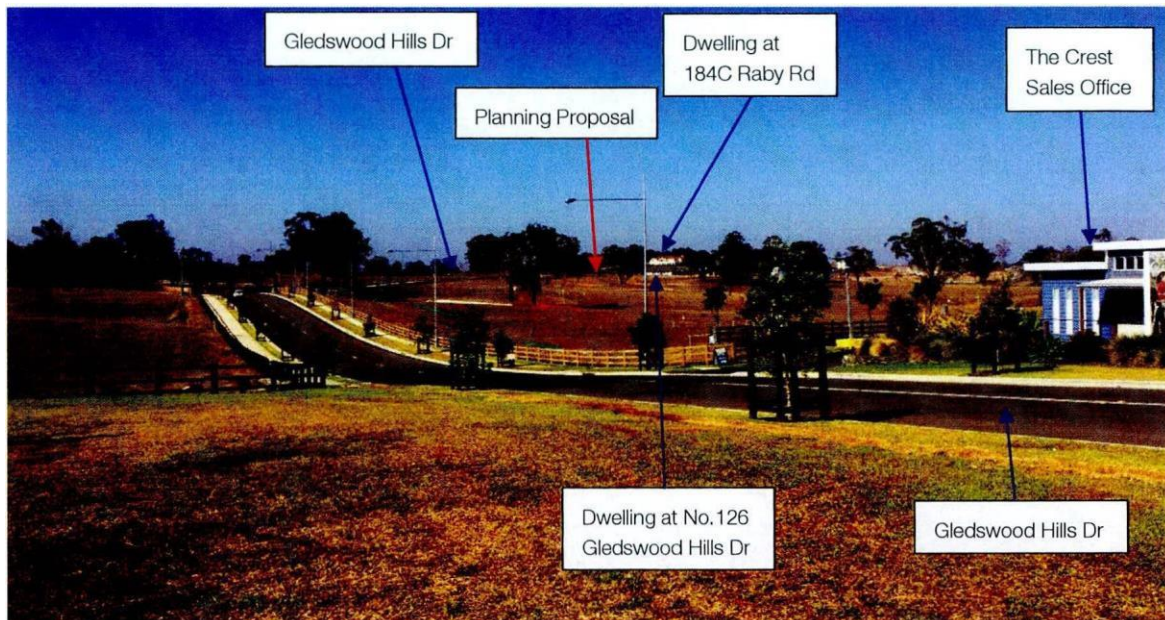
Figure 5: View looking south from the intersection of Gledswood Hills Drive and Raby Road

When viewing the site from the north, adjacent to the Gledswood Hills Drive and Raby Road intersection, Council staff requested a diagram or sketch identifying the existing building and location of the future building on approved subdivisions. The photograph at Figure 5 illustrates the view from this current location.

The photograph of the view looking south toward the Planning Proposal from the Gledswood Hills Drive/Raby Road intersection in Figure 5 comprises:

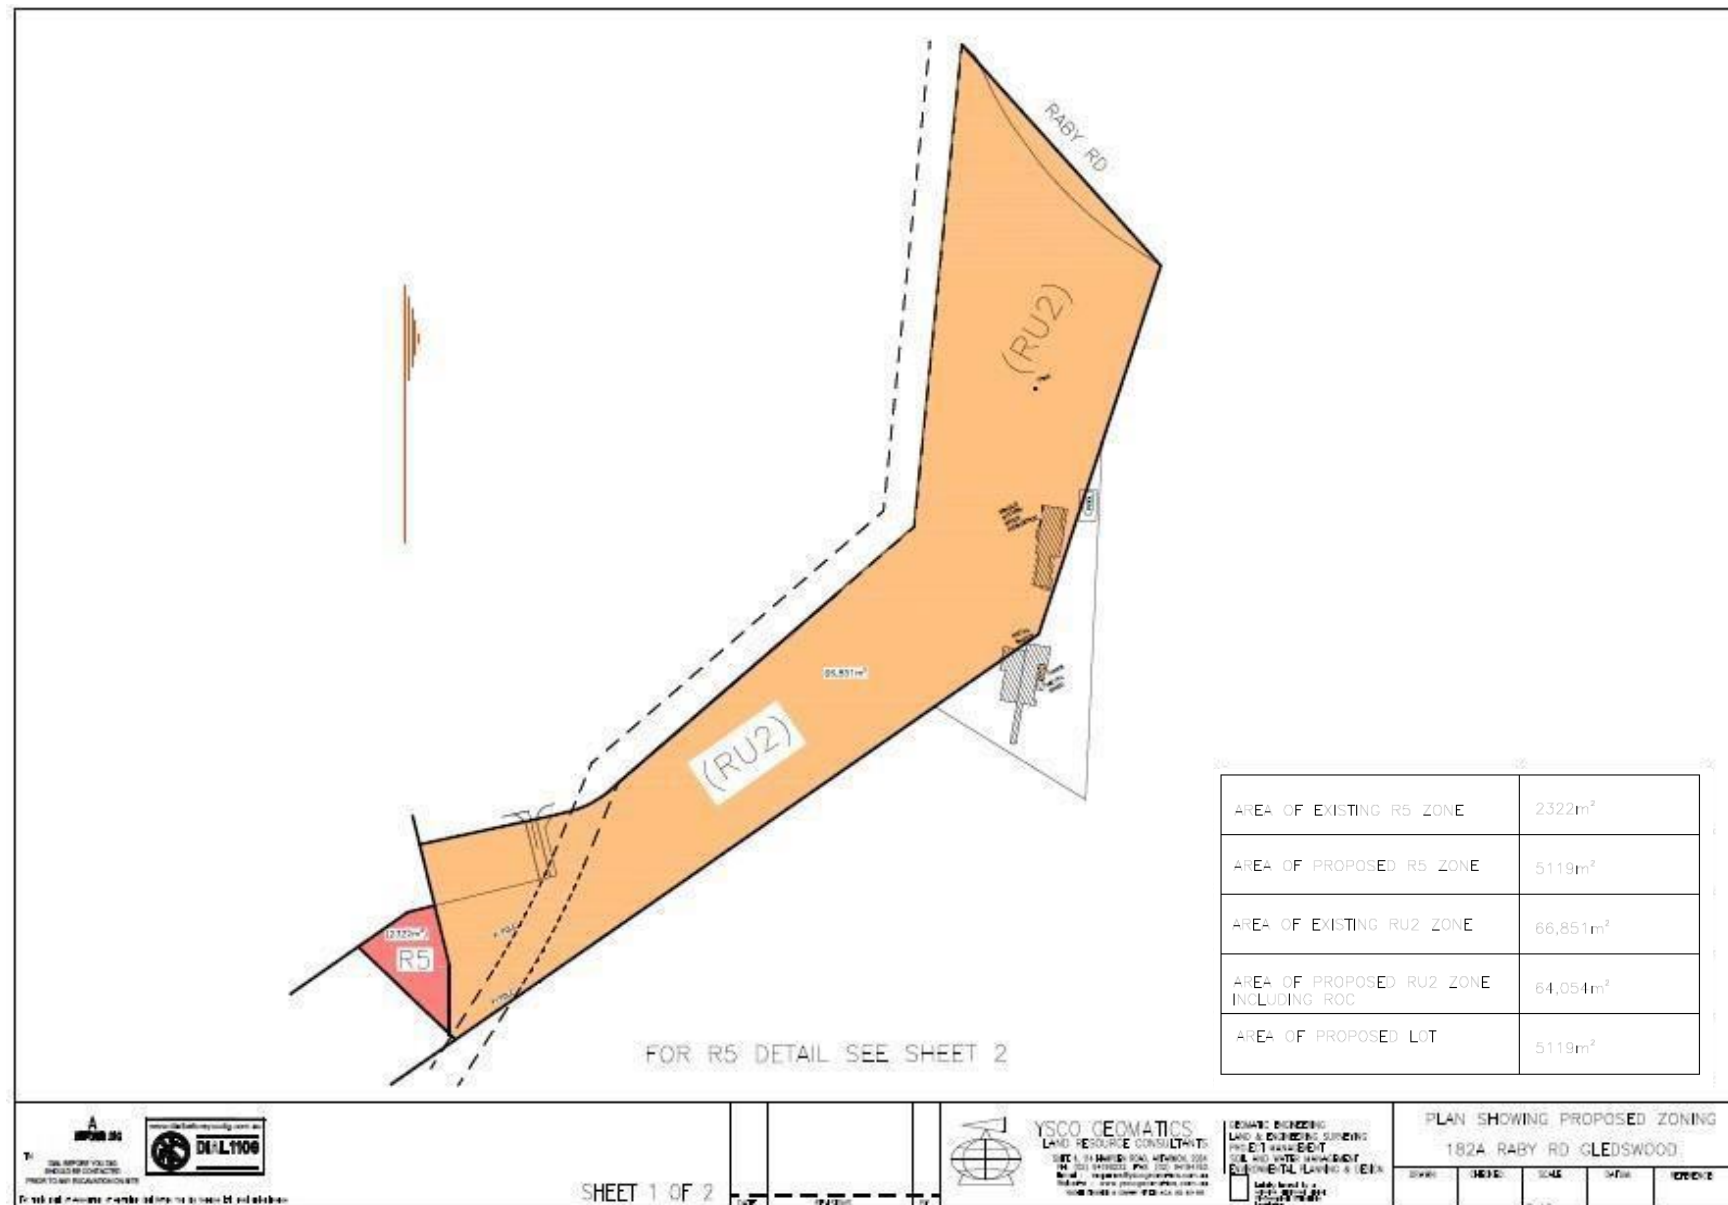
Figure 3: Survey plan showing existing zoning for the study area (182A Raby Road).

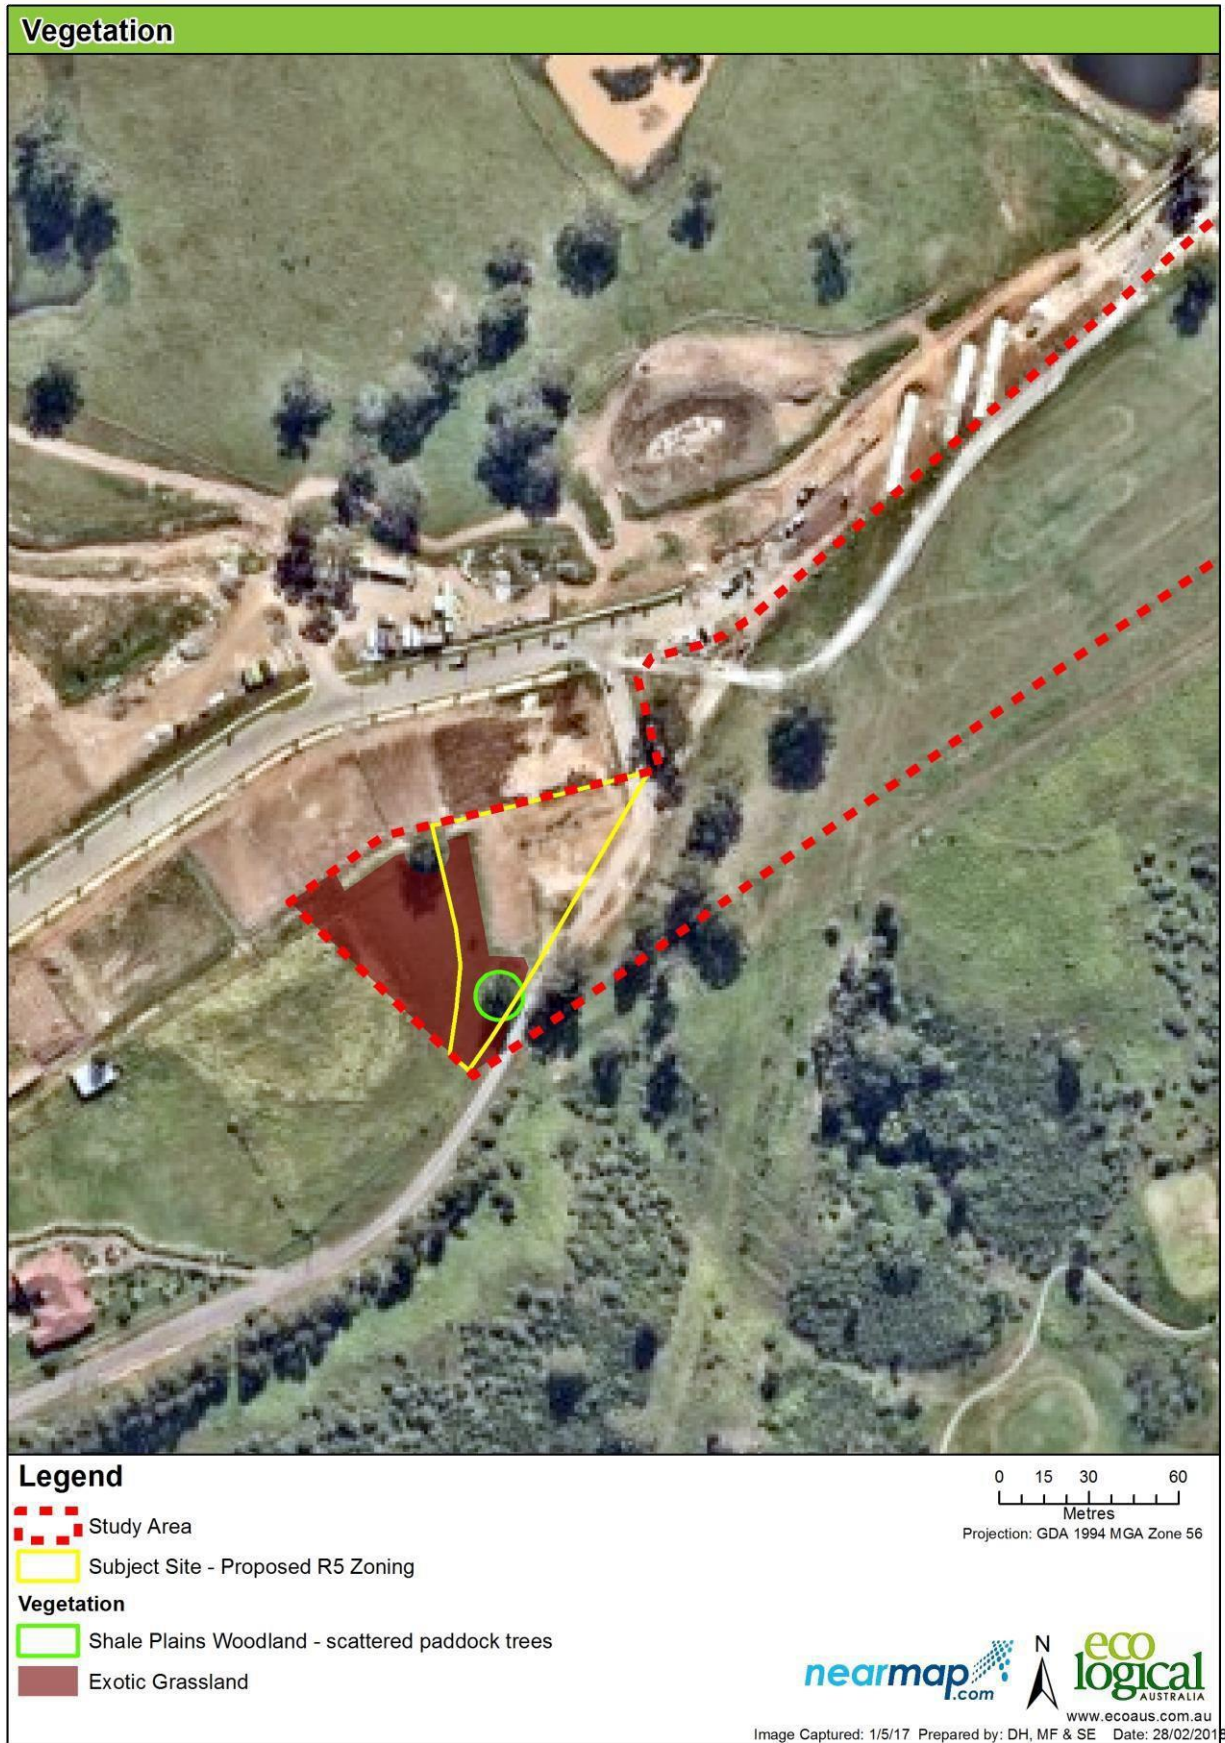
Figure 5: Vegetation map for the subject site.

Previous assessment of the site by ELA (2008) mapped the vegetation within 182A Raby Road as exotic with patches of Shale Hills Woodland (condition TX) and classified the Shale Hills Woodland as a moderate ecological constraint. Under the Camden Natural Assets Policy (CNAP), this vegetation was mapped as “Core-Local” and “Support for Core”. Based on the CNAP, ELA (2010) calculated the vegetation offsets required for the El Caballo Blanco / Gledswood rezoning. As part of the biodiversity certification process for the ECBG study area, the vegetation adjacent to the subject site was remapped by ELA (2015) as Shale Plains Woodland.

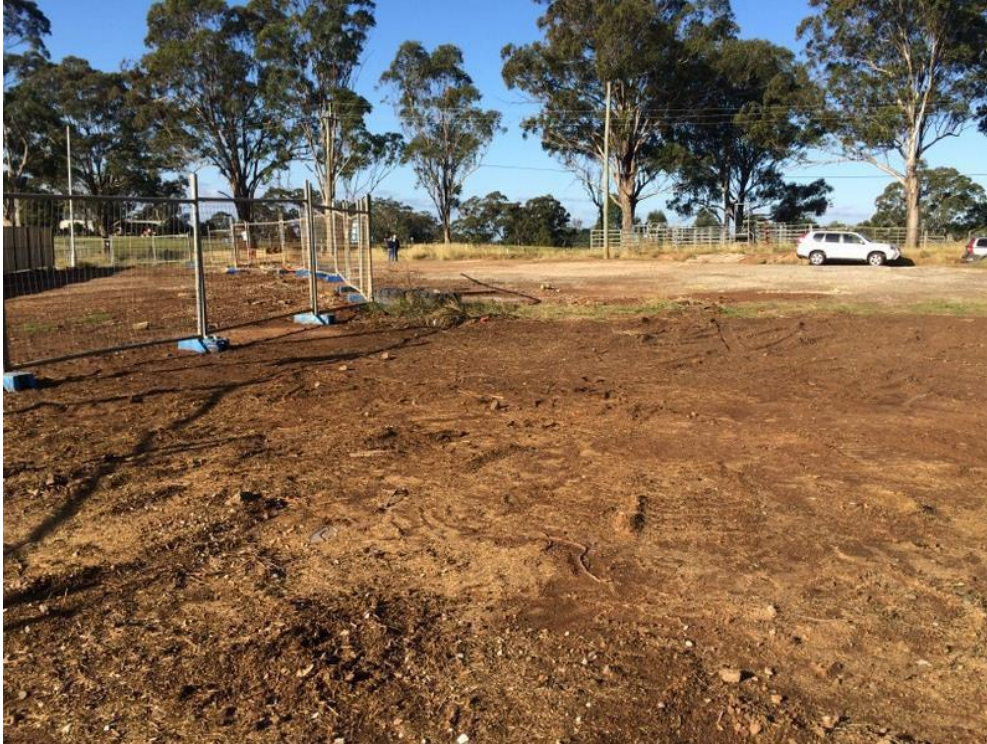
Plate 1: Subject site of proposed rezoning – facing north. The majority of the site is cleared.

The boundaries of the subject site proposed for rezoning is shown in Figure 5 and includes vegetation mapping of the site. The site was previously used as a cattle yard and contained a large hay shed that has been recently removed. As a result, a large portion of the site is hard surface gravel or exposed soil with no vegetation as shown in Figure 5, **Plate 1** and **Plate 2**.

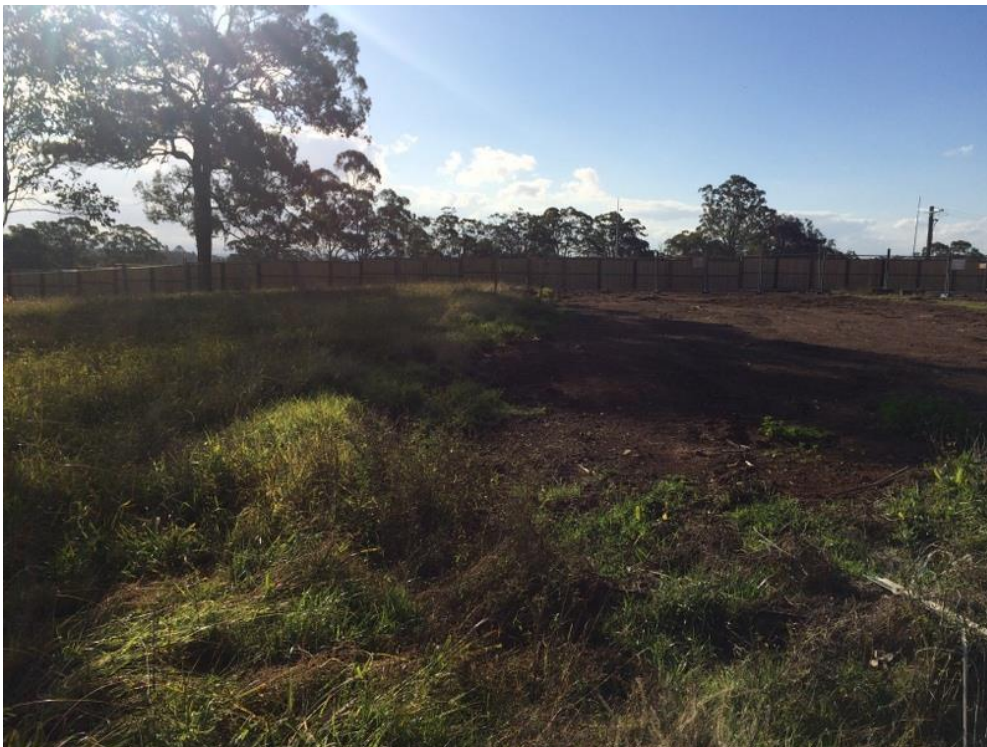
Plate 2: Subject site facing west towards the Mirvac development. The tree shown (*Eucalyptus crebra*) is just outside the subject site.

One native tree (*Eucalyptus tereticornis*) is present within the subject site (Figure 5). Another native tree (*Eucalyptus crebra*) sits just outside northern corner of the subject site. These trees are canopy species associated with the Shale Plains Woodland vegetation community, which is a sub-community of Cumberland Plain Woodland (CPW). CPW is listed as a critically endangered ecological community under the NSW *Threatened Species Conservation Act* (TSC Act) and the Commonwealth *Environment Protection and Biodiversity Conservation Act* (EPBC Act). Under the EPBC Act, only CPW that meets certain condition criteria are protected (based on patch size and percentage cover of native perennial species). As such, these trees are only protected under the TSC Act, as the EPBC Act condition criteria are not met on site.

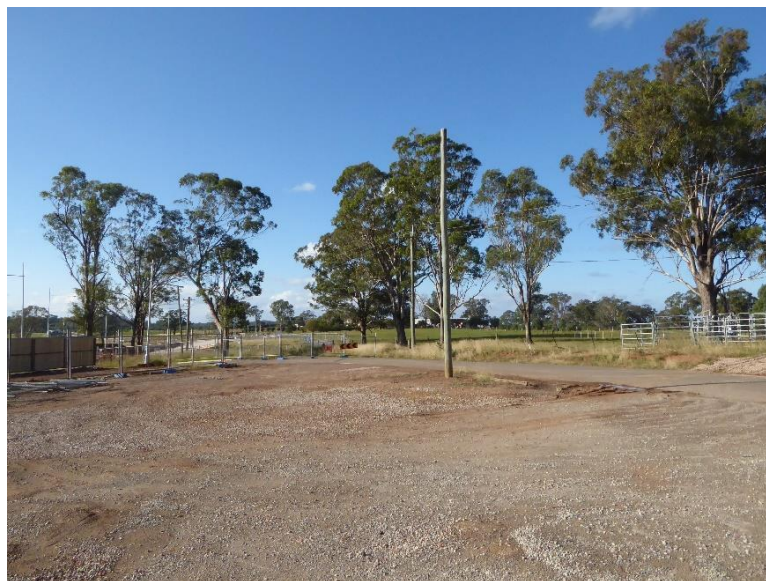
Figure 3 View north from the southern end of the subject property, showing part of the sound attenuation barrier along Gledswood Hills Drive at far left. (Photo: Chris Betteridge, 16 June 2017)

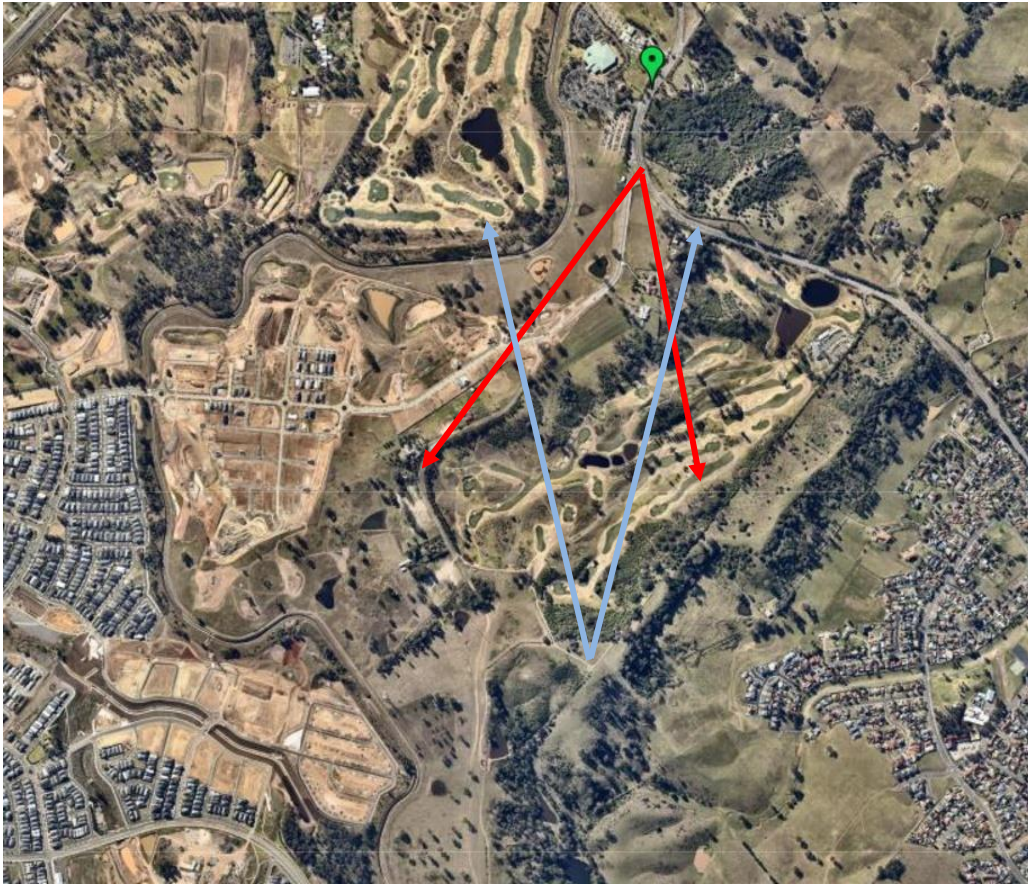
Figure 4 Arcs of view over the subject property from Raby Road (red) and a high point on the ridge southeast of The Grange golf course (blue). (Source: *nearmap* / **MUSEcape**)

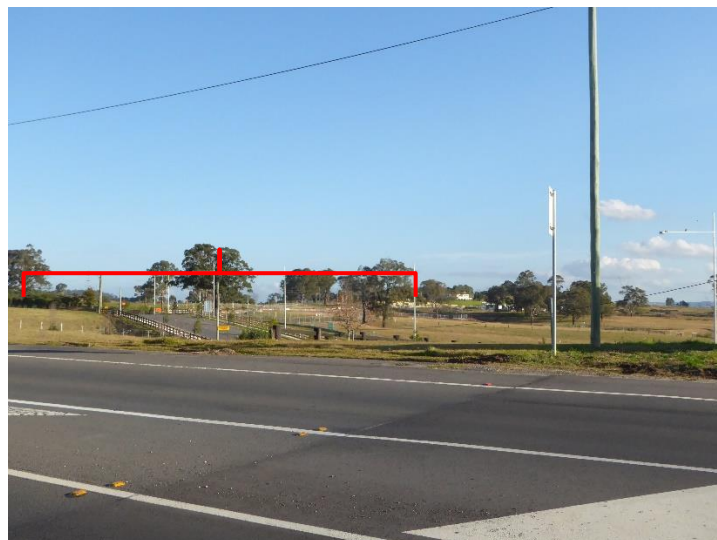
Figure 5 View from the eastbound carriageway of Raby Road over the northern part of Gledswood Hills Drive towards the subject property, within the area marked red. (Photo: Chris Betteridge, 13 June 2017)

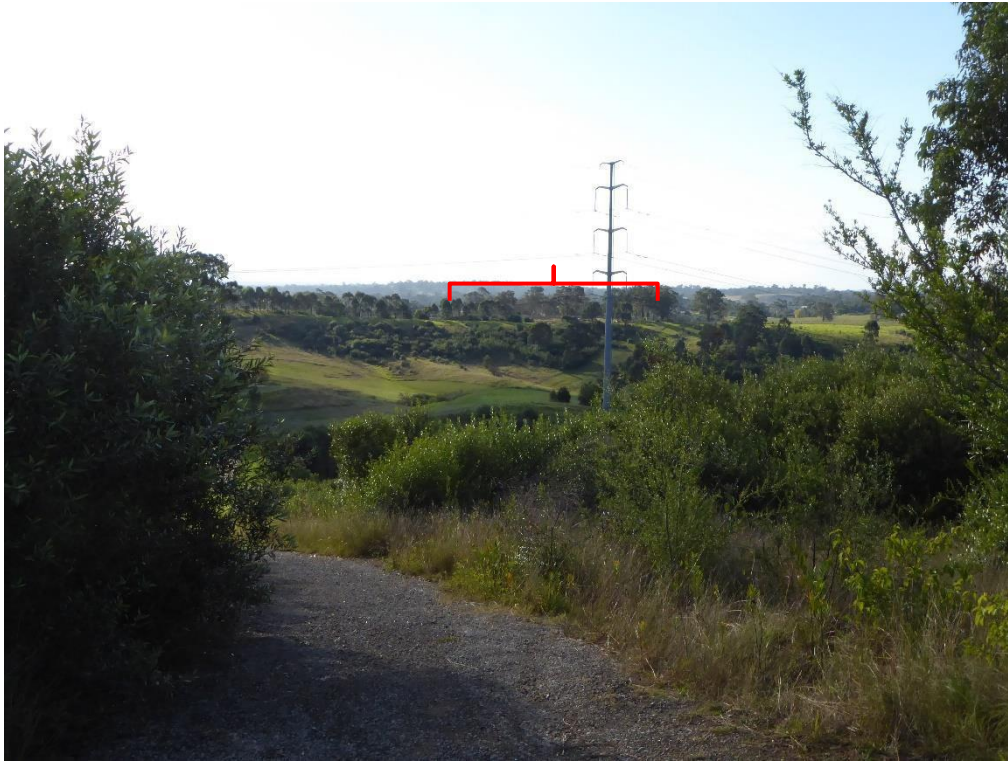
Figure 6 View from high point southeast of The Grange golf course towards the subject property, marked red. (Photo: Chris Betteridge, 13 June 2017)

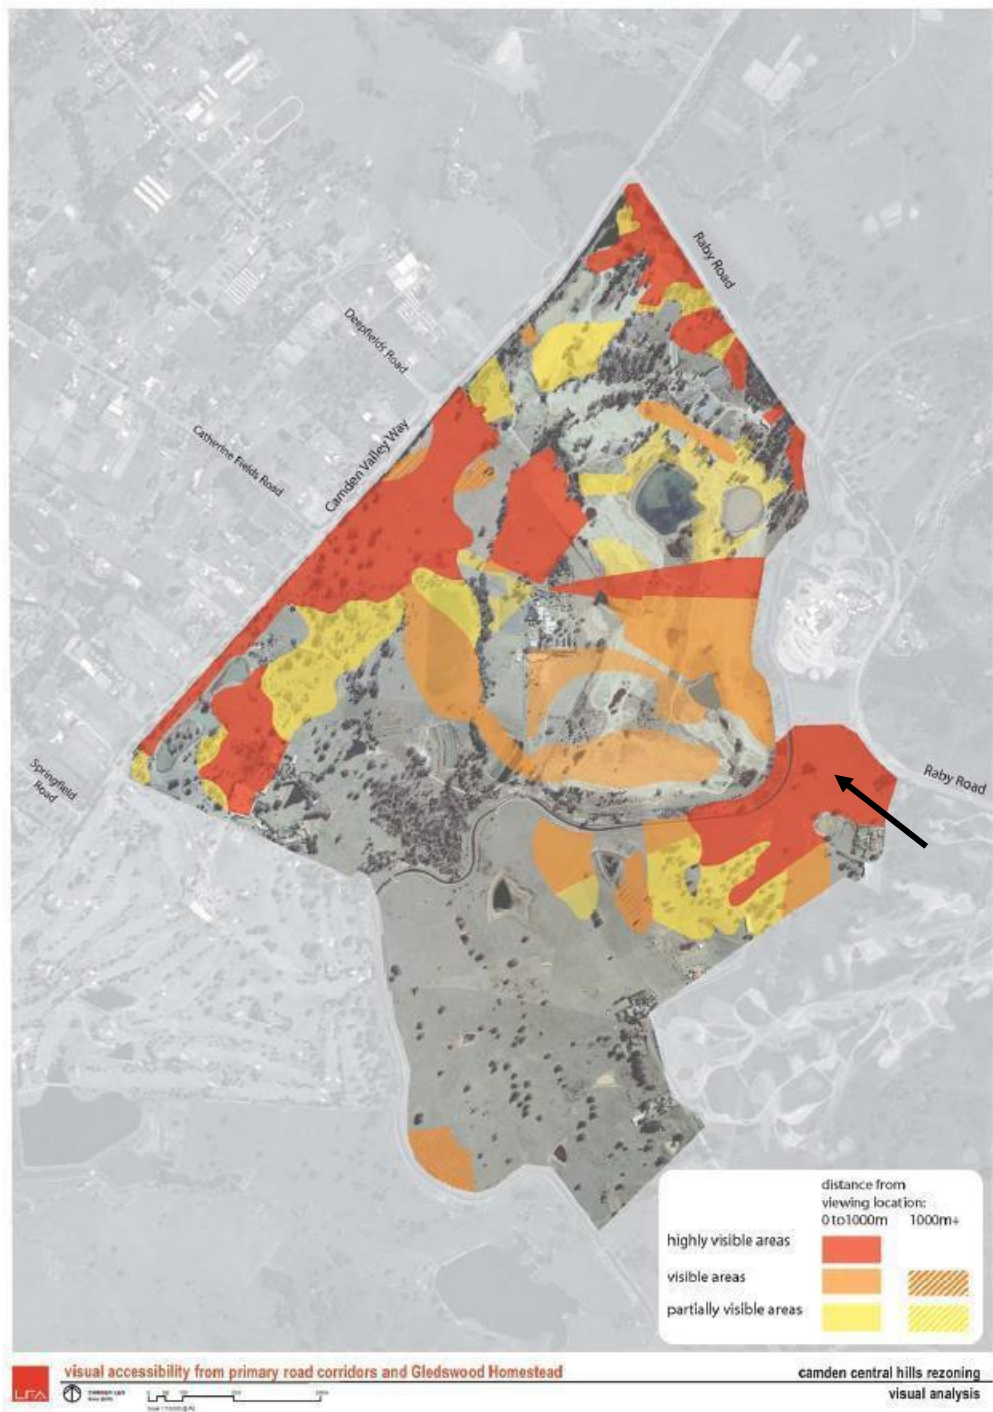
Figure 7 Visual accessibility from primary road corridors and Gledswood Homestead, showing the location of the subject property, arrowed black. (Source: LFA (Pacific) Pty Ltd)

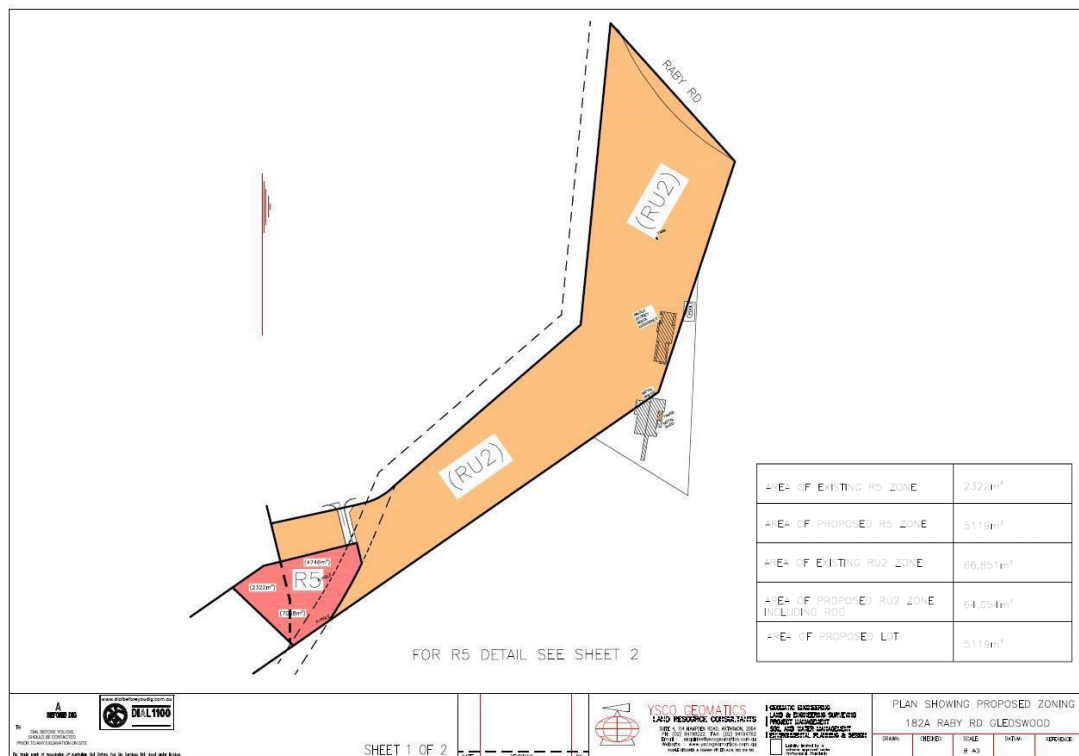
The proposal is detailed in the diagram below.

Figure 8 The subject property showing the current zonings and the areas of existing and proposed zonings. (Source: YSCO Geomatics Land Resource Consultants)

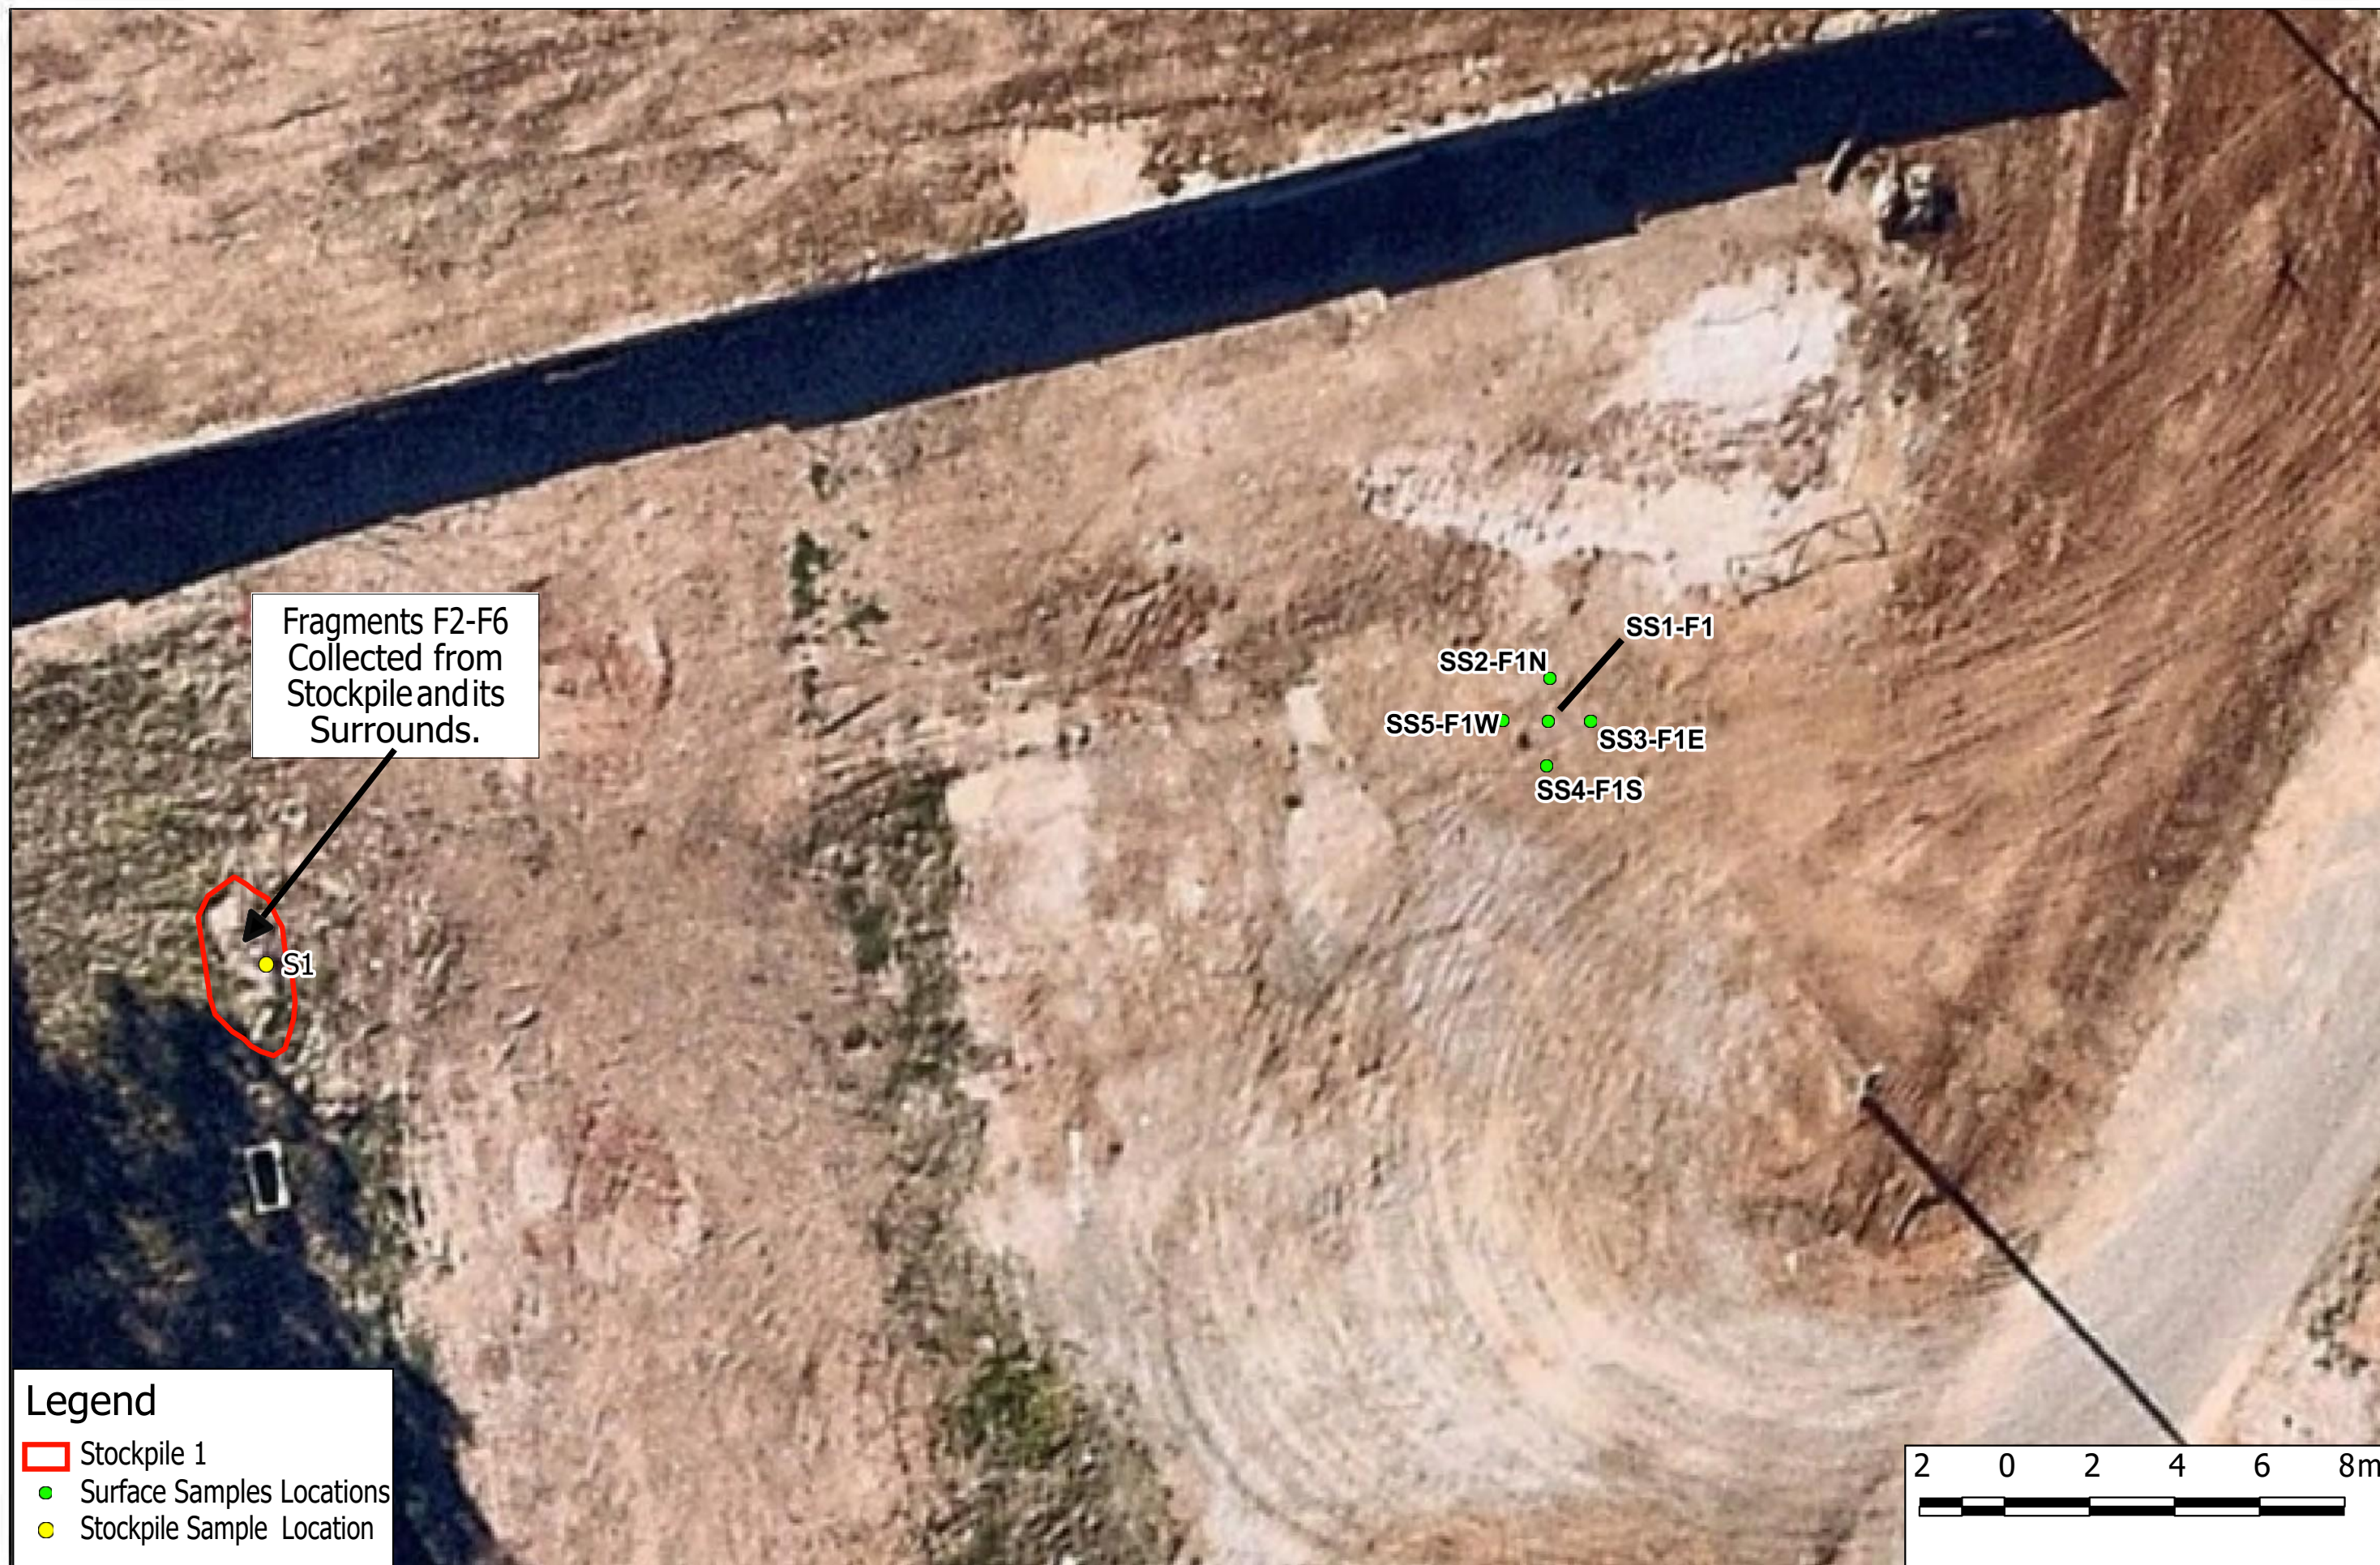
DRAWING No: 2

- Stockpile 1
- Surface Samples Locations
- Stockpile Sample Location

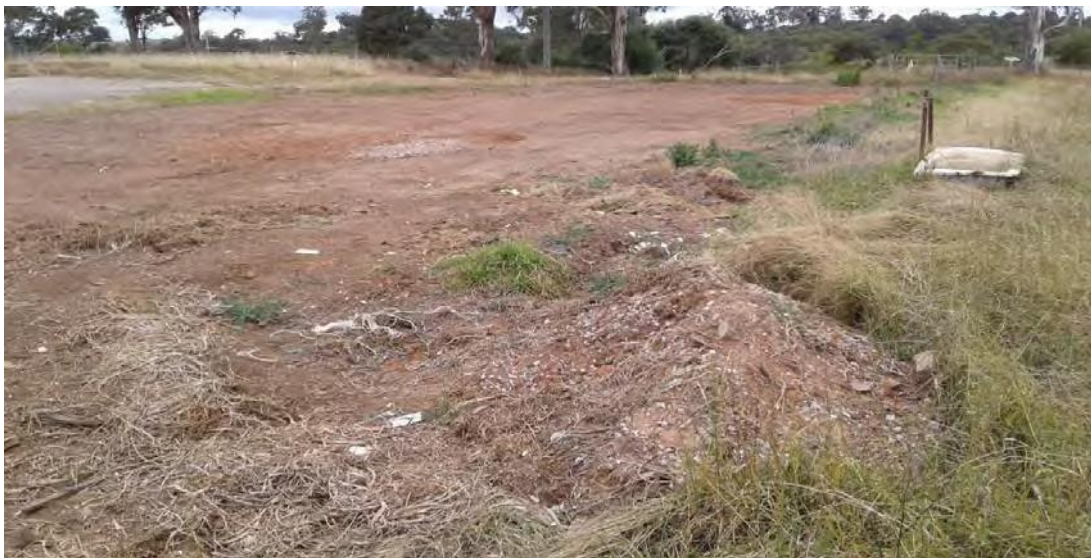
Photograph 4 - Soil / building waste stockpile located in central northern portion of site. Several fragments of fibrous cement material observed in vicinity of stockpile.

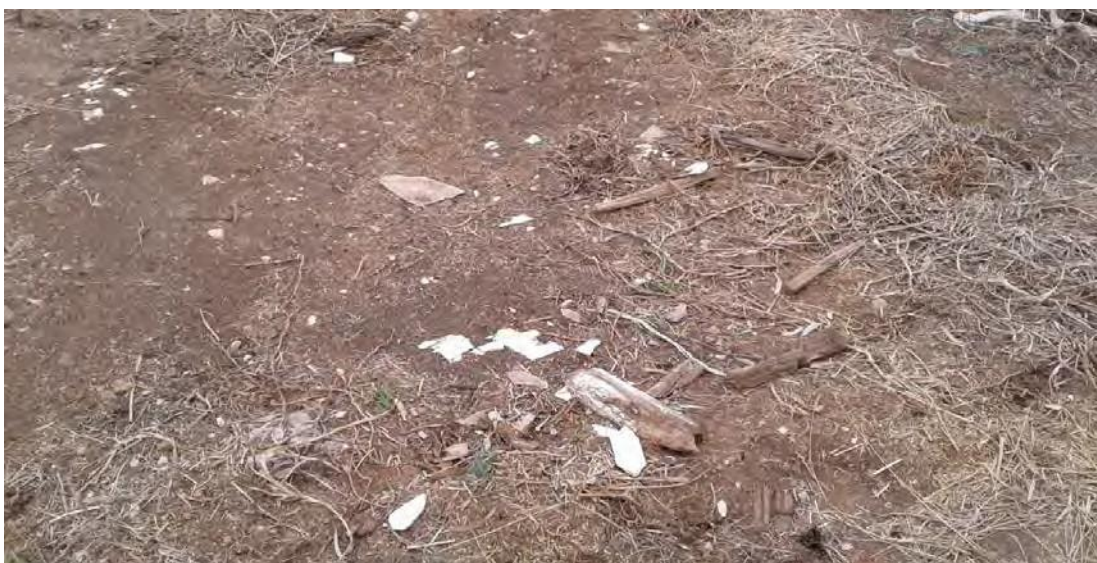
Photograph 5 - Fragments of fibrous cement material in the immediate vicinity of stockpile in central northern portion of site.

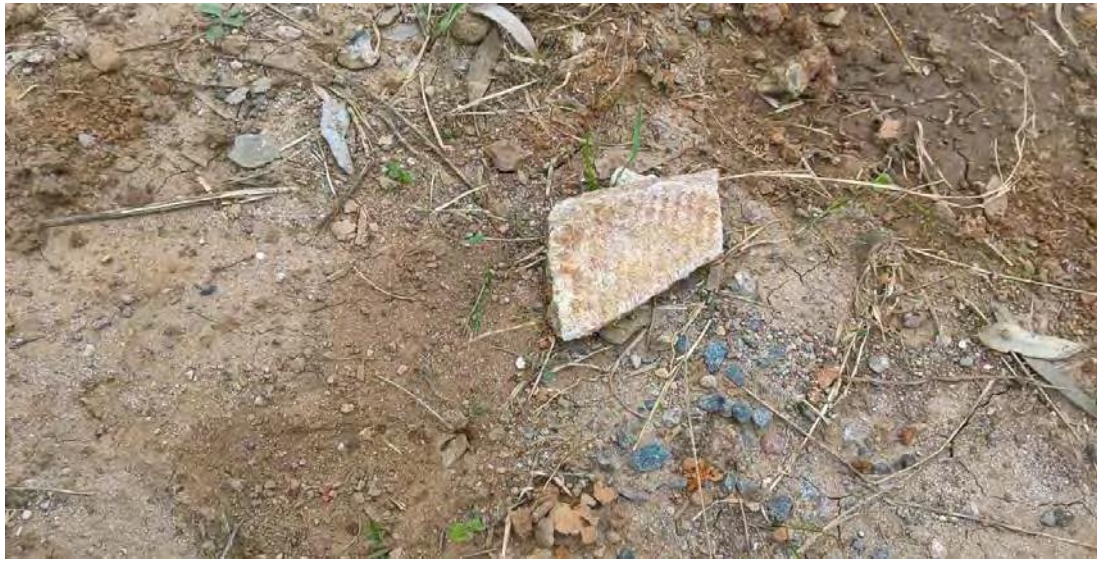
Photograph 9 - Fragment of ACM on surface soils in north eastern portion of site.

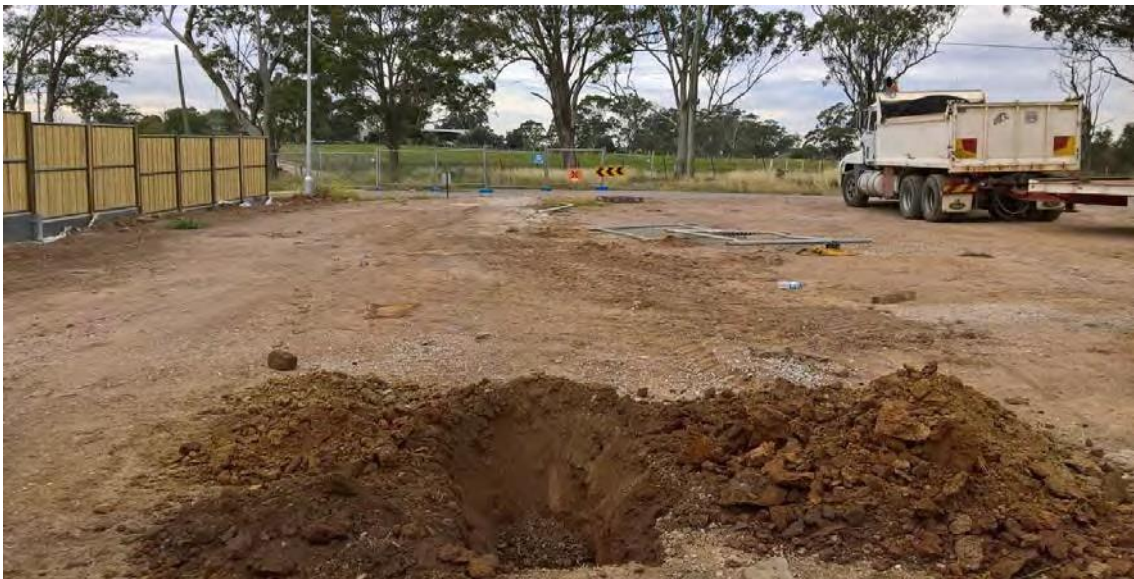
Photograph 10 - Test pit 4 completed in north eastern portion of site.

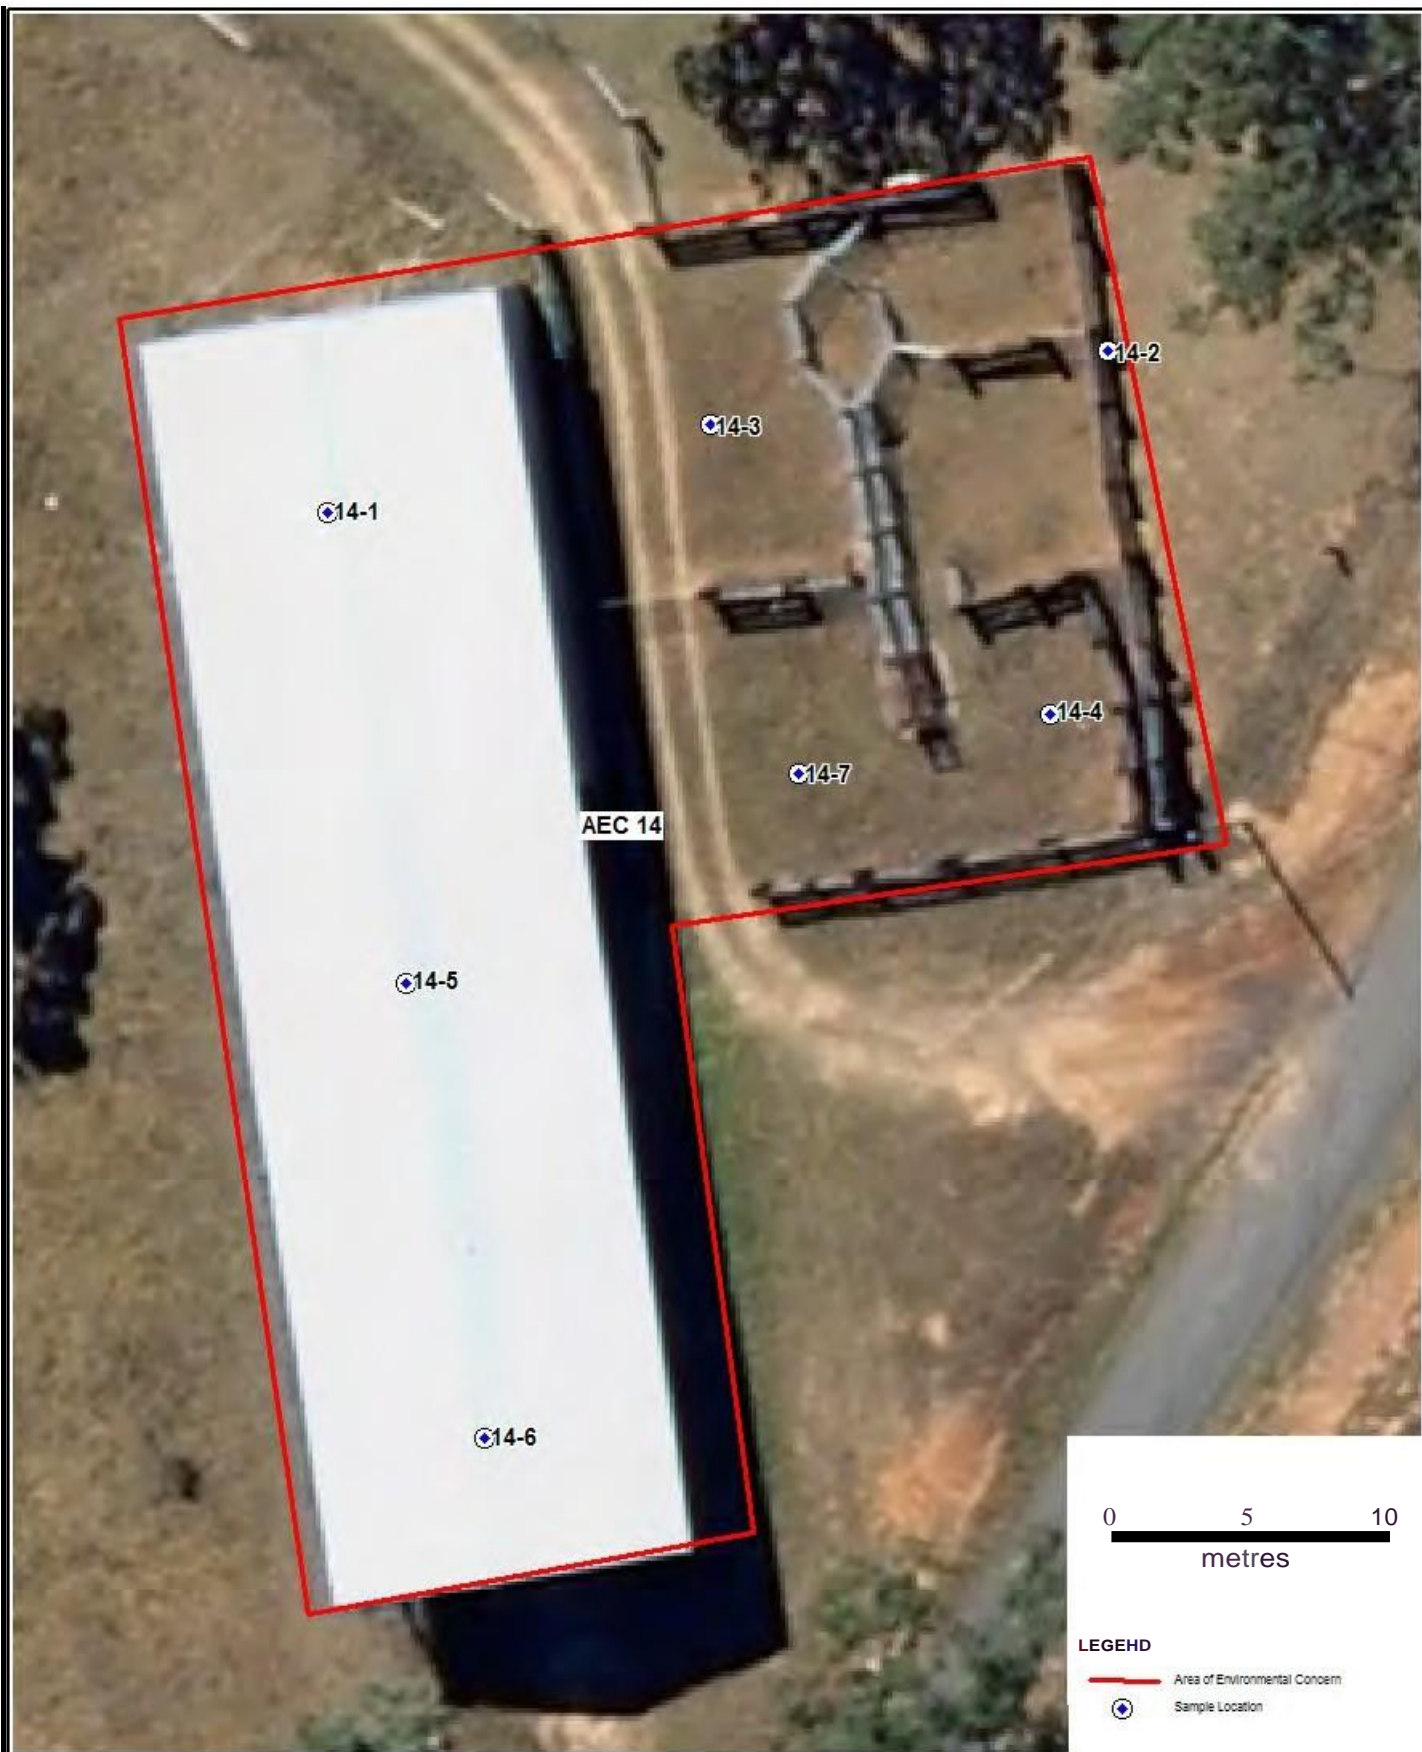
Title: **SAMPLE LOCATIONS - AEC 14**
PHASE 2 CONTAMINATION ASSESSMENT
GLEDSDOOD HOMESTEAD & RURAL PROPERTIES
