**PRELIMINARY CONTAMINATION & GROUNDWATER ASSESSMENT**

**64-68 THE GRAND PARADE, BRIGHTON-LE-SANDS NSW**

**Job No: MPG 2039**

**Report No: ENV AA**

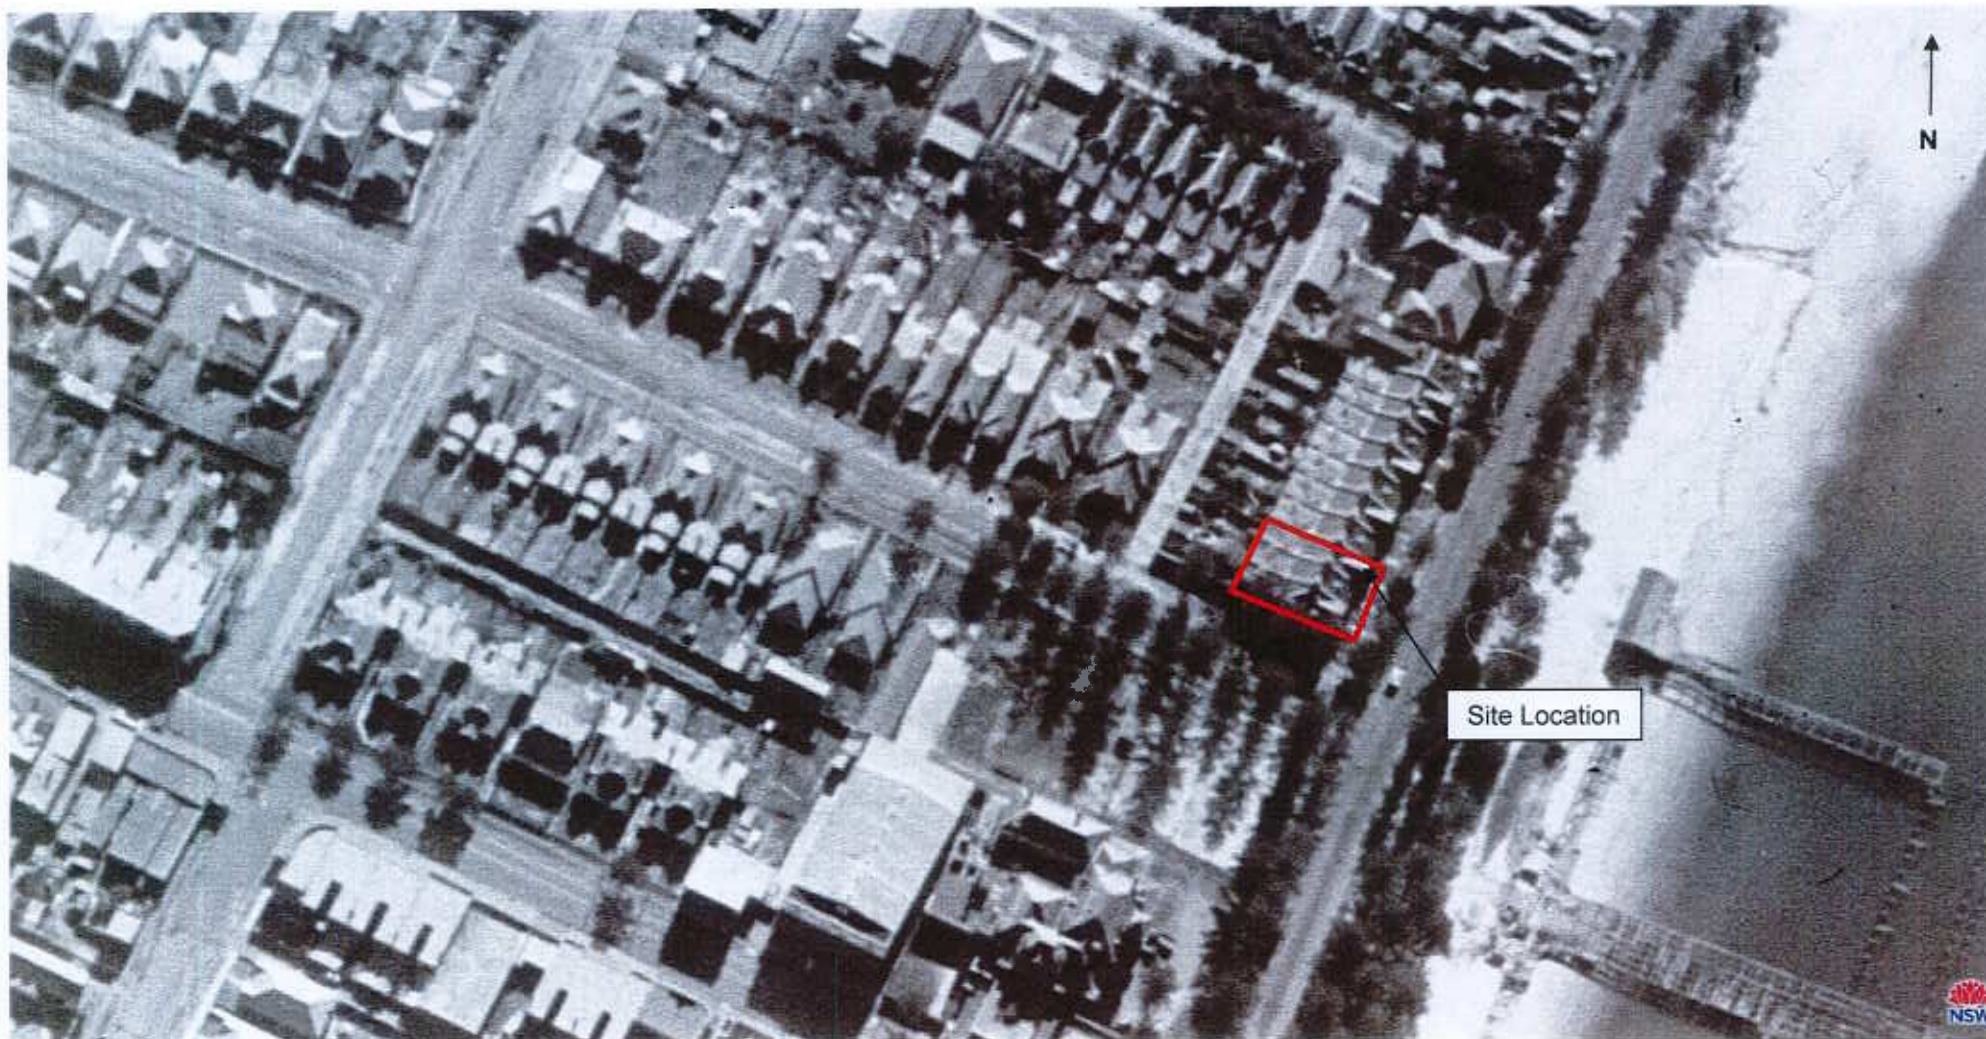
| Drawing No: | ENVAA_001 |

The site and properties immediately north of the site appear to contain terrace houses. Further north, single detached dwellings can be observed. The Grand Parade, Princess Street and the access laneway are all visible, to the East, South and West respectively. To the south of Princess Street, an open grass area is observed, and a large, tall building can be seen. To the west, beyond the access laneway, duplex developments are observed. The beach immediately east of the site appears to have a long jetty extending into the bay. The general area appears to consist predominantly of residential properties.

1943 Aerial Photograph  
 64-68 The Grand Parade  
 Brighton-Le-Sands, NSW

The site is currently occupied by four (4) terrace houses. The houses appear rather old, though generally well maintained. The most southern terrace house (No.: 68) appears to be run-down and abandoned. Based on the appearance of the existing buildings, the site has been used for residential purposes for a long period of time, with the buildings appearing consistent with the 1943 aerial image.

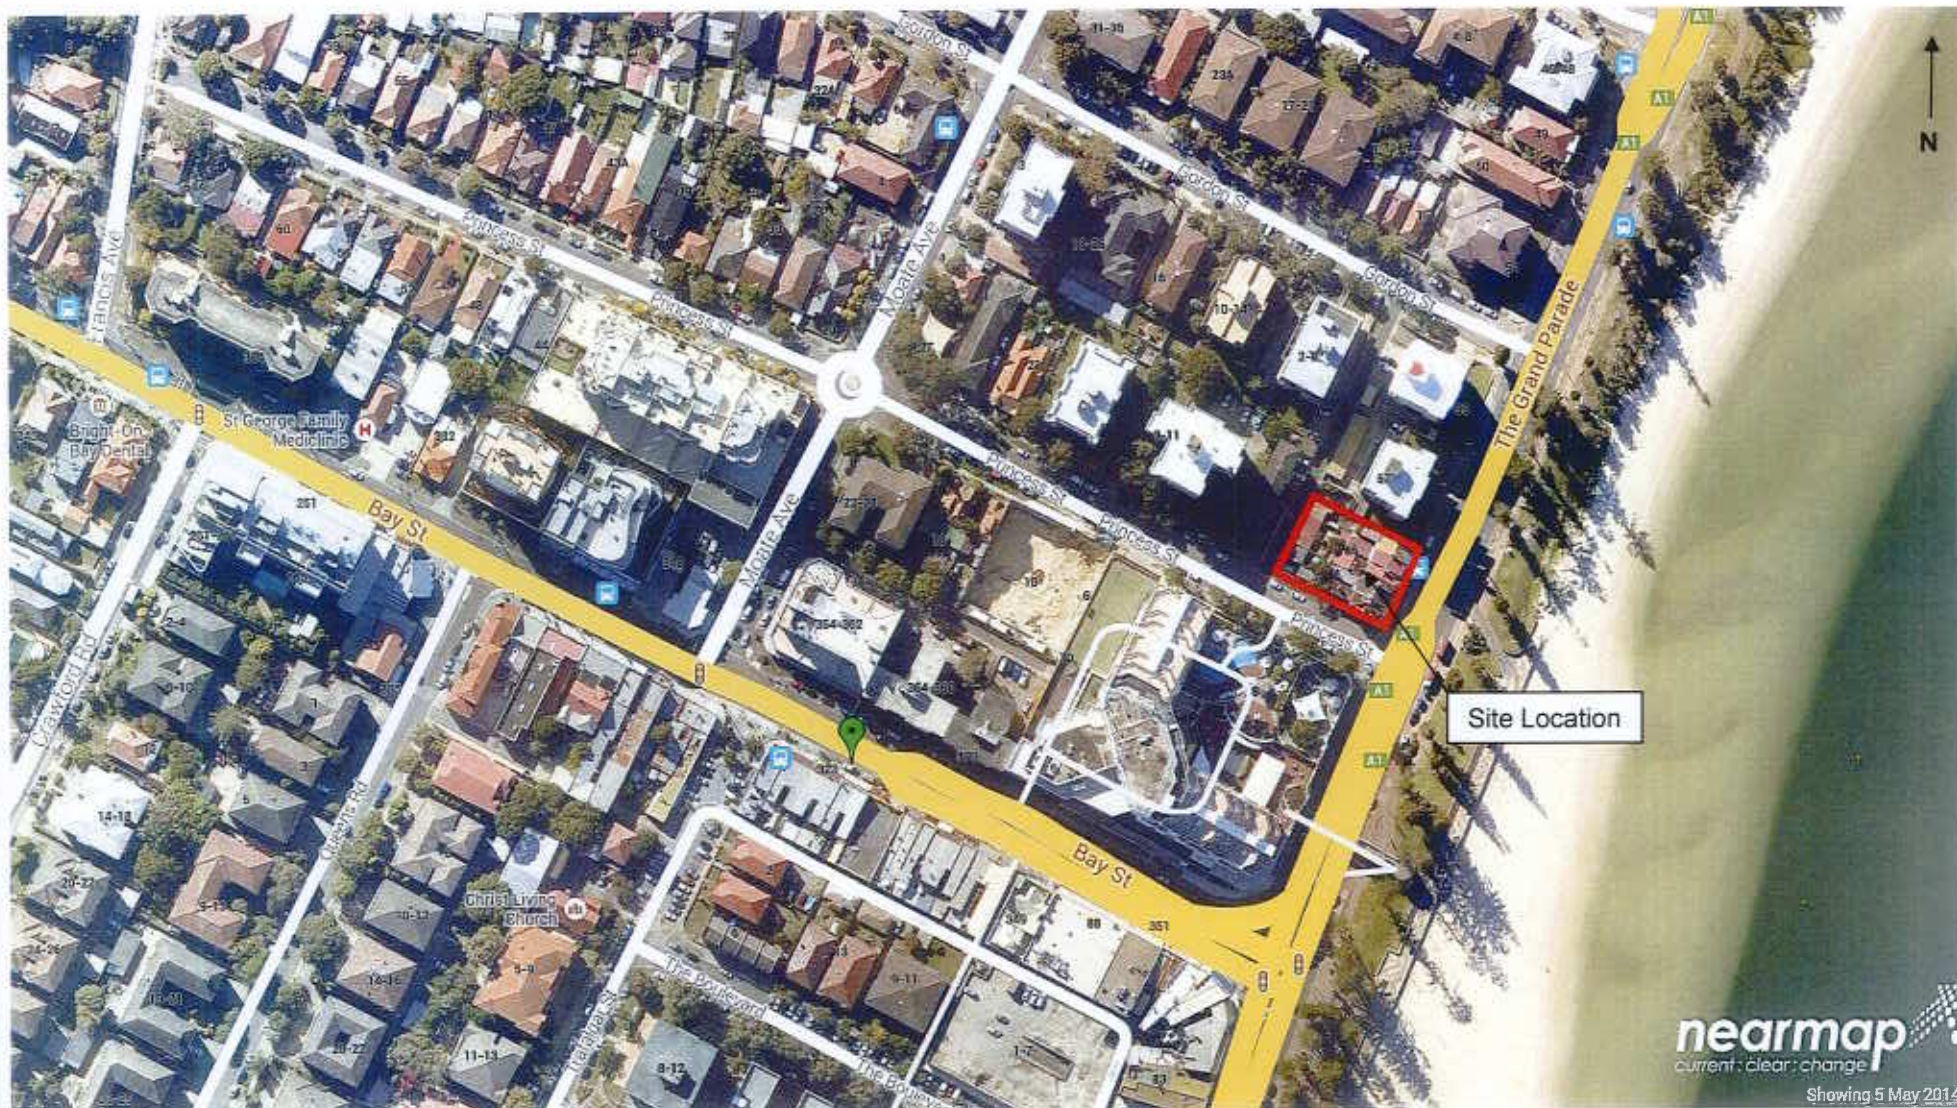
| Drawing No: | ENVA_002 |

The site appears to remain generally unchanged from the 1943 photograph, though the surrounding area has undergone significant redevelopment. The terrace houses to the north, extending to Gordon Street, have been demolished and redeveloped into two (2) apartment complexes. The duplex dwellings to the west have also been replaced with apartment complexes. The grassed area and large building to the south of Princess Street has been redeveloped and is currently a large hotel (Novotel). The jetty on the beach immediately east of the site has been removed.

2014 Aerial Photograph  
 64-68 The Grand Parade  
 Brighton-Le-Sands, NSW
